Stewart Patrick Esq.  
Hailwood House,  
Park Avenue,  
Wortley, S35 7DR.

**Trees and your planning application.**

**Tree protection method statement.**

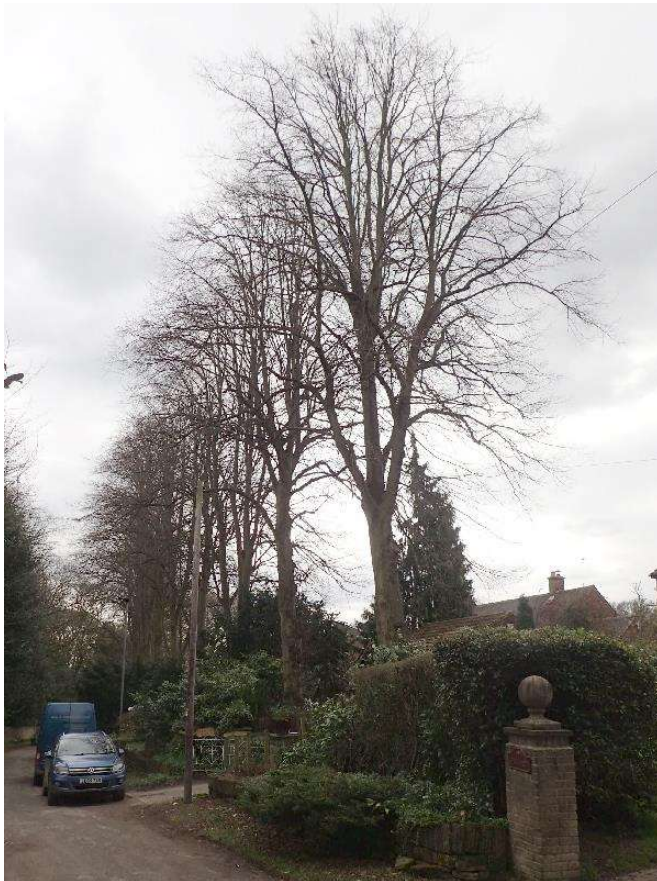
Photograph 1.

Photograph 1 is a view of the trees as seen from the road looking roughly east. Only the first two trees in this photo are in the garden.

Both trees are approximately 20 metres tall. Both are in reasonable condition and appear to be fairly typical of Common Lime trees grown in these situations. The trees are part of a uniform row of trees that extends alongside the road. Your driveway runs between the two trees. Your designer has marked the trees on the site plans, T1 is to the east of the driveway, T2 is to the west. T1 is 700 mm diameter and T2 is 750 mm.

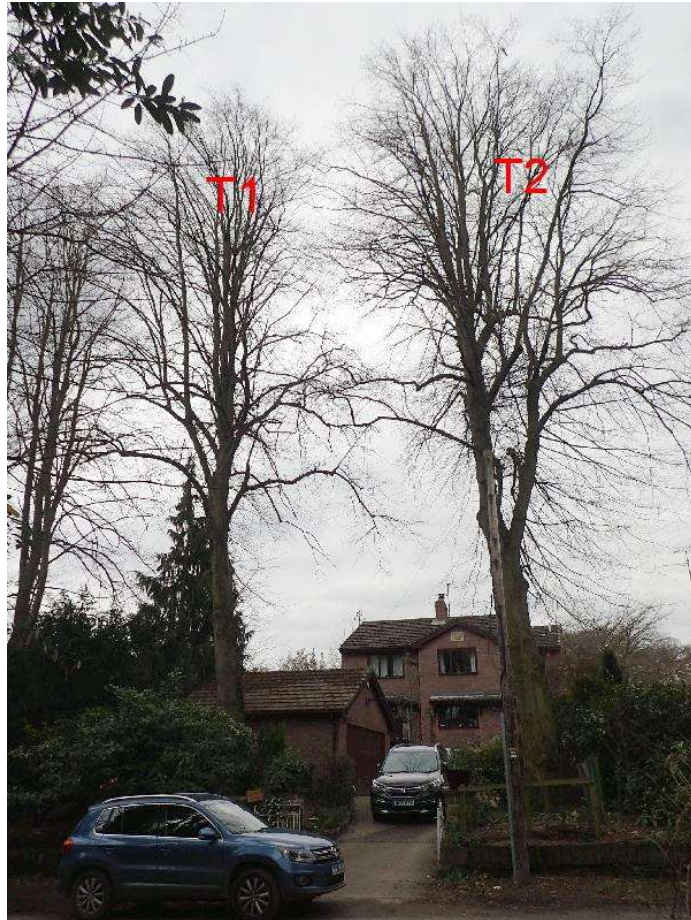
Photograph 2.

Photograph 2 is a view of the two trees taken from the opposite side of The Flatts, looking roughly south.

The trees have both been pruned at least once, seemingly to a height of approximately 14 metres. (I shall discuss the routine management of trees like this below.)

In my opinion, it would be prudent for you to prune your two Lime trees to reduce the height and spread by approximately 6 metres. Ideally I would prune them by more than this, in an effort to get them in proportion with your house, but this is currently not recommended. There is a best practice document for pruning trees, *British Standard 3998 (2010) Tree Work – Recommendations*, which implies that removing more than 30% of any tree's leaf cover is undesirable. Invariably local planning authorities granting permission to prune protected trees will follow this guidance.

In this case reducing the height by 6 metres would be rather more than BS3998 suggests is ideal, but ought to be tolerable for the Council. This is because it's pruning that is overdue; it should have been done some years ago. Fortunately Common Lime is very tolerant of even quite severe pruning so I don't think the trees will suffer unduly.

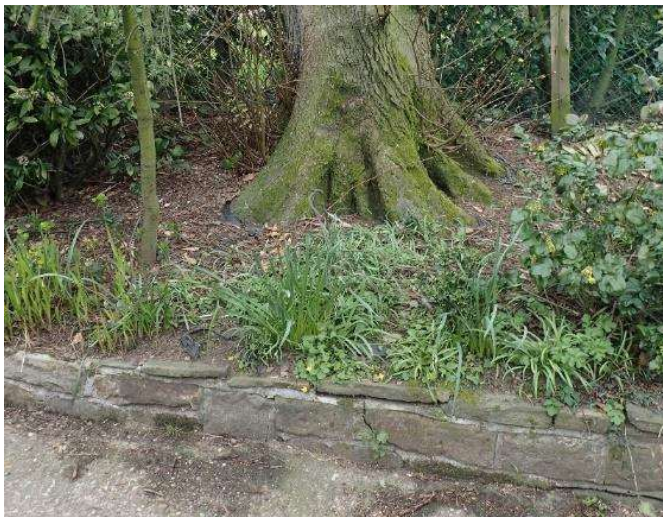
Photograph 3.

Photograph 3 is a view of the base of tree 2. It's approximately 1 metre from the side of the drive, which is surfaced with concrete. The scheme does not call for the drive to be widened so all site traffic will be passing on existing surfaces.

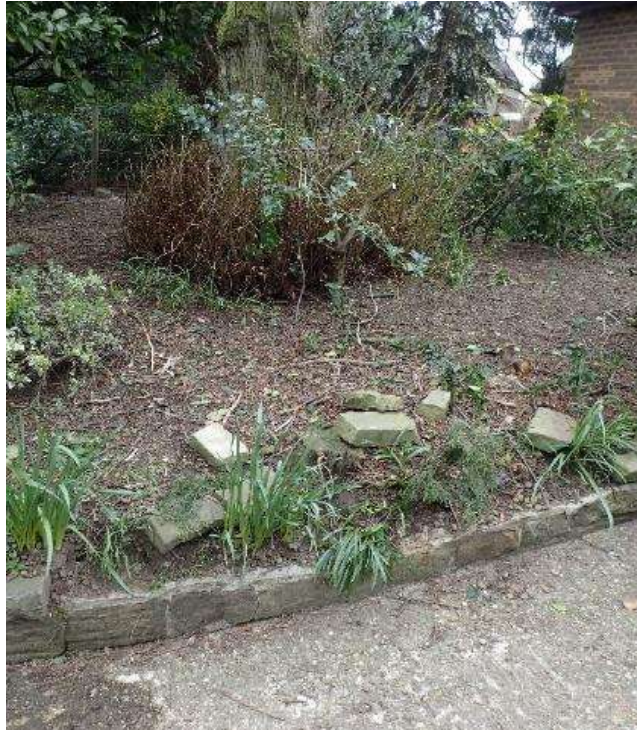
Photograph 4.

Photograph 4 is a view of the base of tree 1. The “basal sprouts” or shoots, often called feathers, that emerge from the base of the trunk are normal on Common Lime trees, and frequently a nuisance requiring regular removal.

This tree is a couple of metres from the driveway, and again there are no plans to alter this situation.

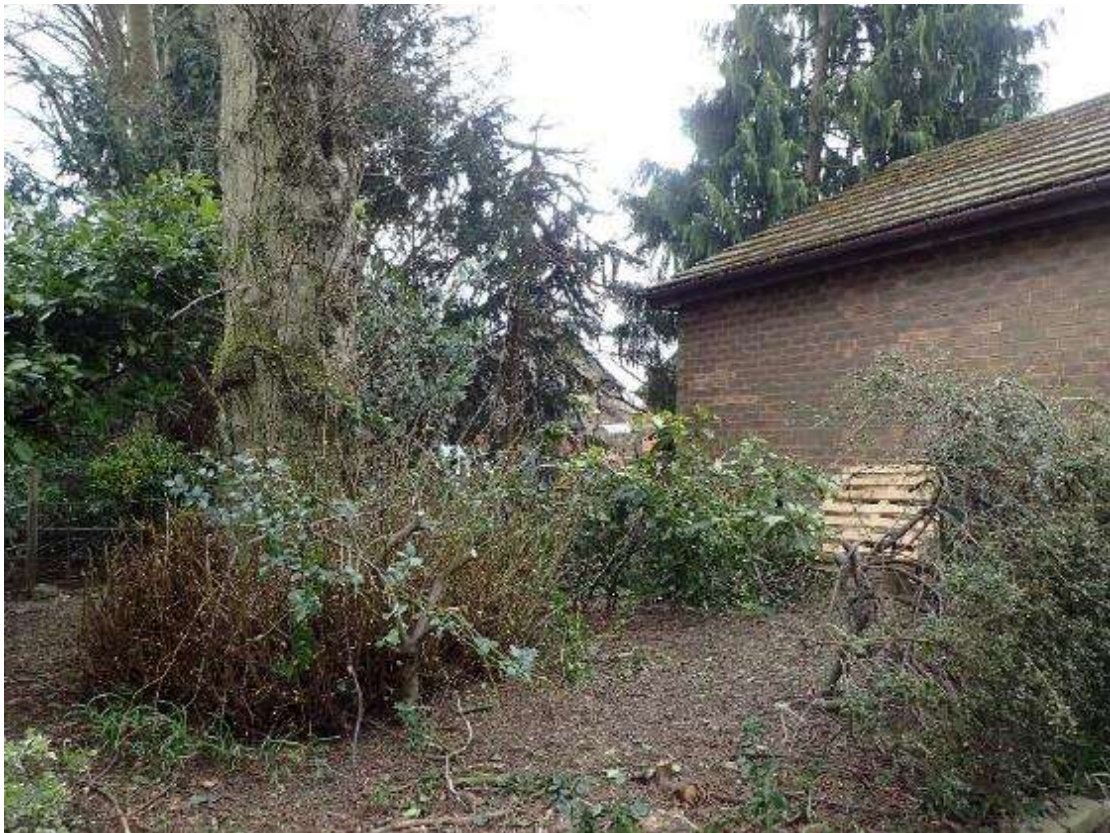
Photograph 5.

Photograph 5 is another view of the base of tree 1, which I’ve included to show the space between it and the garage. A heating oil tank is going to be located in this area. I shall

discuss this matter below. The evergreen, Cypress-like tree beyond the garage is in the neighbouring garden.

This oil tank is going to be quite close to tree 1. Fortunately, it is feasible to construct a concrete stand without doing any excavations, so damaging the roots of tree 1 is not necessary.

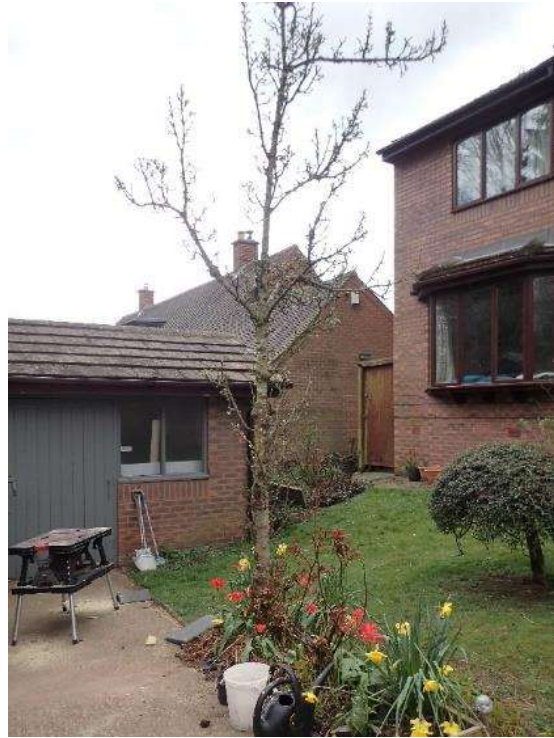
Photograph 6.

Photograph 6 is a photo of the only other slightly significant tree in the site; it's an Apple and is widely infected with Nectria Canker. I recommend this is removed. Nectria Canker is extremely common on domestic apple trees. In this case the infection is so widespread that there seems to be little point in trying to manage the disease, so removal and replacement would be most sensible.

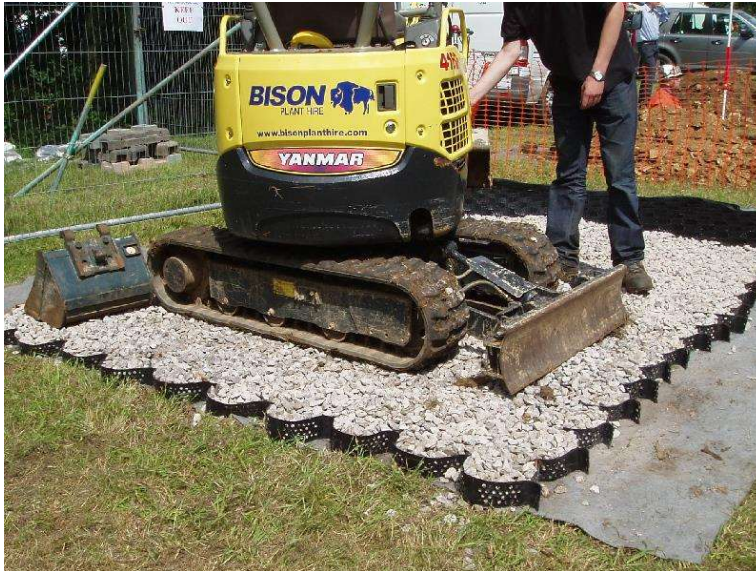
Photograph 7.

Photograph 7 shows a no-dig surfacing system being demonstrated at an arboricultural industry event. This “cellular confinement system<sup>1</sup>” can be used beneath a concrete or tarmac surface. Different thicknesses are available depending on the loads involved.

The principle behind these systems is that they avoid excavation so tree roots are not damaged. Loads are also spread so soil is not compacted and tree roots may continue to garner resources from beneath the surface. Ideally, moisture would still percolate through, although in the case of the oil tank, this would be prevented.

3. The proposals in the tree protection method statement should be followed.
4. The stand for the heating oil tank should be constructed using a no-dig system of surfacing, probably similar to the one illustrated in photo 7.
5. I consider the two Lime trees to be overdue for pruning. I suggest they are pruned with the objective of reducing their height considerably, and then managing them in the future to not allow them to get quite so tall. If you could persuade the neighbours to prune their trees similarly, I think this would be welcomed by the Tree Officer and the neighbourhood's landscape would benefit.

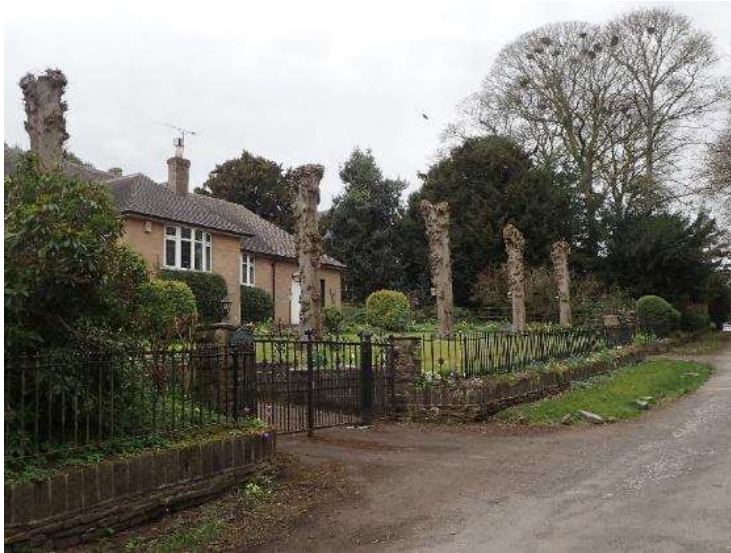
Photograph 8 shows 5 of the Lime trees in the next-door-but-one garden to the west. It seems that the integrity of the row is already lost.

Although I accept that these trees have been pruned in this manner for a long time, and could be regarded as traditional, it is not in the best interests of either the trees or the overall landscape.
