## Wentworth Castle Gardens Ecology Statement

### 1. Introduction

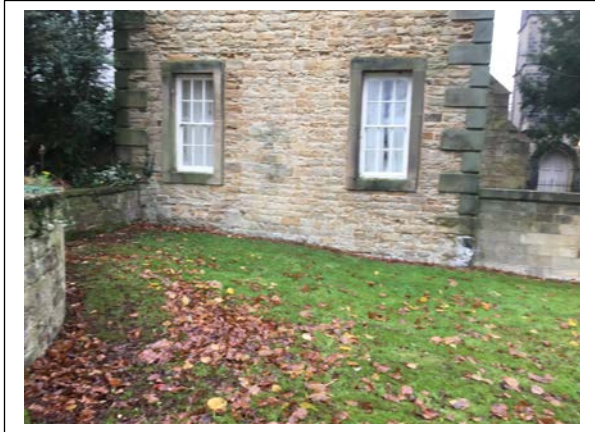
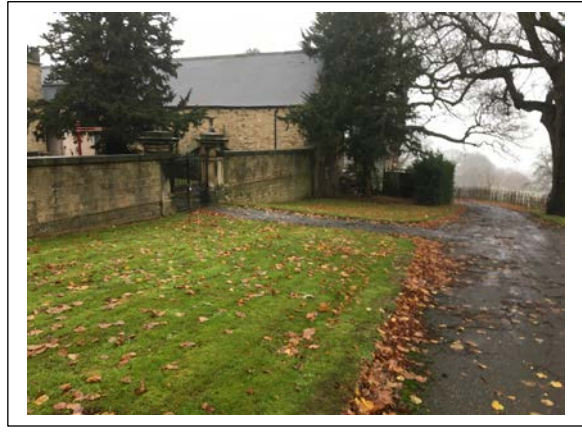
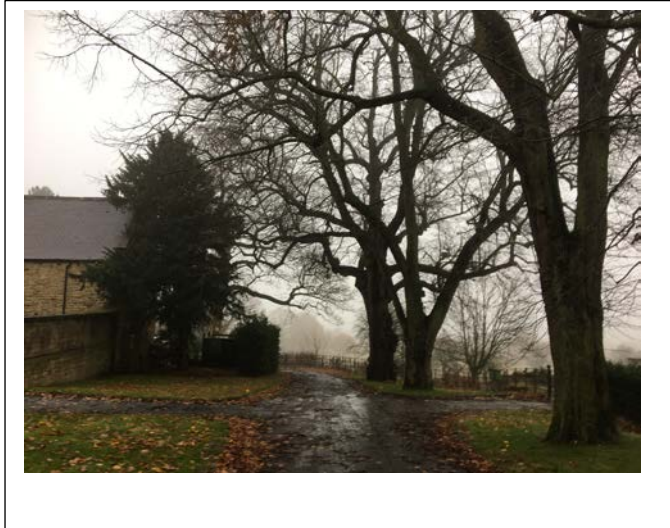
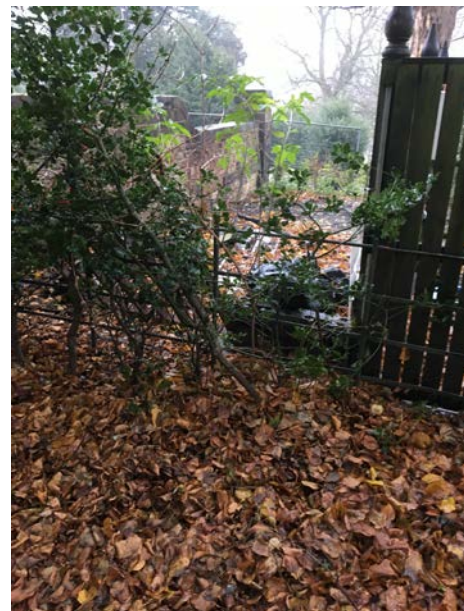
Trench section A-B

**Section A-B:** this section is mown & "improved" amenity grassland lawn of low species diversity, part way along the route passes through a sparse & gappy holly hedge

Gappy & sparse holly hedge, low potential

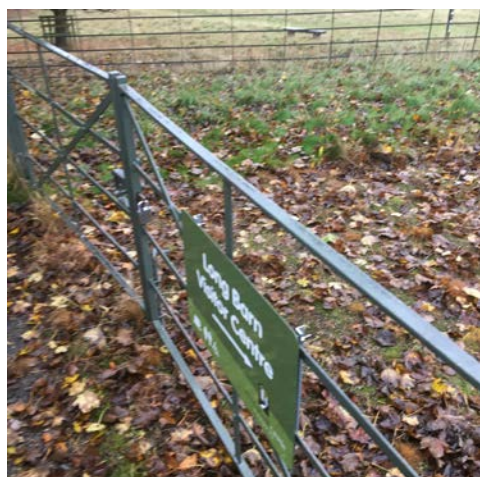
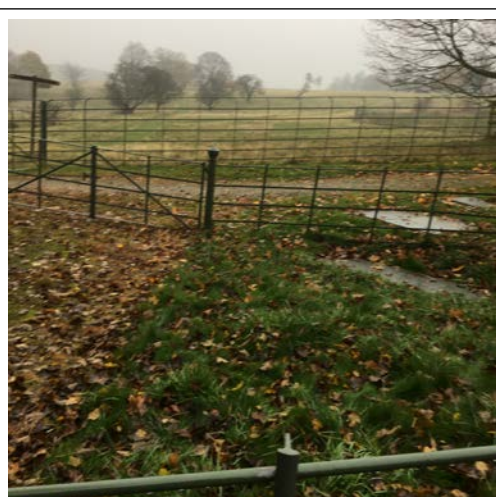
Trench section B-C

**Section B-C:** this section is consolidated hard-core track centre with mown & "improved" amenity grassland lawn verges of low species diversity

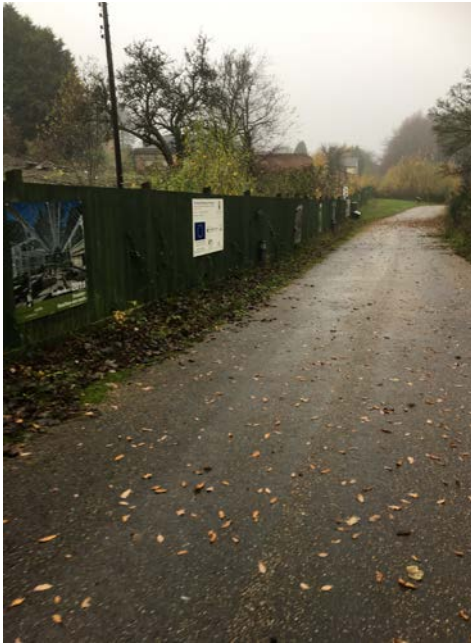
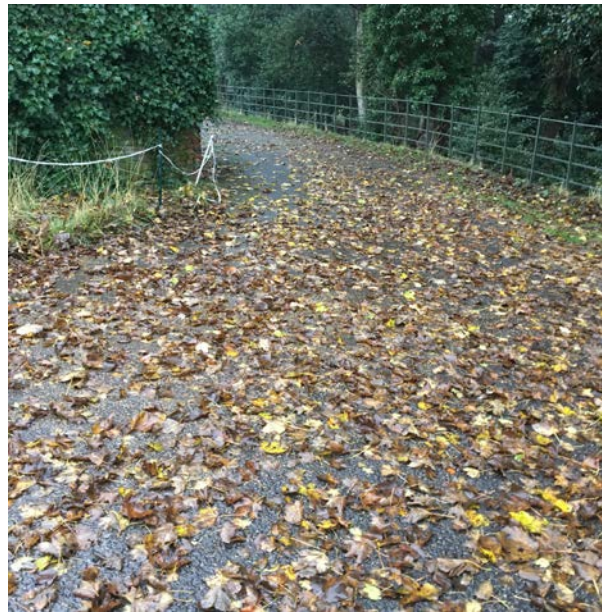
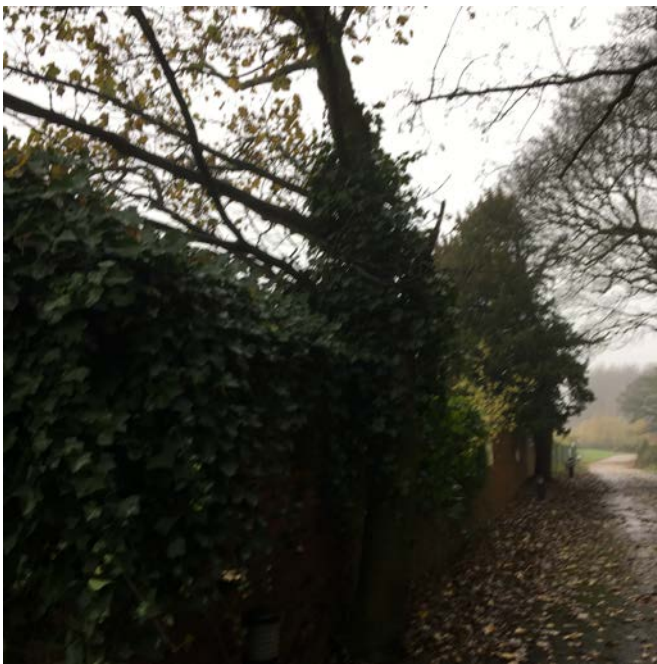
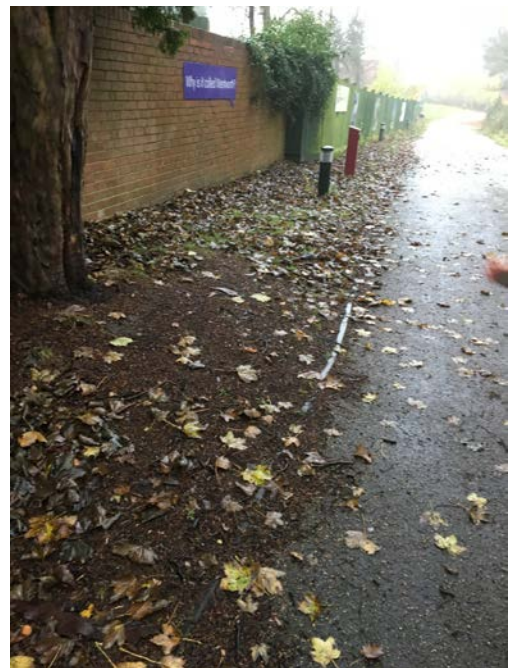
**Trench section C-D**

**Section C-D:** this section is tarmac road with mown & "improved" amenity grassland lawn verge of low species diversity, with some areas under trees being bare soil/humus layer

There is one tree along the route which is considered necessary for removal. This is a small sycamore approximately 20cm DBH. This tree can be seen in trench section C-D photos, Appendix B. The tree is relatively young and has no veteran tree features, and has been assessed by the author as being of very low potential as bat habitat.

Trench section C-D, showing young sycamore tree to be removed (low bat potential)

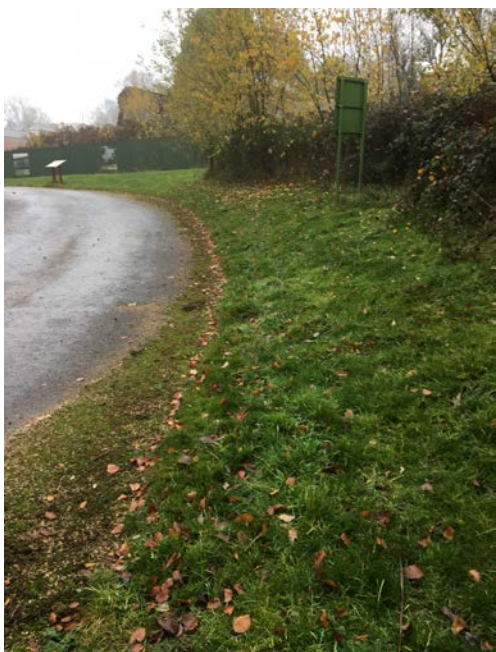
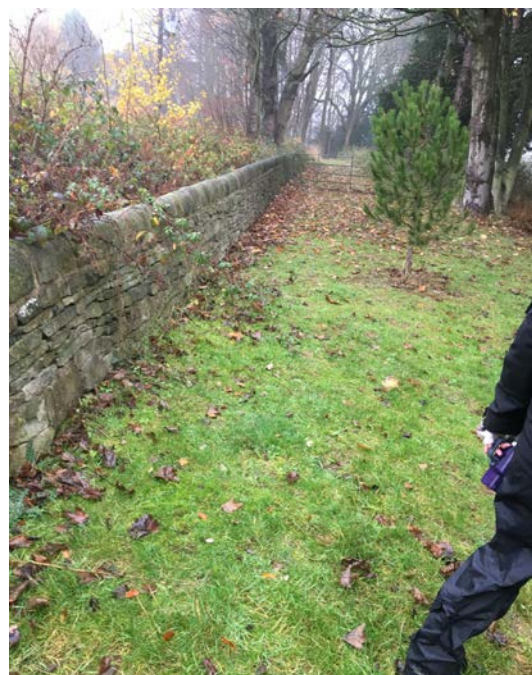
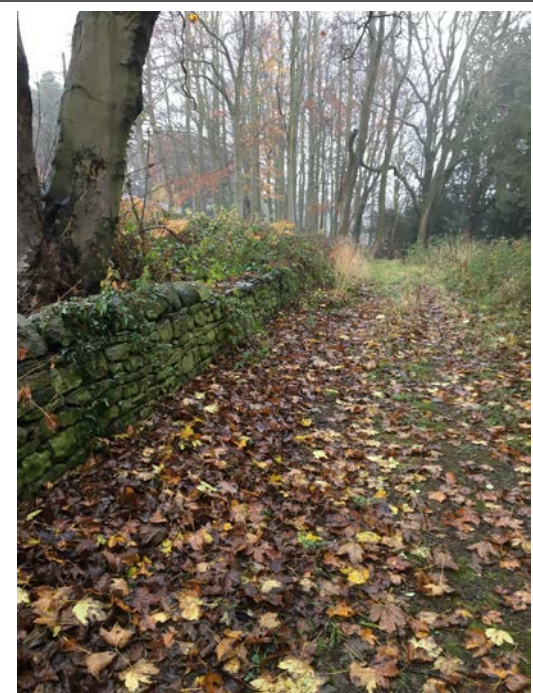
Trench section D-E

**Section D-E:** this section starts as tarmac road with mown & "improved" amenity grassland lawn verge of low species diversity, then becomes a grassy woodland track, mown grassland of low species diversity, then becomes a woodland edge track with heavy layers of leaf mulch in parts

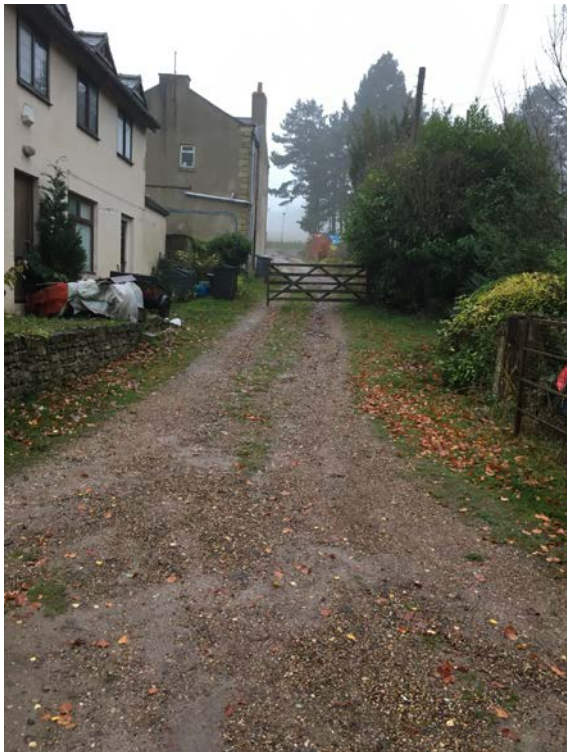
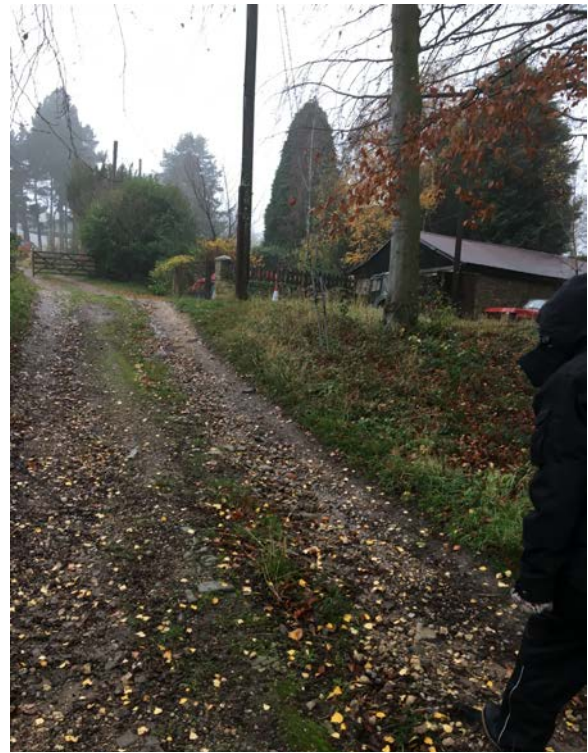
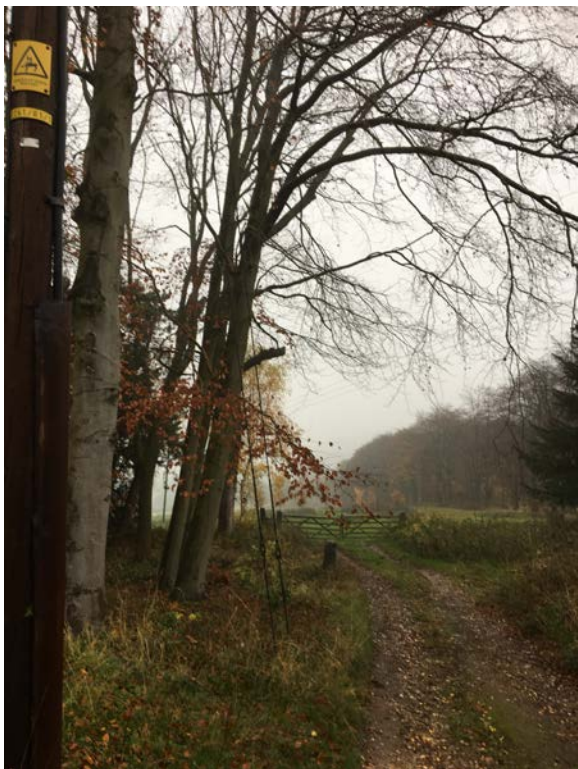
Trench section E-F

**Section E-F:** this section is consolidated hard-core track centre with mown & "improved" amenity grassland lawn verges of low species diversity, quite rough grassland grading into bramble & nettle further away from road

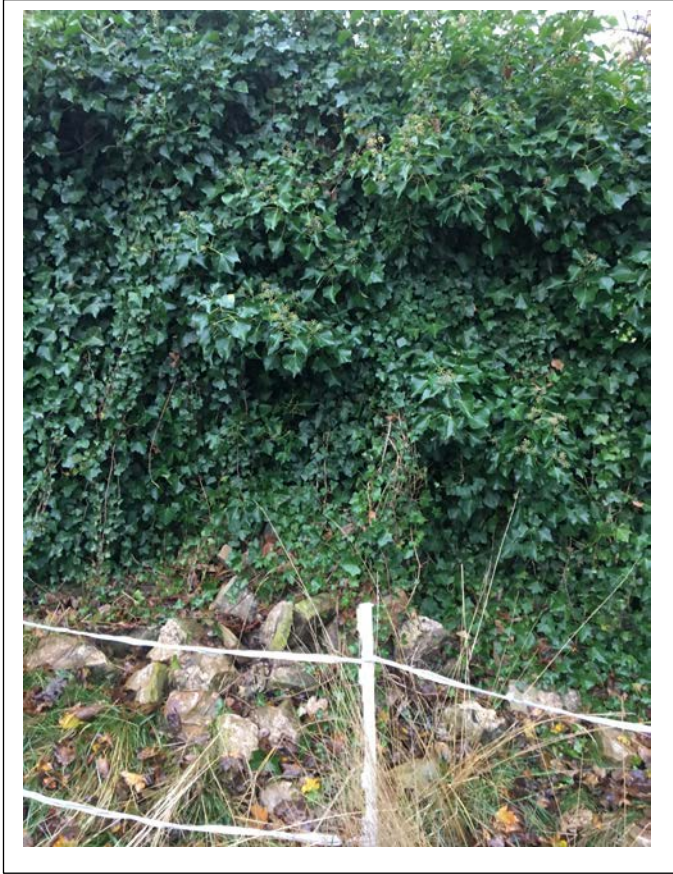
There is a short section of deteriorated & collapsed wall along section C-D. The wall is generally sound apart from the collapsed area, with intact mortar and few opportunities for roosting bats. The wall is covered with dense ivy, which provides opportunities for nesting & roosting birds. The collapsed area of wall was inspected internally on 22/11/2018, see photos Appendix C; the

External view collapsed wall

- All structural work will be undertaken by hand, being aware that bats may be present beneath and between loose stones. All ivy removal will take place by hand.

- Apart from the main failure, minor pointing works, affecting gaps less than 30mm deep or 10mm wide, can be undertaken with care, first checking the cavity for the presence of a bat. Larger crevices may need to be checked by an ecologist prior to work commencing.

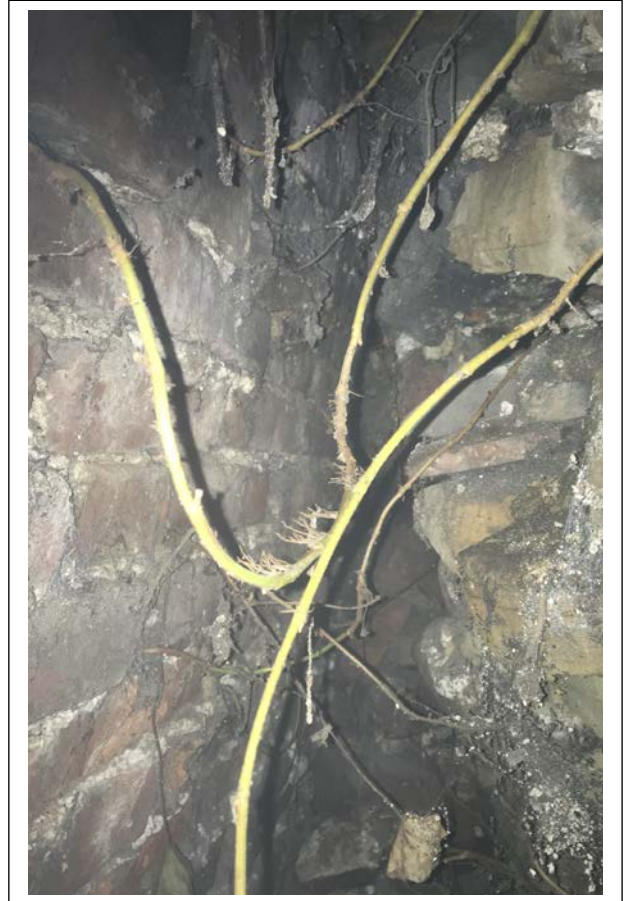
cavity was open and relatively discreet, with the boundaries of the cavity visible. Ivy stems and spiderwebs were present throughout the cavity, and the bat potential of the cavity was rated as low by the author.

Internal view collapsed wall

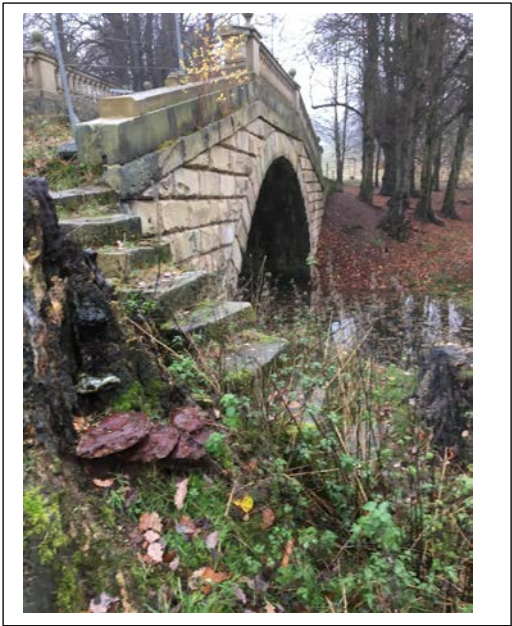
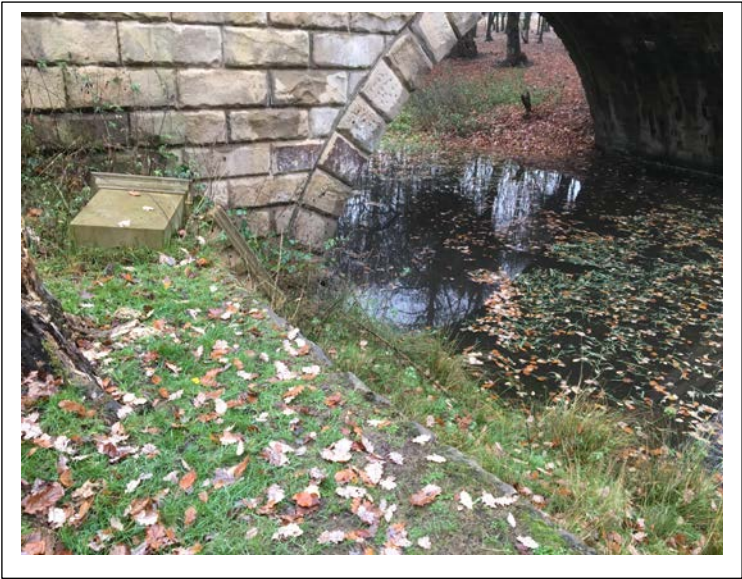
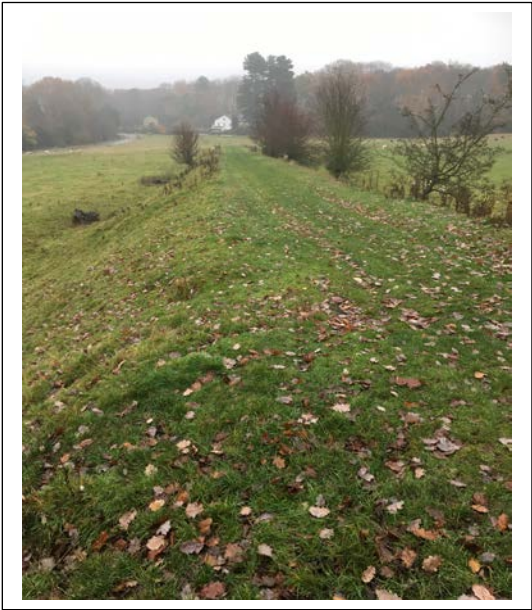
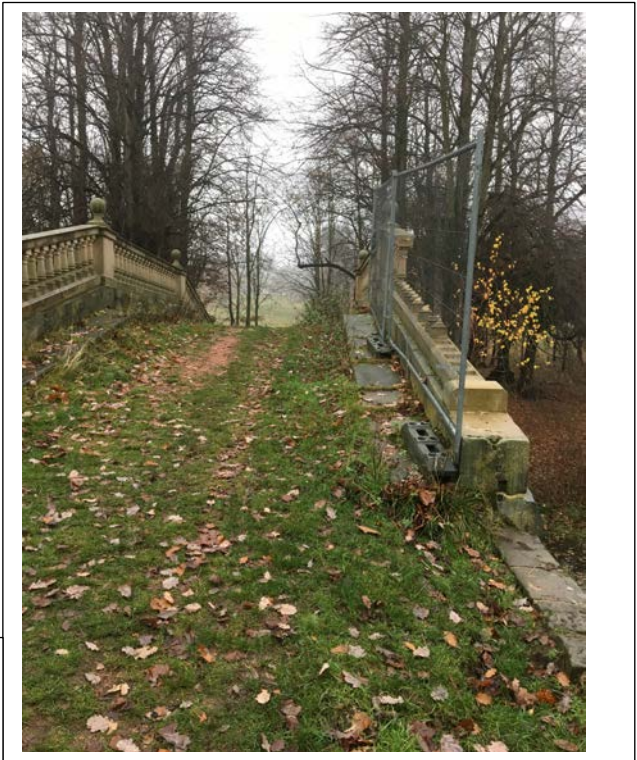
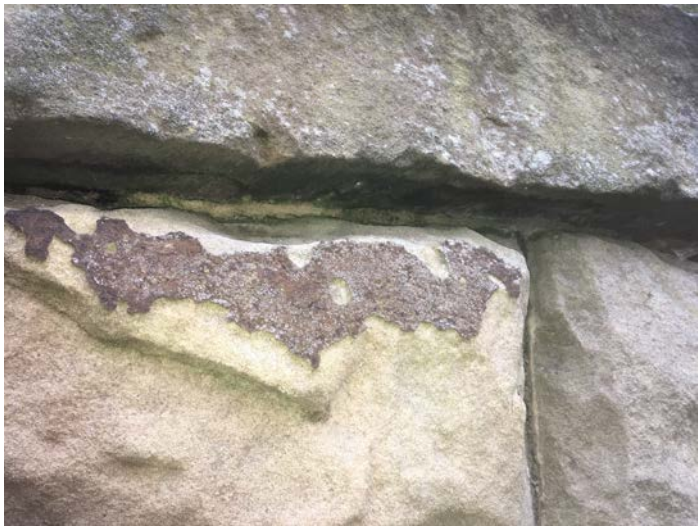
The bridge itself is of relatively low ecological value; it lies on the North-eastern boundary of the LWS. In 2003 the Serpentine Bridge was noted as "Still in very good condition with no gaps for bats", this is still the case Nov 2018 (pers. obs). Photos are included showing the sides and underside of the

bridge, with a representative photo of some of the mortar gaps which are sound and well mortared, both on the sides and the underside of the bridge. The risk to bats using the bridge is therefore assessed as low, with no specific mitigation proposed.

Bridge mortar detail
