# **91a High Street, Dodworth, Barnsley, S75 3RQ**

## **Bat Report**

Final Report

06 May 2025

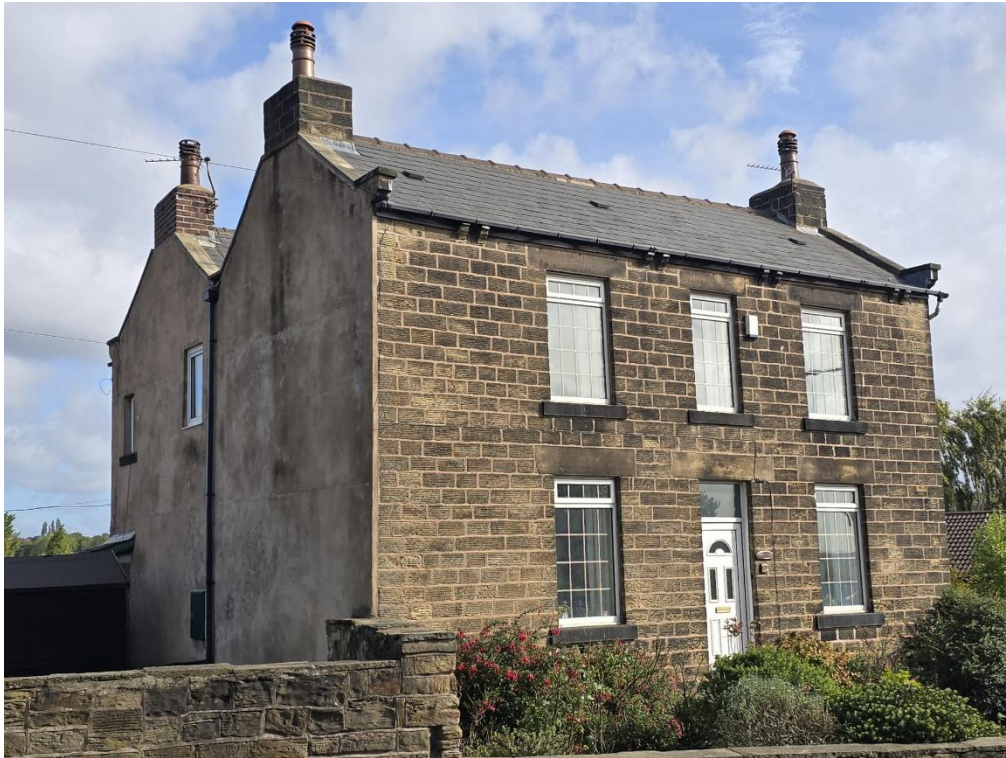
Photograph 1: Front of main house

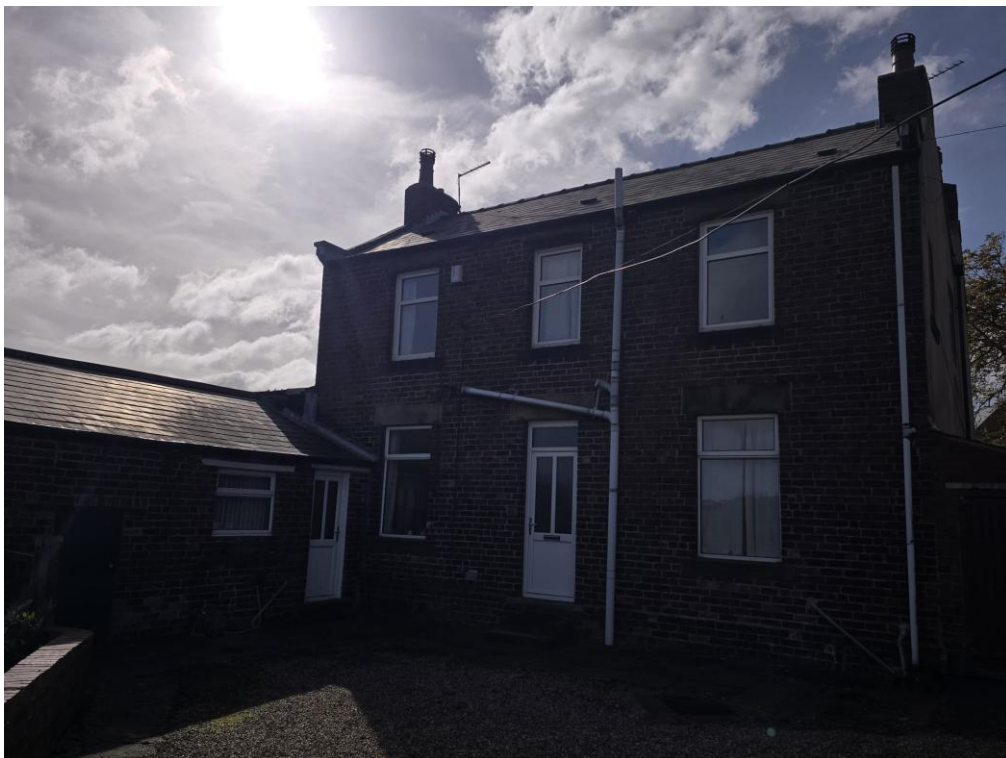
- 3.6 The following was noted:
- The building is two storey, double pitch house. The walls are constructed from brick, with rendered gable ends.
  - The roofs are pitches, with slate tiles and clay ridge in good condition. The roofs look tight with no visible gaps. Through use of close focussing binoculars it was possible to examine the tiles on both of the middle pitches of the building.
  - The window and door frames are constructed from uPVC.
  - There are four chimneys present. All flashing looks tight with no visible gaps.
  - No signs of nesting birds were recorded.

Photograph 2: Rear of main house

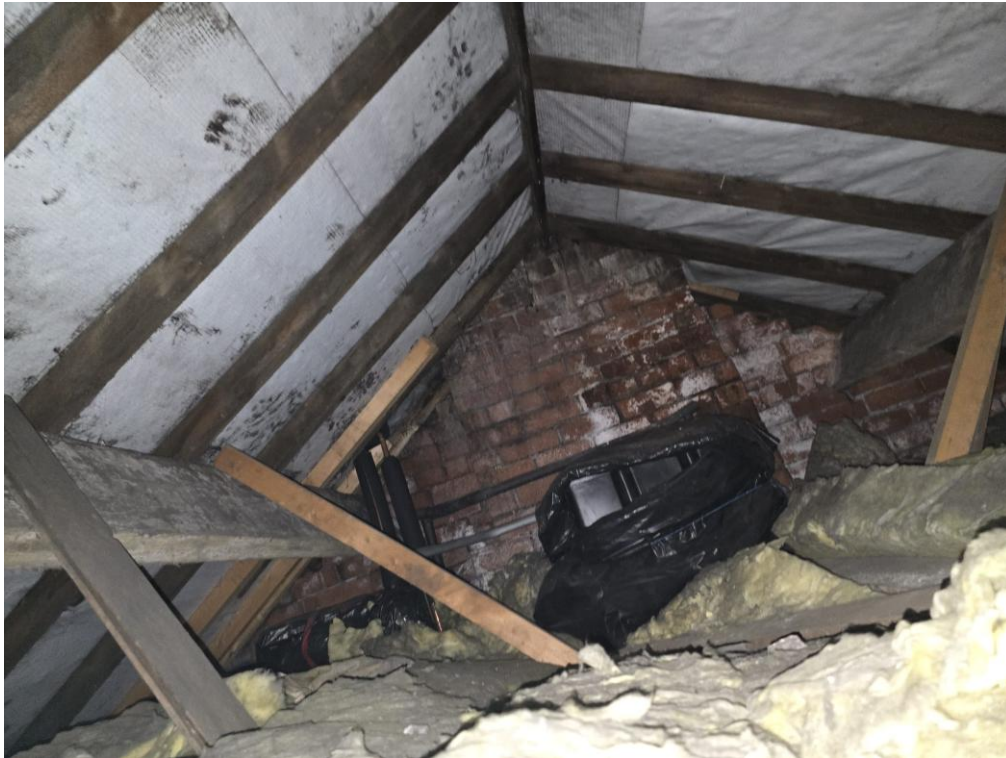
- The beams, struts and purlins are constructed from wood.
- There is a breathable membrane liner in the void.
- Fibreglass insulation is present, covering a lot of the rafters. This is in reasonable condition.
- There is a disused water tank present which is fully covered.
- No signs of bats or bat droppings were recorded in the void.

3.8 The house is considered to hold negligible potential to support roosting bats due to a lack of suitable access points, or roosting opportunities.

Photograph 3: In roof void of main house

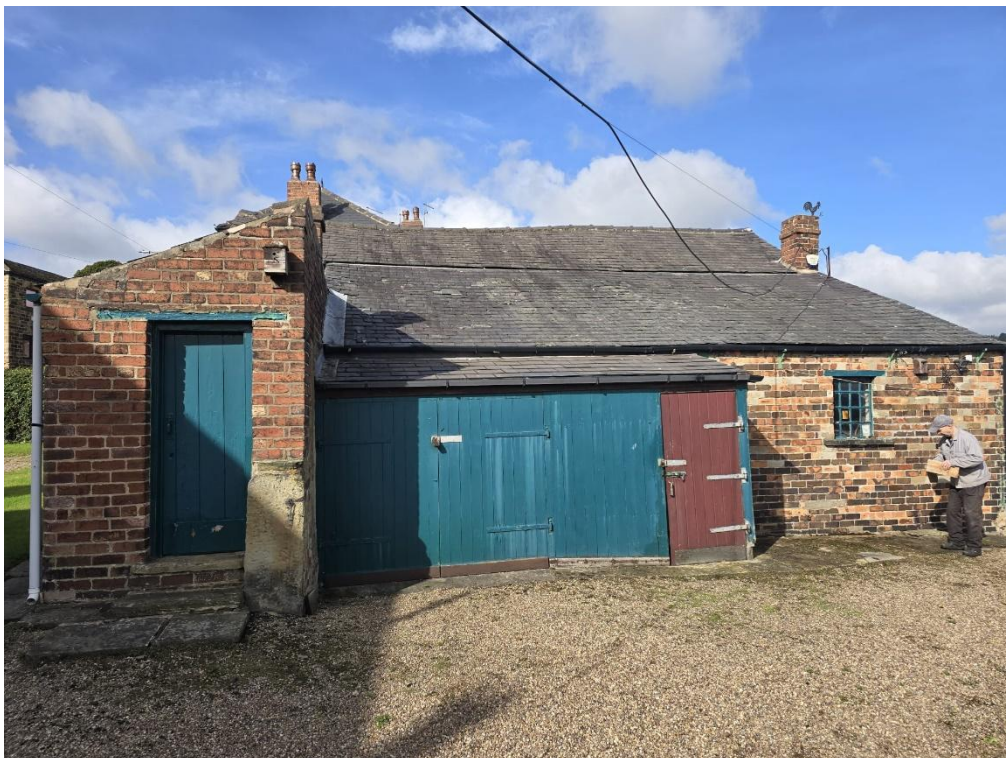
3.9 There is a large outbuilding to the northwest of the house which comprises a variety of segmented buildings. The building is a two-storey brick building, with a single storey extension on the eastern elevation. The window and door frames are constructed from wood and are in reasonable condition. The majority of the doors and windows are well sealed with no gaps. There is a chimney present on the toilet block in the east of the building. The roof on the main building is pitched and constructed from slate tiles with some gaps. The roof of the toilet block and other areas are also pitched/mono-pitched and constructed from slate roof tiles.

- 3.11 There were a small number of crevice features which could not be assessed due to their location. As such outbuilding 1 is considered to hold low potential to support roosting bats.

Photograph 4: Outbuilding 1

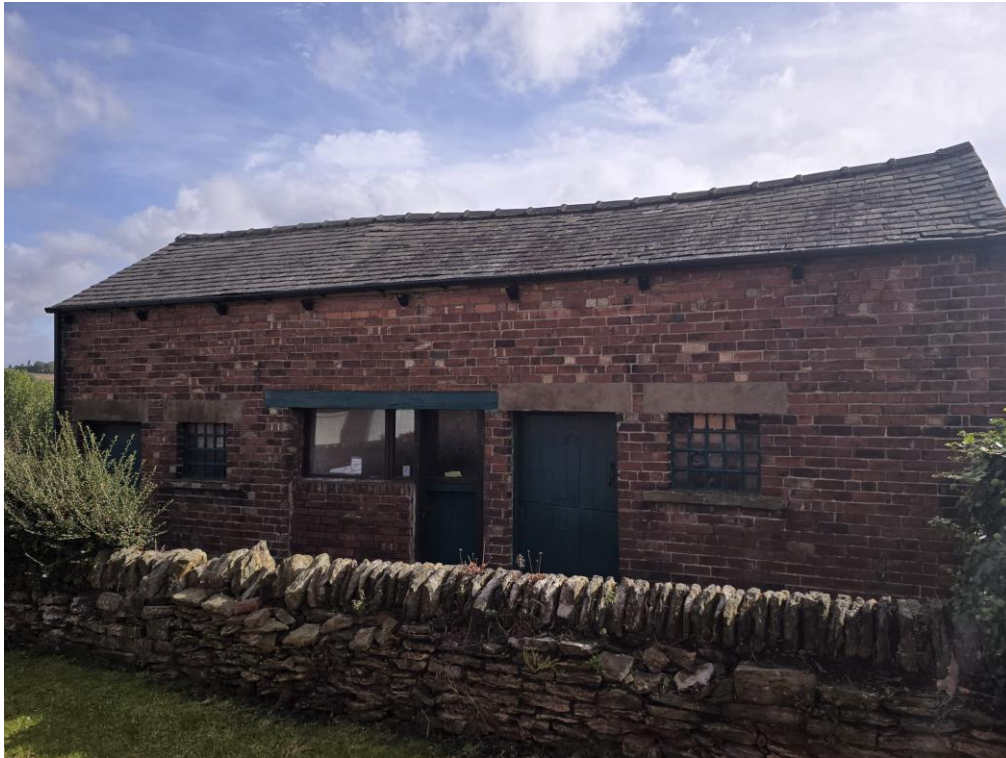
Photograph 5: Outbuilding 1

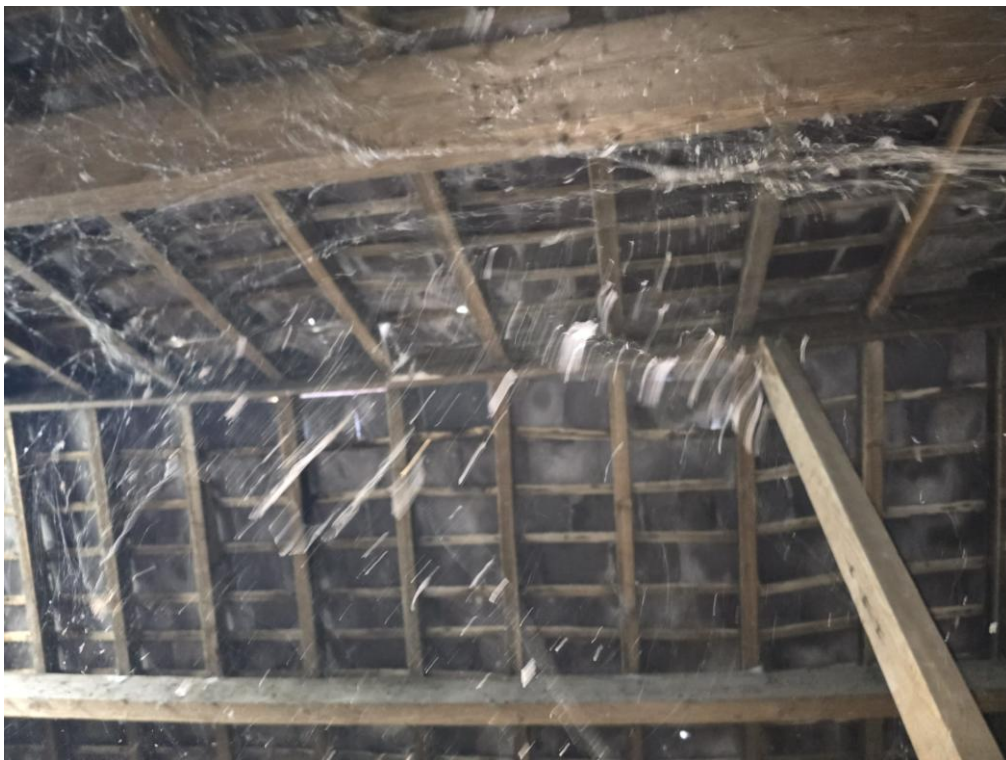
3.10 Internally the building is open to the rafters in the majority of places, with dense cobwebbing along the beams showing multiple years of dust accumulation on the cobwebs. The interior of the tiles was viewed in large portions of the building and no evidence of bats or physical bats were present. The areas where tiles could be checked internally are shown on the aerial image below. There are some areas of the building which are used for storage, but the majority of the building is currently not in use. It was possible to check the majority of the features present in the building for presence of roosting bats and no bats or signs of bats were recorded.

Photograph 6: Inside outbuilding 1

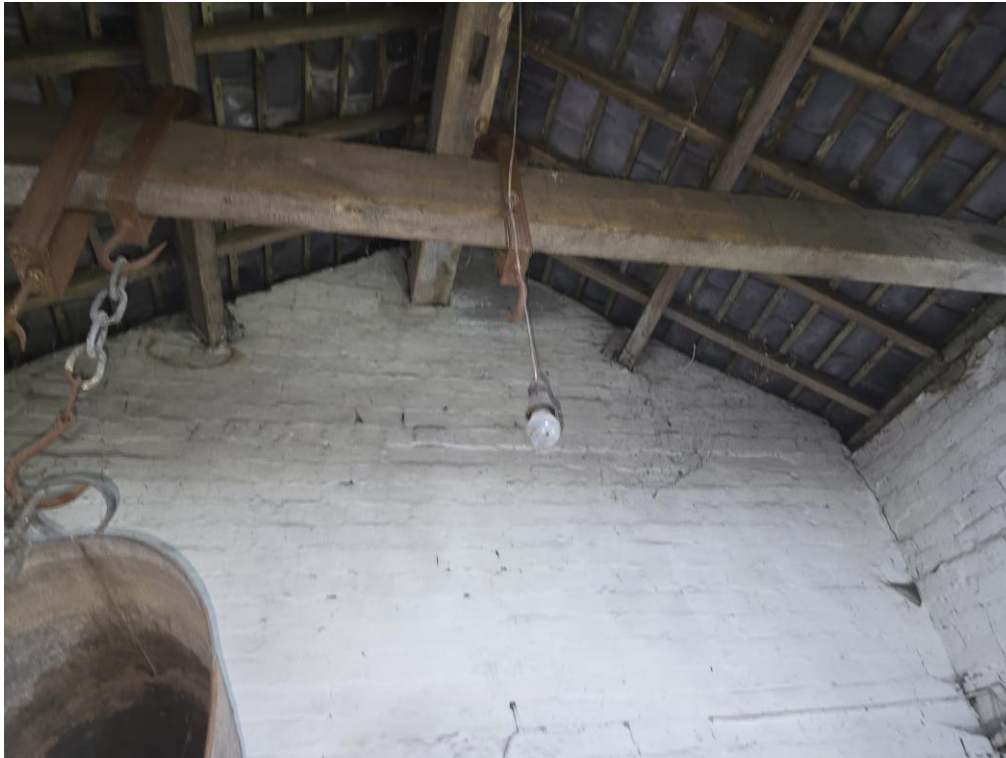
Photograph 7: Inside outbuilding 1

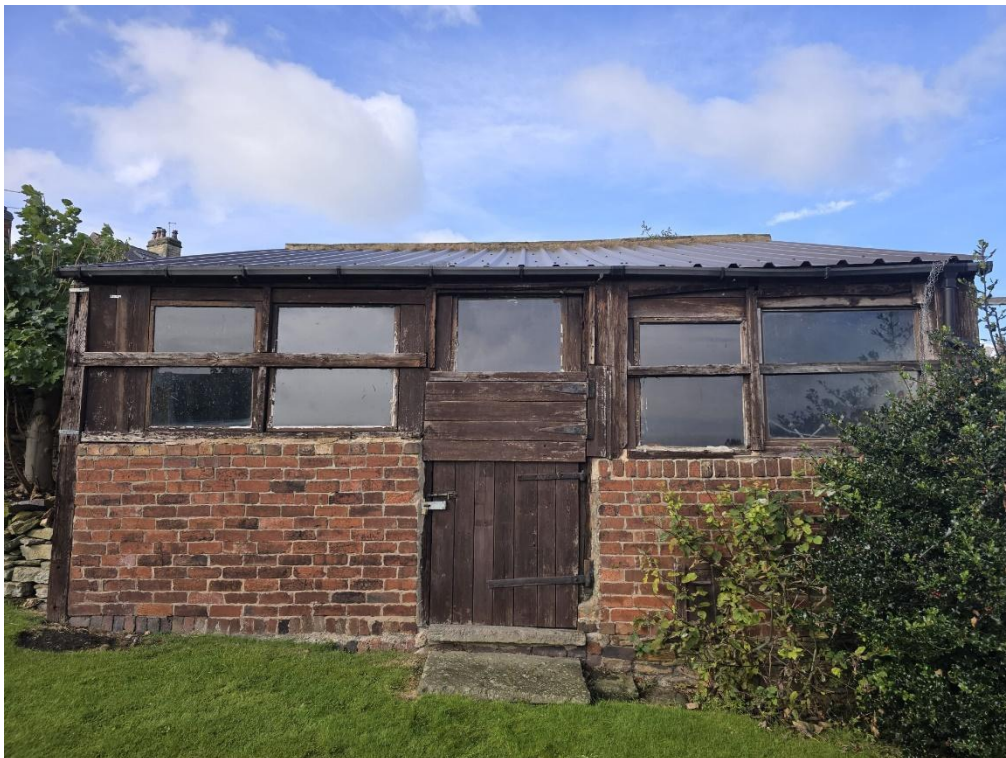
- 3.14 There is a small outbuilding in the north-west corner of the site. The outbuilding is a single storey brick building with a mono-pitched roof constructed from corrugated sheet material. There are wooden window and door frames, with no visible gaps present.
- 3.15 Internally the beams are constructed from wood, and repairs to the beams are visible from the newer wood which is reinforcing the older structure. The outbuilding is used for storage. No bats or evidence of bats was recorded in the outbuilding. There are no access opportunities into the building.
- 3.16 Outbuilding 2 was considered to have negligible potential to support roosting bats.

Photograph 8: Outbuilding 2

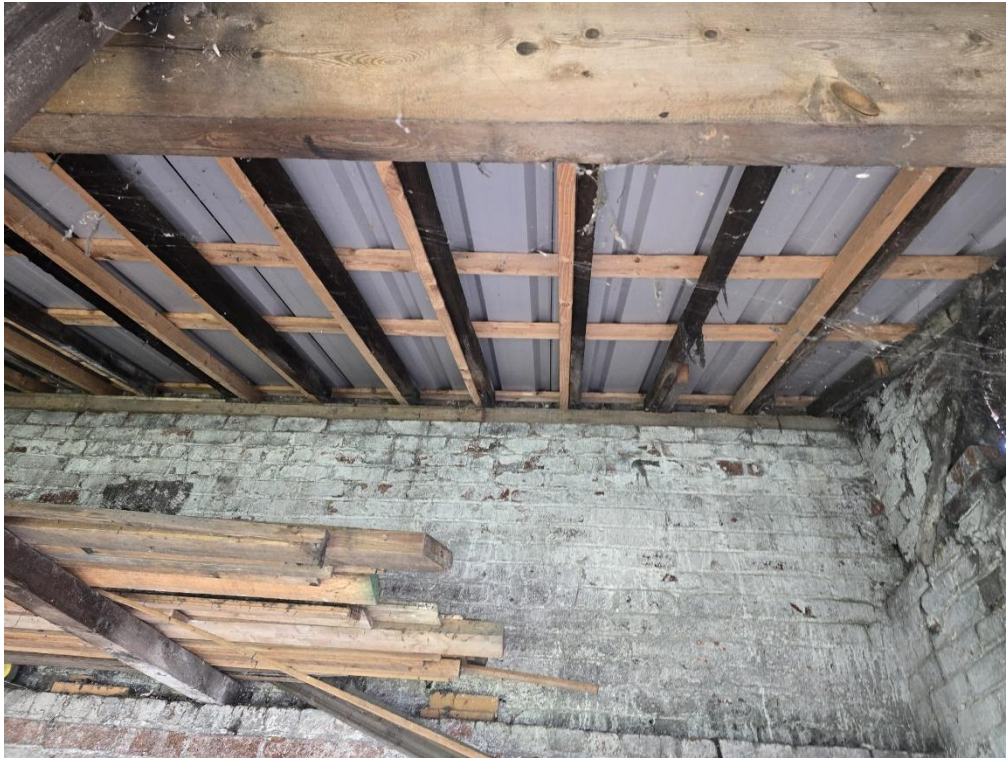
Photograph 9: Inside outbuilding 2

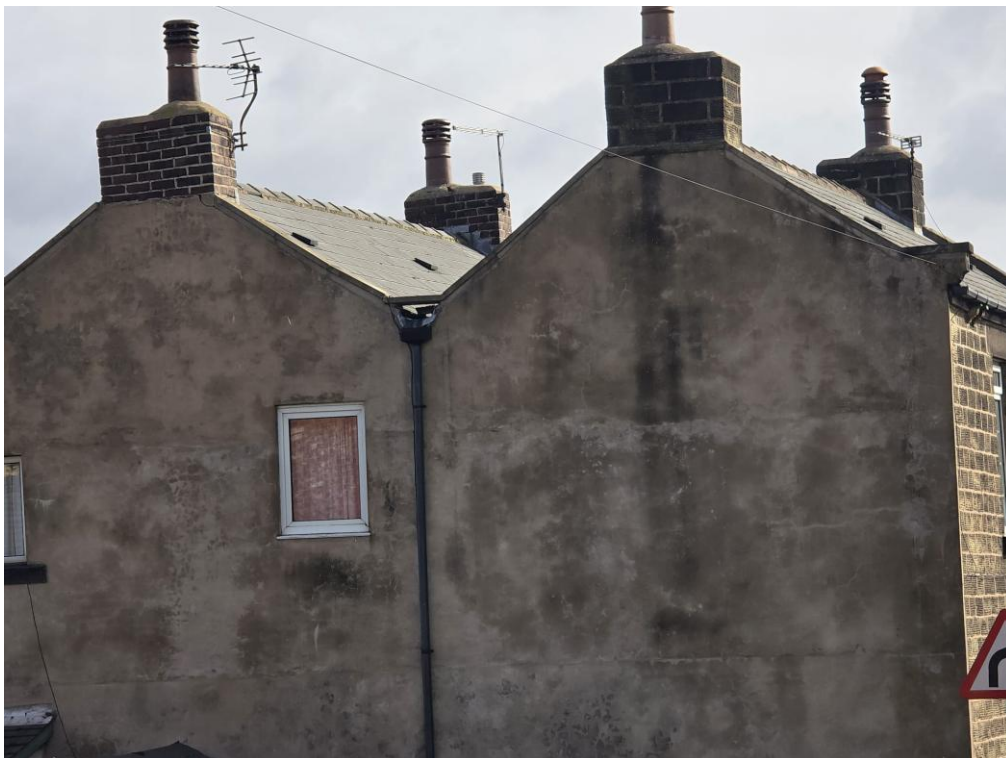
Photograph 10: Between pitches on main house
