# ARBORICULTURAL REPORT

To BS 5837:2012 at:

***St. James Square,  
Hoyland,  
Barnsley,  
S74 9AA***

September 2015

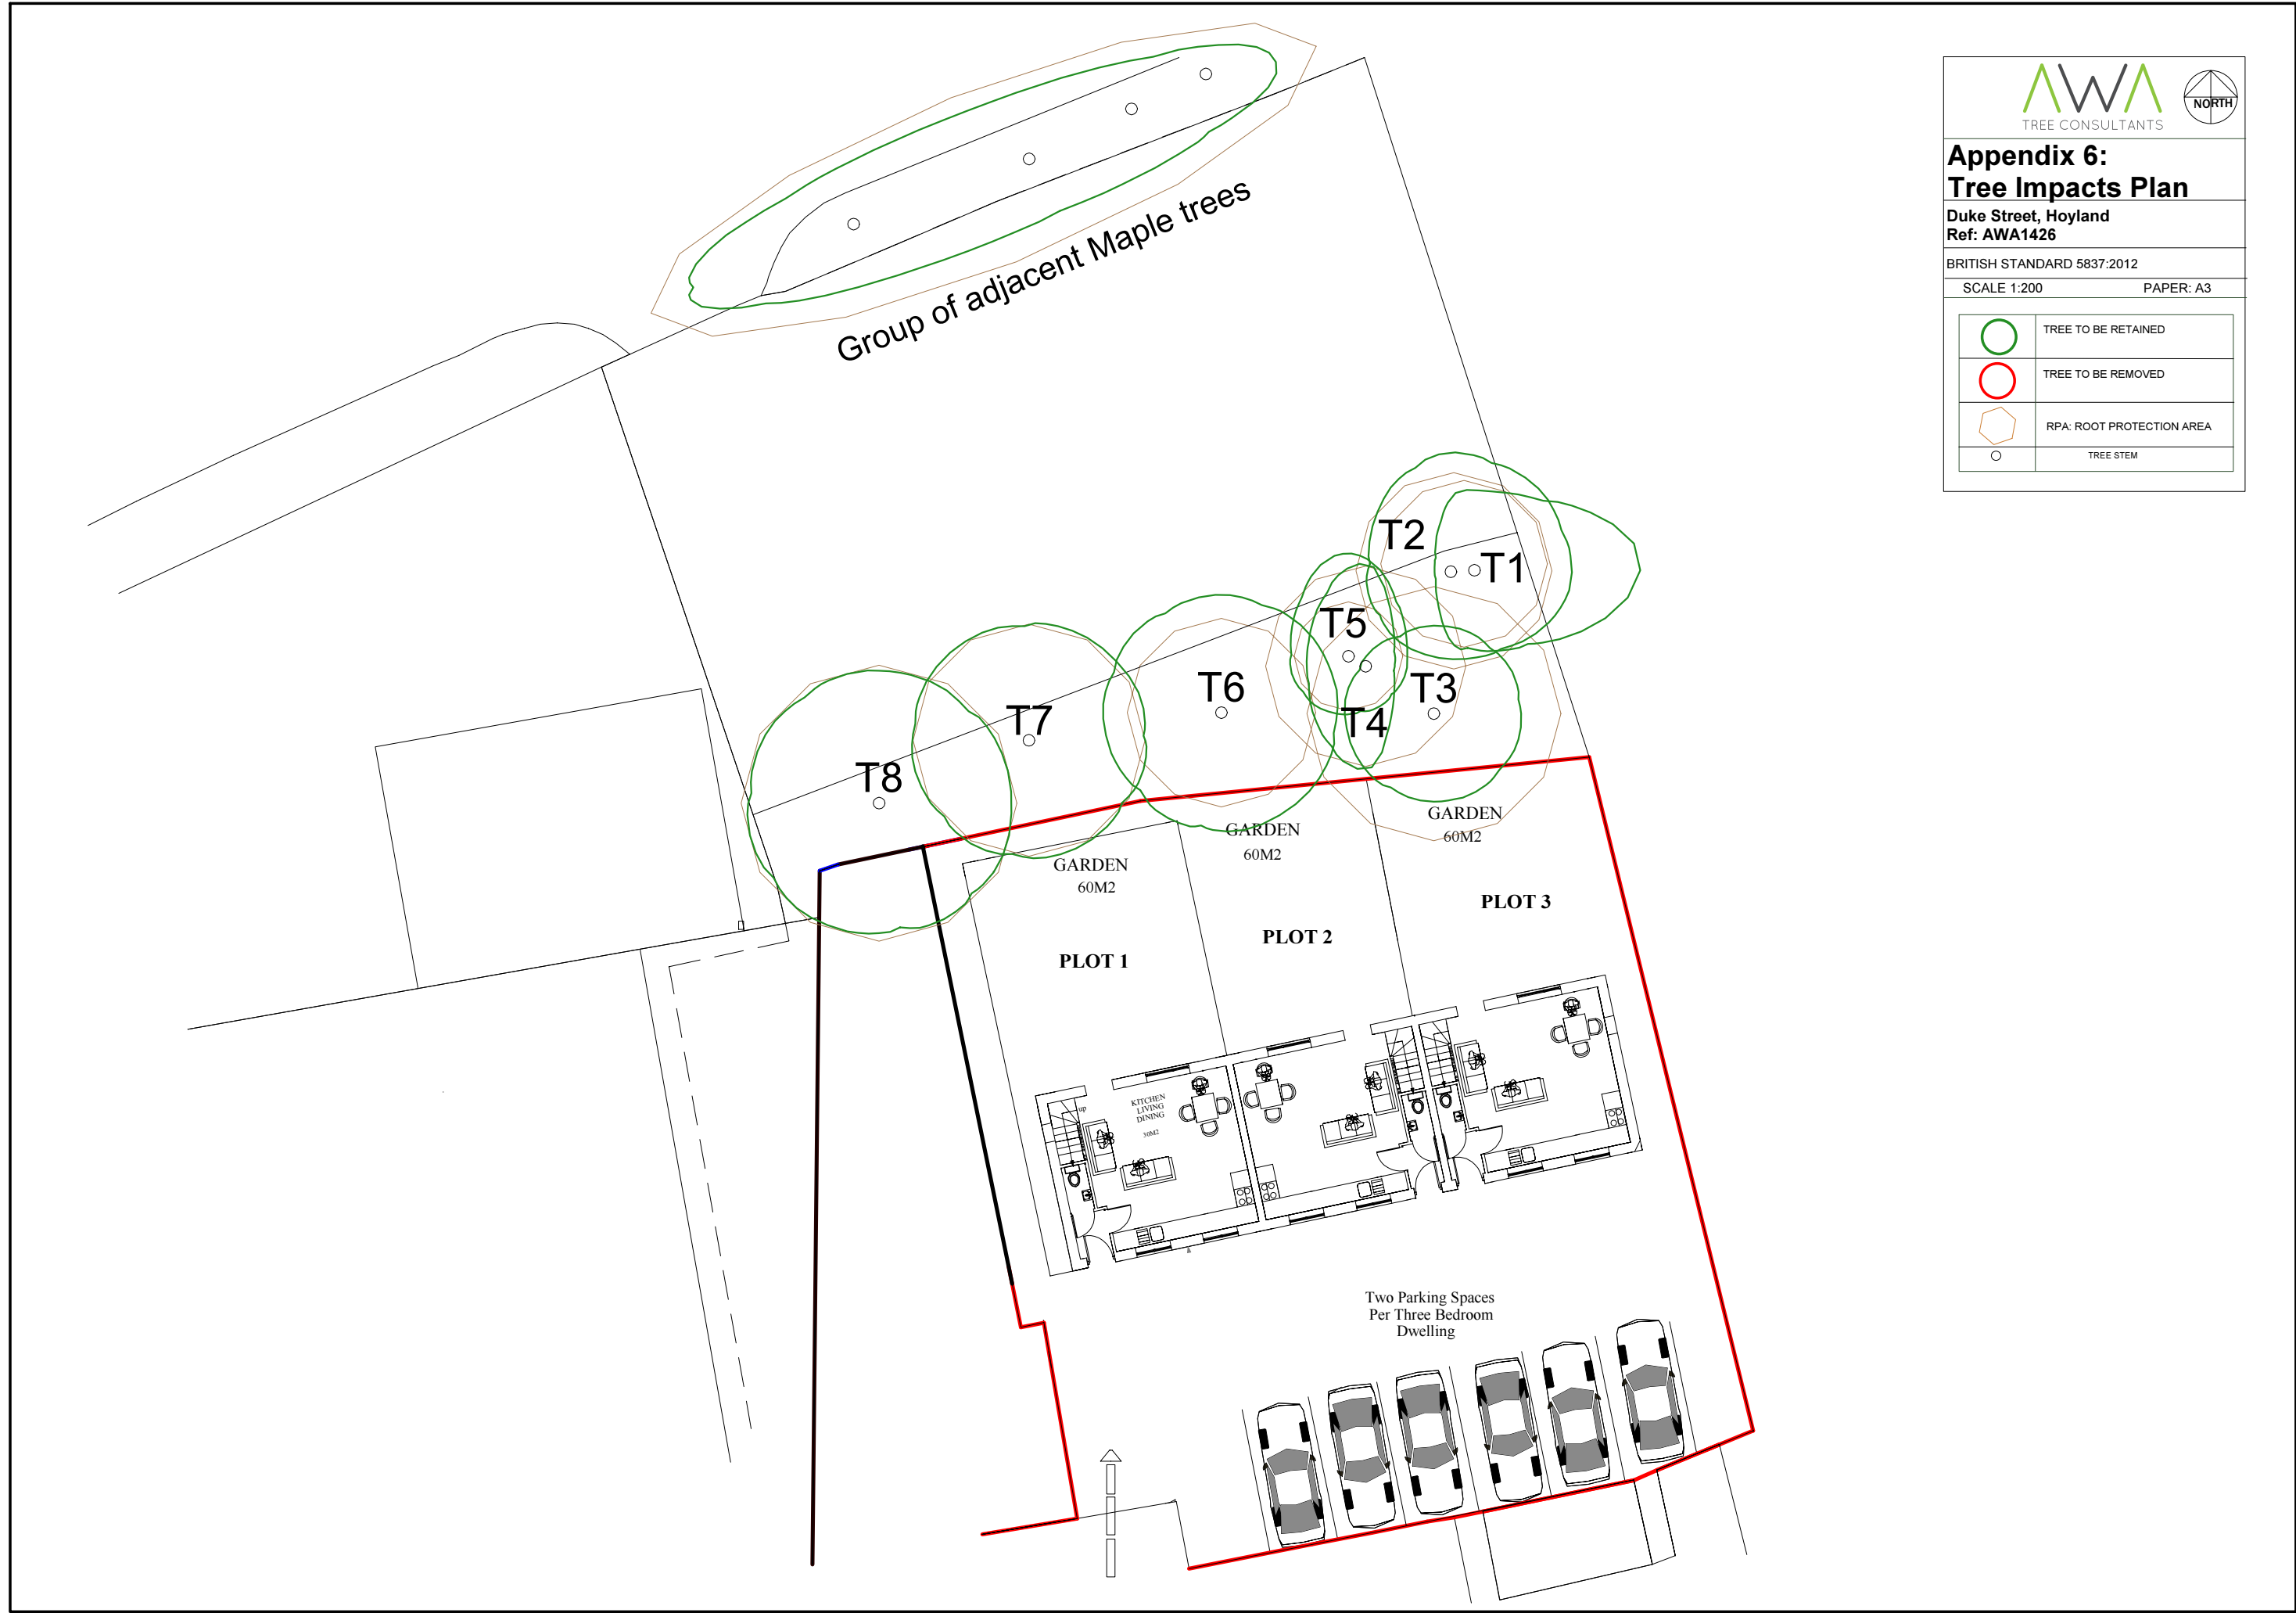
## Appendix 5: Tree Constraints Plan

- 3.2.5 Several of the surveyed trees are in a poor condition. Two Norway Maple trees, T6 and T7, are showing signs of decline and have limited long term prospects. In addition, a Goat Willow, T1, has grown at a significant angle and shows signs of root plate heave, along with an unbalanced canopy. This tree has limited long term prospects and its long term suitability for retention is very limited. It is advised that the owner of the trees is contacted and that a request is made that the trees should be made safer by suitable pruning.
