**Coal Drops**  
Land at St Mary's Street  
**Penistone**  
Fairbank Investments Ltd

**Coal Drops & Signal House**  
Works to Existing

Drawing Number  
**27845 A(18) 01 P01**

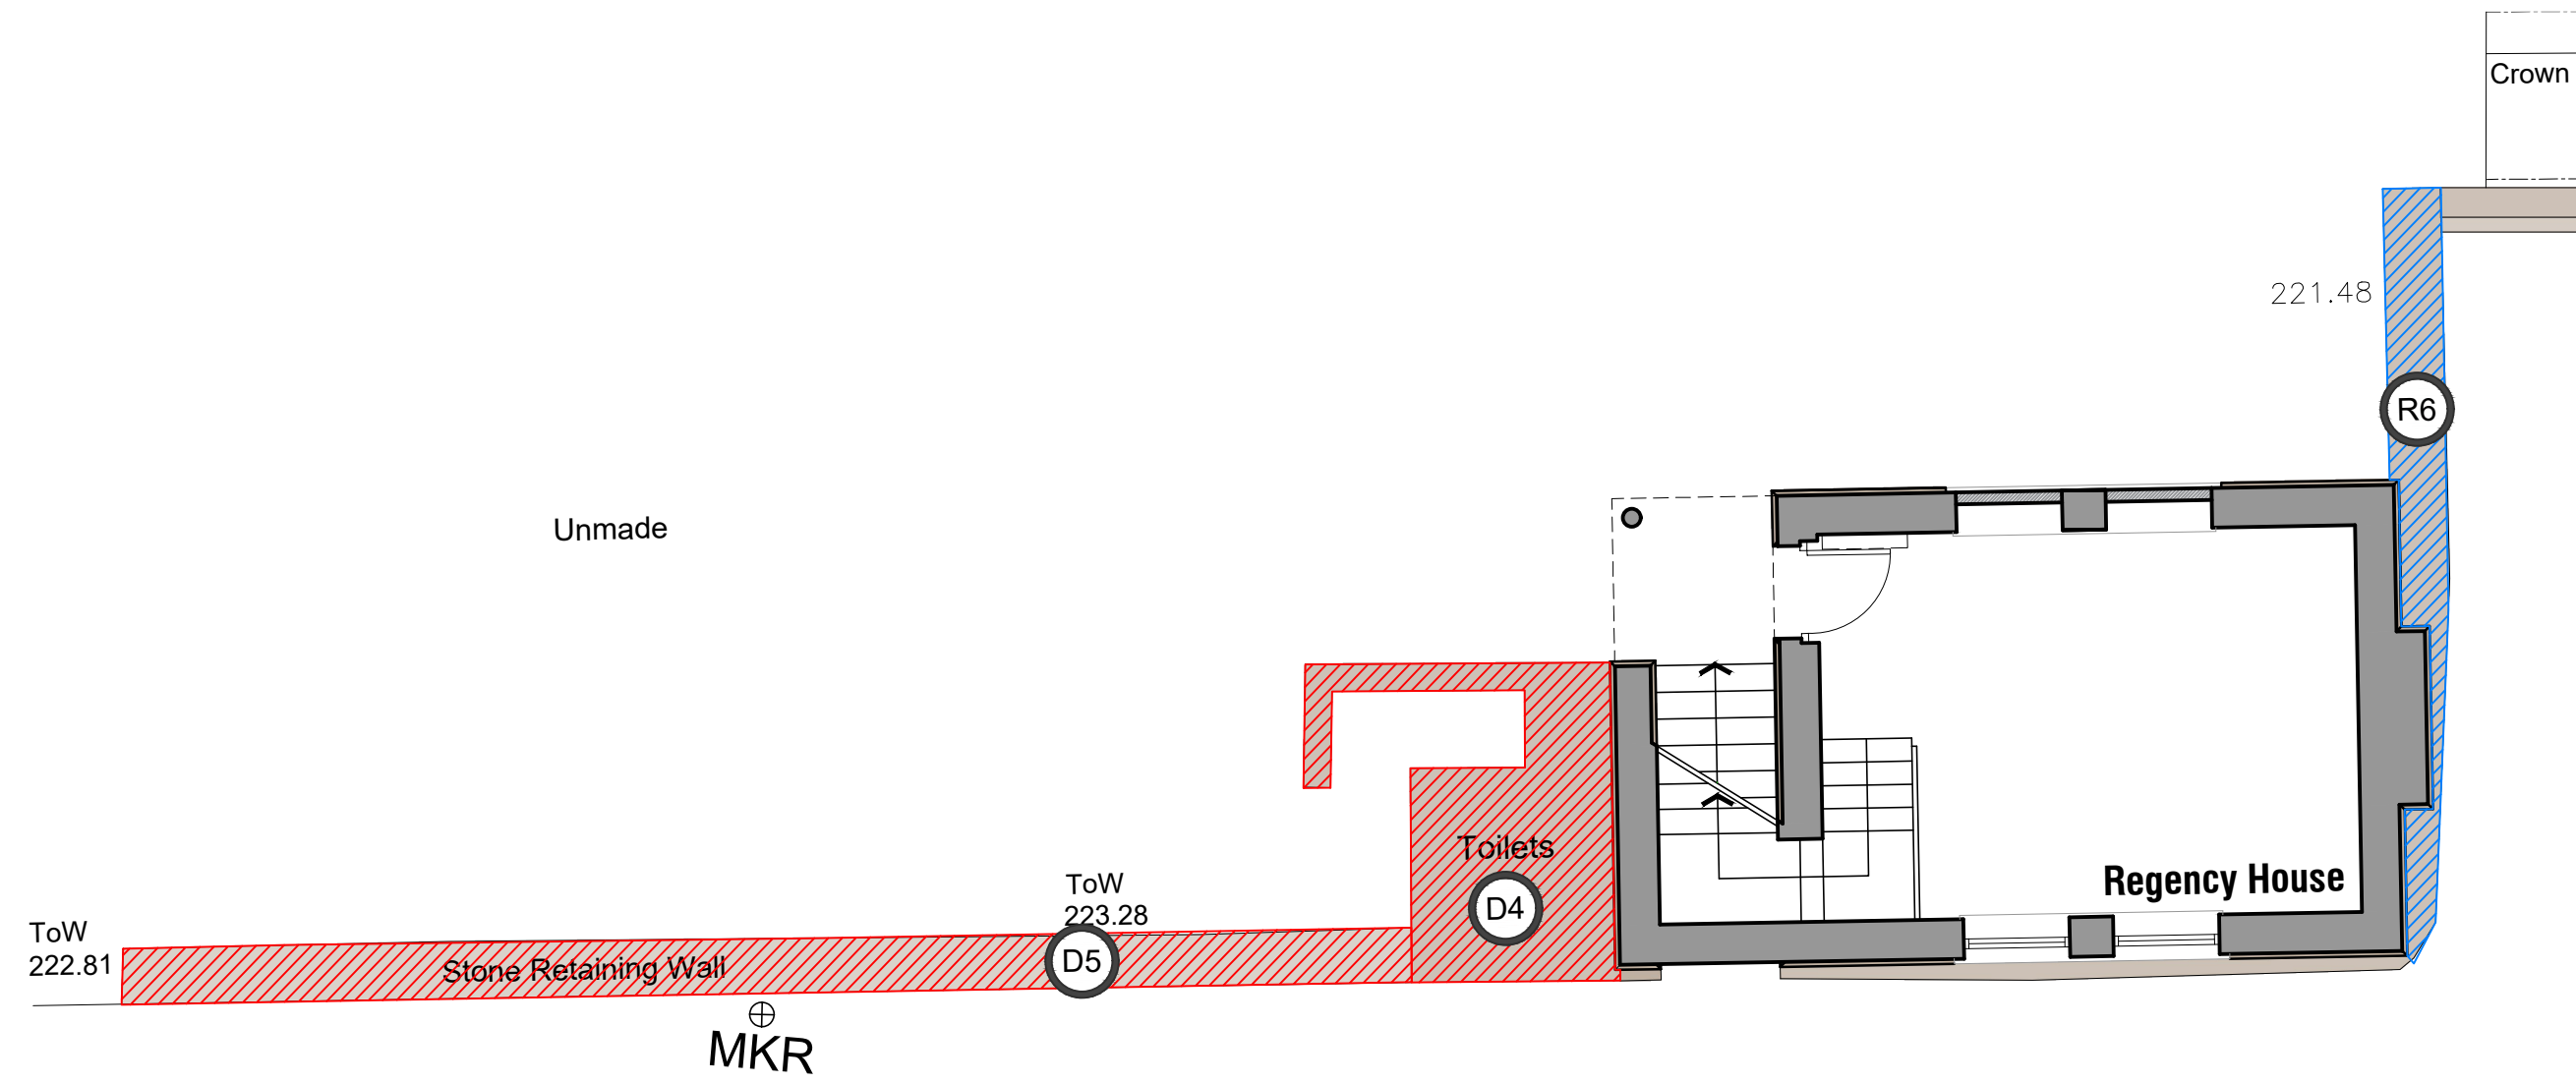
SIGNAL HOUSE UPPER GROUND FLOOR

**R2** - Western retaining wall to Bay 1: Areas of western retaining wall require rebuilding due to displacement, with stainless steel dowels to prevent repeat failure. The inner wall of front barrel vault requires rebuilding. The wall of the rear barrel vault requires partial rebuilding. Refer to Structural Survey Report section 4.1.2.

**R4** - Bay 6 Arch/ Buttressing Pier/ East Wall: Structural repair works required to Bay 6 arch due to vertical displacement; buttressing pier due to lateral displacement; and east wall due to a large crack present. Options for repair are outlined in the Structural Survey Report section 4.1.4.

**R5** - Coping stones: Masonry and coping stones above arch 6 have cracked, and require rebuilding and repointing, using reused stone where possible. Coursing pattern and mortar jointing to match existing.

**R6** - Adjacent retaining Wall: Existing retaining wall between Coal Drops and Signal House is deformed and failed to a significant height -requiring dismantling and rebuilding, with possible strengthening works required. Refer to Structural Survey Report section 4.2.1.

**R1** - Repointing of stonework: Repointing of Coal Drop arches and wall where required, using suitable lime mortar.

**R3** - Subdividing walls: Heads of inner walls strengthened with new mortar and relaying of some masonry where required. Refer to Structural Survey Report section 4.1.3.

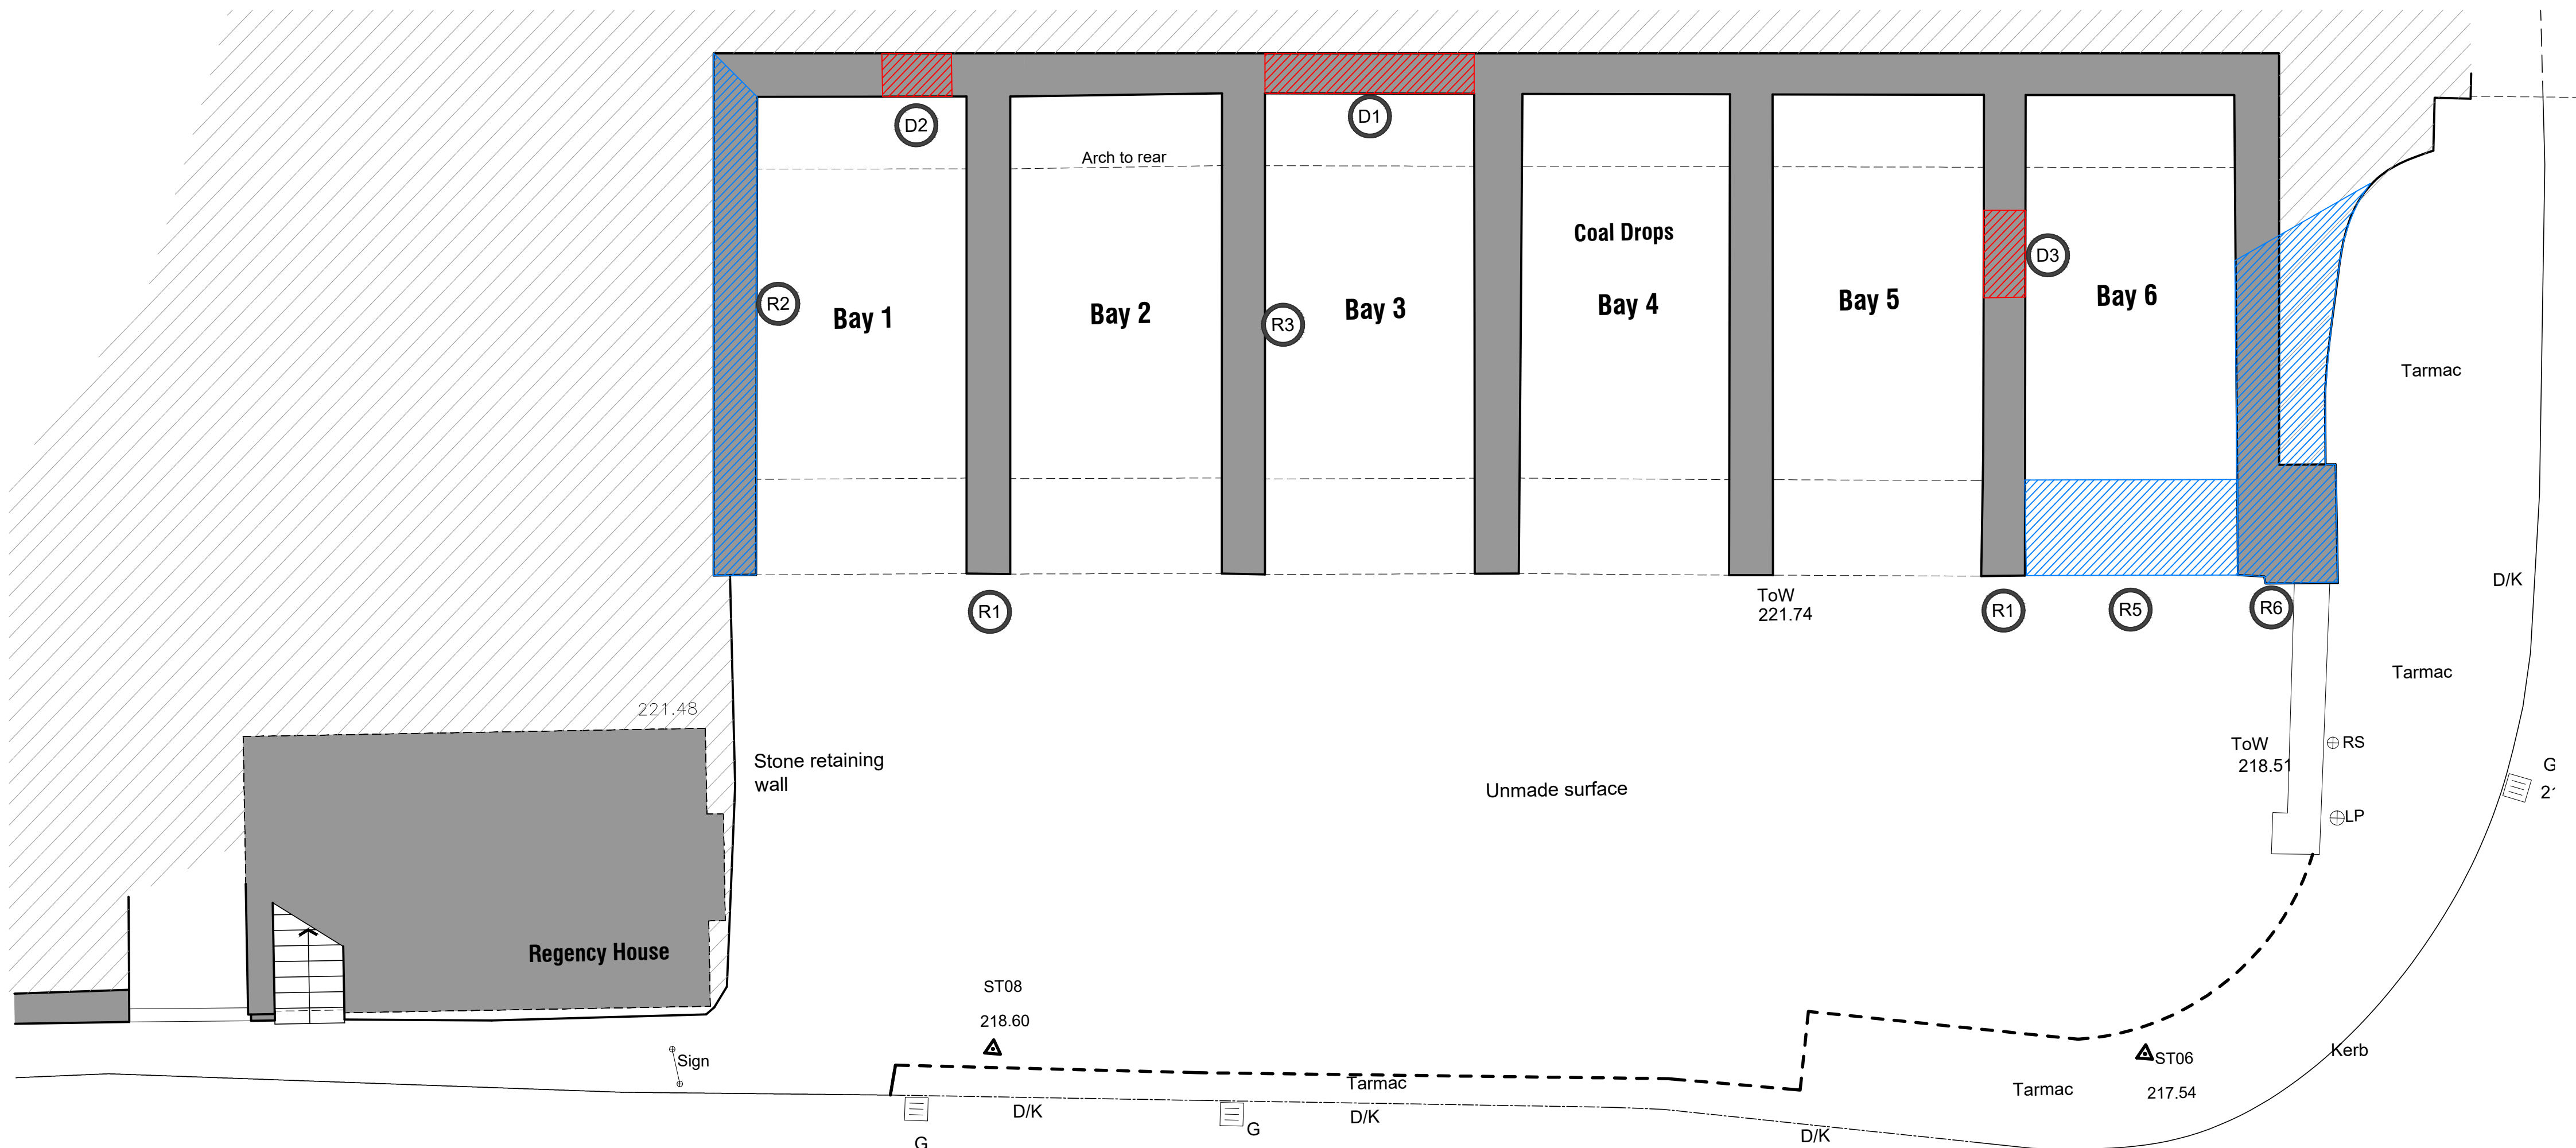
SIGNAL HOUSE/ COAL DROPS LOWER GROUND FLOOR

**D1** - Rear of Bay 3: Rear wall of Bay 3 removed to form the main entrance/ connection to the restaurant and bar.

**D2** - Rear of Bay 1: Small doorway opening formed to connect proposed kitchen to store.

**D3** - Side wall between Bays 5 and 6: Doorway opening formed to create large retail space.

**D4** - Existing toilet block to Signal House: Masonry toilet block removed. Planning precedent established in previous planning approval (ref 2013/0544).

**D5** - Retaining wall adjacent Signal House: Coursed stone retaining wall to southern site boundary, adjacent Signal House, to be removed. New curved retaining wall structure to vehicle access ramp to be built from reused stone where possible, to match existing coursing and mortar jointing. Planning precedent established in previous planning approval (ref 2013/0544).
