**Arboricultural Implication Assessment
35 Intake Lane
Barnsley
S75 2HX**

Report Reference: 1161 AIA.1
8 December 2018

Tree Constraints Plan
 35 Intake Lane, Gawber, Barnsley, S75 2HX

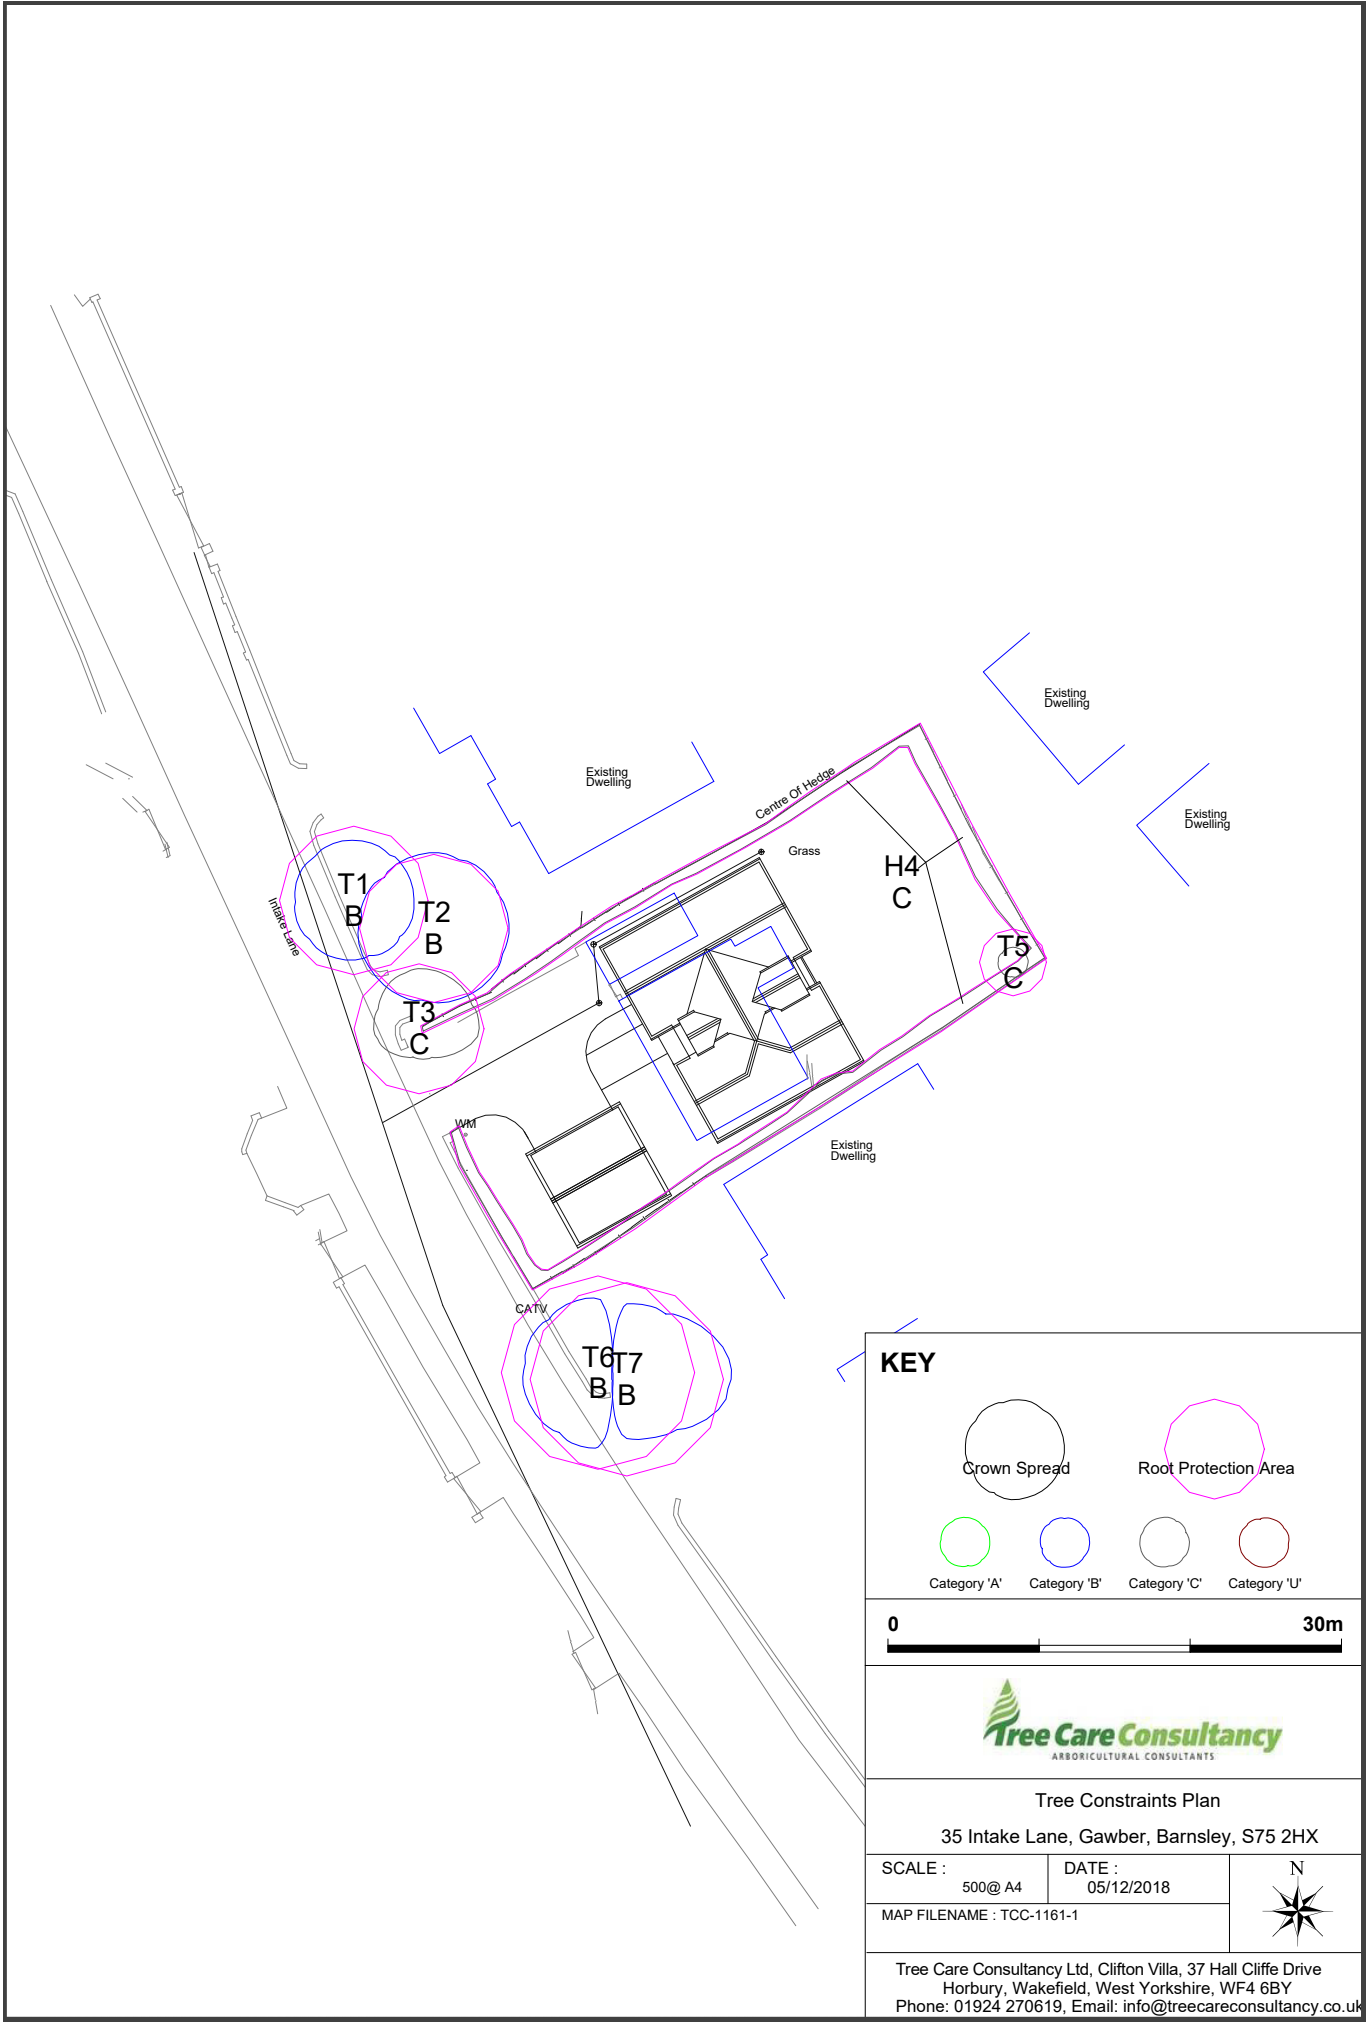
3.3.3. It will be seen the proposed dwelling and garage do not encroach in a negative nature within the RPAs of any trees, other than a small section of hedgerow H4. In terms of the hedgerow material this can be hard pruned or coppiced in the knowledge it will have the capacity to regenerate post construction.

3.3.4. In so far as the RPA of the offsite Sycamore T3 is concerned the proposed drive is to be constructed on the line of the existing drive and will therefore not materially impact on the viability of this tree.

3.4.2. In terms of the potential impact of the proposed dwelling and garage on hedgerow H4 should the need arise this can be hard pruned or coppiced in advance of construction with a view to allowing it to regenerate post construction.

3.5.1. A protective barrier will be erected at the face of H4 prior to the commencement of any site works e.g. before any demolition takes place and materials are brought on site. The protection shall comprise of palisade fencing braced together and retained in position for the duration of demolition and construction work.
