ARBORICULTURAL REPORT

With Impact Assessment
To BS 5837:2012 at:

Martin Croft Garages
Silkstone
Barnsley
South Yorkshire
S75 4JS

Reference: *AWA2810*

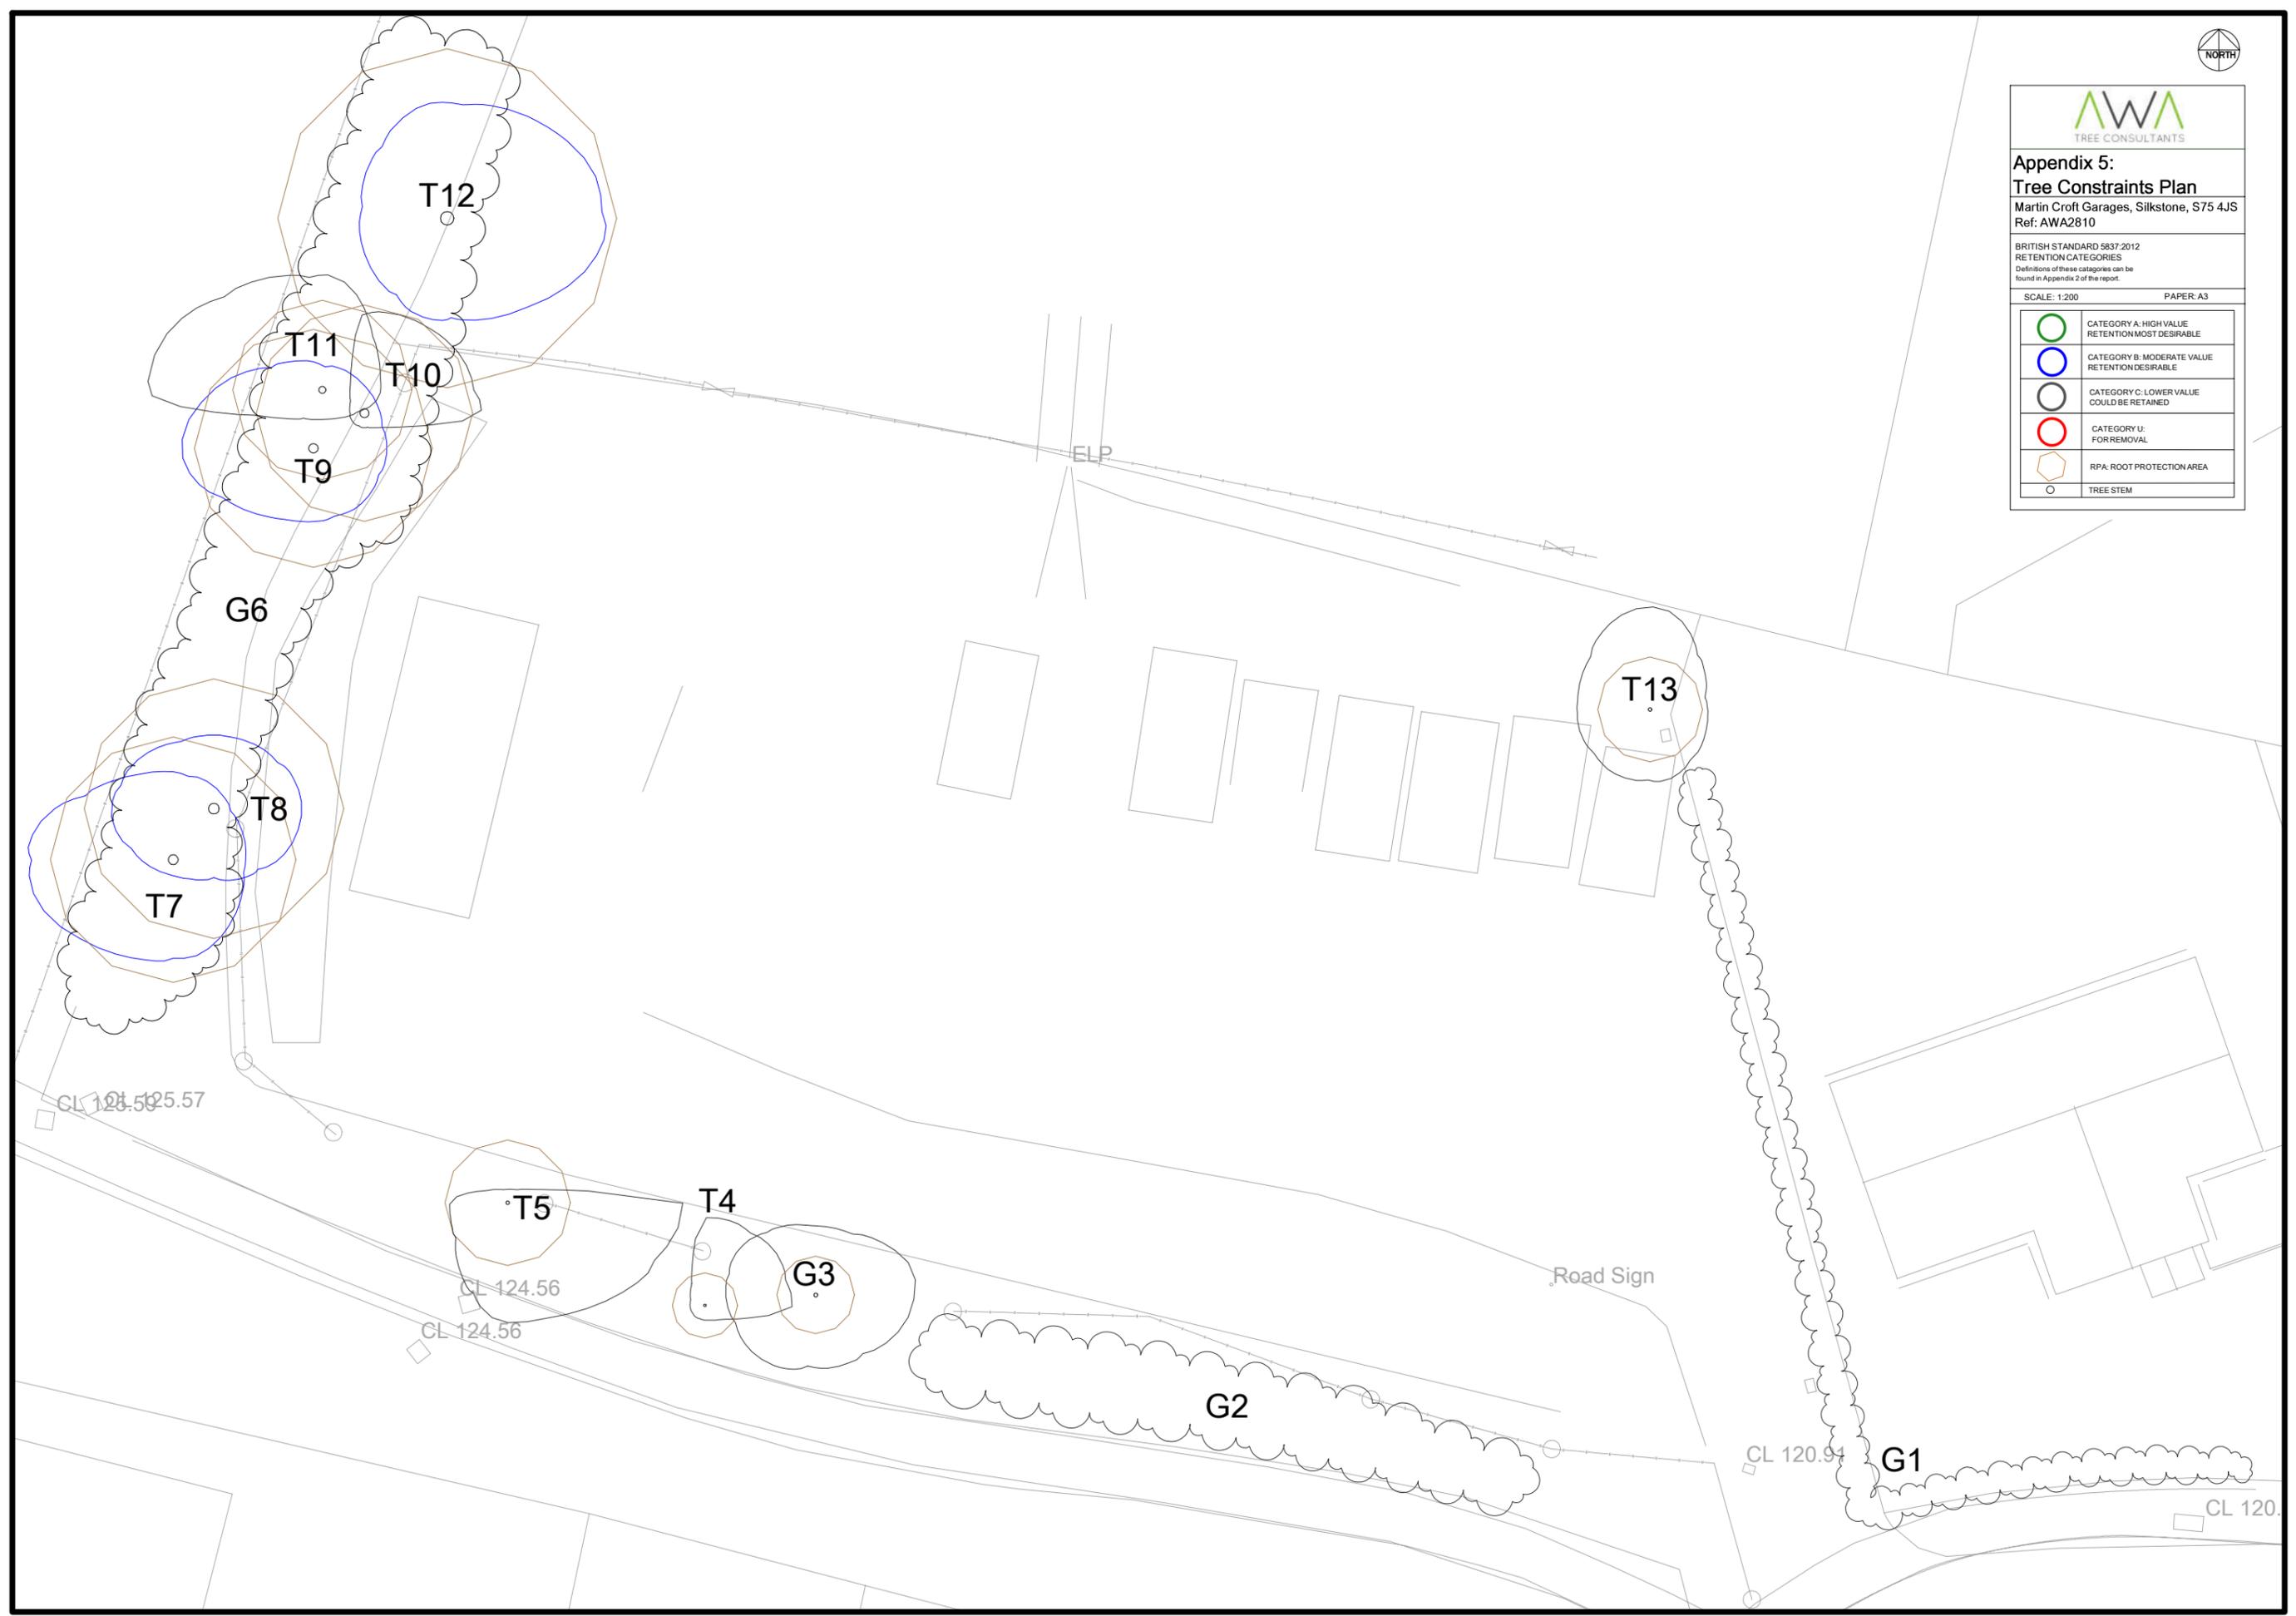
Appendix 5:
Tree Constraints Plan
 Martin Croft Garages, Silkstone, S75 4JS
 Ref: AWA2810

- 3.2.10 The tree Root Protection Area (RPA) detailed on the Tree Constraints Plan at Appendix 5, has been used as a layout design tool, to inform on the area around a tree where the protection of the roots and soil structure is treated as a priority.

- 3.2.12 The RPA for each tree has been plotted as a polygon centred on the base of the stem. Due to the presence of roads, structures, topography (and past tree management) the RPA is likely to be a simplified representation of the tree roots actual morphology and disposition. However, detailed modifications to the shape of the RPA would largely be based on conjecture and so have been avoided.

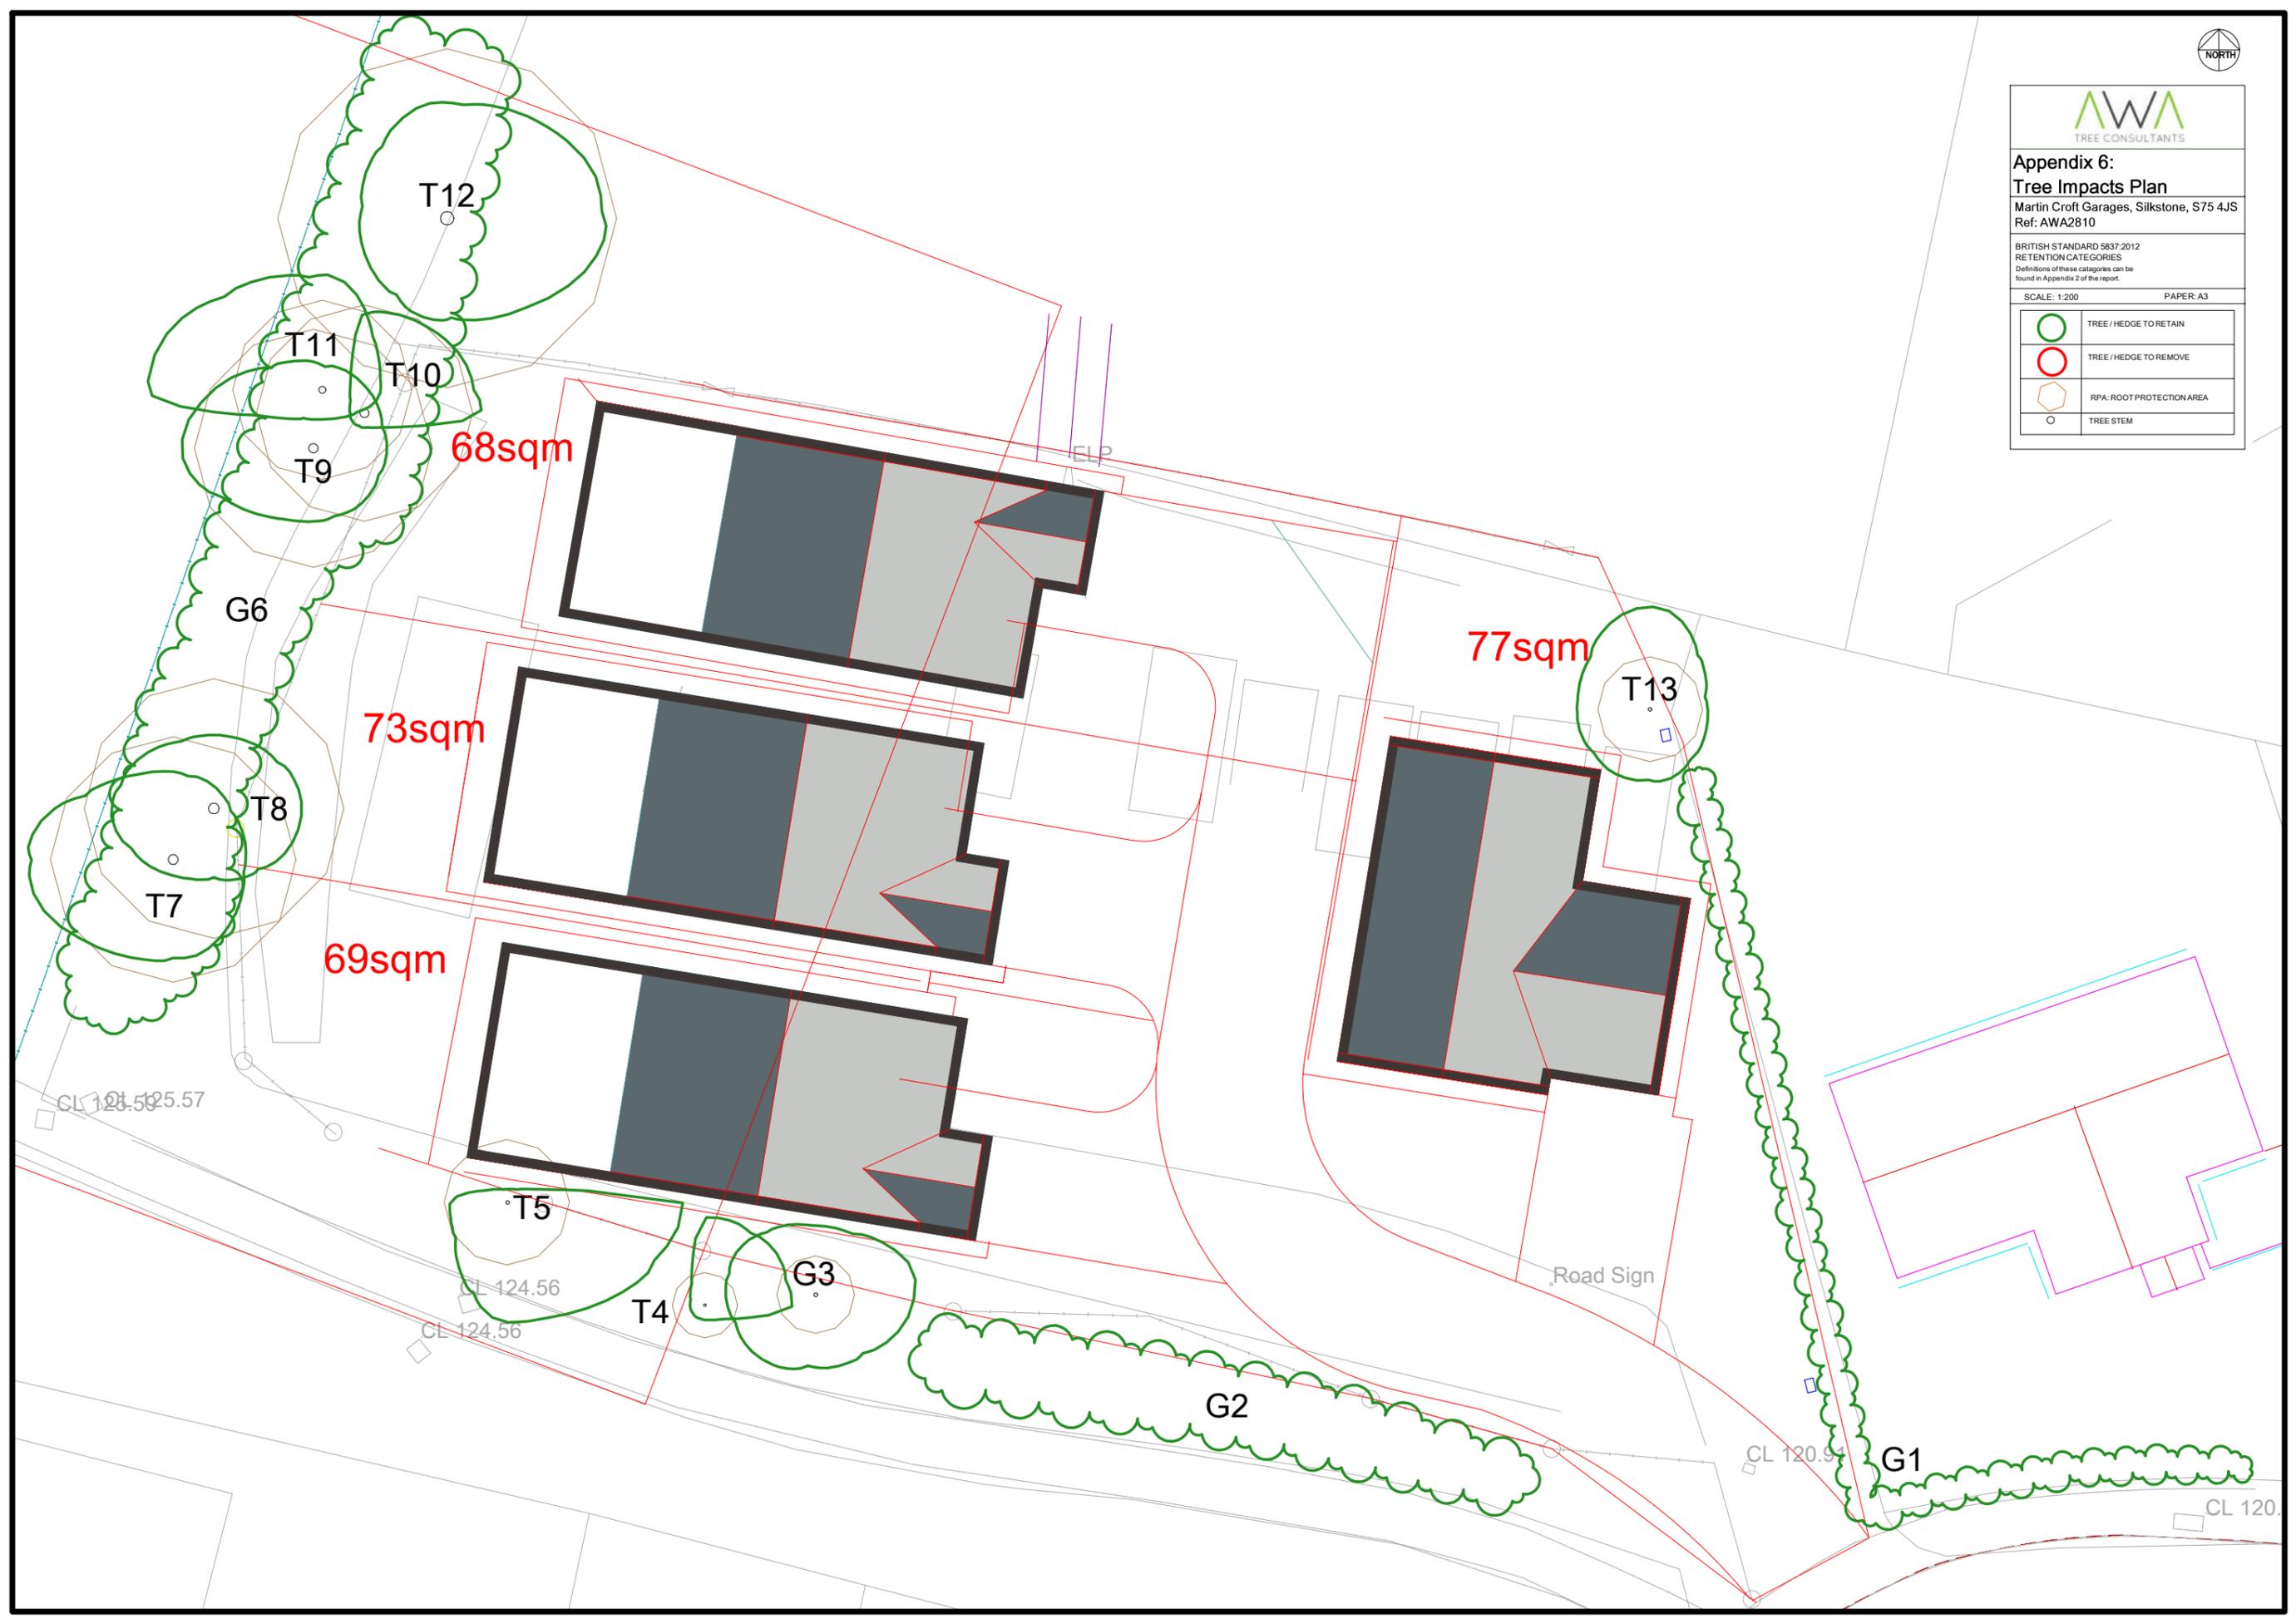
Appendix 6:
Tree Impacts Plan
Martin Croft Garages, Silkstone, S75 4JS
Ref: AWA2810

- 4.2.1 From assessing the new development proposals, no trees will require removal. However, it is advised to heavily prune back the low value trees/shrubs T5 Hazel and T13 Holly.
- 4.2.2 As the surveyed trees are to be retained, the development will have no significant negative arboricultural impact.

- 4.3.2 Potentially damaging activities are proposed in the vicinity of retained trees. The new development encroaches close to and into the edge of the RPA of T5 and T13. Construction within the RPA can have negative impacts on tree roots. However, the encroachment is very minor, and the detailed RPA for these trees is likely to be a slightly exaggerated representation of the trees actual rooting area. As such, it is unlikely that significant roots will be within these areas and the retained tree should remain largely unaffected by the works, provided care is taken during construction.

4.5.1 The retained trees may require protection by fencing in accordance with BS 5837: 2012, during the development phase.
