**Arboricultural Impact Assessment  
Mount Vernon Hospital, Barnsley**

Report reference: AR-3716-01.01  
September 2019

Report Title: Arboricultural Impact Assessment  
Mount Vernon Hospital

Report Reference: AR-3716-01.01

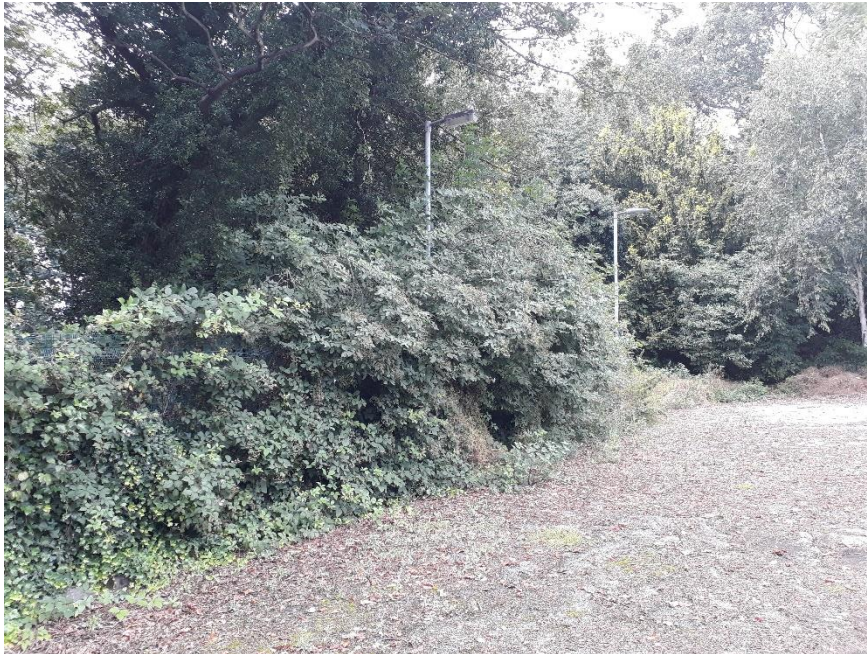
Photograph 1

The lower, south-east corner of the Site where a section of palisade fencing stands between the woodland belt and the car parking area (discernible on the left side of image above the bramble). This fencing could be utilised as a tree barrier protecting the woodland, subject to the location of proposed garden fencing.

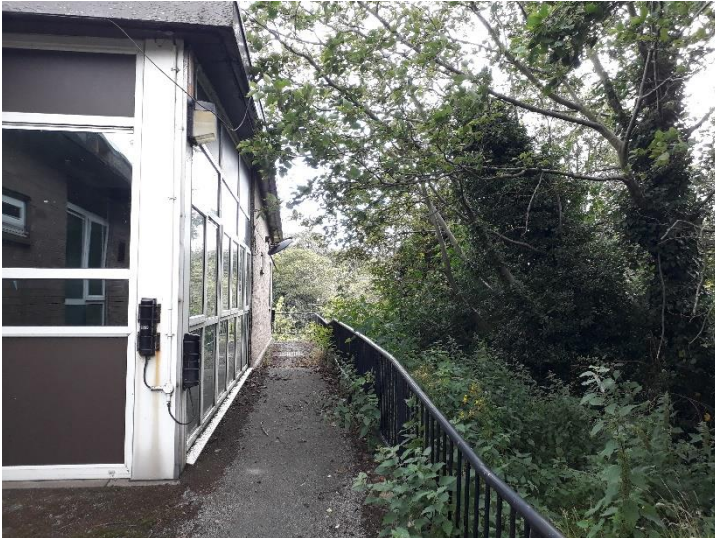
Photograph 2

Looking south-east along the edge of one of the disused hospital buildings on the left and the top of the steep slope with the woodland belt to the right. The tree protection barrier is recommended at the top of this slope, approximately where the railings are now in the centre of the image.

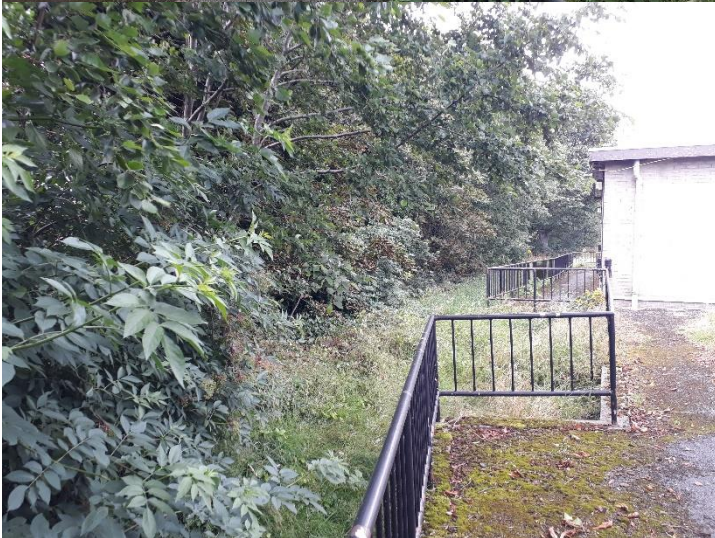
Photograph 3

Looking north-west along the edge of one of the disused hospital buildings on the right and the top of the steep slope with the woodland belt to the left. The tree protection barrier is recommended at the top of this slope, approximately where the railings are now in the centre of the image.

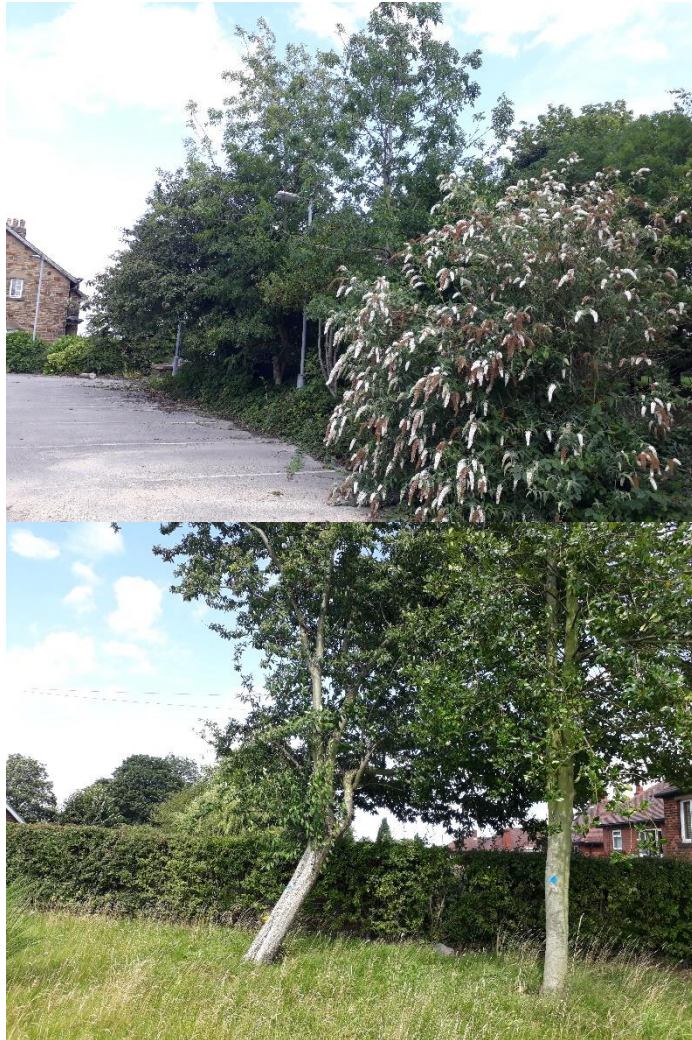
Photograph 4

Looking north-east along the Mount Vernon Road side of the Site to tree 1924 Swedish whitebeam (left hand side) and group G6 are expected to be retained within the development.

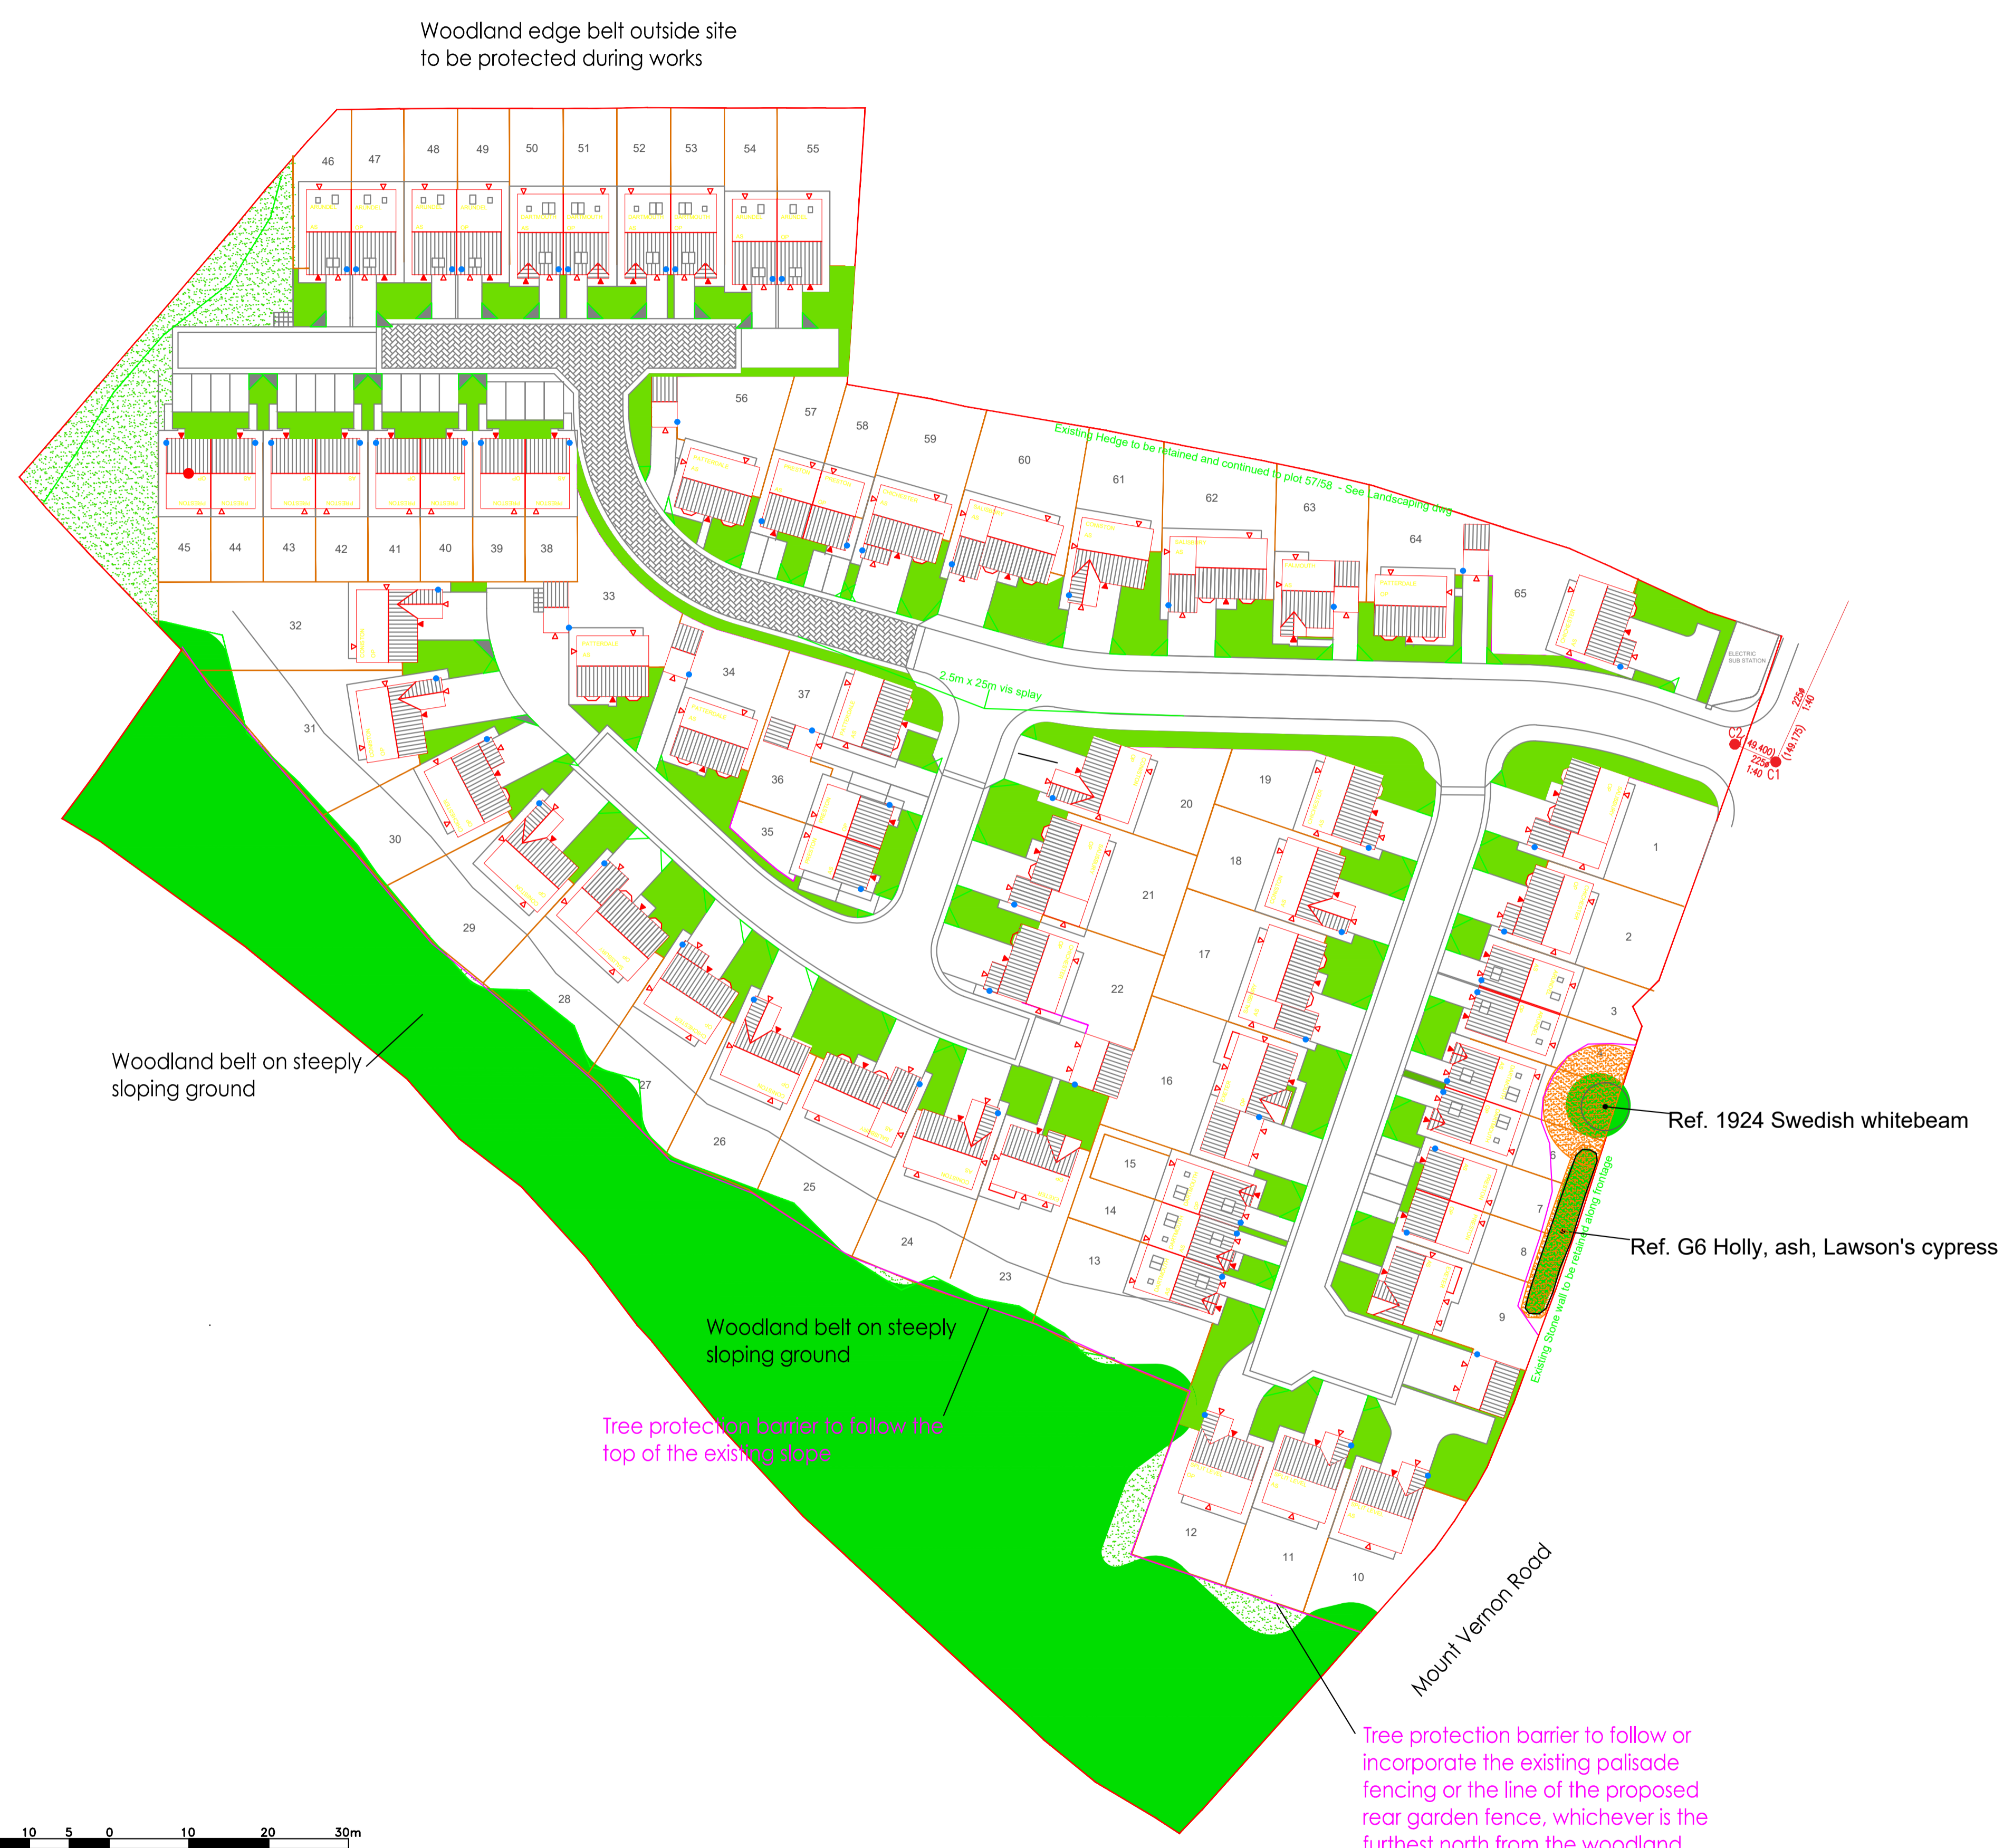
Tree Protection Plan

The line of the tree protection barrier is estimated and confirmation of required location should be ascertained on site.
