# ARBORICULTURAL IMPACT ASSESSMENT

Elsecar Heritage Centre, Wath  
Road, Elsecar, Barnsley, S74 8HJ

21 May 2025

REF: 0634 Rev. A

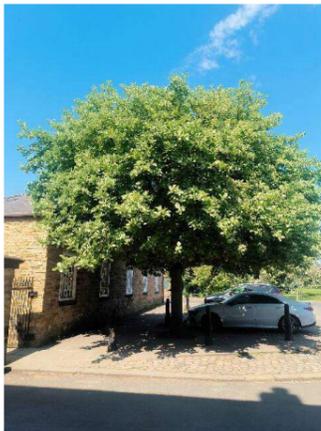
1.90	2.5m.South.2m	WHITEBEAM Sorbus aria	8.50	350 (Yes)	55	4.20	5.50	5.50	4.50	5.00	Mature (M)	<p>Tree is situated adjacent to car park and pedestrian entrance way into the site.</p> <p>Tree has a spreading crown and good amenity value. Physiological condition is good.</p> <p>The tree has multiple stems at approximately 2- 2.5m. The unions are relatively tight and V-shaped and branches extend over parking areas. This is typical of the species but the tight unions may pose an elevated risk of failure. Structure is fair.</p> <p>Branches extend over and are resting on the roof. Tree has good amenity value at the entrance way into the site</p>	Monitor unions for cracking or decay annually	20 - 40 Years	B1

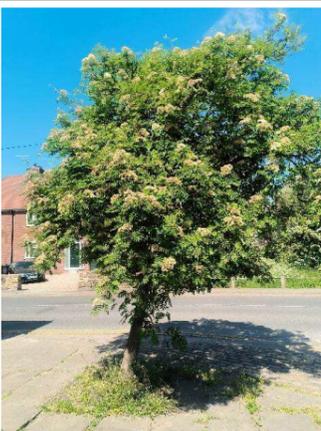
T2	Tree

1.30	2m.North East.1m	ROWAN [MOUNTAIN ASH] Sorbus aucuparia	4.00	129 (No)	7	1.50	2.50	2.00	1.50	2.00	Semi-Mature (SM)	<p>Tree leans Northeast.</p> <p>The tree is not particularly large but does have some amenity value as it is adjacent to the main road.</p> <p>Physiological condition is good. Structural condition is fair.</p> <p>The crown is somewhat busy with some crossing and merging branches. Tree provides moderate amenity value.</p>	No preliminary work recommended	20 - 40 Years	B2
T3	Tree

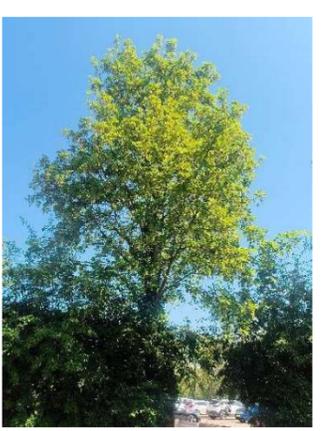
5.20	3m.South West.4m	NORWAY MAPLE Acer platanoides	13.00	288 (No)	41	3.60	3.00	3.50	4.00	3.00	Semi-Mature (SM)	<p>Tree is situated North of road in verge.</p> <p>Understory shrubs around the trees. Tree is growing over pedestrian path, car park and road.</p> <p>Physiological condition is good. Tree has 2 stems and the smaller the stem has been reduced.</p> <p>Tree has some amenity value and arboricultural value. It is growing as part of a group line of trees which screen the car park from the road.</p>	No preliminary work recommended	20 - 40 Years	B2

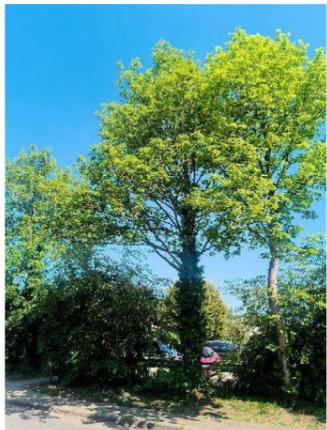
4.50	3.5m.North West.4m	SYCAMORE Acer pseudoplatanus	14.00	360 (No)	55	4.20	4.00	4.00	5.50	5.00	Semi-Mature (SM)	Tree is situated within verge between road and car park. It is growing as part of a group line of trees.  Ivy restricted inspection  Physiological condition appears good and structural condition appears good.  Tree provides screening and amenity value as part of a group.	No preliminary work recommended	20 - 40 Years	B2
T5	Tree

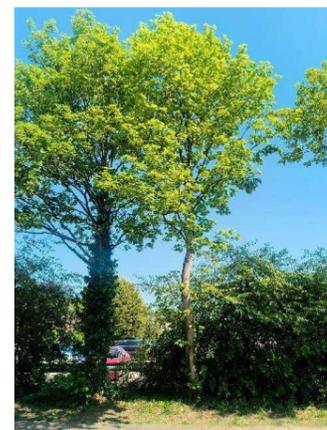
4.00	4m.South West.4m	SYCAMORE Acer pseudoplatanus	12.50	257 (No)	28	3.00	4.00	3.00	5.00	2.00	Semi-Mature (SM)	Tree is situated growing in a verge between the car park and road. It is growing as part of a line of trees and is affected by group pressure.  Physiological condition is good. Structural condition is good. Future growth can be expected of this tree.  Tree provides screening and amenity value as part of a group.	No preliminary work recommended	20 - 40 Years	B2

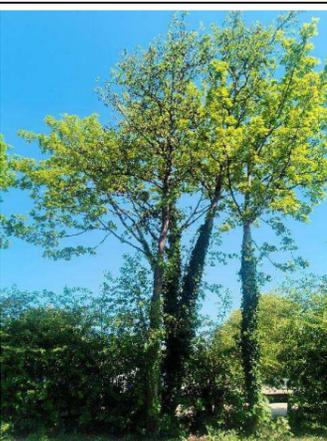
T6	Tree

5.50	4.5m.West.5m	COMMON ALDER Alnus glutinosa	14.00	448 (Yes)	92	5.40	3.00	4.00	5.00	3.50	Mature (M)	Tree a situated growing in a line of trees.  It has two stems joined at the base. One stem leans South towards the road but this does broadly correct.  Ivy is present on all stems limiting inspection to some extent.  Physiological condition is good. Structural condition is fair. Tree provides screening and amenity value as part of a group.	Remove the ivy and inspect union at a base.	20 - 40 Years	B2

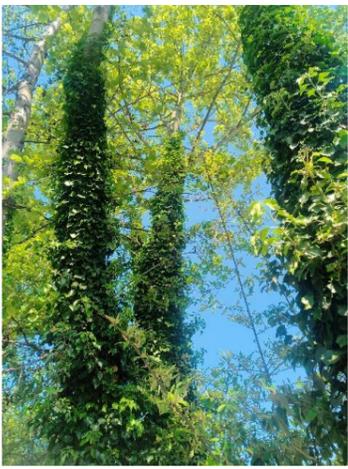
6.00	5m.North West.5m	SYCAMORE Acer pseudoplatanus	14.00	330 (Yes)	48	3.90	5.50	4.00	3.00	6.00	Semi-Mature (SM)	<p>Tree is situated in close proximity to a twin stemmed Alder (T6)</p> <p>Tree is significantly affected by group pressure and crown appears slightly sparse</p> <p>Physiological condition is fair. Structural condition is good.</p> <p>Ivy limited inspection. Tree has moderate amenity value growing as part of a group</p>	Remove the ivy	20 - 40 Years	B2
T8	Tree

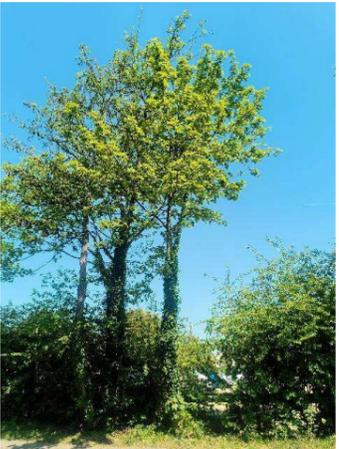
5.00	5m.South West.4m	SYCAMORE Acer pseudoplatanus	13.00	290 (No)	41	3.60	4.00	4.00	5.00	2.00	Semi-Mature (SM)	<p>Tree is ivy clad and is situated growing as part of a group line of trees between car park and road.</p> <p>Ivy limited inspection. Tree has quite a high crown.</p> <p>Physiological condition appears good structural condition appears fair.</p> <p>Future growth can be expected.</p> <p>Tree provides screening and amenity value as part of a group.</p>	No preliminary work recommended	20 - 40 Years	B2

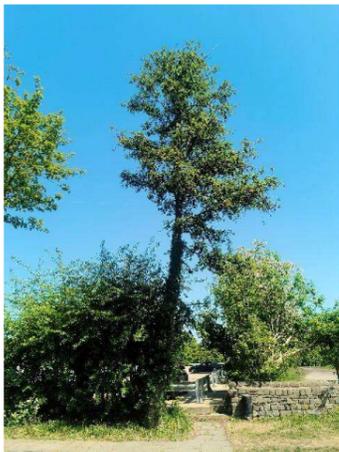
T9	Tree

4.50	5m.South East.3m	COMMON ALDER Alnus glutinosa	14.00	330 (No)	48	3.90	3.00	4.00	4.00	2.00	Semi-Mature (SM)	<p>Tree is situated on verge between car park and road. The tree has an edge structure and a high crown. Ivy present limiting inspection.</p> <p>Minor dieback visible on the Northeast side of the crown and at the top of the crown.</p> <p>Physiological condition is fair, structure is good. Tree provides some amenity value as part of a group.</p>	Sever ivy	20 - 40 Years	B2

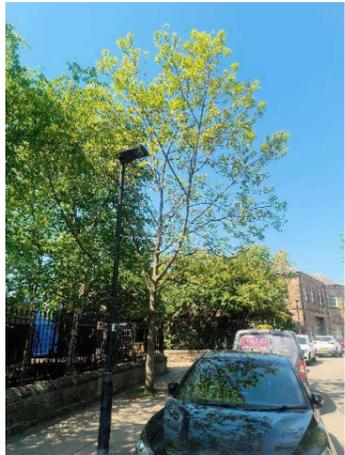
3.50	1.9m.South.5m	COMMON ASH Fraxinus excelsior	11.00	207 (No)	18	2.40	4.50	4.00	4.50	4.50	Semi-Mature (SM)	A street tree situated within a planting pit within the pavement.  Physiological condition is reduced with Ash Dieback Disease suspected. Canopy appears slightly sparse and total canopy deadwood estimated to be around 30%.  Deadwood diameter maximum is at around 30mm.	Monitor for Ash Dieback Disease progression	10 - 20 Years	C2
T11	Tree

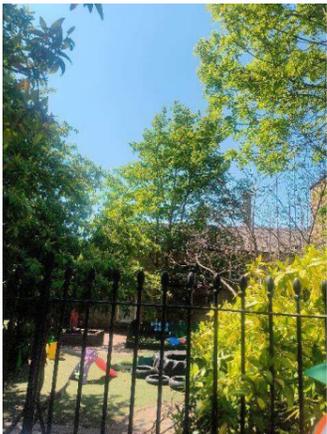
2.00	1.9m.East.4m	SYCAMORE Acer pseudoplatanus	12.00	300 (Yes)	41	3.60	3.50	4.00	4.00	4.00	Semi-Mature (SM)	Access was restricted. Inspection was limited and measurements were estimated.  Tree is situated within Day Care Nursery playground, against building.  Physiological condition appears good. Significant future growth can be expected of this tree.  Structure appears good but can be expected to grow larger in size and may affect the building in future.	No preliminary work recommended	20 - 40 Years	B2

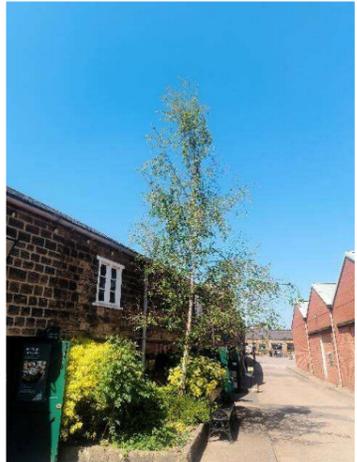
T12	Tree

1.60	1.7m.South East.3m	SILVER BIRCH Betula pendula	11.00	113 (No)	7	1.50	3.00	3.00	3.00	1.00	Semi-Mature (SM)	A relatively young tree situated in a raised plant bed adjacent to building.  Significant future growth can be expected of this tree.  Physiological condition is good. Structural condition is good.	No preliminary work recommended	10 - 20 Years	C2

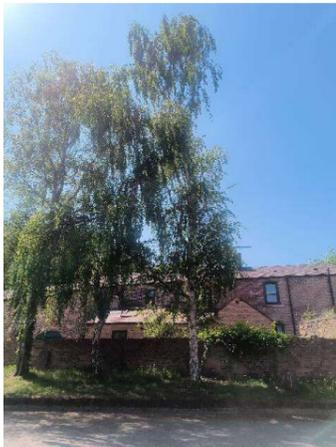
2.50	2.5m.South East.3m	SILVER BIRCH Betula pendula	16.00	300 (No)	41	3.60	4.50	3.50	4.50	2.00	Mature (M)	<p>Tree is situated in a raised banking growing as part of the group of trees.</p> <p>A tree to the North of this tree has previously been removed. This tree is slightly unbalanced, likely as due to the presence of a previous tree. But overall physiological condition is good.</p> <p>Structural condition is good.</p> <p>Tree provides amenity value as part of a group.</p>	No preliminary work recommended	20 - 40 Years	B2
T 14	Tree

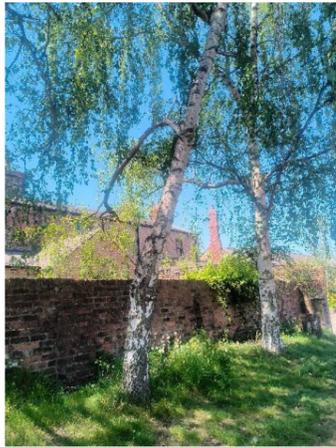
2.00	4m.West.3.5m	SILVER BIRCH Betula pendula	13.00	265 ( )	34	3.30	3.50	3.00	3.00	5.00	Mature (M)	<p>Tree is growing on a raised banking as part of a group of trees. It is affected by group pressure and is distorted North from 2m upwards. The upper section of the tree does correct to some extent.</p> <p>A cavity is present on the main stem on the East side at around 3m.</p> <p>Physiological condition is good. Structural condition is fair.</p> <p>Tree provides amenity value as part of a group.</p>	No preliminary work recommended	20 - 40 Years	B2

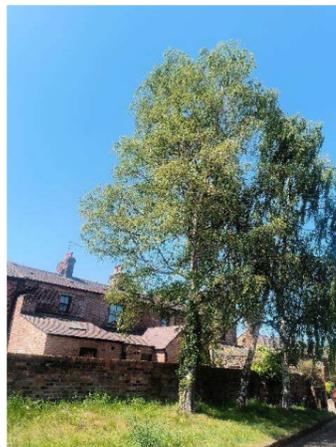
T 15	Tree

2.00	3.5m.West.3m	SILVER BIRCH Betula pendula	16.00	390 (Yes)	72	4.80	4.00	3.50	3.00	5.00	Mature (M)	<p>Tree is the edge tree of a line of trees situated on a raised banking.</p> <p>The physiological condition appears good. Structural condition appears good.</p> <p>Minor ivy is present on the main stem.</p> <p>Tree provides amenity value as part of a group.</p>	No preliminary work recommended	20 - 40 Years	B2

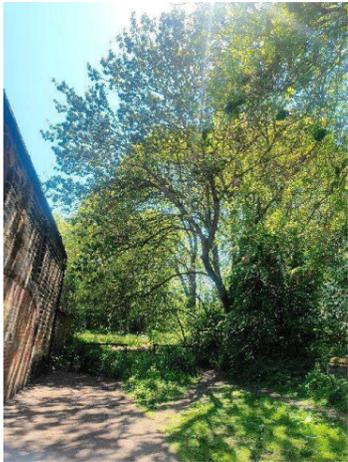
2.00	1.5m.East.4m	COMMON ASH Fraxinus excelsior	18.00	650 (Yes)	191	7.80	9.00	9.00	5.00	7.00	Mature (M)	<p>Tree is situated off-site on the edge of woodland group G3. It is situated on a raised banking adjacent to the stone bridge.</p> <p>The crown extends over pedestrian footpath and towards and over one of the Heritage buildings on site.</p> <p>The overhang over this building is approximately up to 1.5m.</p> <p>This is a large tree. The crown appears slightly thin and Ash Dieback Disease is suspected. Current canopy deadwood is probably at around 10 to 20%.</p> <p>Low hanging branches are present on the East side with canopy clearance approximately 2.2m. Maximum diameter deadwood estimated at around 40mm.</p> <p>This is the largest tree in proximity to the Heritage centre.</p>	Monitor for Ash Dieback Disease progression	20 - 40 Years	B2
