**ARBORICULTURAL REPORT  
to BS 5837:2005  
at  
Hoyle Mill Road (North Site)  
Barnsley  
South Yorkshire**

**Client:**  
FDA Landscape Ltd.

**JCA Ref:**  
10125/RG

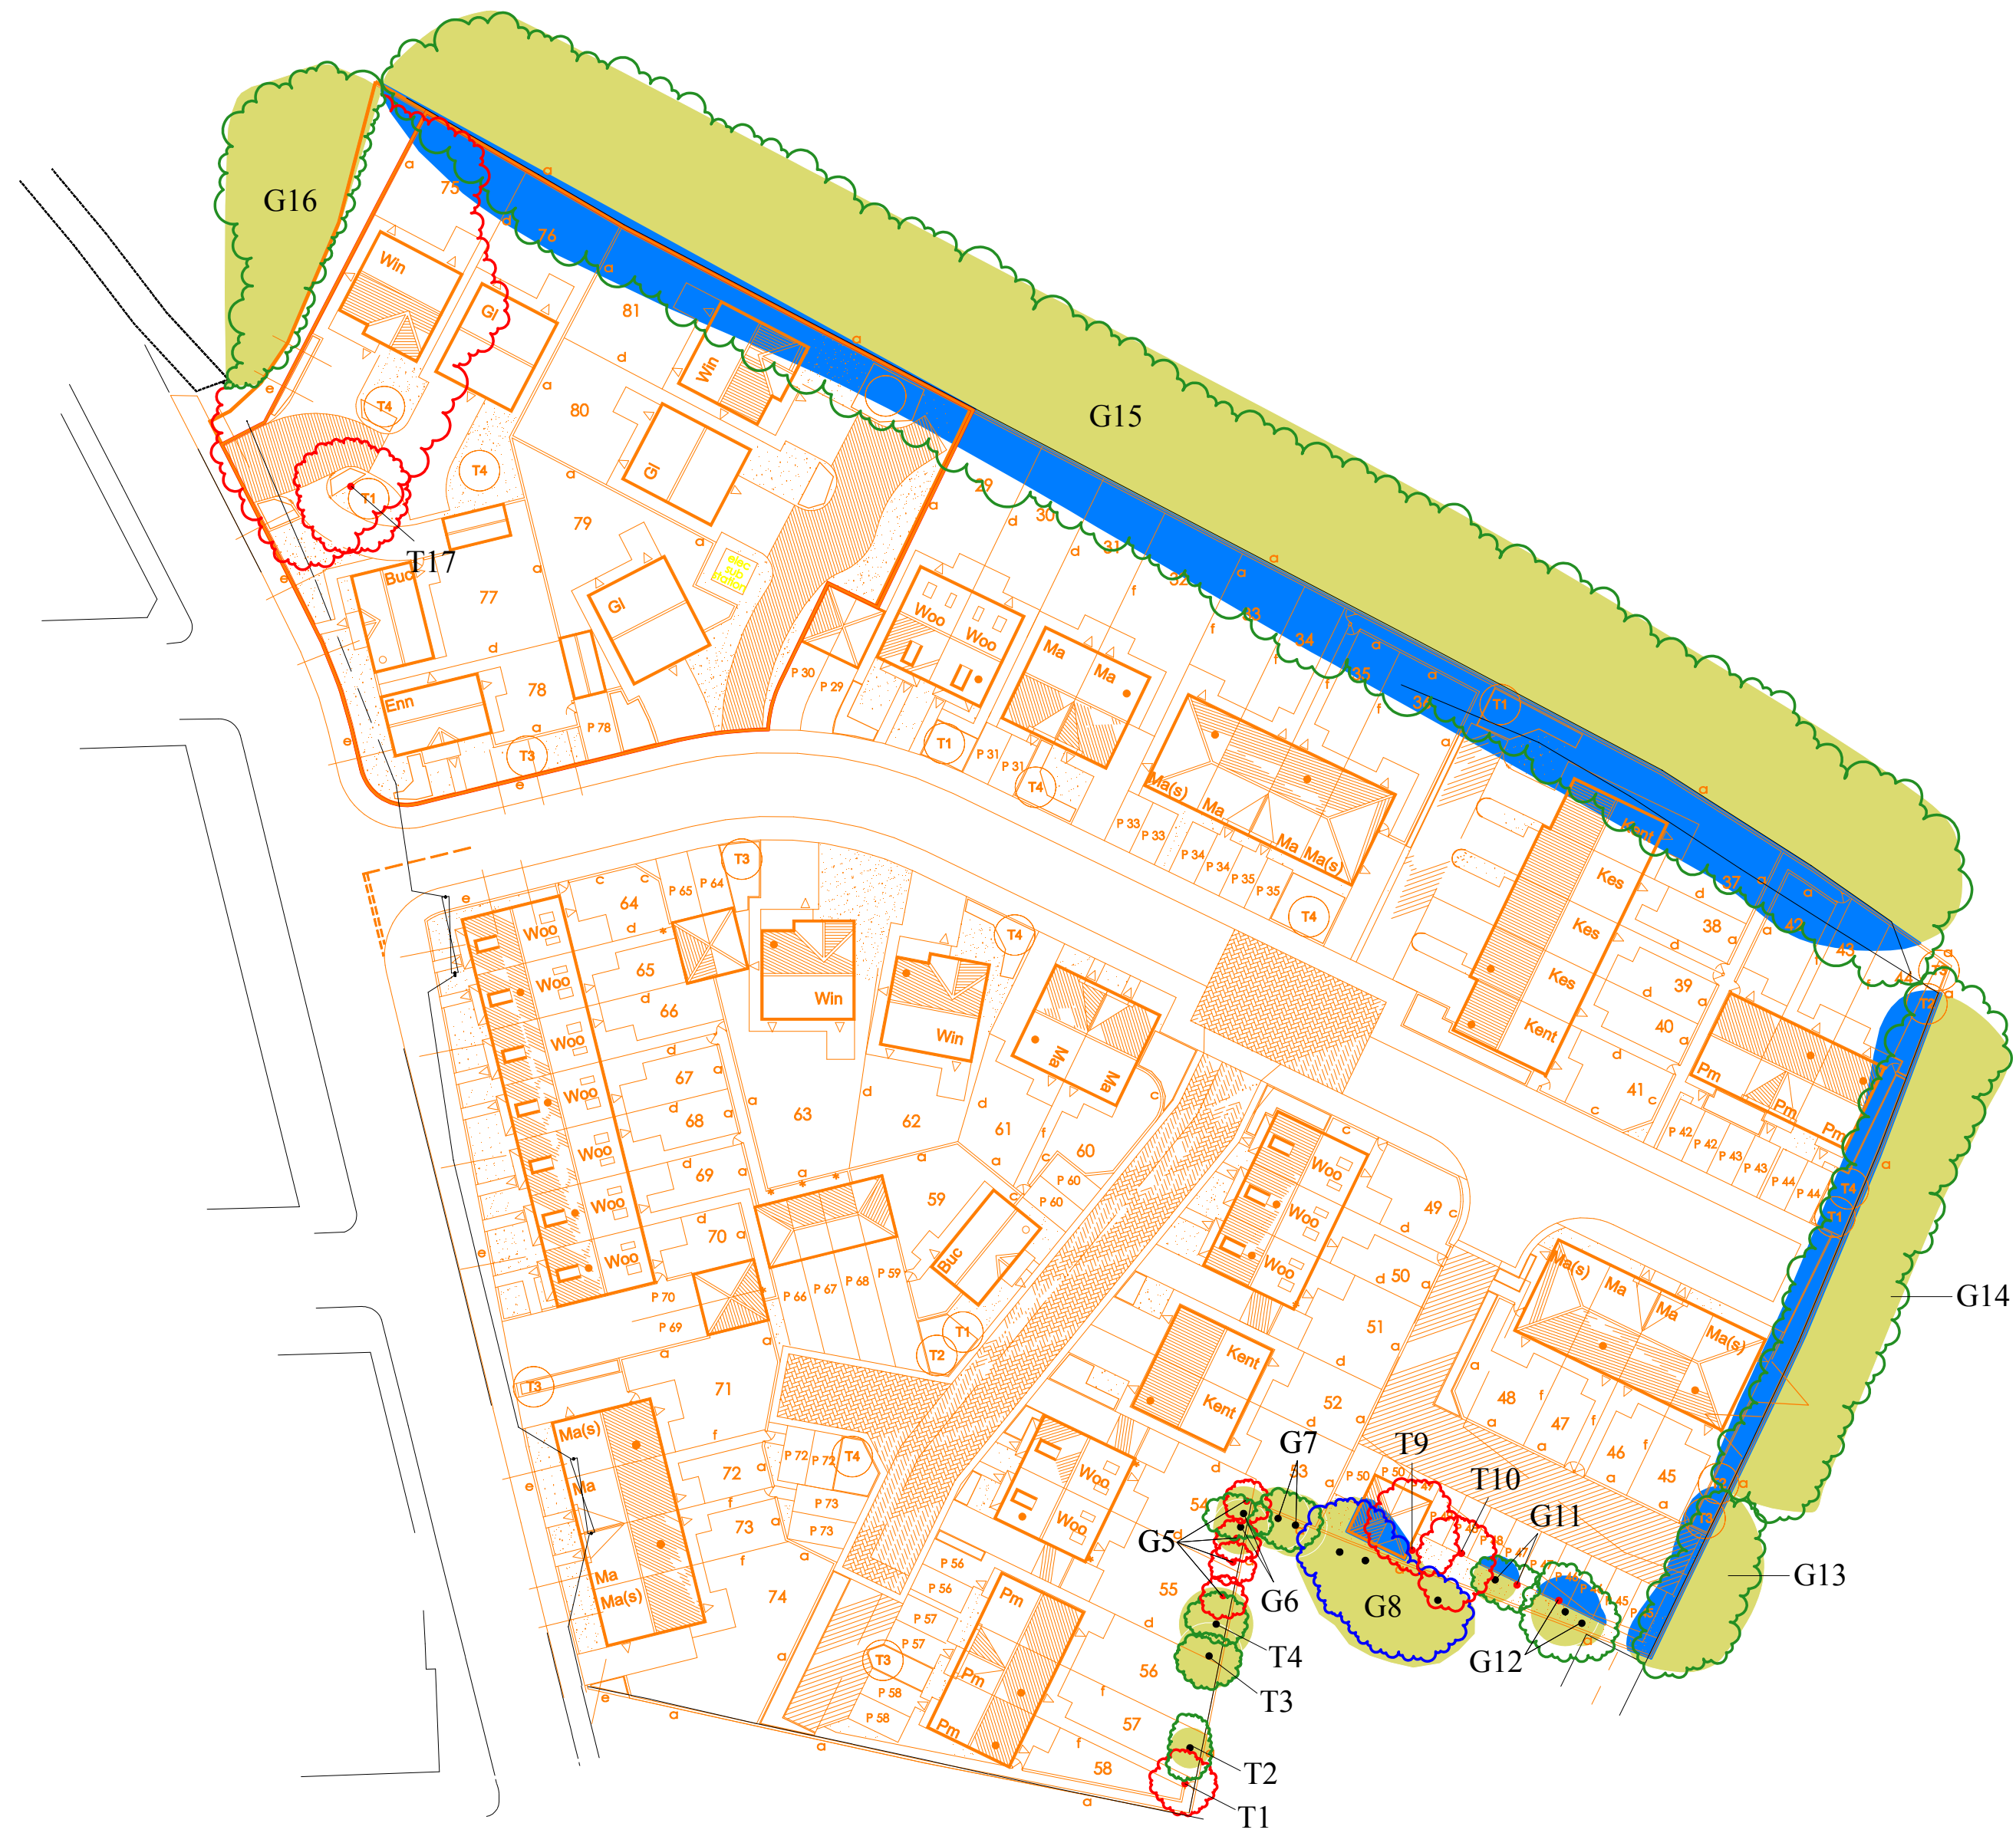
**Appendix 7:  
Development Proposals**

- 6.2.1 **T1, T9, T10, G11** (one tree), **G12** (one tree), **G16** (part of) and **T17** shall require removal as they are situated within the footprint of the proposed development.

- 6.2.5 It is proposed to construct hard surfaces (car parking spaces and driveways) within the RPAs of **G8, G11, G12, G13, G14** and **G15**. **If these trees are to be retained**, the minimum dig and no-dig methods of construction must be considered when working within the RPAs. The finished surface must be porous in order to allow air and water to reach the tree roots, whilst at the same time is able to withstand the load applied.

- 6.2.6 The proposed new dwellings (Plot 81 and Plot 44) encroach into the RPAs of some of **G14** and **G15**. The rooting activity at the point where the foundations are to be laid must first be investigated by hand excavation in the presence of an arboricultural consultant. If significant roots are found then the new building will need to be constructed upon pile and beam foundations, or a similar foundation type, instead of the more traditional trench/strip foundation.

- 6.3.2 Where it is not possible to protect the entire RPAs by fencing, specialist measures must be taken during the construction phase to avoid ground compaction and minimise root damage, where the RPAs remain unprotected. Such areas are highlighted in blue on the Development Proposals Plan at **Appendix 7**.
