# **ARBORICULTURAL REPORT & Impact Assessment** to BS 5837:2012 at:

***All Hallows,  
Church Lane,  
High Hoyland,  
Nr Barnsley,  
South Yorkshire,  
S75 4BJ***

Date: August 2022

Reference: AWA4374

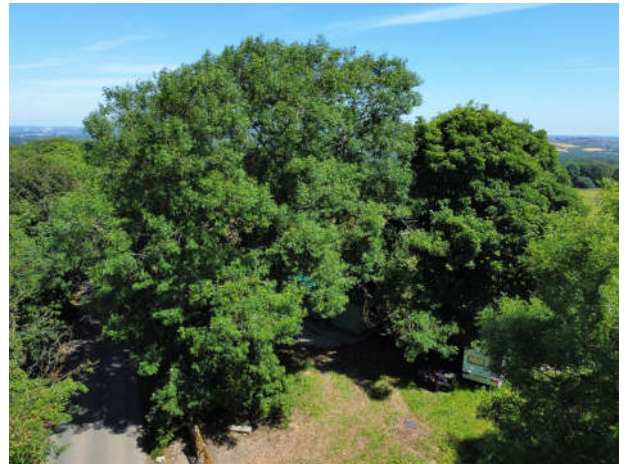
- 3.2.5 Most of the trees are semi-mature with only occasional early mature to mature trees.
- 3.2.6 Mature Ash T1 is located centrally along the western boundary. While T1 provides a moderate degree of amenity it has several defects that limit its long-term potential and is of low value overall.

- 3.2.8 T2 is a multi-stemmed Sycamore growing close to the eastern boundary wall. It contains a tight union at the base and other minor defects and is of low value despite having moderate amenity within the site.

Photo 2: T1 and T2, looking north

- 4.2.1 T1 and T2 will require minor crown lifting works to facilitate the development (as detailed in Appendix 4). It is likely the trees will readily tolerate these works and the amenity value they provide will not be significantly impacted.

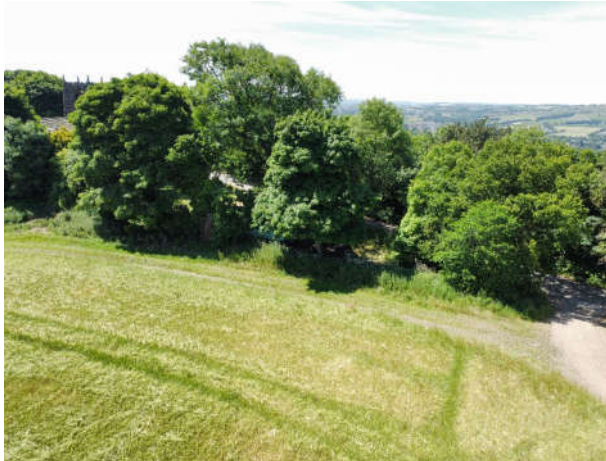
- 3.2.9 Oak T3 and Sycamore T4 are also growing close to the eastern boundary. T3 has several significant pruning wounds leaving stubs on its western aspect that limit its amenity and value, however it does provide effective screening. T4 has good long-term potential but is currently of low value.

Photo 3: T2, T3, T4, T11 and T12 along the eastern boundary, looking west

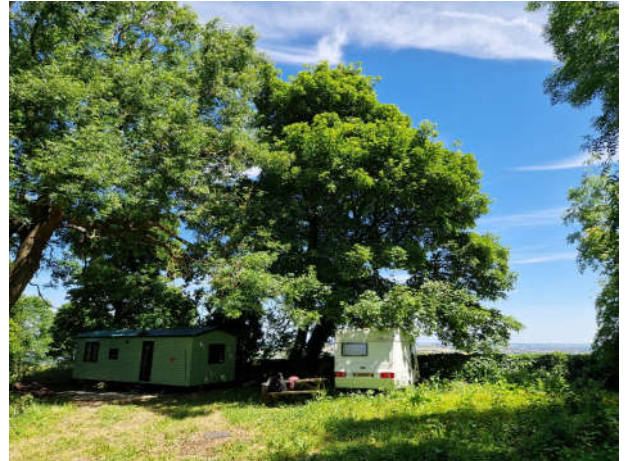
Photo 4: T1 and T2 looking east from the sites gateway

- 4.3.2 A new detached garage is proposed that encroaches close to and into the RPA of T1 and T2. Construction within the RPA can have negative impacts on tree roots. The detailed RPA for these trees is likely to be a slightly exaggerated representation of the trees actual rooting area. If required, it should be possible to employ special foundation design such as mini/micro pile and suspended beam or a cantilevered foundation, in order to overcome or minimise any negative impact on the tree roots.

- 4.3.3 A new driveway is proposed within the RPA of T1. The construction of hard surfaces within the RPA can have negative impacts on tree roots. However, the potential negative impacts can often be overcome or minimised by employing a 'no-dig' type construction method with a porous final surface.

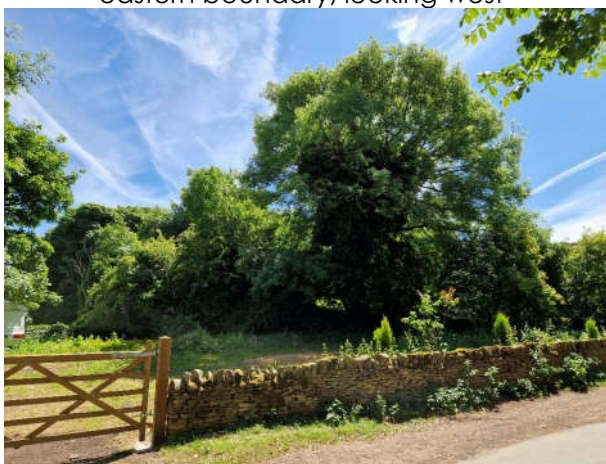
southern boundary, managed to the south to allow clearance of the adjacent public footpath. The trees within the group are covered in dense Ivy and while it provides good screening the group is of low value.

- 3.2.14 Mature Ash T13 is growing within G12 and is also covered with dense Ivy. As it has limited long-term value, T13 is considered as low value overall.

Photo 5: G12 and T13 looking south from Litherop Road

- 4.2.2 The trees that require removal are all lower value, retention category 'C'. Ash T13 is shrouded in dense Ivy, and while it has some amenity within the context of the site its long-term prospects are likely to be limited as a result of Ash dieback disease. G12 is a group of unmanaged Hawthorn shrubs with little amenity or value.

- 4.2.1 From assessing the new development proposals, T13 will require removal and G12 will require partial removal as they are situated in the footprint of the development or their retention and protection throughout the development is not suitable. Trees and groups requiring removal have been identified in red on the attached Tree Plan at Appendix 4.

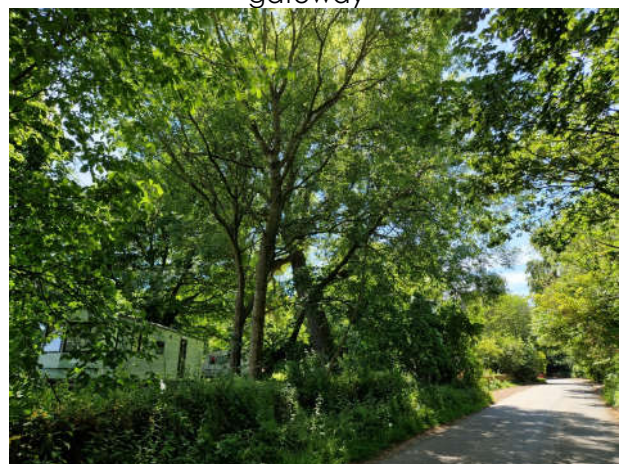
- 3.2.10 Goat Willow T5, Ash T6 and Elm T7 form a low amenity group of trees growing at the eastern boundary, overhanging Litherop Road. While they provide the site with effective screening, they are low amenity and value, with limited long-term prospects.

Photo 6: T5 and T6 overhang Litherop Road, looking south
