# ARBORICULTURAL REPORT

To BS 5837:2012 at:

*Land at*  
**Manchester Road**  
**Thurlstone**  
**Barnsley**  
**S36 9LQ**

Reference: AWA3411

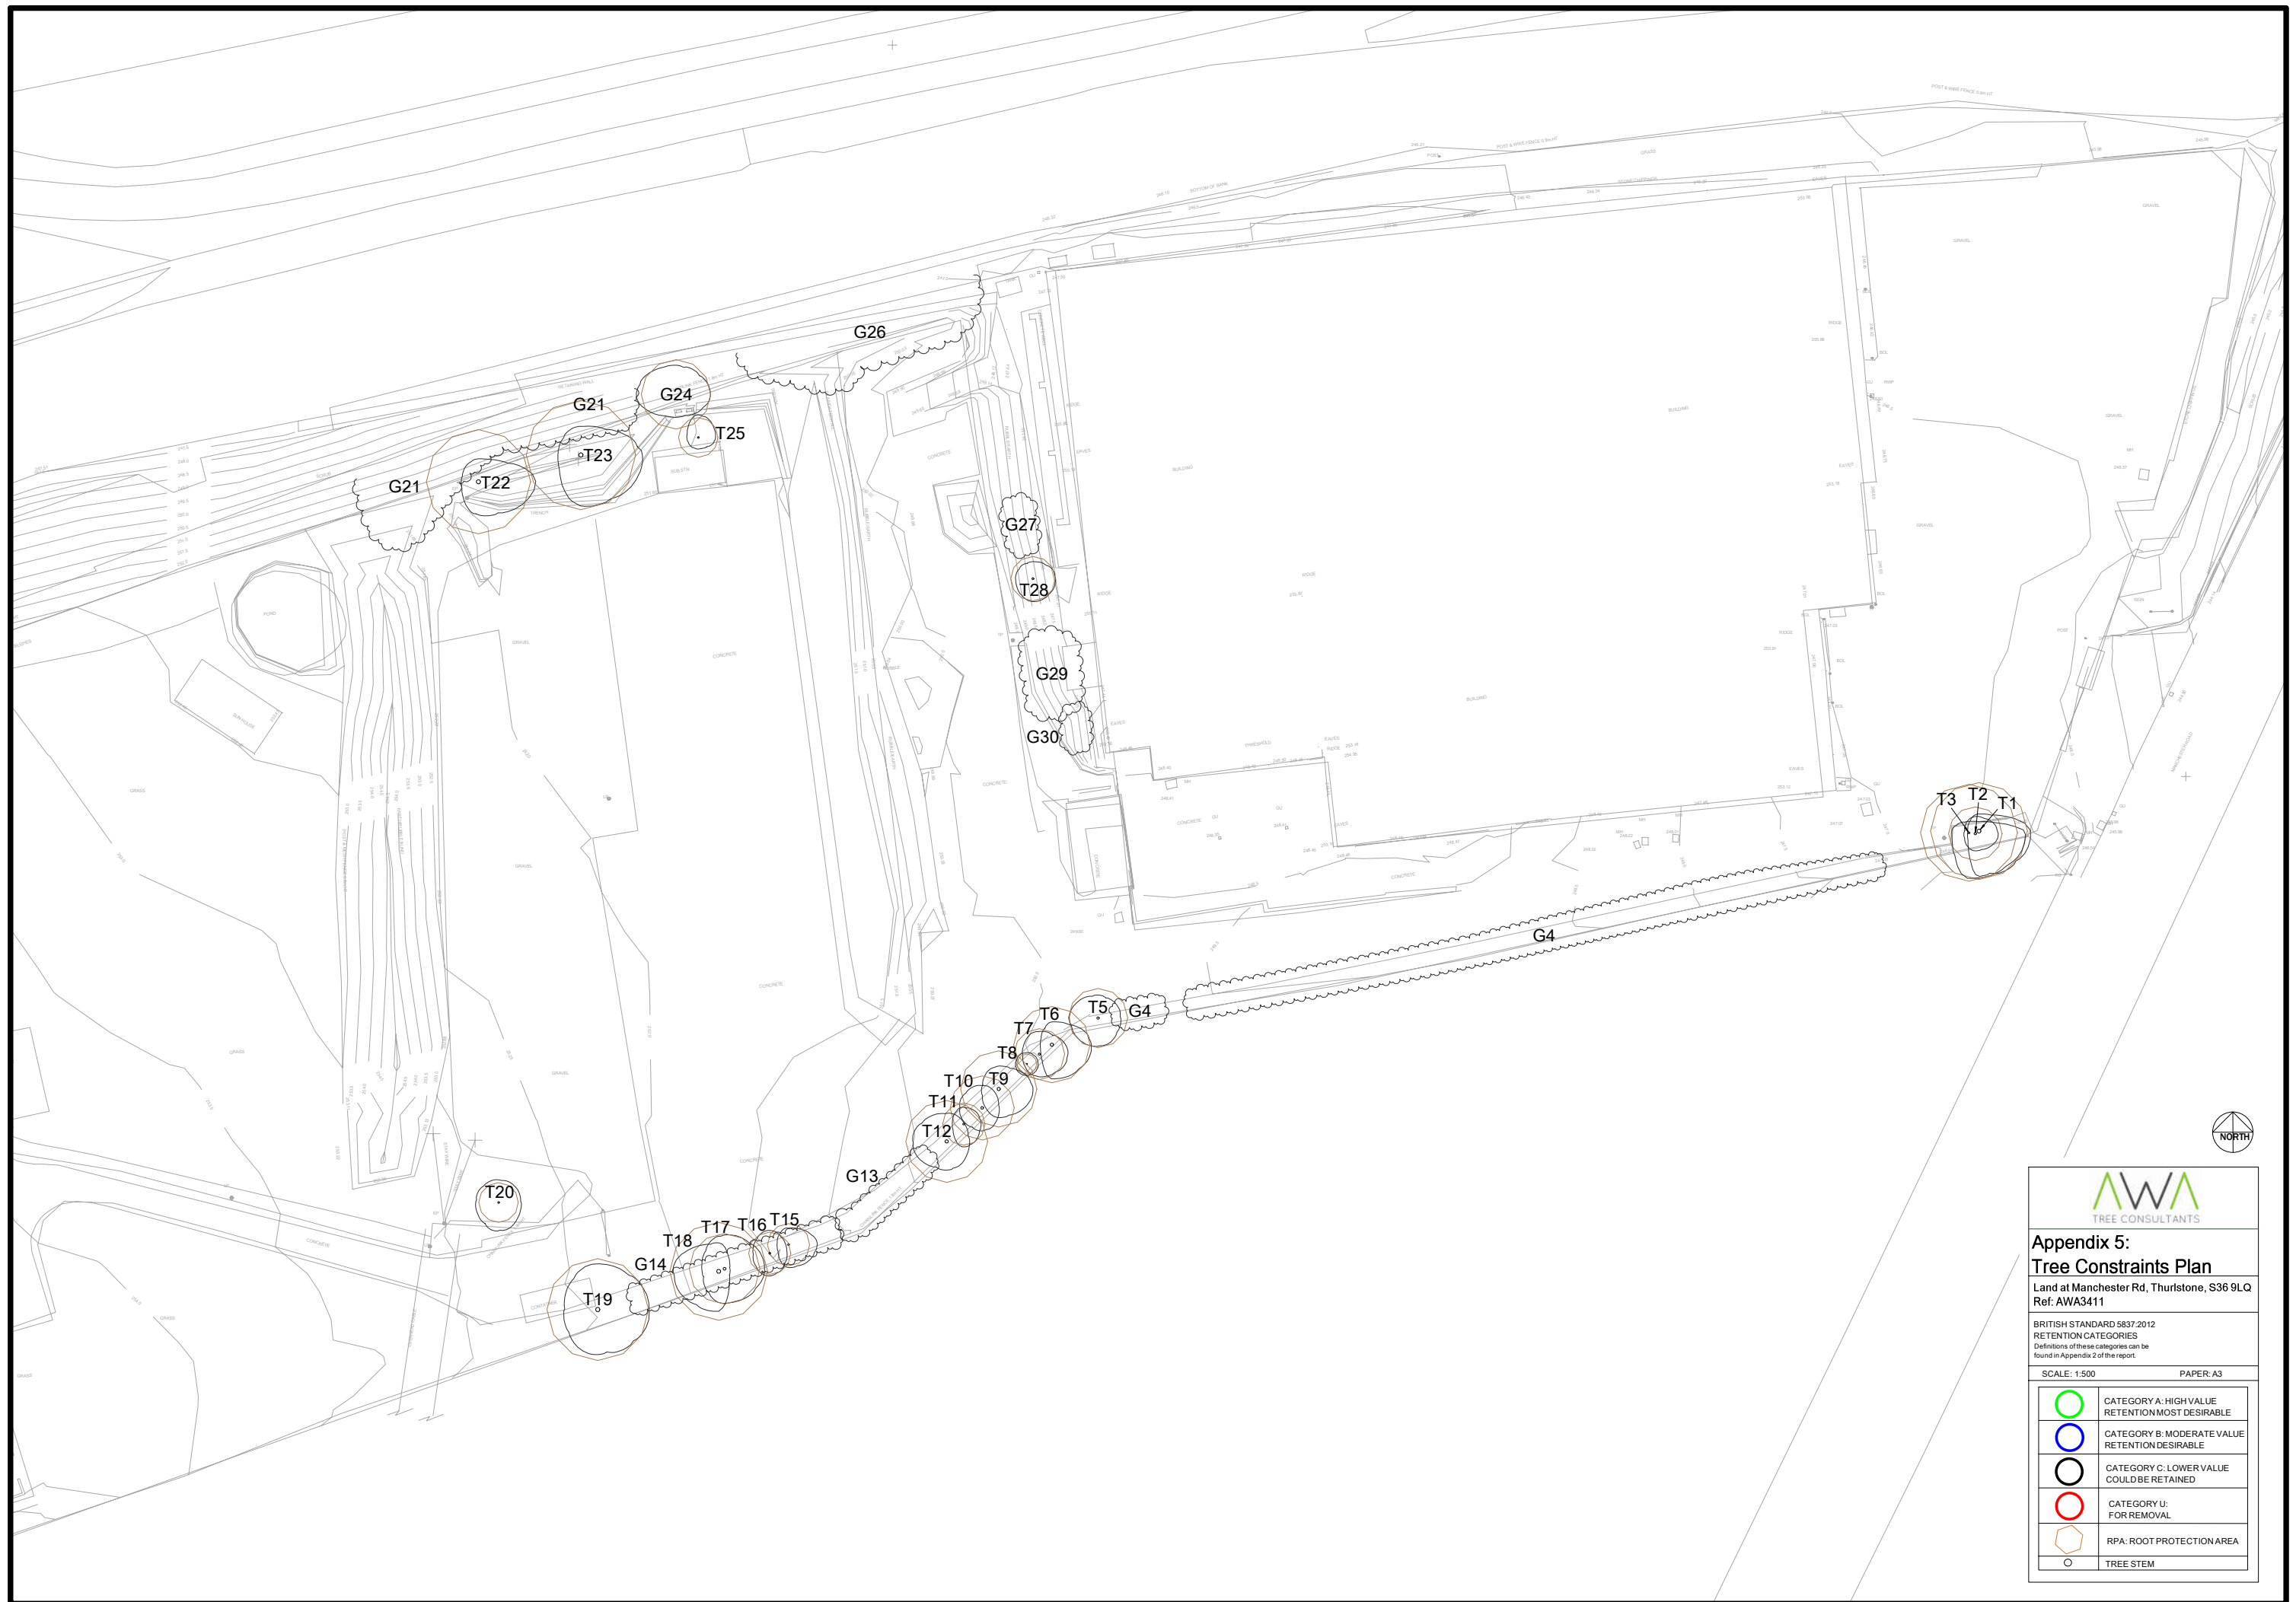
**Appendix 5: Tree Constraints Plan**

- 3.3.4 The tree Root Protection Area (RPA), detailed on the Tree Constraints Plan at Appendix 5, should be used as a layout design tool, to inform on the area around a tree where the protection of the roots and soil structure is treated as a priority.
