# **ARBORICULTURAL REPORT**

to **BS5837:2012** at:

***Smart Innovation Centre,  
Church Street,  
Darfield,  
Barnsley,  
South Yorkshire  
S73 9LG***

Reference: AWA2312

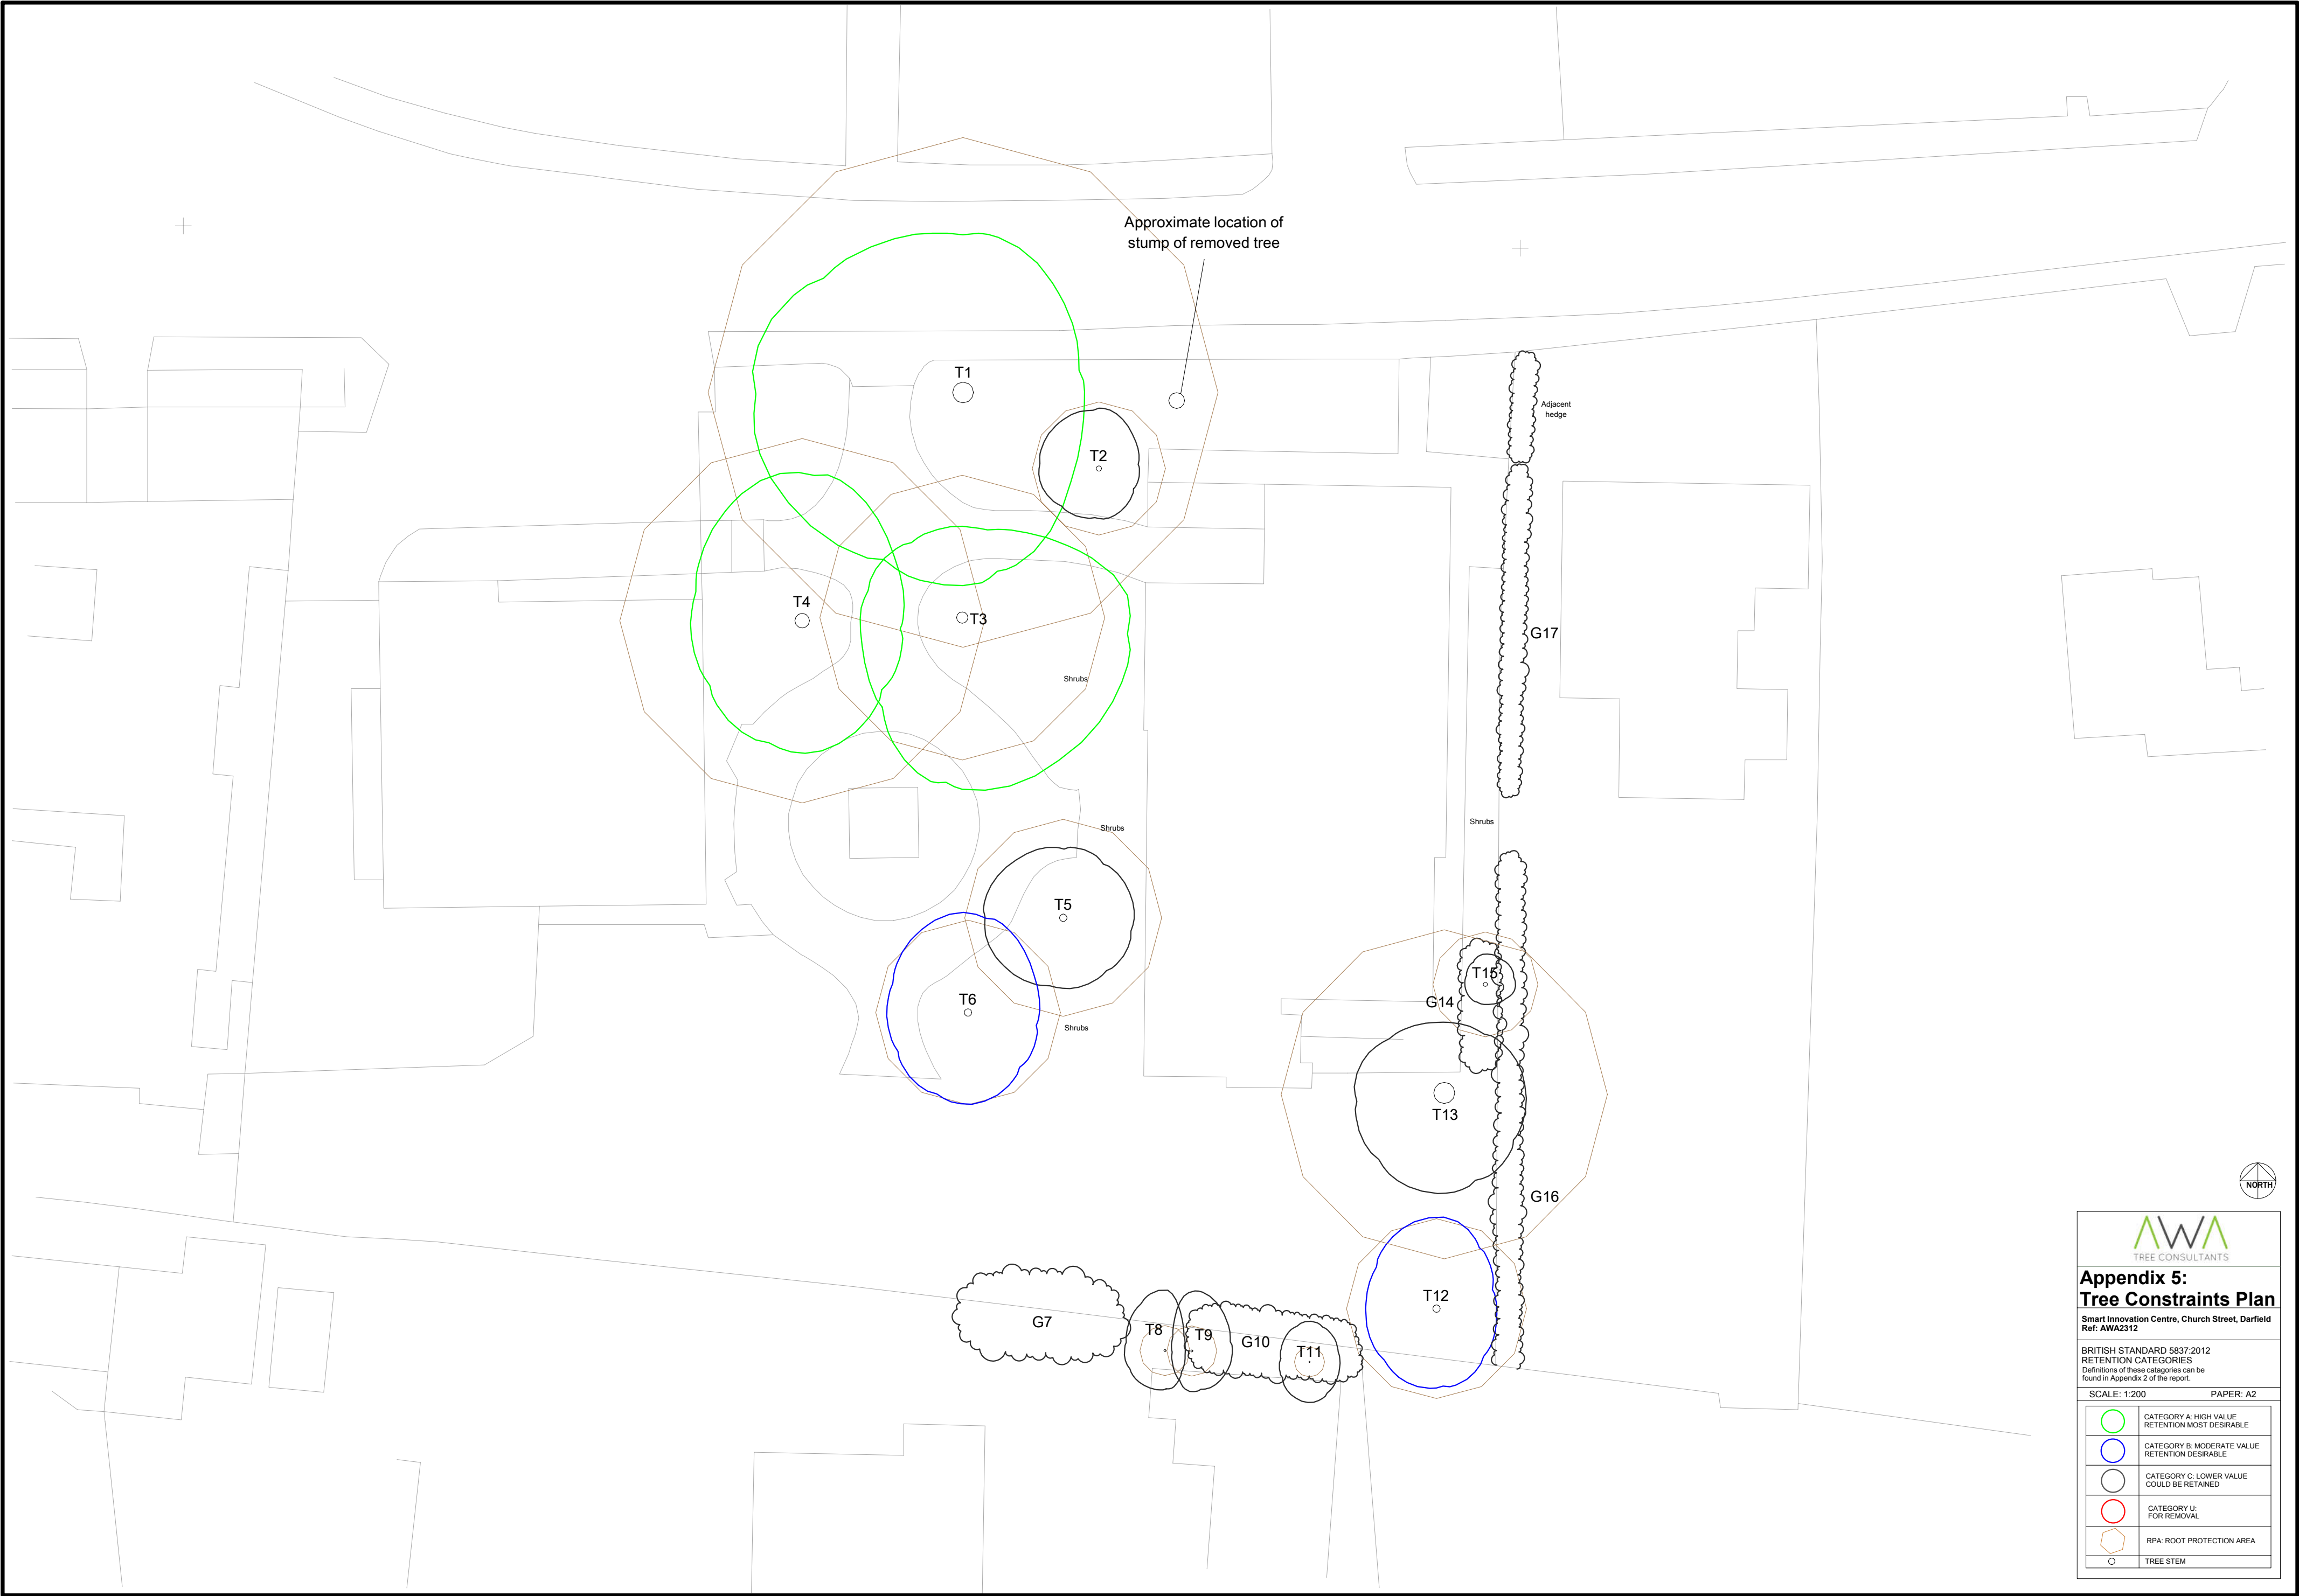
**Appendix 5:  
Tree Constraints Plan**

- 3.2.11 The tree Root Protection Area (RPA) is detailed on the Tree Constraints Plan at Appendix 5. The RPA for each tree has been plotted as a polygon centred on the base of the stem. Due to the presence of roads, structures, topography (and past tree management) the RPA is likely to be a simplified representation of the tree roots actual morphology and disposition.

- 4.3.3 It was noted that the stump of a recently removed tree is situated to the front of the building, close to where the new access point and gate will be situated (approximately indicated on the Tree Plans at Appendices 5 and 6).
