**Arboricultural Impact Assessment  
Mount Vernon Hospital, Barnsley**

Report reference: AR-3716-01.03  
September 2019  
Revised February 2020

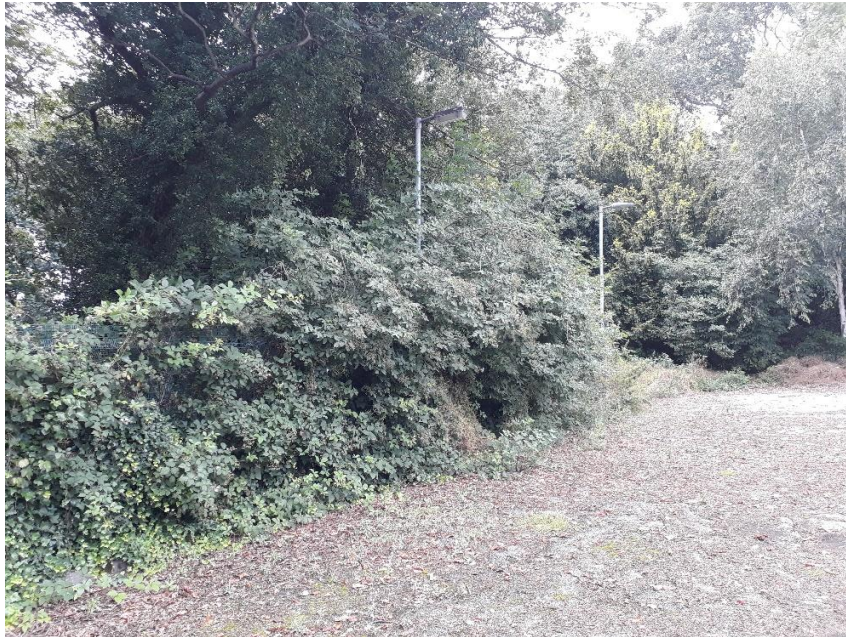
Photograph 1

The lower, south-east corner of the Site where a section of palisade fencing stands between the woodland belt and the car parking area (discernible on the left side of image above the bramble). This fencing could be utilised as a tree barrier protecting the woodland, subject to the location of proposed garden fencing.

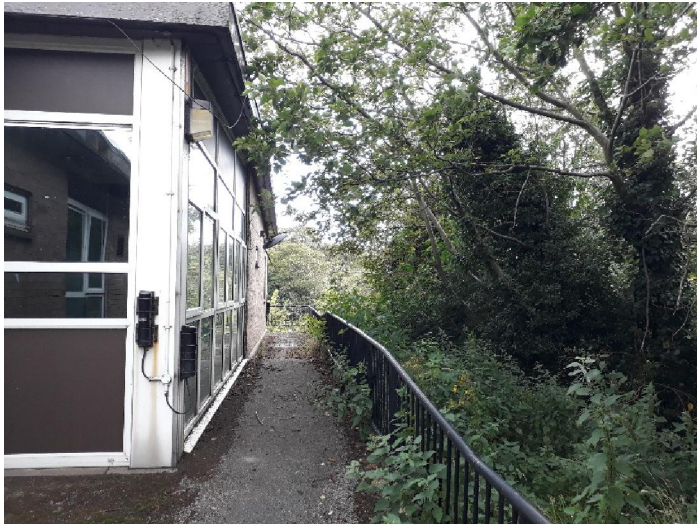
Photograph 2

Looking south-east along the edge of one of the disused hospital buildings on the left and the top of the steep slope with the woodland belt to the right. The tree protection barrier is recommended at the top of this slope, approximately where the railings are now in the centre of the image.

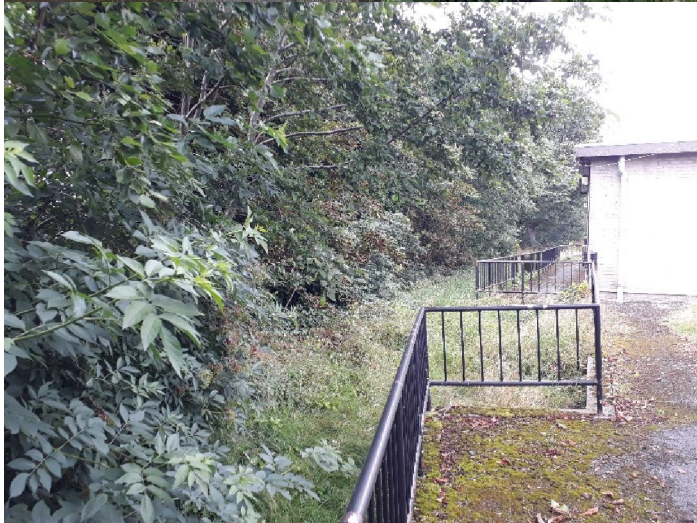
Photograph 3

Looking north-west along the edge of one of the disused hospital buildings on the right and the top of the steep slope with the woodland belt to the left. The tree protection barrier is recommended at the top of this slope, approximately where the railings are now in the centre of the image.

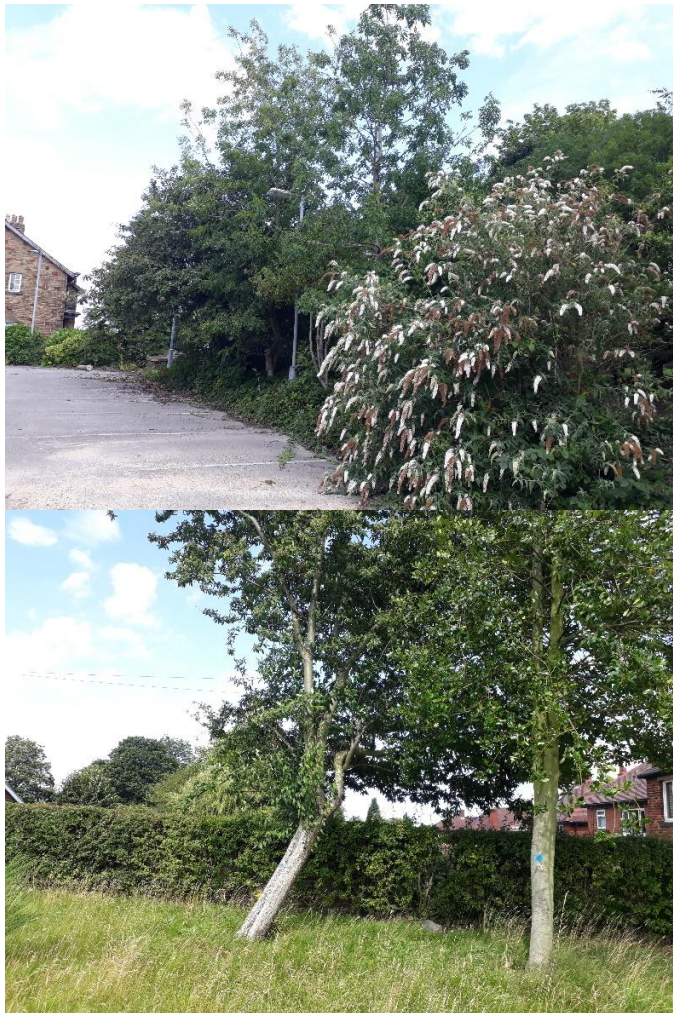
Photograph 4

Looking north-east along the Mount Vernon Road side of the Site to tree 1924 Swedish whitebeam (left hand side) and group G6 are expected to be retained within the development.

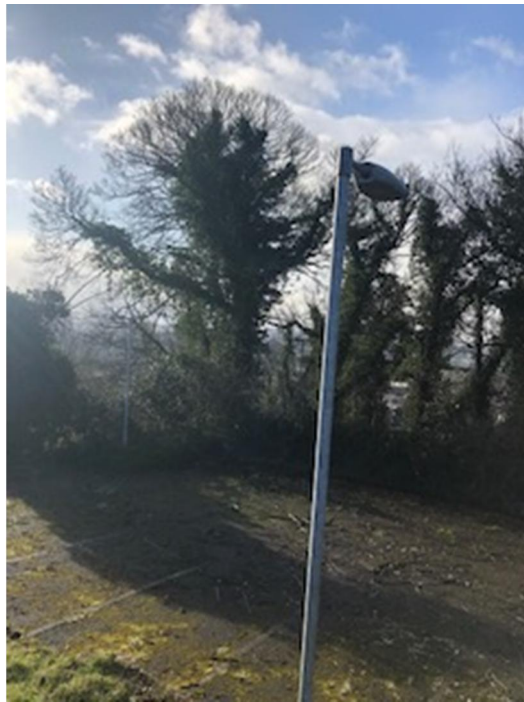
Photograph 6

Tree ref.	Species	Brief description	DBH in mm	Required works
<b>N</b>	Sycamore	Single stemmed. Covered in dense ivy.	Est 800	Remove the dense ivy that consumed the stem and re-inspect for defects
<b>O</b>	Sycamore	Single stemmed. Covered in dense ivy.	Est 750	Remove the dense ivy that consumed the stem and re-inspect for defects
<b>P</b>	Alder	Leaning. Single stemmed	Est 220	Remove. Can not be protected during construction.

Looking south at Tree N

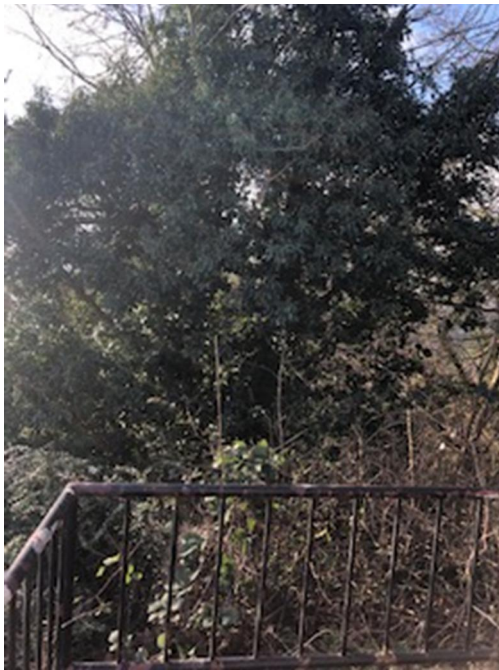
Tree ref.	Species	Brief description	DBH in mm	Required works
<b>A</b>	Ash	Twin stemmed at 0.5 with balanced canopy. Covered in dense ivy.	Est 600	Remove the dense ivy that consumed the stem and re-inspect for defects.
<b>B</b>	Alder	Single stemmed. Leaning and scrappy looking trees. Overhanging building. Covered in dense ivy.	Est 360	Remove the dense ivy that consumed the stem and re-inspect for defects. Reduce canopy back by 1.5m.
<b>C</b>	Alder	Single stemmed. Covered in dense ivy.	Est 320	Remove the dense ivy that consumed the stem and re-inspect for defects.
<b>D</b>	Ash	Twin stemmed at 1m. Deadwood and stubs noted within canopy. Covered in dense ivy.	Est 400 at base	Crown clean. Remove the dense ivy that consumed the stem and re-inspect for defects.

Photograph 7  
Looking south at Tree A

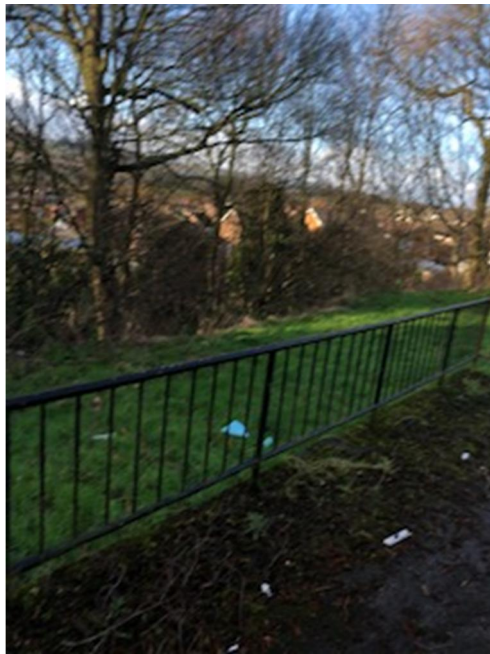
Photograph 8

Tree C

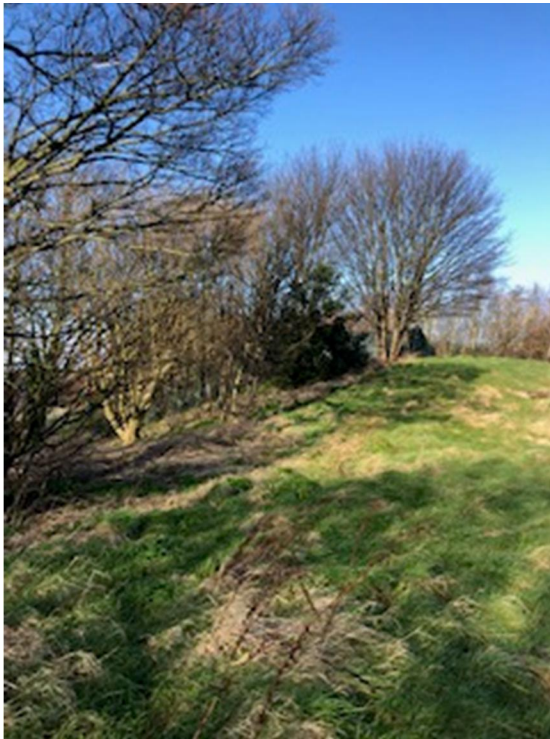
Photograph 9

<b>K</b>	Ash	Single stemmed. Deadwood and stubs noted. Low hanging canopy.	Est 750	Crown clean. Crown lift to 2.5m.
<b>L</b>	Sycamore	Single stemmed. Epicormic growth around base. Deadwood and stubs.	Est 550	Remove epicormic growth and re-inspect. Crown clean.
<b>M</b>	Sycamore	Multi stemmed at ground level. Very minor deadwood.	Est 150 to 300 x 8	Light crown clean

Looking east at L & M

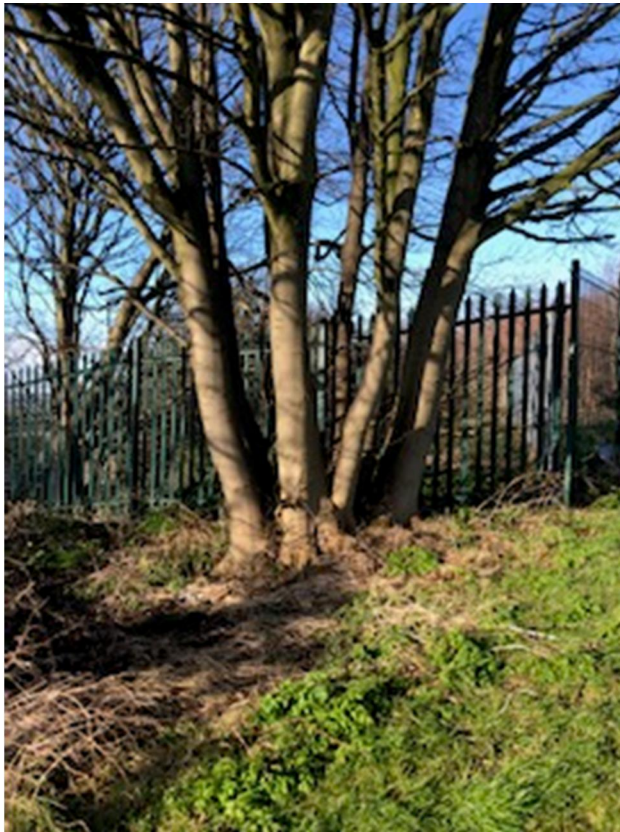
Photograph 10

Tree M
