**Carlton Road, Barnsley**  
**Arboricultural Impact Assessment**  
**and Arboricultural Method Statement**

**Keepmoat Homes Ltd**

Report Title: **Carlton Road, Barnsley  
Arboricultural Impact Assessment and  
Arboricultural Method Statement**

Revision: **V04**  
Issue Date: **January 2020**  
Report Ref: **10112**

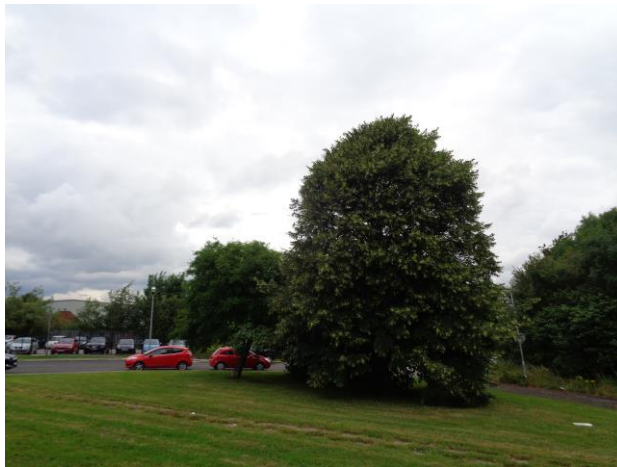
| Tree No | Species | Ht (m) | Stem Diam @ 1.5m (cm) | Canopy Spread (m)<br>N- E- S- W | | | | Height of Crown Clearance | Age Class | Est yrs | Overall Condition | Comments | Management Recommendations<br>For Arboricultural Method Statement | BS 5837 Category | RPA Radius (m) | RPA (m <sup>2</sup> ) |
|---|---|---|---|---|---|---|---|---|---|---|---|---|---|---|---|---|
| T13 | Rowan ( <i>Sorbus aucuparia</i> ) | 7 | 32 | 4 | 4 | 4 | 3 | 1 | M | 40+ | Fair | Girdling root on north side, lean to east, minor mower damage | - | B2 | 3.84 | 46.32 |

**Plate 1:** Lime tree T14, with rowan T13

- 3.9.2 To compensate for root damage and stress caused by construction activities retained trees T13, T14 should be mulched. The materials that may be used for mulching include coarsely divided plant matter, such as wood chip, pulverized bark, or leaf mould, any of which may be combined with well-rotted animal manure. The mulched

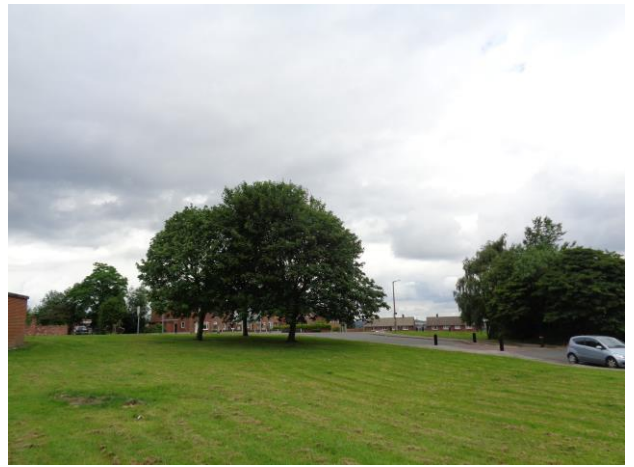
| Tree No | Species | Ht (m) | Stem Diam @ 1.5m (cm) | Canopy Spread (m)<br>N- E- S- W | Height of Crown Clearance | Age Class | Est yrs | Overall Condition | Comments | Management Recommendations For Arboricultural Method Statement | BS 5837 Category | RPA Radius (m) | RPA (m <sup>2</sup> ) |
|---|---|---|---|---|---|---|---|---|---|---|---|---|---|
| T1 | Norway Maple ( <i>Acer platanoides</i> ) | 9 | 35 | 2 6 5 5 | 1.8 | EM | 20+ | Poor | Occluded union at 2m, weep coming from base of occlusion and at ground level on south. | <b>Removed in 2018 due to storm damage</b> | U | 4.20 | 55.42 |
| T3 | Swedish whitebeam ( <i>Sorbus intermedia</i> ) | 9 | 34 | 5 4 4 5 | 1.8 | EM | 40+ | Fair | Minor mower damage on east side | - | B2 | 4.08 | 52.30 |

**Plate 2:** T1-T3 middle left

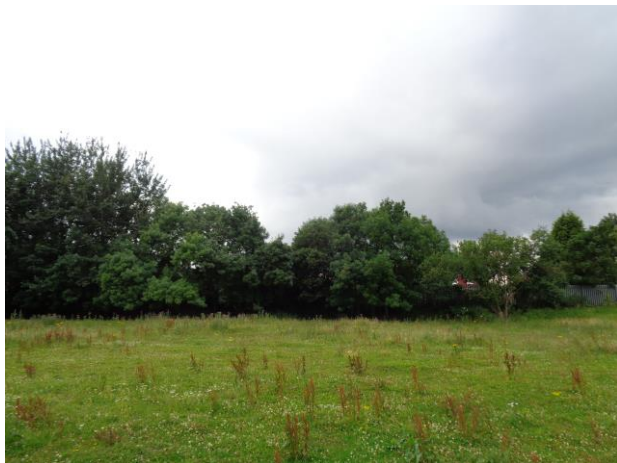
**Plate 3:** Western site boundary, (l-r) G48 – T26

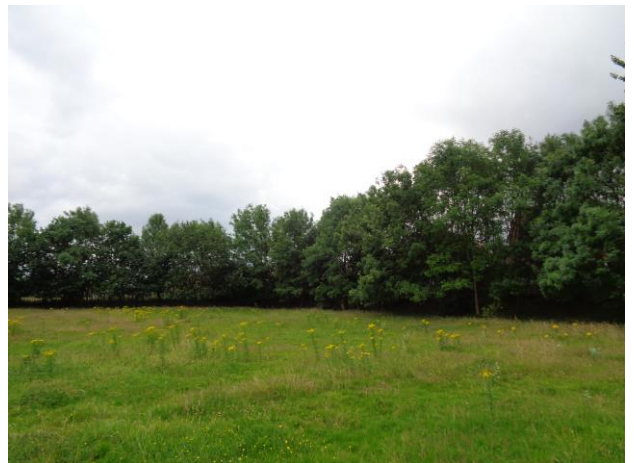
- 2.2.3 A small section of group G056 must be removed to create the link between the north and south parts of the site. A small amenity woodland group planted densely and never thinned, this group has been given a C Category. The partial loss of this group is of limited consequence and the remaining portion should be thinned to encourage better tree development.

**Plate 4:** SW corner of former school site, (r-l) G50 –G56

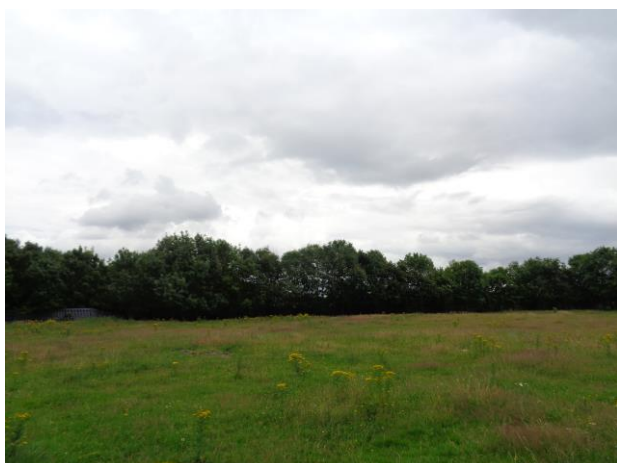
**Plate 5:** NE corner of site G66

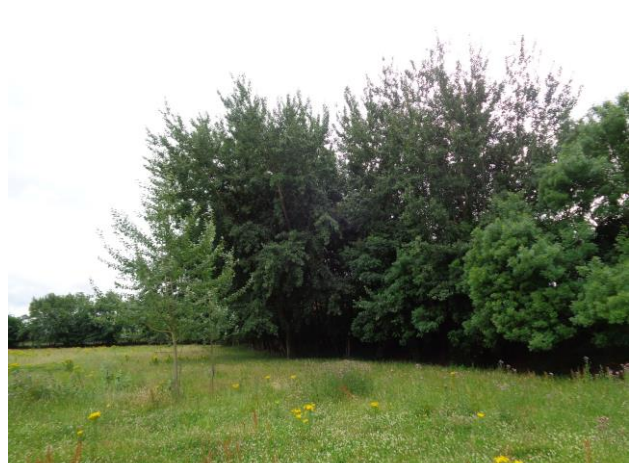
**Plate 6:** T49 centre, with G48 behind
