# Arboricultural Work Specification

## TREE MAINTENANCE, CROWN REDUCTION & HYGIENE REPORT (V2)

| Site Location | Kay's Terrace, Barnsley, S70 3EA | Date of Revision | June 21, 2026 |

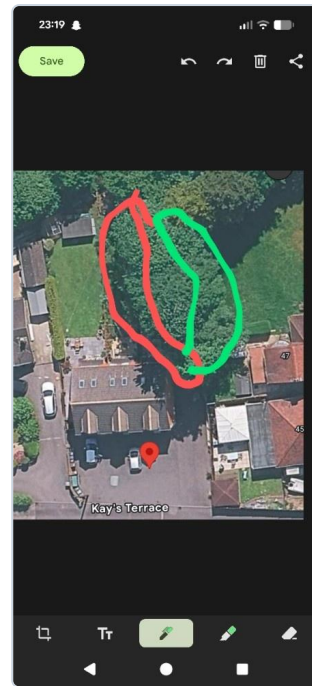
Figure 2: Delineation of the linear canopy group overhanging the properties.

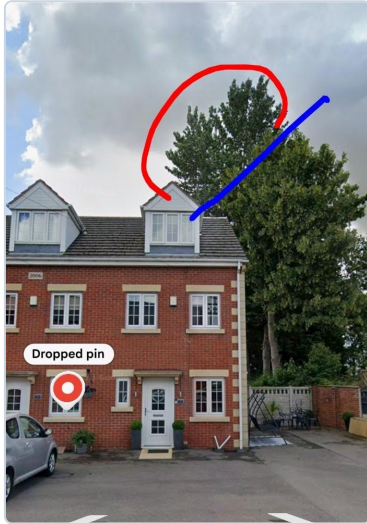
Figure 3: Detailed view of the lower-canopy profile and lateral limb extensions over fence tracking.

- **Height Reduction:** The taller mature trees currently standing at approximately 15 meters will be systematically reduced in height down to 12 meters, matching the line of the naturally shorter 12-meter specimens.
- **Lateral Reduction:** The crowns on all sides of the 13 trees will be brought inward to prevent an overhang exceeding 1 meter past localized boundaries. This translates to an approximate reduction of lateral limbs by 1 to 2 meters.
- **Pruning Standard:** All cuts will be precisely executed at suitable growth points, branch collars, or lateral stems in strict adherence to **BS 3998:2010** protocols to guard against decay or structural failure.

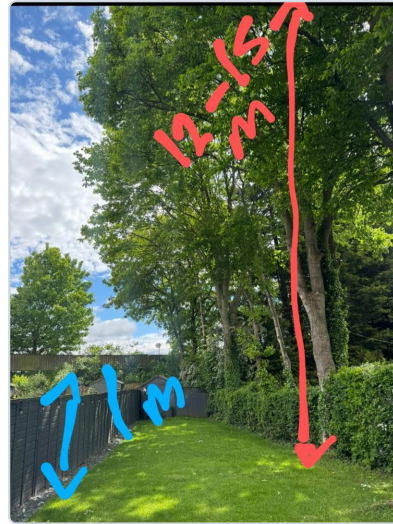
Figure 4: Upward canopy context showcasing the target 15-meter specimens designated for height reduction.

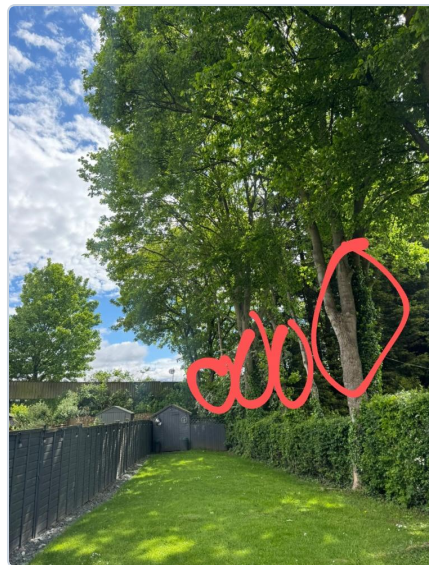
Figure 5: Side lateral aspect documenting specific limb overgrowth over adjacent garden borders of 45 and 47 Field Lane.
