# BRIERLEY VILLAGE HALL, BARNESLEY

## BAT REPORT:

Preliminary Roost Assessment incl.

At-Height Endoscopic Inspection

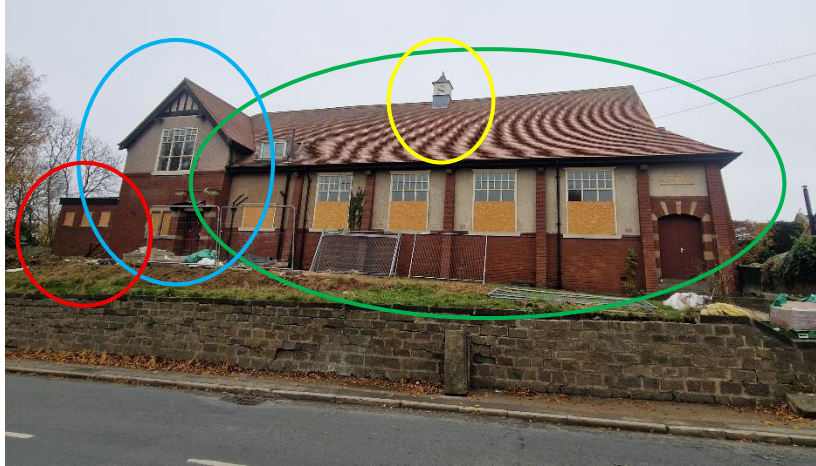
Brierley Village Hall is a long brick property that runs northwest to southeast with a pitched brick gable roof and several large windows (Photo 1 – green circle). At its southern elevation is an adjoining section of building that has a perpendicular pitched gable roof (Photo 1 – blue circle). As a result, three gable ends are present (northwest elevation and the east and wide sides of the adjoining section), all of which had black wooden soffits and fascias. In addition to the two main pitched roofs, there are two windows on the southeastern elevation which each have a small, pitched roof (Photo 2), and two hipped-roofed columns are present either side of a flat-roofed area on the northwest elevation (Photo 3). A brick chimney (Photo 2) is present in the southwestern corner of the building, and a belltower structure is present atop the centre of the building (Photo 1 – yellow circle). These foundations are to stay in-situ as the Proposed Development mainly involves internal renovation and external aesthetic works (such as repointing, etc) only.

A brick one-storey extension with a flat bitumen roof is also present at the buildings' southern elevation (Photo 1 – red circle and Photo 2), which is the only section of building due to be demolished as part of the Proposed Development.

**Photo 1.** Brierley Village Hall showing the three main sections of building as demarcated by the green, blue and red circles. The central belltower is demarcated by the yellow circle. The areas shown in the green, blue and yellow circles are to remain in-situ, whilst the one-storey extension shown in the red circle is to be demolished as part of the Proposed Development.

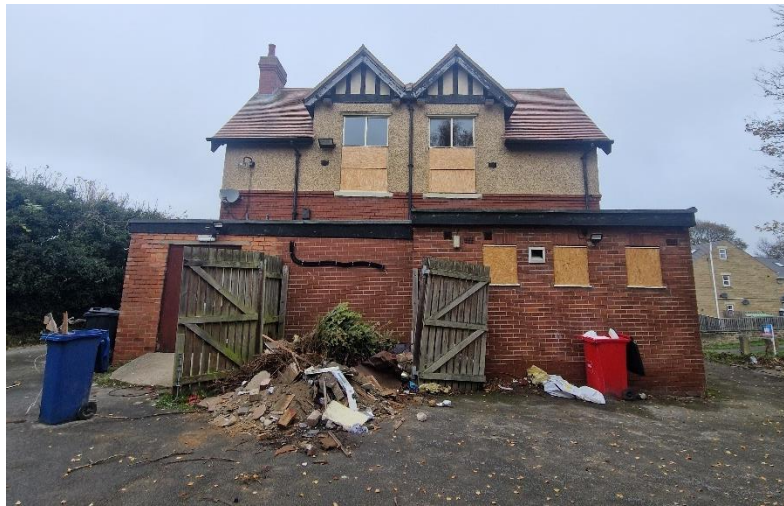
**Photo 2.** Southeastern elevation of Brierley Village Hall showing the two windows on the first storey that have a small, pitched roof atop, and the one-storey flat roofed extension that is the only section of the building that is to be demolished as part of the Proposed Development.

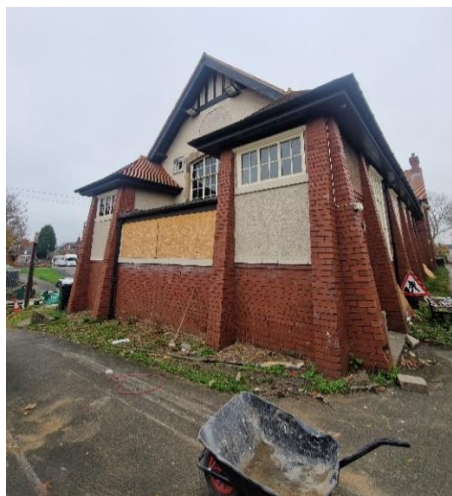
**Photo 3.** Northwestern elevation of Brierley Village Hall where two hipped-roof columns are present either side of a flat-roofed area. This is the area where the BMS must be adhered to, as detailed below in Section 4.

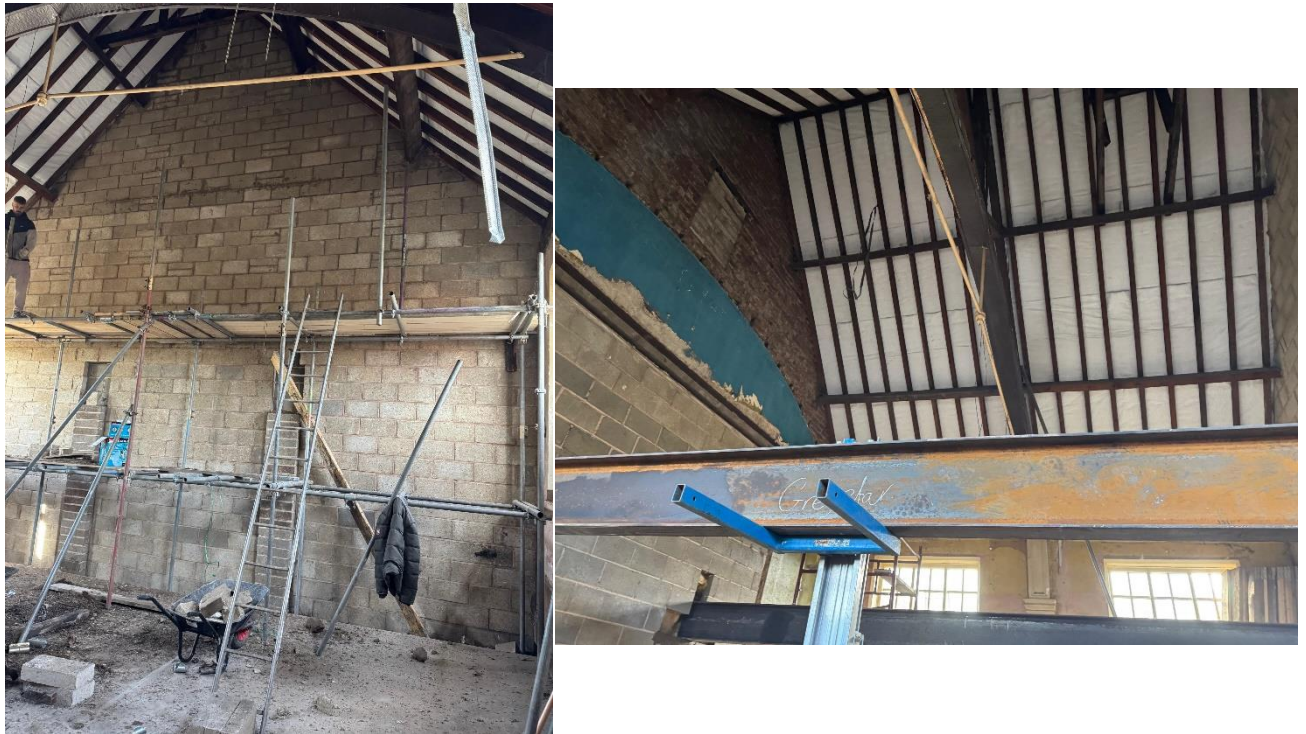
There are no loft voids in the property, and that the interior of the roof, comprising of white roofing membrane and wooden beams and rafters, is visible, as evidenced in the photographs (Photos 4 and 5). These images illustrate that the inside of the property is light and exposed, likely resulting in draughty and cold conditions. The white roofing membrane does not retain heat effectively, unlike black bitumen roofing felt, and no suitable roosting crevices are present. Since bats prefer dark, enclosed, warm, and stable environments, the internal conditions of the property are deemed unsuitable for roosting bats. Therefore, if roosting bats were to exist in the building, it would likely be through external crevices only, such as those identified at PRF5 and PRF6 mentioned below.

**Photos 4 and 5.** The interior of Brierley Village Hall. No crevices suitable for roosting bats are present, and the building is considered too light, open and exposed to be suitable for roosting bats (that favour dark, warm, non-draughty, stable environments). Therefore, if roosting bats were to be present on-Site, it would be via an external feature such as PRF5 & PRF6.

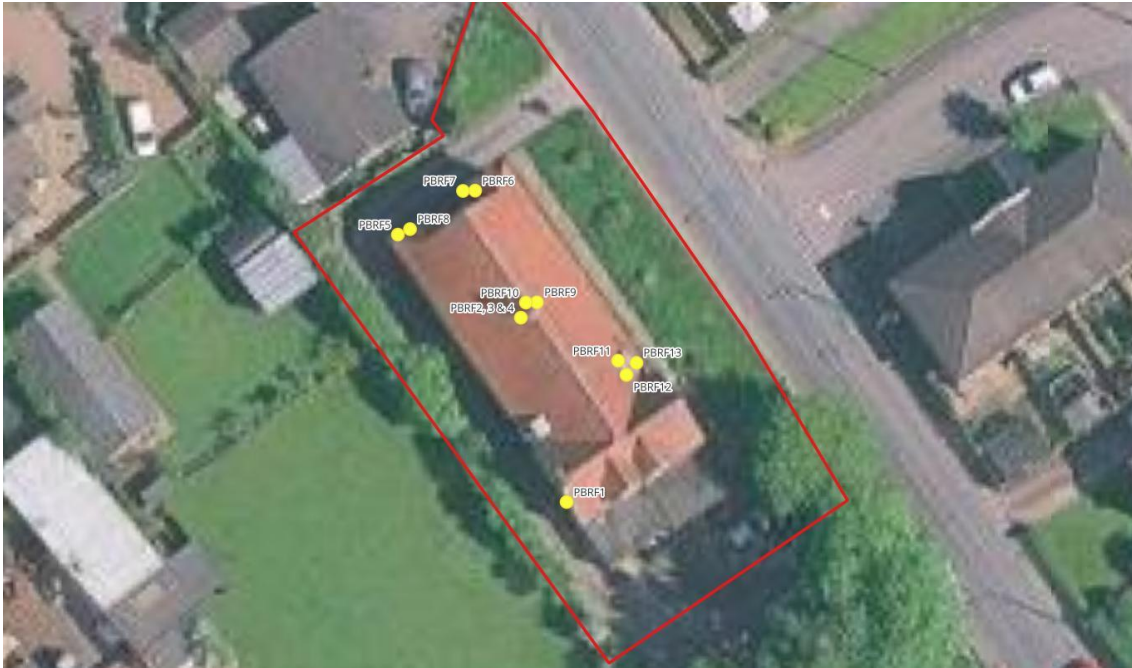
**Figure 3.** PRFs 1-13 on Brierley Village Hall

The initial PRA Site Visit completed on 7<sup>th</sup> November 2025 identified a total of 13 PRFs, as shown in **Figure 3** below and detailed in full in **Appendix 2**. All thirteen features identified were small crevices unlikely to have the space or conditions to support more than an individual bat, or small numbers of bats, opportunistically. Therefore, all 13 PRFs were categorised as having a very low potential to support roosting bats as per best practice guidelines (Collins, 2023).

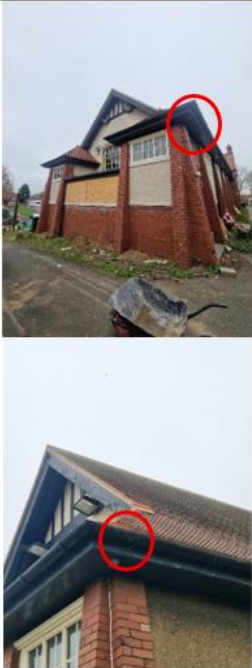
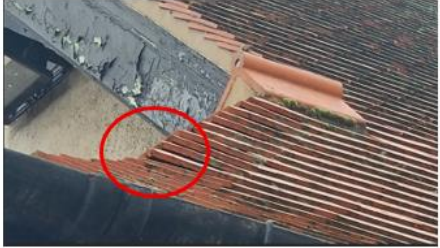
Figure 4. Extracts from Appendix 2 that provide the description and photographs of PRF5 & PRF6.

Potential Roost Feature Reference (PRF)	Description	Bat Roost Suitability Category (as per Collins, 2023)	Wider Context Photograph	Closer Context Photograph
PRF5	There are two pitch roofed extensions present at the buildings' northern elevation. The most westerly column has lifted sloping edge-tiles.	Low

Potential Roost Feature Reference (PRF)	Description	Bat Roost Suitability Category (as per Collins, 2023)	Wider Context Photograph	Closer Context Photograph
PRF6	There are two pitch roofed extensions present at the buildings' northern elevation. The most easterly column has lifted sloping edge-tiles.

As the habitat surrounding the Site is moderately suitable for bats, and that bat roosts have been recorded in the area (see Section 3.1), it is considered necessary that PRF5 and PRF6 are given due regard to ensure that roosting bats are not detrimentally impacted by the Proposed Development (see Section 4 below).

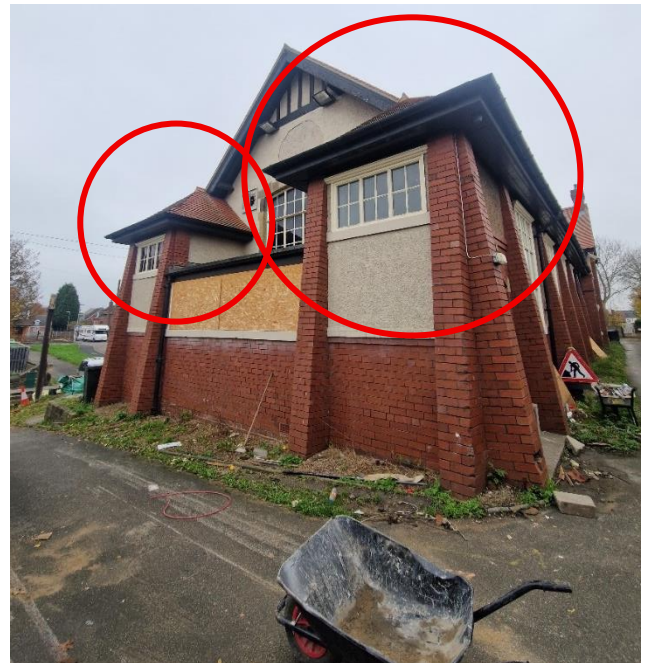
**Photo 6.** The two areas where internal and external works must be completed April – September (in suitable weather conditions for bats) and supervised by an SQE.

As part of the BMS, the following building specific precautionary measures will be adopted for the two areas circled in red in Photo 6 below:

- All contractors involved in the Proposed Development will be made aware that bats can occupy buildings, so that in the unexpected circumstance a bat is seen during the works, all works will cease until a SQE has been contacted for further advice.
- Internal roof/loft works and external roofing renovations in these two areas will be conducted when bats are active (April – September) and in suitable conditions for bats (overnight temperatures  $>8^{\circ}\text{C}$  for  $>5$  nights, no rain, no heavy winds).
- A SQE will conduct an inspection for bats on the day that works are scheduled in this area and then will

remain on-Site to provide a 'toolbox talk' to contractors (discuss ecologically sensitive ways of working with contractors in this area e.g. lifting roof tiles carefully with hand tools and checking both sides before discarding) and supervise works until they are satisfied that roosting bats are no longer a constraint to the Proposed Development.

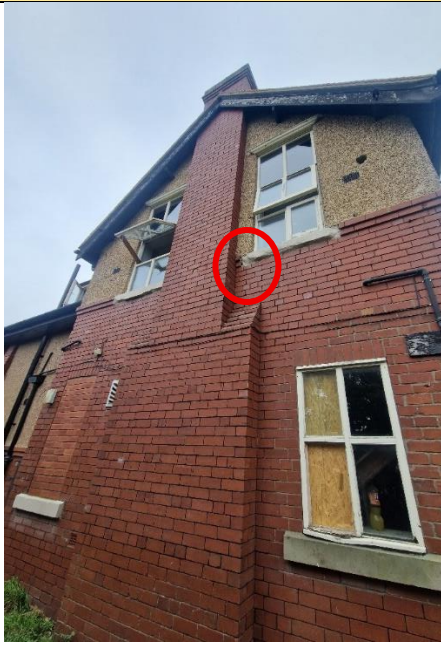
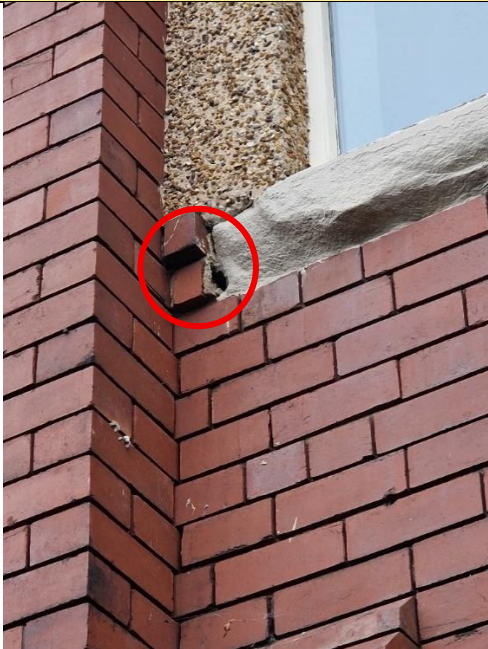
Potential Roost Feature Reference (PRF)	Description	PRA Site Visit 1 (07/11/2025) Result – Bat Roost Suitability Category (as per Collins, 2023)	Wider Context Photograph	Closer Context Photograph	PRA Site Visit 2 Result – Description & Bat Roost Suitability Category (as per Collins, 2023)
PRF1	<p>A small circular hole at the edge of the external windowsill where the plaster meets the adjoining brickwork. Located under a first storey window on the buildings' southwestern aspect.</p>	Low

<p>A open, small cavity that went c.5cm back. Not a suitable crevice for roosting bats as it is too open, and too shallow to provide sufficient protection from inclement weather.</p> <p style="text-align: center;"><b>No BRP.</b></p>

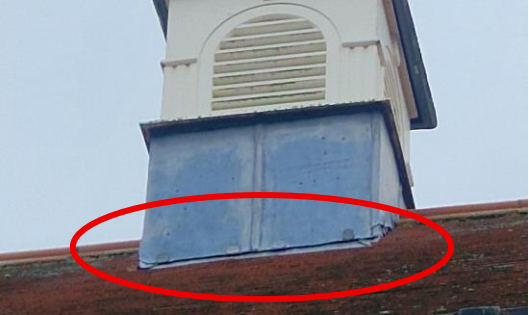
Potential Roost Feature Reference (PRF)	Description	PRA Site Visit 1 (07/11/2025) Result – Bat Roost Suitability Category (as per Collins, 2023)	Wider Context Photograph	Closer Context Photograph	PRA Site Visit 2 Result – Description & Bat Roost Suitability Category (as per Collins, 2023)
PRF2	Gaps in the metal sheeting that form the base of the central belltower on the buildings' southwestern aspect.	Low

Optical misnomer from the ground as there is no cavity here. <b>No BRP.</b>

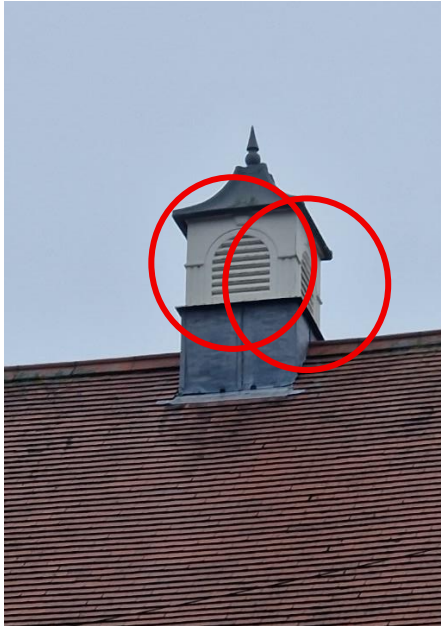
Potential Roost Feature Reference (PRF)	Description	PRA Site Visit 1 (07/11/2025) Result – Bat Roost Suitability Category (as per Collins, 2023)	Wider Context Photograph	Closer Context Photograph	PRA Site Visit 2 Result – Description & Bat Roost Suitability Category (as per Collins, 2023)
PBRF3	Possible access for bats between the window slats of the belltower. Present on every aspect of the belltower.	Low

N/A	Optical misnomer from the ground. There are no gaps between the slats, the windows are completely sealed. <b>No BRP.</b>

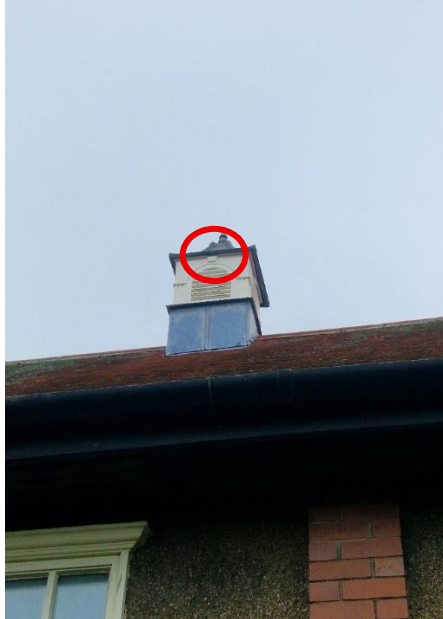
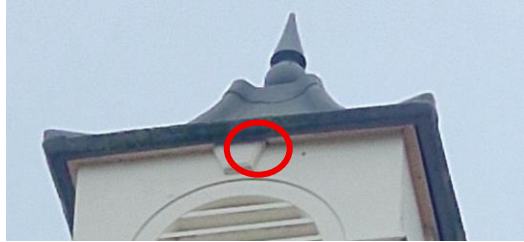
Potential Roost Feature Reference (PRF)	Description	PRA Site Visit 1 (07/11/2025) Result – Bat Roost Suitability Category (as per Collins, 2023)	Wider Context Photograph	Closer Context Photograph	PRA Site Visit 2 Result – Description & Bat Roost Suitability Category (as per Collins, 2023)
PBRF4	A small gap to the right of the central decorative moulding above the belltowers' slat window on the buildings' southwestern aspect.	Low

The hole looks larger from the ground. Once at-height, the hole is too small to allow access for roosting bats. <b>No BRP.</b>

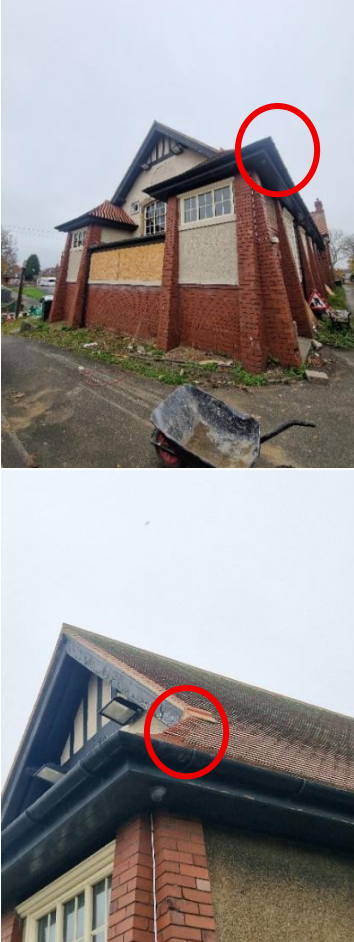
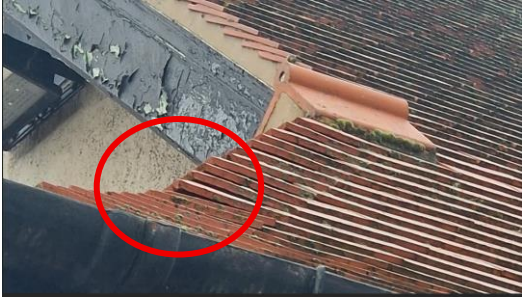
Potential Roost Feature Reference (PRF)	Description	PRA Site Visit 1 (07/11/2025) Result – Bat Roost Suitability Category (as per Collins, 2023)	Wider Context Photograph	Closer Context Photograph	PRA Site Visit 2 Result – Description & Bat Roost Suitability Category (as per Collins, 2023)
PBRF5	There are two pitch roofed extensions present at the buildings' northern elevation. The most westerly column has lifted sloping edge-tiles.	Low

Gaps exist between the lifted roofing tiles and the internal roofing material below, providing a suitable crevice space for roosting bats. Although, the gaps are limited in size and therefore only potentially suitable for low numbers of bats. <b>Low BRP.</b>

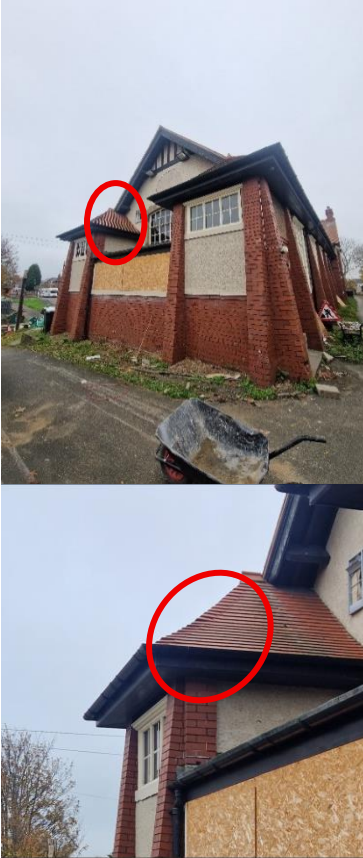
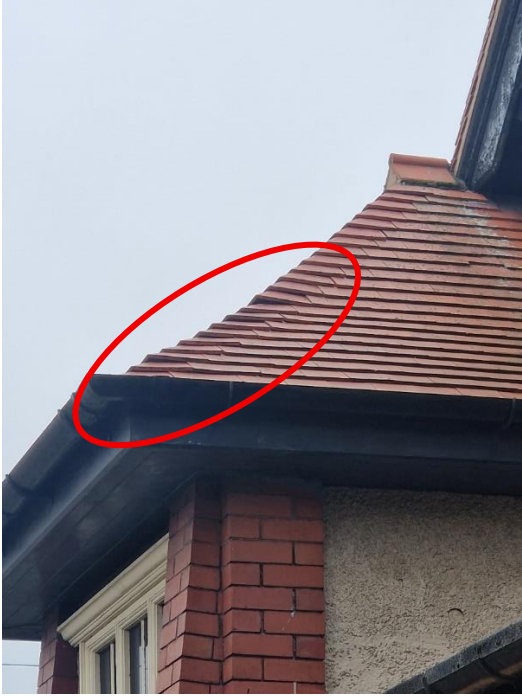
Potential Roost Feature Reference (PRF)	Description	PRA Site Visit 1 (07/11/2025) Result – Bat Roost Suitability Category (as per Collins, 2023)	Wider Context Photograph	Closer Context Photograph	PRA Site Visit 2 Result – Description & Bat Roost Suitability Category (as per Collins, 2023)
PBRF6	There are two pitch roofed extensions present at the buildings' northern elevation. The most easterly column has lifted sloping edge-tiles.

Gaps exist between the lifted roofing tiles and the internal roofing material below, providing a suitable crevice space for roosting bats. Although, the gaps are limited in size and therefore only potentially suitable for low numbers of bats. <b>Low BRP.</b>

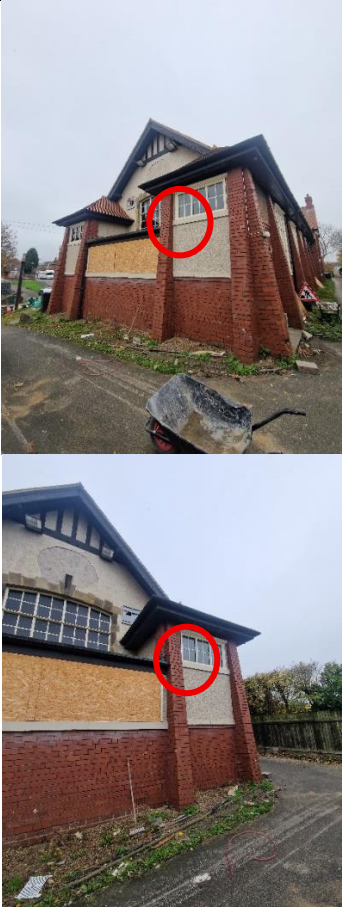
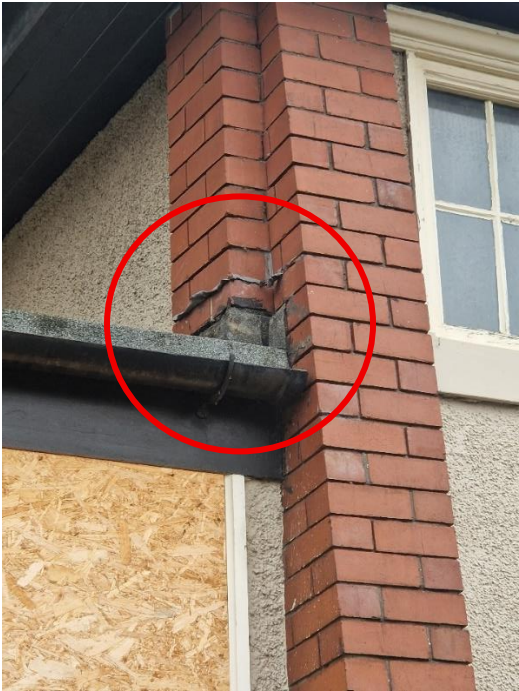
Potential Roost Feature Reference (PRF)	Description	PRA Site Visit 1 (07/11/2025) Result – Bat Roost Suitability Category (as per Collins, 2023)	Wider Context Photograph	Closer Context Photograph	PRA Site Visit 2 Result – Description & Bat Roost Suitability Category (as per Collins, 2023)
PBRF8	There are gaps where the bitumen felt atop the flat roof that extends from the buildings' northern elevation meets the brickwork of the adjoining most westerly pitched-roof extension.

This crevice is very shallow and therefore too exposed to be suitable for roosting bats. <b>No BRP.</b>

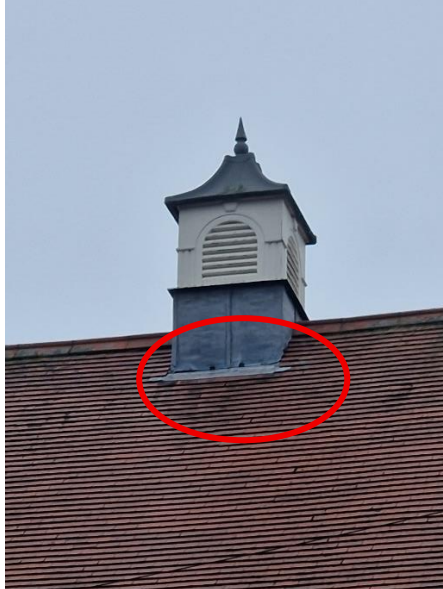
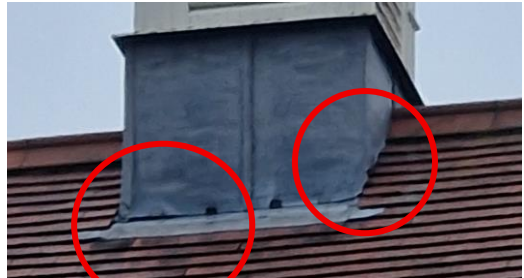
Potential Roost Feature Reference (PRF)	Description	PRA Site Visit 1 (07/11/2025) Result – Bat Roost Suitability Category (as per Collins, 2023)	Wider Context Photograph	Closer Context Photograph	PRA Site Visit 2 Result – Description & Bat Roost Suitability Category (as per Collins, 2023)
PBRF9	There are gaps at the metal base of the belltower on the buildings' easterly elevation.	Low

Optical misnomer from the ground. There is no crevice here. <b>No BRP.</b>

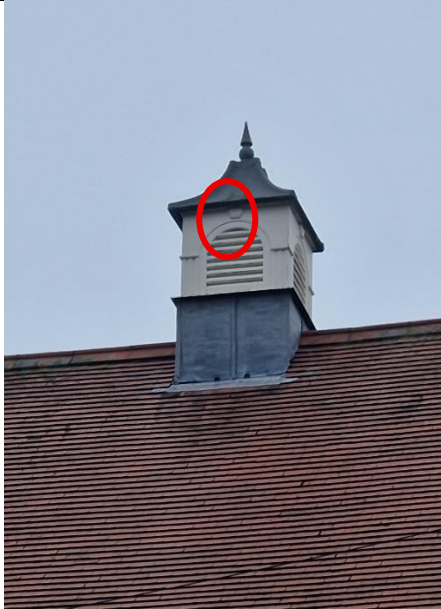
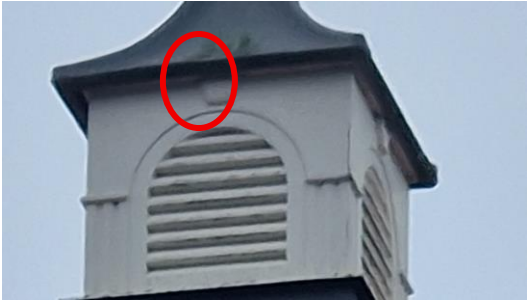
Potential Roost Feature Reference (PRF)	Description	PRA Site Visit 1 (07/11/2025) Result – Bat Roost Suitability Category (as per Collins, 2023)	Wider Context Photograph	Closer Context Photograph	PRA Site Visit 2 Result – Description & Bat Roost Suitability Category (as per Collins, 2023)
PBRF10	A small gap is present to the left of the central decorative moulding above the belltower slat window on the buildings' northern aspect.	Low

The hole looks larger from the ground. Once at-height, the hole is too small to allow access for roosting bats. <b>No BRP.</b>

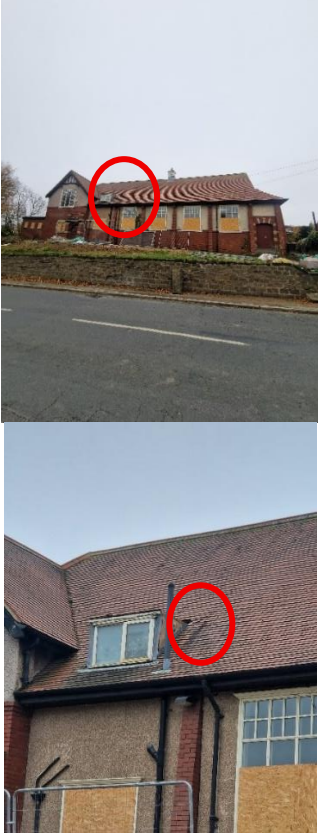
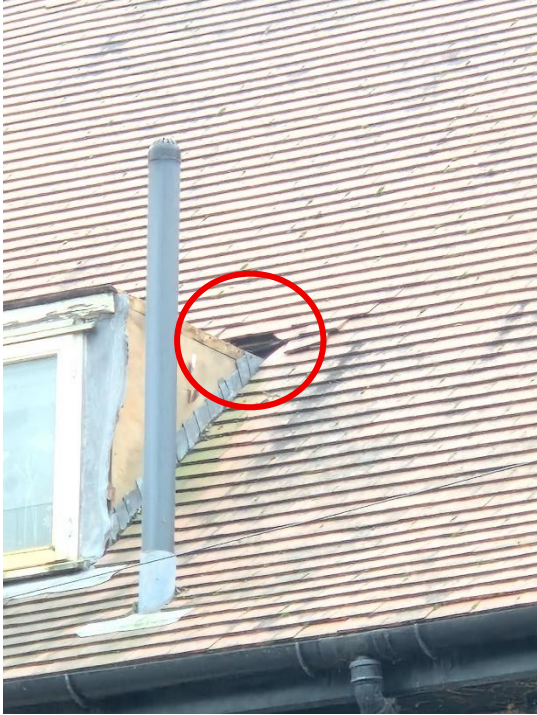
Potential Roost Feature Reference (PRF)	Description	PRA Site Visit 1 (07/11/2025) Result – Bat Roost Suitability Category (as per Collins, 2023)	Wider Context Photograph	Closer Context Photograph	PRA Site Visit 2 Result – Description & Bat Roost Suitability Category (as per Collins, 2023)
PBRF11	There is one dormer window on the buildings' eastern elevation, where a few brick roof tiles have slipped at the top right, creating a potential cavity suitable for bats.	Low

This gap is too large, wet and draughty to be suitable for roosting bats. <b>No BRP.</b>

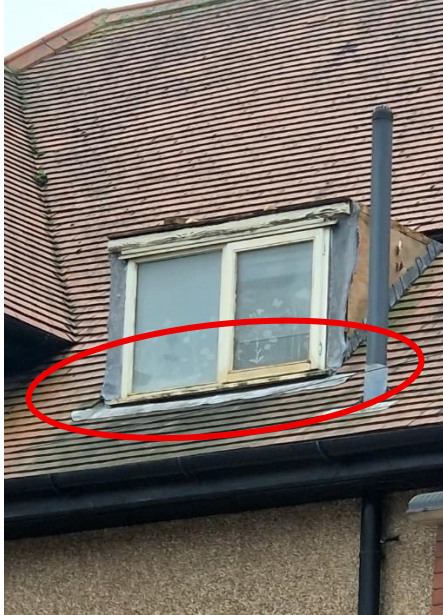
Potential Roost Feature Reference (PRF)	Description	PRA Site Visit 1 (07/11/2025) Result – Bat Roost Suitability Category (as per Collins, 2023)	Wider Context Photograph	Closer Context Photograph	PRA Site Visit 2 Result – Description & Bat Roost Suitability Category (as per Collins, 2023)
PBRF13	A gap appears to be present between the lead flashing and the rotting wooden windowsill of the dormer window on the buildings' eastern elevation.	Low

N/A	This is an optical misnomer from the ground. There is no crevice here. <b>No BRP.</b>
