**ARBORICULTURAL REPORT
AND
ARBORICULTURAL IMPACT ASSESSMENT
to BS 5837:2012
at
264 Dodworth Road
Barnsley
South Yorkshire
S70 6PN**

Client:
Matt Crisp

JCA Ref:
22448/SB

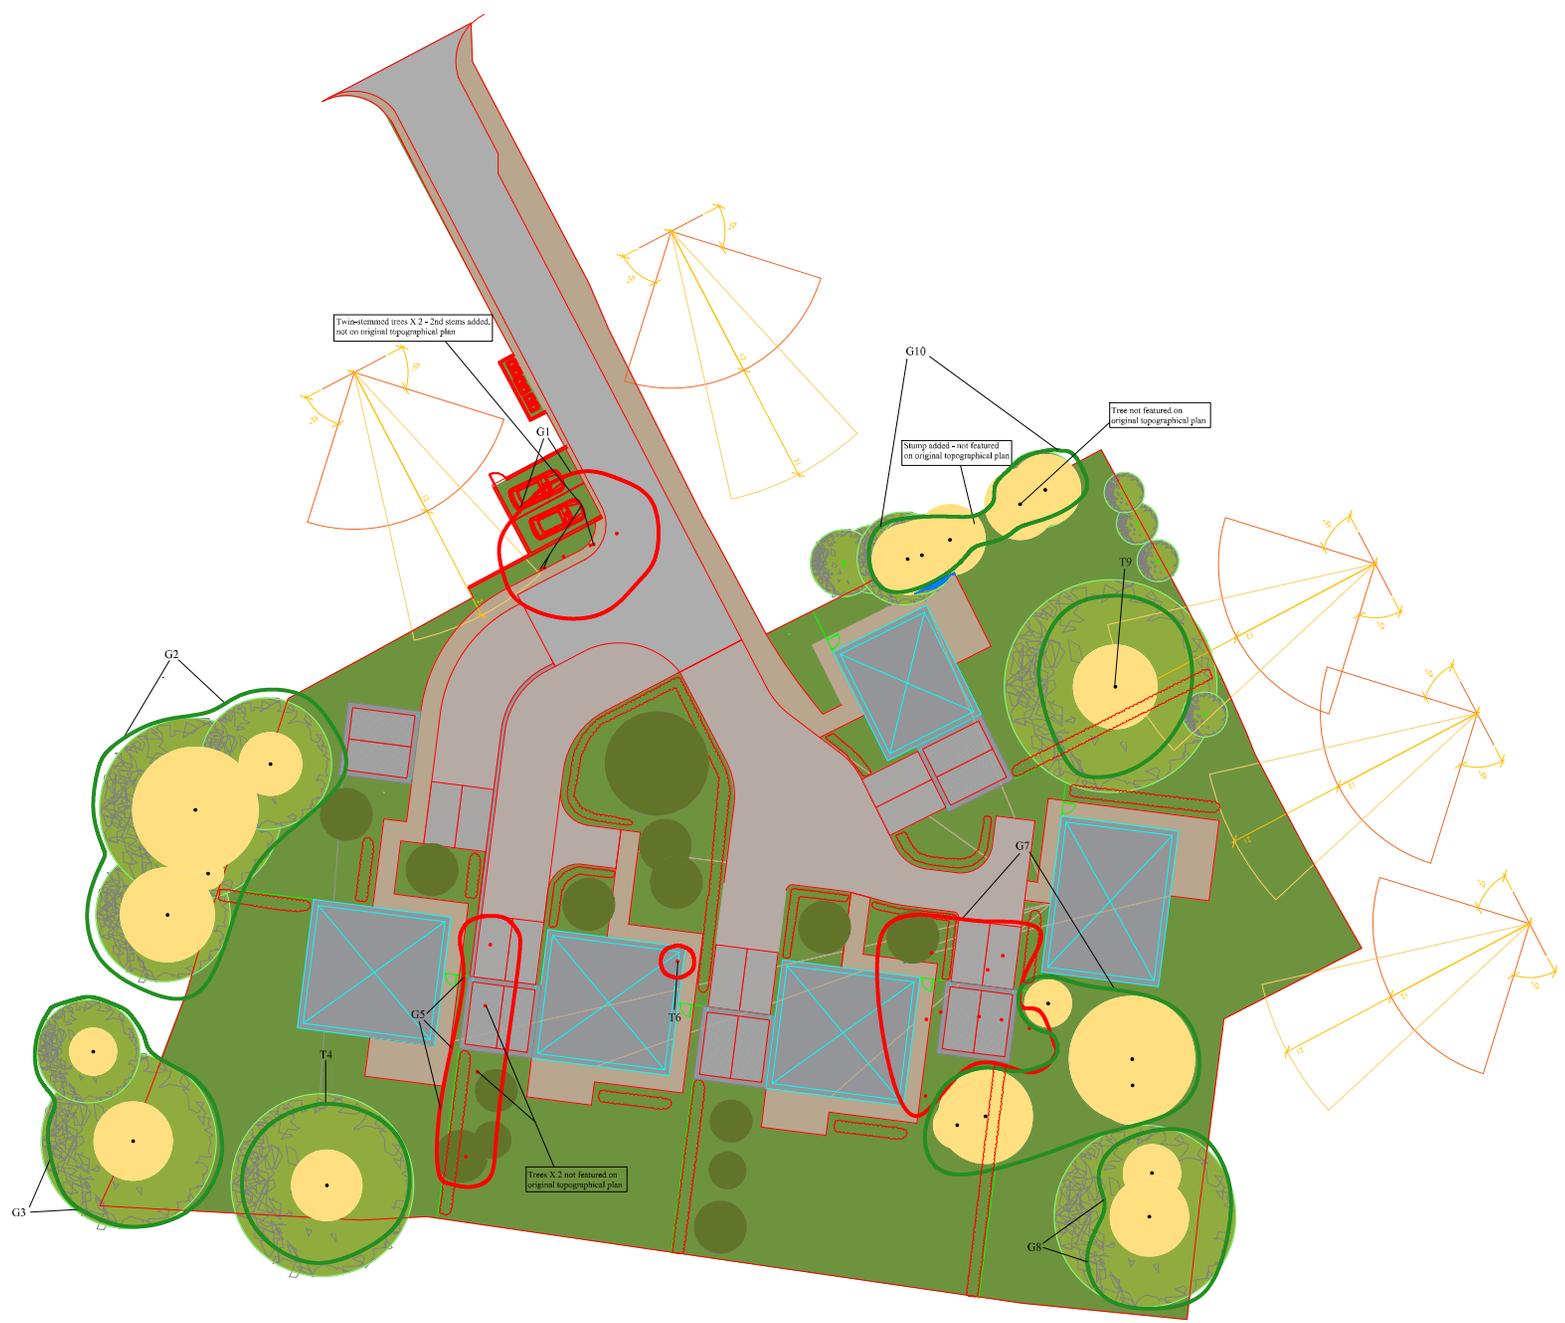
Appendix 6: Arboricultural Implications Plan

4.5.3.4 Proposed hard surfacing is located within the RPA of 3 of the retained trees within group **G10**. Due to the minimal nature of the incursion, it is not considered necessary to install specialised surfaces. Instead, root pruning will be undertaken to minimise potential damage to tree roots and prevent 'ripping' damage, which is commonly associated with mechanical excavation.
