## BS5837:2012 Arboricultural Report

**Reference:** WTS-WVB-26a

1 - Initial Report - Tree Constraints Plan and Arboricultural Impact Assessment - 28/09/2026

Albro House, 30 Worsbrough Village, Barnsley, S70 5LS

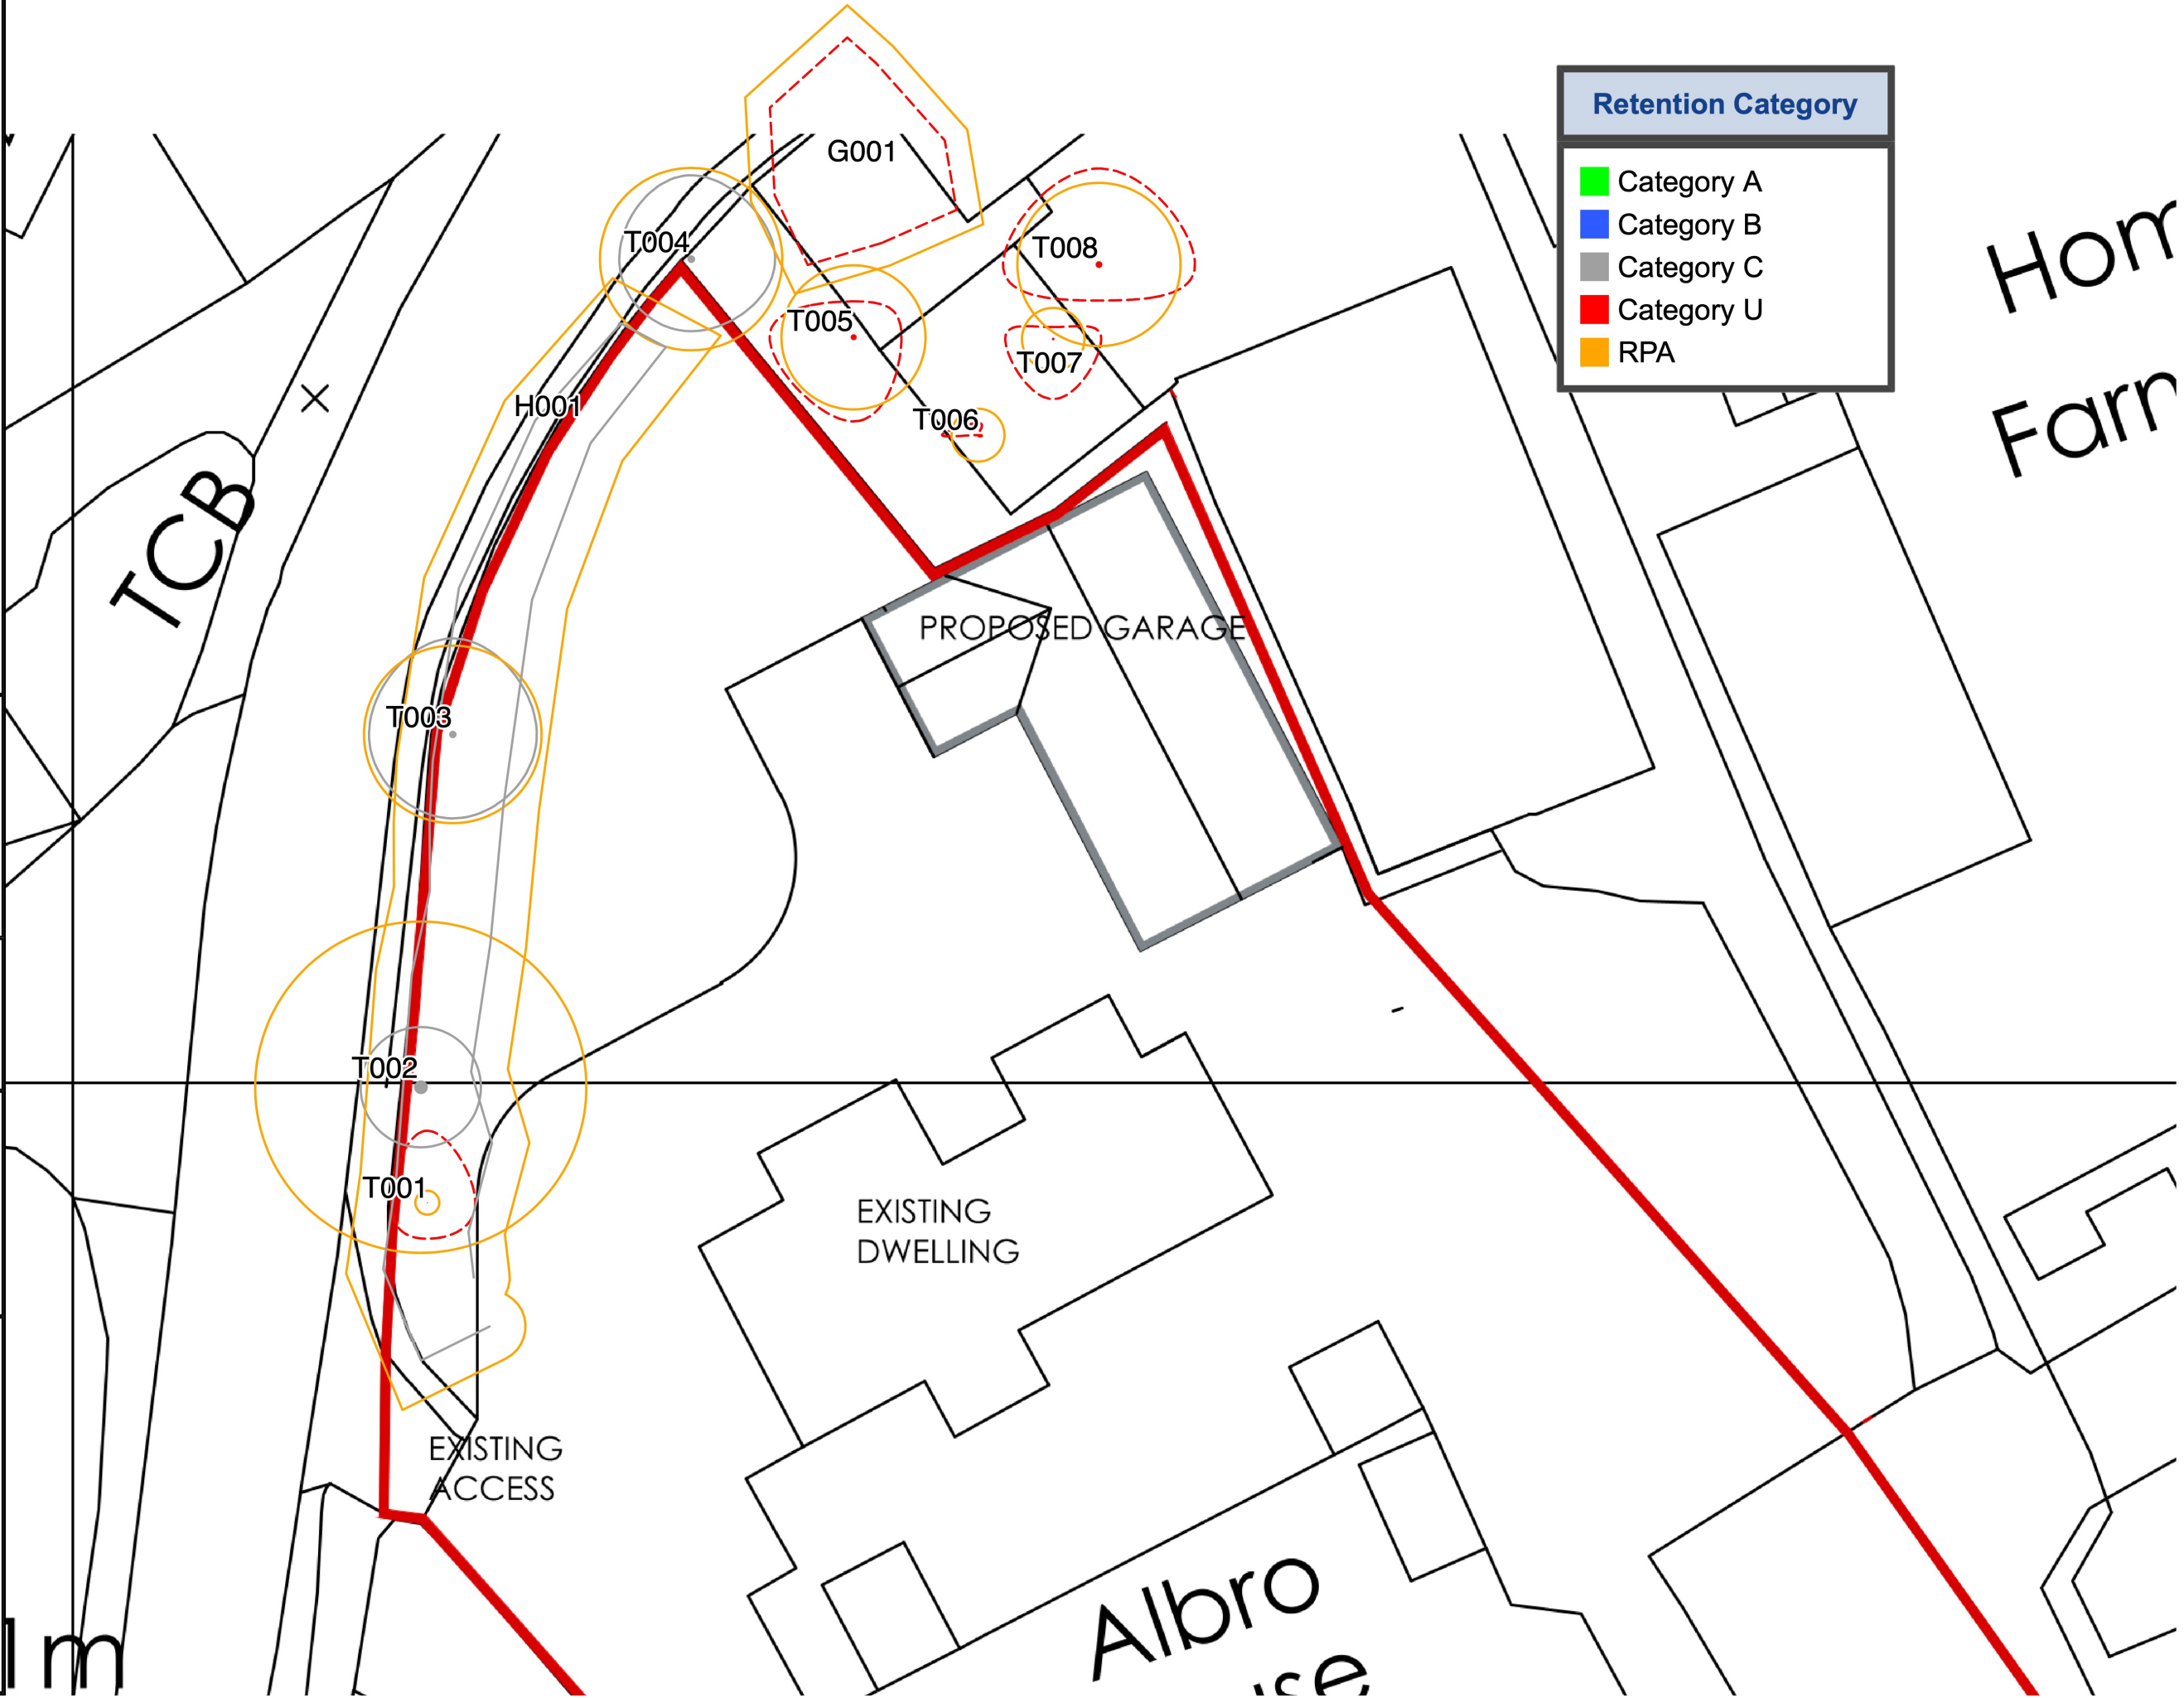
- 8.1. The Tree Constraints Plan plots the surveyed trees, hedging, canopy spreads and calculated RPAs in relation to the application boundary, existing access, existing dwelling and proposed garage.

- 8.2. Along the western boundary, the RPAs of T002-T004 and the area associated with H001 extend primarily along or beyond the boundary/access corridor. The existing low retaining wall and established access create a clear physical relationship between the trees and the working area. The schedule records each of these features as not forming a constraint to redevelopment.

- 8.3. T001 has a very small calculated RPA because of its modest estimated stem diameter and poor condition. It is located beside the existing access and retaining wall and does not constrain the garage footprint.

- 8.4. To the north, G001 and T005-T008 are situated on neighbouring land around the derelict building. Their RPAs do not create a meaningful overlap with the proposed garage footprint. Most are Category U, but the acceptability of the proposal does not rely on their removal.

- 8.5. The TCP therefore demonstrates that the proposed garage can be accommodated without significant RPA encroachment, canopy conflict or loss of a retained tree.

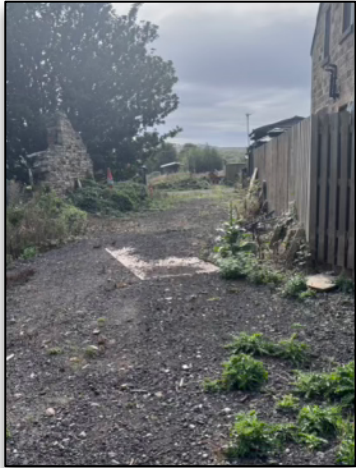
*Image 1 - Southern access track, looking S, showing drainage point next to current building.*

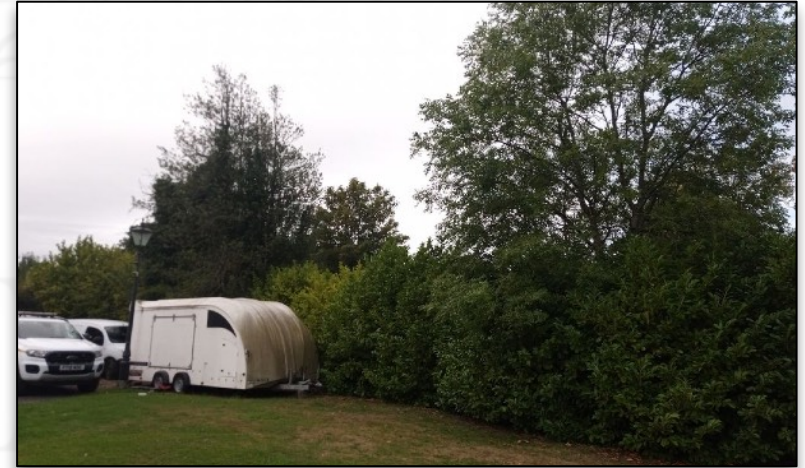
| Ref. | Species | Full Structure | Measurements | Survey Notes | Retention Category | RPA | Comments | Physio' Condition | Structural Condition | Public Amenity Value | Recommendations |
|---|---|---|---|---|---|---|---|---|---|---|---|
| T001 | Common hawthorn<br>(Crataegus monogyna) | Tree | Height (m): 8<br>Stem Diam(mm): 400<br>Spread (m): 3N, 2E, 1.5S, 1.5W<br>Crown Clearance (m): 1<br>Lowest Branch (m): 0.5(E)<br>Life Stage: Mature<br>Rem. Contrib.: <10 years | Ivy clad. DBH estimated due to ivy. Top completely dead, line branches low down to around 1m. | U | Radius: 4.8m<br>Area: 72 sq m. | Low retaining wall restricts access to base and immediate soil area. | Poor | Poor | Moderate | Remove main stem down to hedge height (2.5m) |

- 7.3. T001 Common hawthorn is Category U. The schedule records significant upper crown dieback/death and recommends reducing the main stem to approximately hedge height (2.5 m). This is a condition/management recommendation rather than a development facilitation requirement.
- 7.4. T005, T006, T007, T008 and G001 are all Category U because their long-term retention is considered unviable immediately beside the neighbouring building. The schedule expressly notes that these do not need to be removed to facilitate the proposed development.

*Image 3 - Open ground area with T001 (far left), T002 (middle) and T003 (right) as well as H001*

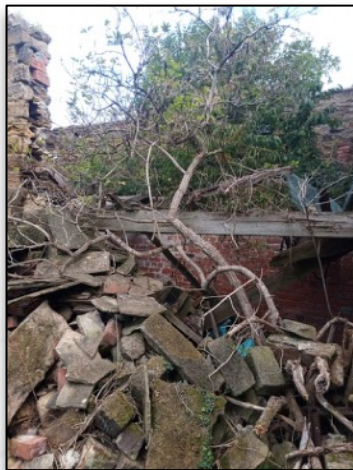
| Ref. | Species | Full Structure | Measurements | Survey Notes | Retention Category | RPA | Comments | Physio' Condition | Structural Condition | Public Amenity Value | Recommendations |
|---|---|---|---|---|---|---|---|---|---|---|---|
| T006 | Elder<br>( <i>Sambucus nigra</i> ) | Tree | Height (m): 3.5<br>Stem Diam(mm): 90<br>Spread (m): 0.5N, 0E, 0S, 1.5W<br>Crown Clearance (m): 0<br>Lowest Branch (m): 0<br>Life Stage: Semi Mature<br>Rem. Contrib.: <10 years | Tree in neighbouring property. Growing out of rubble of neighbouring building. Extremely poor condition. Retention unviable. | U | Radius: 1.1m.<br>Area: 4 sq m. | This tree does not form a constraint to the redevelopment of the site, however, removal long term is advised. | Poor | Poor | Low | Request to remove tree from landowner |

*Image 4 - Showing T006, example of poor quality self set tree growing on derelict building edge*

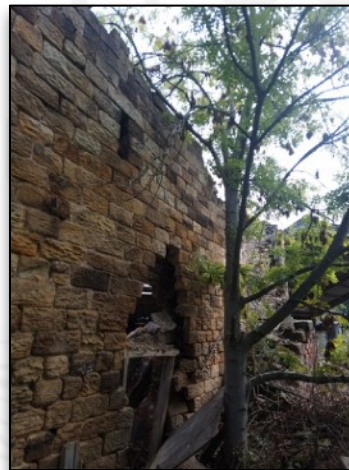
| Ref. | Species | Full Structure | Measurements | Survey Notes | Retention Category | RPA | Comments | Physio' Condition | Structural Condition | Public Amenity Value | Recommendations |
|---|---|---|---|---|---|---|---|---|---|---|---|
| T005 | Rowan<br>( <i>Sorbus aucuparia</i> ) | Tree | Height (m): 7<br>Stem Diam(mm): 250<br>Spread (m): 1.5N, 2E, 3.5S, 3.5W<br>Crown Clearance (m): 0.5<br>Lowest Branch (m): 0.5(S)<br>Life Stage: Early Mature<br>Rem. Contrib.: <10 years | Self set tree growing next to doorway of neighbouring building.growing within 0.5m of building. Upper branches in contact with wall. Base is within rubble and fallen stone from building. Retention unviable. | U | Radius: 3.0m.<br>Area: 28 sq m. | This tree will not have to be removed to facilitate a proposed future development, however, removal long term is advised.<br><br>This tree does not form a constraint to the redevelopment of the site. | Fair | Fair | Low | |

*Image 5 - Showing T005, tree growing in close proximity to neighbouring derelict building*

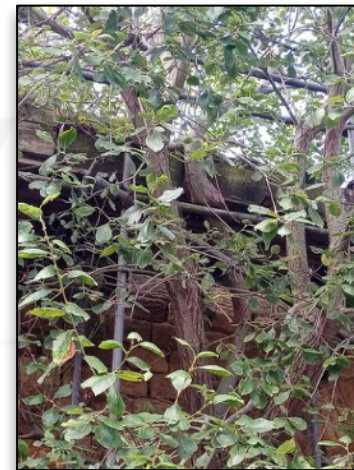
| Ref. | Species | Full Structure | Measurements | Survey Notes | Retention Category | RPA | Comments | Physio' Condition | Structural Condition | Public Amenity Value | Recommendations |
|---|---|---|---|---|---|---|---|---|---|---|---|
| T008 | Goat willow<br>( <i>Salix caprea</i> ) | Tree | Height (m): 10<br>Stem Diam(mm): 280<br>Spread (m): 4N, 4E, 1.5S, 4W<br>Crown Clearance (m): 0.5<br>Lowest Branch (m): 2.5(N)<br>Life Stage: Early Mature<br>Rem. Contrib.: <10 Years | In courtyard N of neighbouring building. Self set, growing directly next to wall of derelict building and through scaffolding, entwined. Retention unviable. | U | Radius: 3.4m.<br>Area: 36 sq m. | This tree does not form a constraint to the redevelopment of the site, however, removal long term is advised. | Fair | Poor | Low | |

*Image 6 - Showing T008, largest tree surveyed growing intertwined with scaffolding around neighbouring derelict building.*
