**COAL MINING RISK ASSESSMENT**  
**LAND ADJACENT NO. 9 REASBECK TERRACE**  
**BARNSELEY**  
**FOR**  
**ARCHITECTURAL DESIGN CONSULTANT LTD**

**Report No. S0179**

**July 2019**

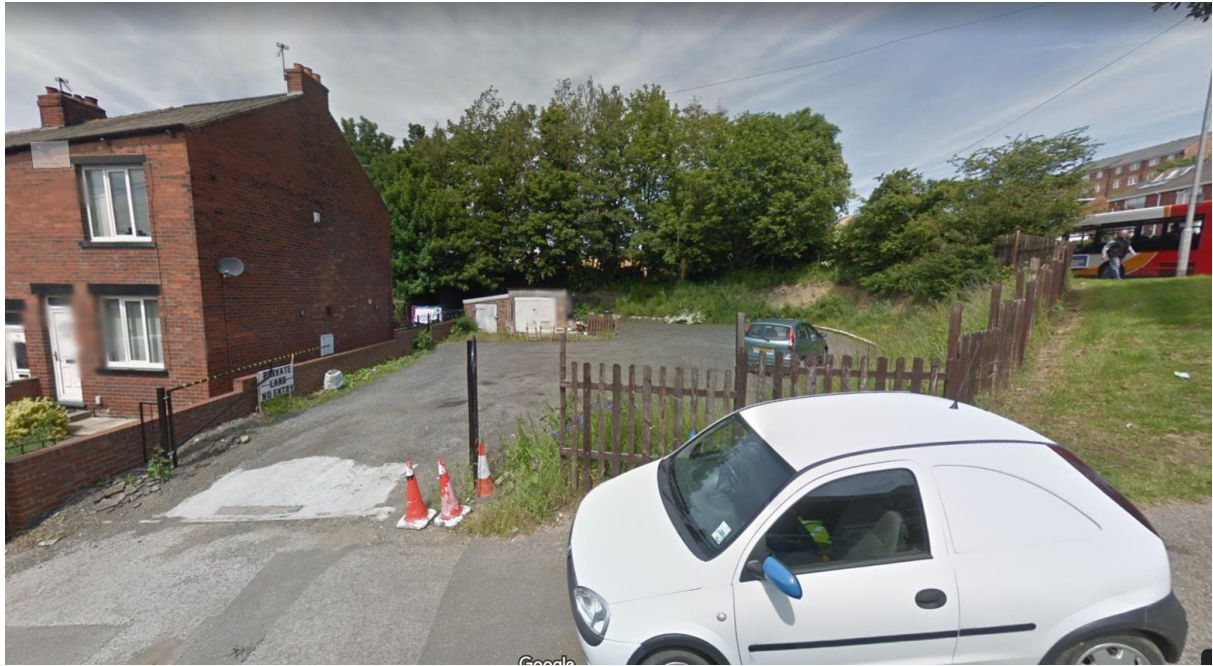
**Figure 3 Street view photograph of existing site**

- 2.6 A street-view photo of the existing garage building is shown below in Figure 3

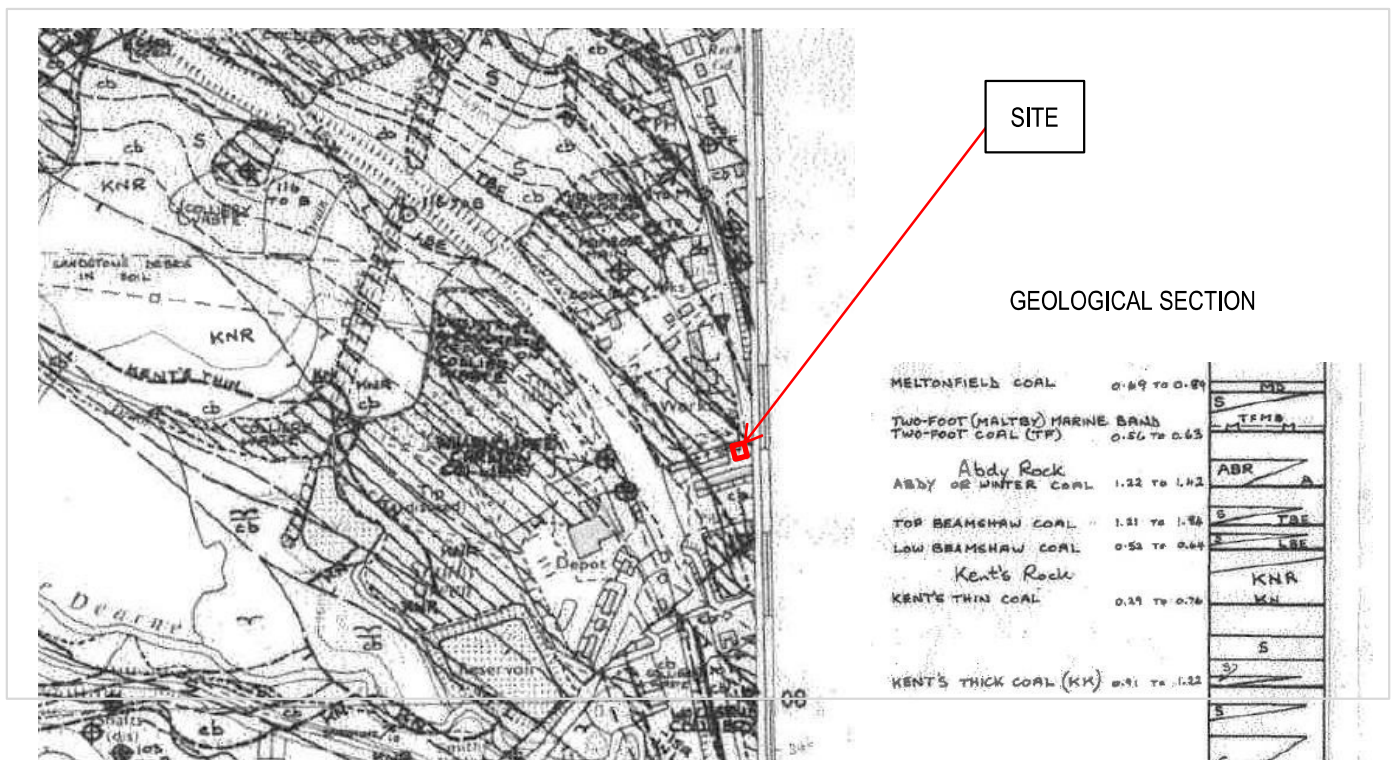
**Figure 4 Geological Map Extract (Sheet SE30NW 1:10,000)**

- 3.5 Both geological sheets show the site is positioned on the vertical section just below the Top Beamshaw coal (TBE), meaning the Low Beamshaw coal (LBE) seam to be outcropping close to the south-west of the site, dipping beneath the site at probable shallow depth. The vertical geological section indicates the LBE to be between 0.52m to 0.64m thick.

- 3.9 Taking the conjectured outcrop positions of the TBE and LBE from the 1:10,000 geological sheet (SE30NW) and using the vertical separation of the seams from the map key and the old shaft section for East Gawber Hall Colliery, we are able to calculate the beds are dipping at approximately 5° to the north east. Accordingly, using trigonometry, the LBE coal may be expected at an approximate depth of between 4.2 and 6.2m below the site's surface – shallowest on the western (down-slope) side.

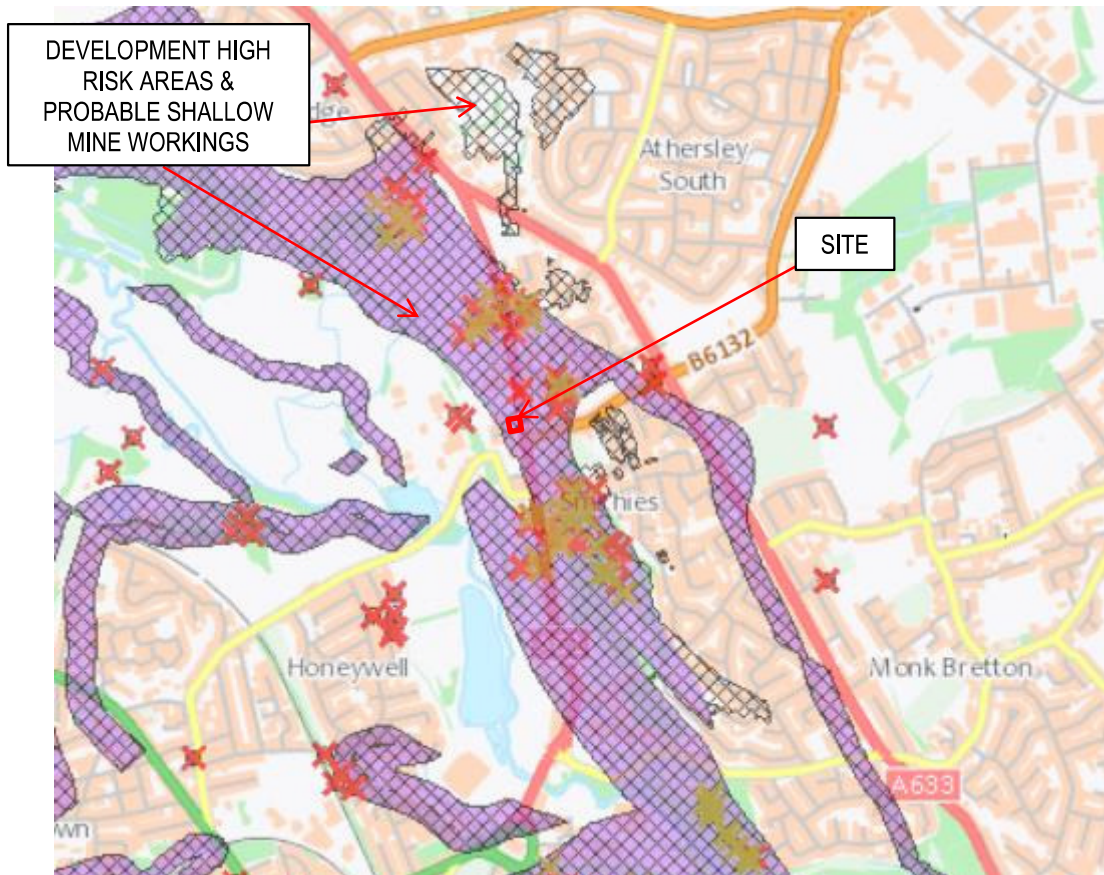
**Figure 5 Development High Risk Area, Past and Probable Shallow Coal Workings**

- 3.18 There is a property within 50m of the site – a house on the south side of Reasbeck Terrace that has a claim for subsidence against the Coal Authority.
- 3.19 There is a one property 331m to the south-east with a mine-gas incident.
- 3.20 The Coal Authority Interactive Map Viewer (Figure 5) shows the site to be located within a Development High Risk Area associated with probable shallow coal mine workings.

- 4.13 Mitigation works are considered necessary on the site for the proposed construction of the two-storey development.
- 4.14 An intrusive investigation is recommended to prove the depth, thickness and condition of the Low Beamshaw Coal. If bell-pitting has occurred then there may be little continuity of working across the site. A total of four rotary open holing boreholes are recommend which should be drilled to a depth of 15m across the development area.

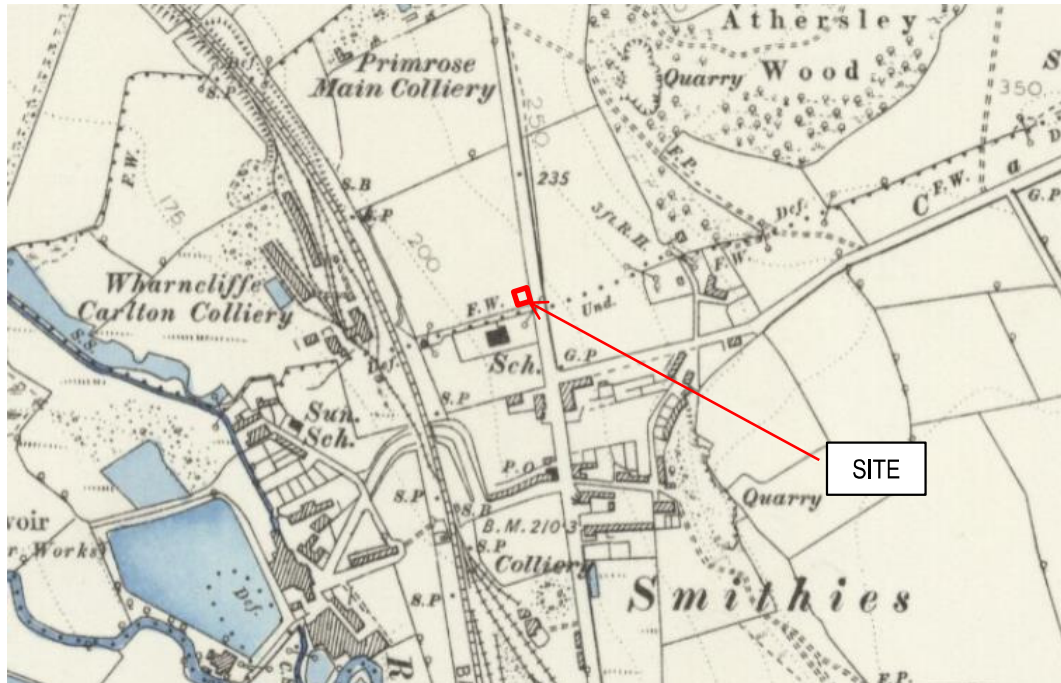
**Figure 6 Extract of Yorks Sheet 274NE 1:10,560 (published 1894)**

- 3.24 Historical mapping dating from 1855 has been reviewed.
- 3.25 On the earliest map seen of note, the 1894 sheet (Yorkshire sheet 274 NE (1:10,560)), the housing on Reasbeck Terrace are not yet built; there is a school on the land that is now the southern side of the Terrace. In the wider area there are a number of collieries marked. There

appears to be just fields on the site itself. See Figure 6 below with an extract of the 1894-published map.

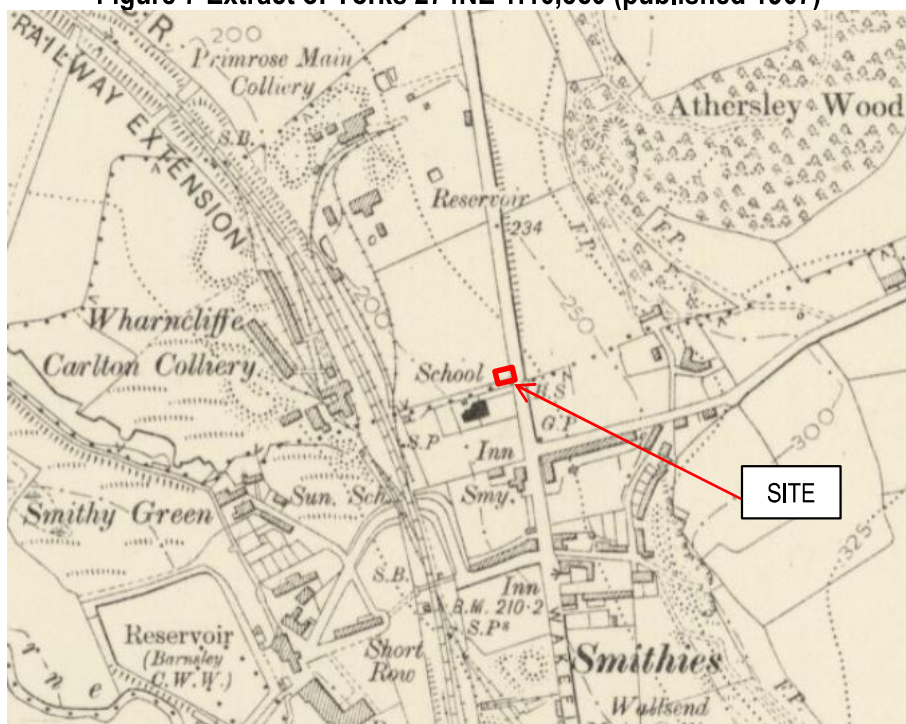
**Figure 7 Extract of Yorks 274NE 1:10,560 (published 1907)**

- 3.26 By 1907, the the site appears unchanged – fields; although the surrounding area houses in Smithies have been built off Wakefield Road. Please see below in Figure 7.

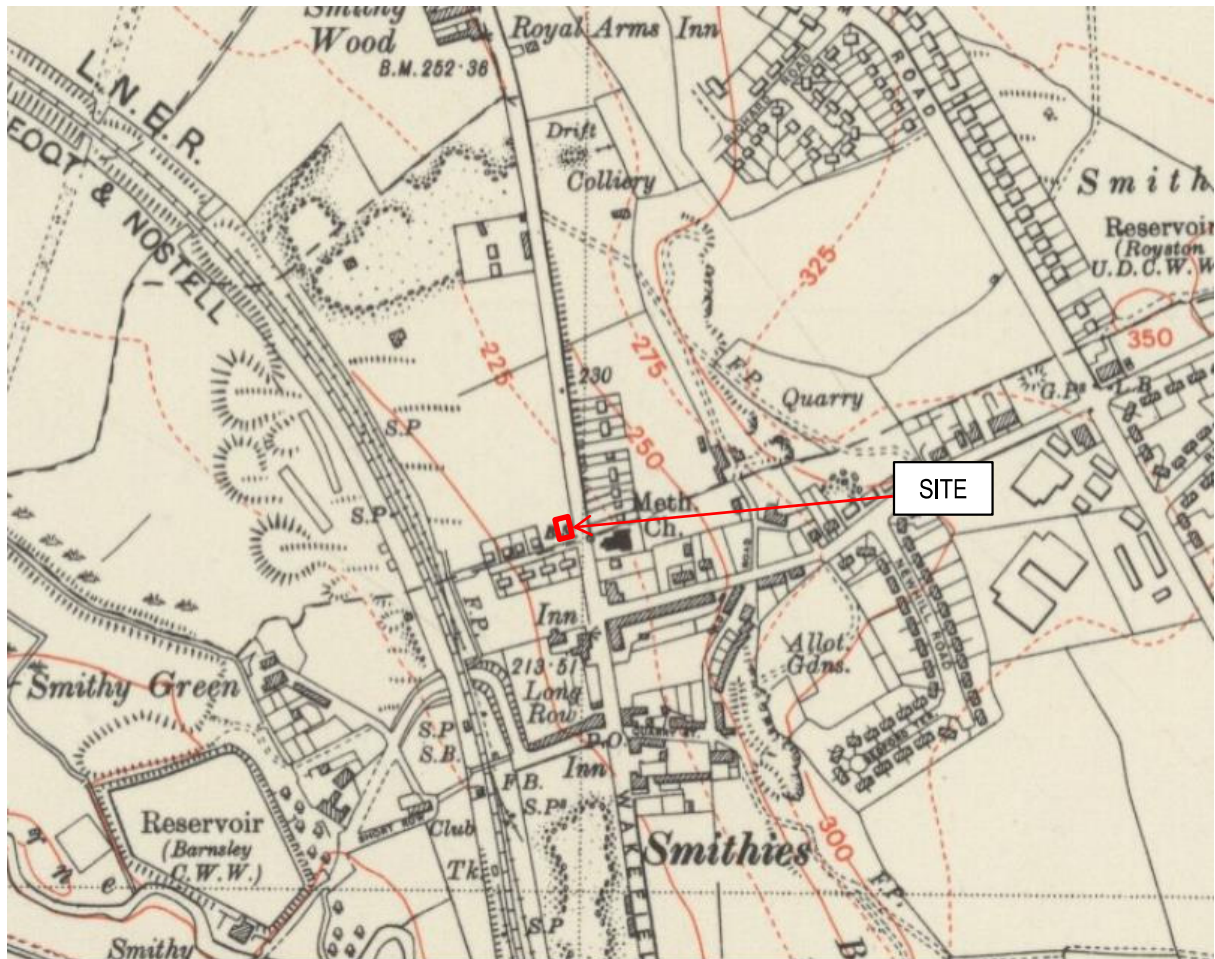
**Figure 8 Extract of Yorks 274NE 1:10,560 (published 1948)**

- 3.27 By 1937, Reasbeck Terrace is built, the former school is gone. There is a vacant plot on the site as it is today. The former Warncliffe Carlton and Primrose Main Collieries shown on previous editions are gone; only mounds and an indication they were once there can be seen. A drift colliery is marked north of the site – in the area of the Coal Authority recorded shafts. Please see below in Figure 8.
