## **Bat Emergence Survey Interim Report**

**Cannon Hall, Cawthorne, Barnsley**

Report reference: R-2560-01.1

July 2016

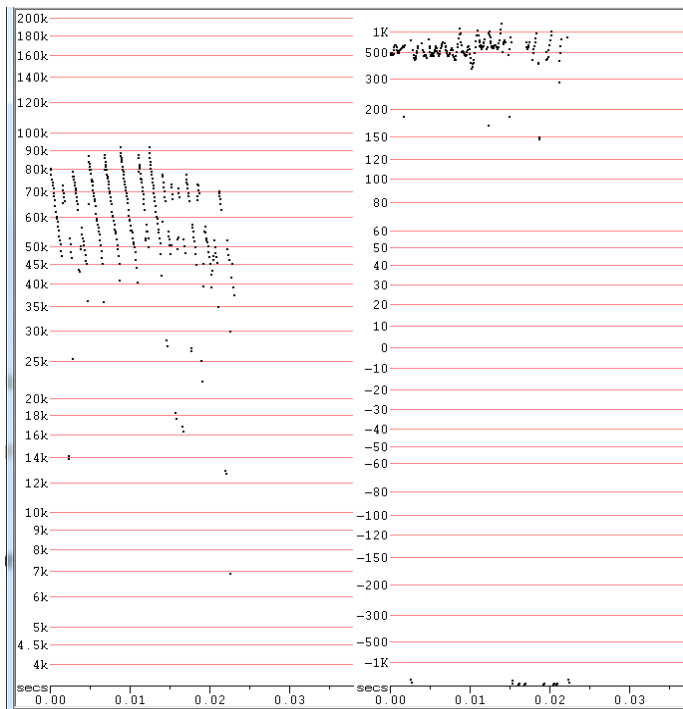
**Figure 2**

Suspected  
registration.

whiskered bat

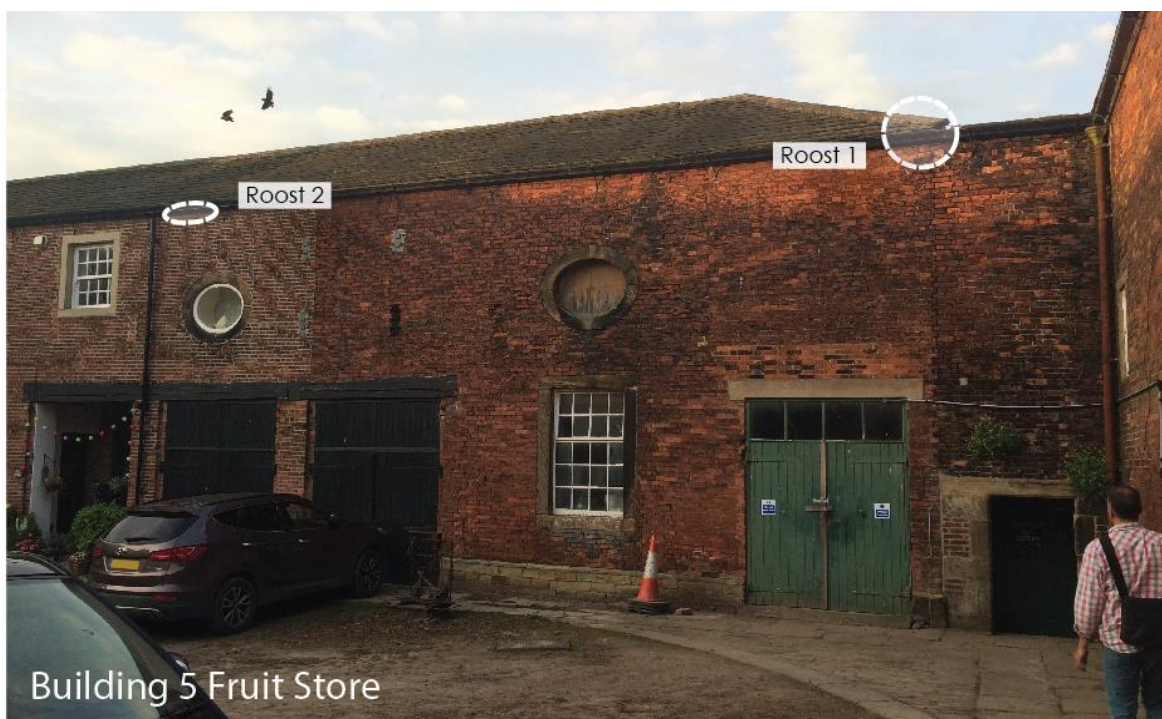
| Ref. | Location | Feature | Details |
|---|---|---|---|
| Roost 1 | Building 5 | Gap along eaves towards southwest corner | 4 common pipistrelles & 1 myotis |
| Roost 2 | Off-site | Gap along eaves - western elevation | Single common pipistrelle |

**Figure 3** Western elevation of Building 5 - Roosts 1 & 2 highlighted

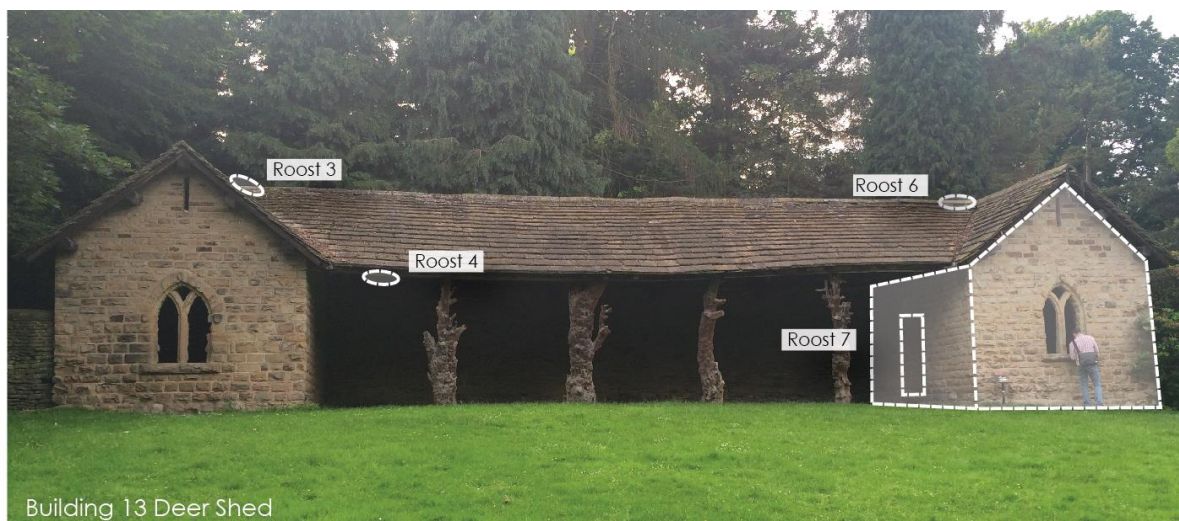
| Ref. | Location | Feature | Details |
|---|---|---|---|
| Roost 3 | Building 13 | Gap beneath roof tile - western end | Single common pipistrelle |
| Roost 4 | Building 13 | Roof structure - interior | Single brown long eared |
| Roost 6 | Building 13 | Gap beneath roof tile - eastern end | Single common pipistrelle |
| Roost 7 | Building 13 | Eastern room | Brown long eared maternity colony (10 adults) |

**Figure 4** Southern elevation of Building 13 - Roosts 3, 4, 6 & 7 highlighted

55. The exception is a brown long eared maternity colony discovered within the eastern room of Building 13 (Deer Shed). Roosts of this nature are considered to be of greater conservation significance and works to this building will need to be carefully planned to ensure impacts to this sensitive roost are minimised and that's bat continued use of the building is allowed.

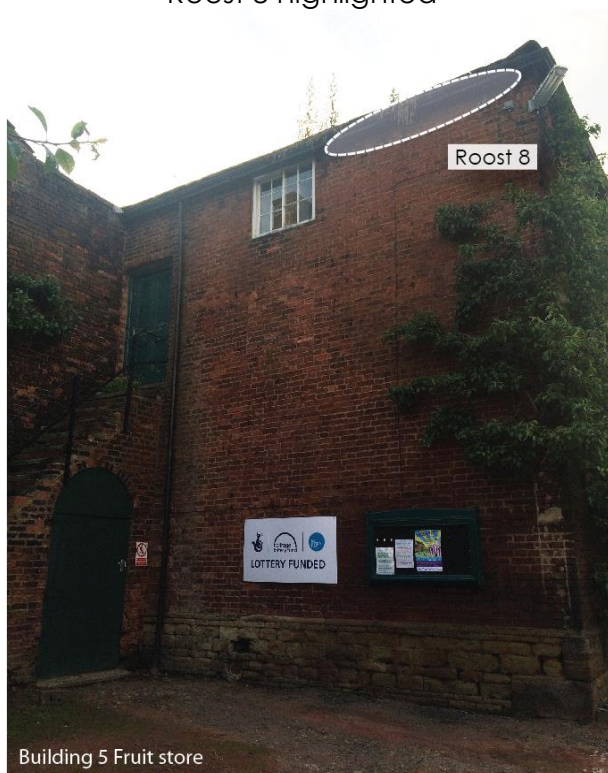
| Ref. | Location | Feature | Details |
|---|---|---|---|
| Roost 8 | Building 5 | Gap along eaves of southern elevation | Single common pipistrelle |

**Figure 6**  
Southern elevation of Building 5 –  
Roost 8 highlighted

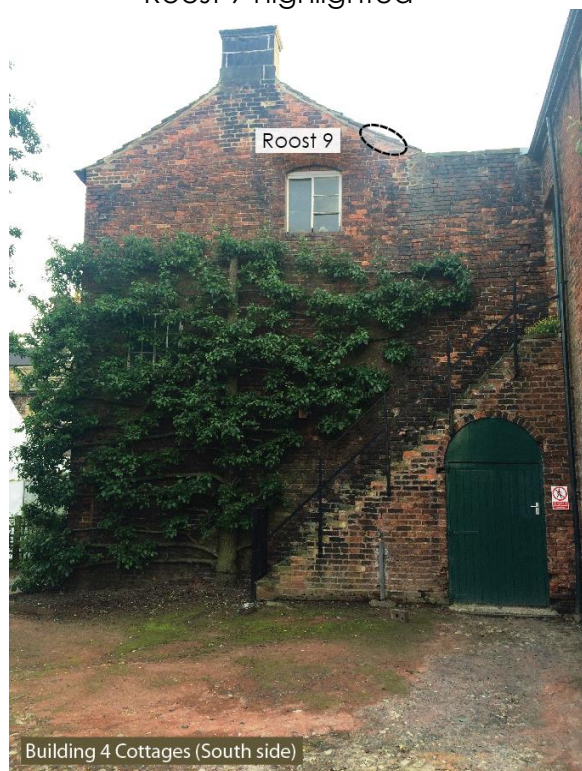
| Ref. | Location | Feature | Details |
|---|---|---|---|
| Roost 9 | Building 4 | Gap along verge of eastern elevation | Single common pipistrelle |

**Figure 7**  
Eastern elevation of Building 4 –  
Roost 9 highlighted
