DEARNE VALLEY PARKWAY, BARNSELY
for Marshall Construction (West Yorkshire) Ltd.

REVISED ARBORICULTURAL IMPACT ASSESSMENT

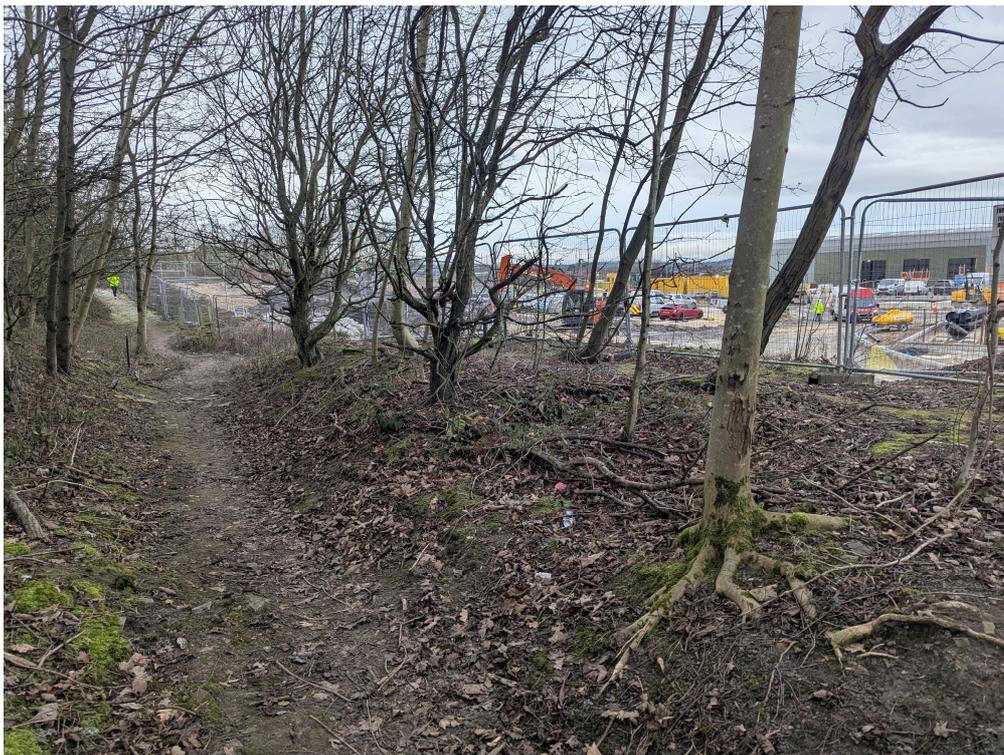
Figure 1: Photo facing west. Trees on the north side of the footpath (on the right) to be removed.

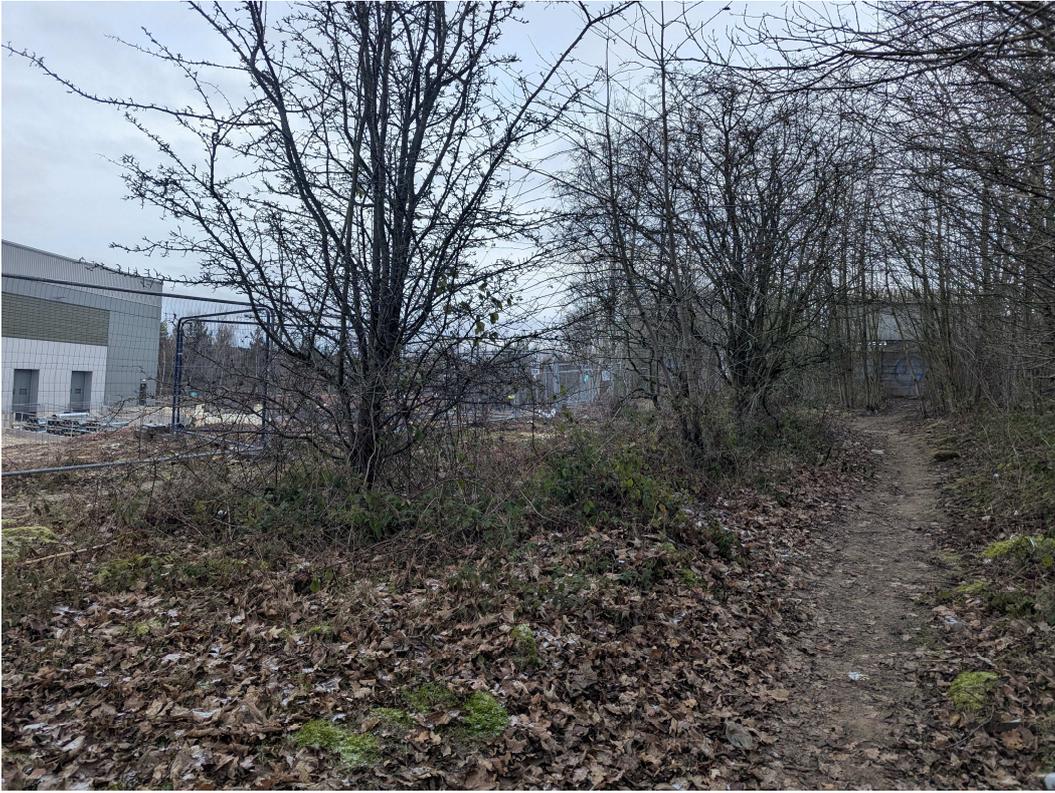
Figure 2: Photo facing east. Trees on the northside (on the left) to be removed.

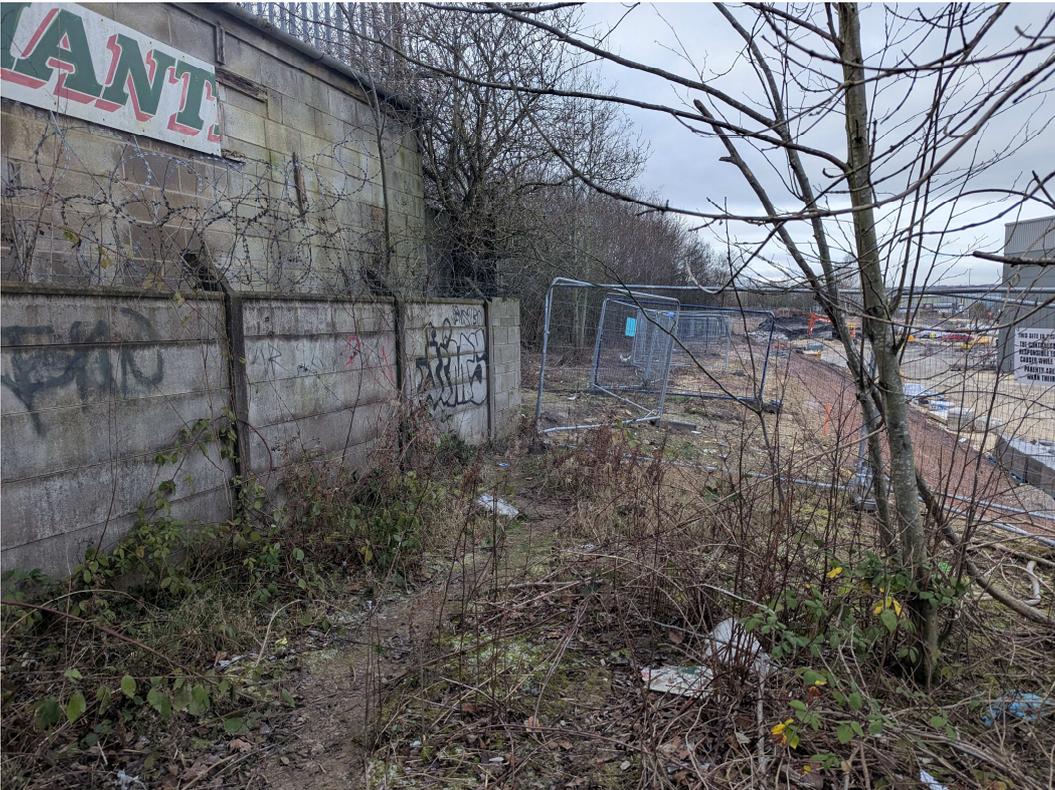
Figure 3: In the corner of the site facing west. Existing wall shown is to be retained which requires a short section of retaining wall in this area. The rest of the affected area is to be subjected to banking with a batter.

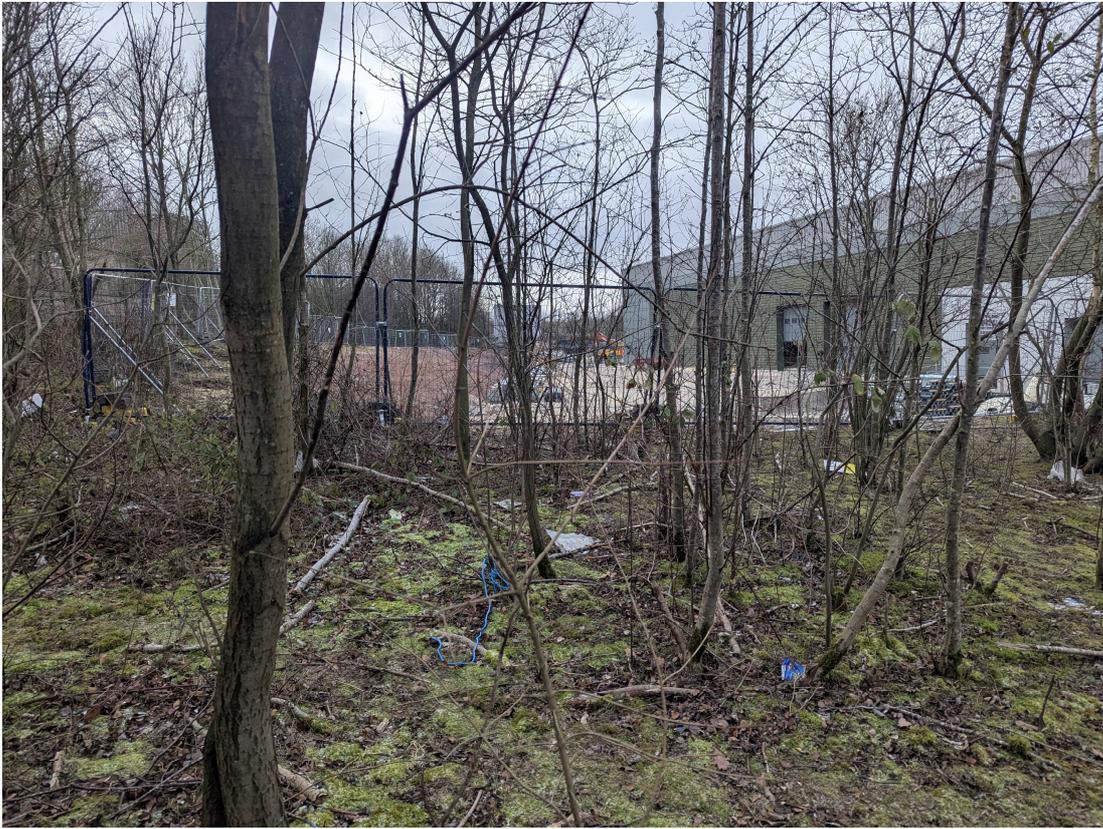
Figure 4: Photo facing west. Furthest, easternmost extent of proposed earthworks. Trees within photo are to be removed.
