# **Replacement of Roof Coverings with Subsequent Alterations to:**

**Springfield House, Springfield Street,  
Barnsley, S70 6EQ**

Design and Access Statement

August 2023

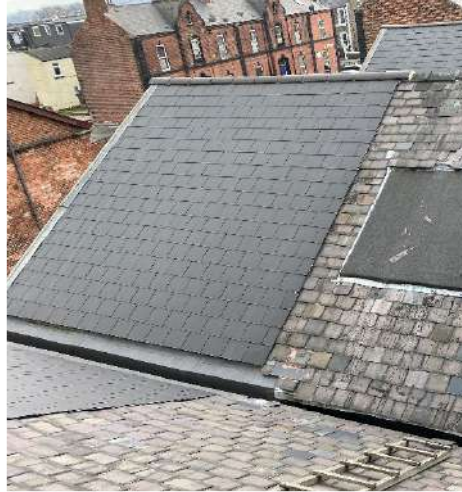
- 2.10 As the property now houses residential flats it is assumed that the previous applications for the change of use were accepted.
- 2.11 Images from around the time following these applications show that some work was undertaken to the roof. Recent access to the roof has shown that the first 5m of pitched roof coverings to the eastern side of the building have been overlaid with a cement based slate.

*Figure 4 - 5m of overlaid roof to eastern end of pitched roof*

- 4.3 Although the first 5m of roof covering to the eastern side of the building are in a newer condition (Figure 4), the overlay is poorly detailed with no weathering detail provided at the abutment to the original slate finish.

- 7.4. The current contrast between original natural slates and the overlaid cement based slates should be eliminated. Although re-roofing with new natural slates would be more aligned to the original construction, the considerable area and cost involved for these materials would be beyond the freeholders budget. The supply of new natural slates is often provided from foreign countries and unfortunately these can often include impurities in the form of pyrites. These impurities can result in a reduced life expectancy of the slates.

- 7.5. The proposed solution is therefore to replace roof coverings with a cement based slate which aims to reflect the colour and texture of a natural slate while providing a consistent factory made finish of quality controlled materials. This reduces the risk of impurities and premature failure of the new roof coverings. The use of Cedral Rivendale “black-blue” cement slates is proposed as an alternative to natural slates as they are available in various sizes to replicate natural slates and with a textured finish:

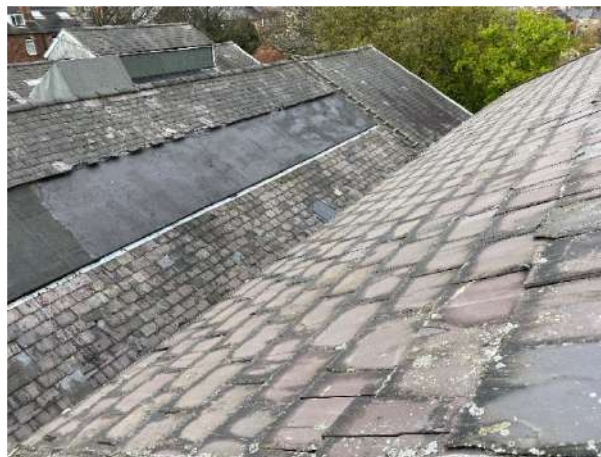
- 4.4 Beyond the initial 5m to the east to be life expired natural slate finishes laid over timber sarking boards. Many of the slates are slipped, damaged or missing across the building creating numerous points for water ingress to occur or at least creating risk of the deterioration to the sarking board below.

*Figure 5 - Life expired slate roof coverings*

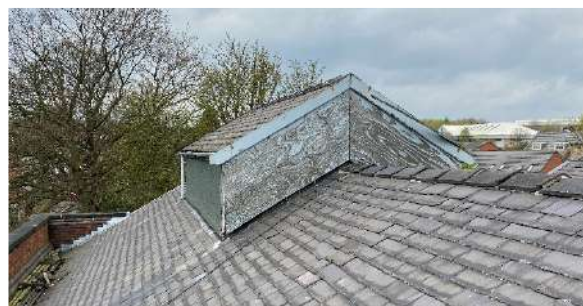
*Figure 6 - Monitor "B" as shown on drawings*

- 4.7 Although replacement of roof coverings may be considered a permitted development (provided the coverings are replaced with a similar material), the roof coverings are interrupted by the various raised details (monitors - Figure 6, brickwork towers, and automatic smoke vent window set in raised frames) as well as the plywood covering previous roof window positions (see Figure 5). These raised elements require their own maintenance and the various abutment details between elements of the construction create potential points of water ingress to occur if not now, then in the future.
- 4.8 The bitumen felt applied over plywood infills, or to the sides of the monitors has begun to peel away in a number of areas, exposing the timber behind to the elements and leading to weathering of the timber (Figure 7).

- 7.6. The raised monitor features no longer serve their original purposes as they have been boarded over. Although these could be re-clad with newer, more modern materials, any cladding is likely to have a shorter lifespan than a slate roof covering.

- 7.10. These considerations together with the fact that very little of these features can be seen from ground level around the building resulted in the design approach proposing the removal of as many of these features as possible. The proposed new slate roof coverings would instead be extended across the areas where these features once were.

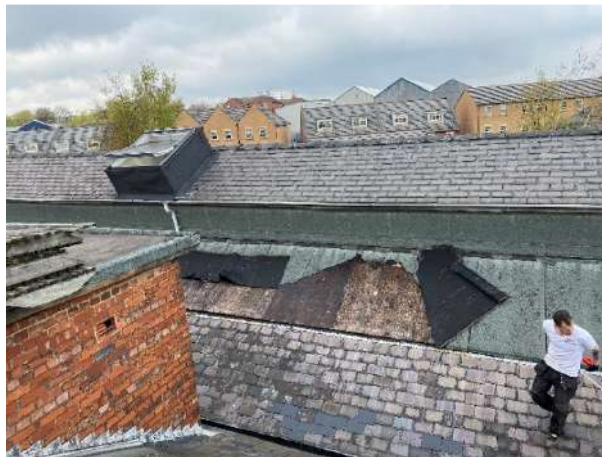
*Figure 7 - Exposed plywood infill to previous roof windows*

- 7.7. Similarly, previous roof windows have been boarded over and in some cases overlaid with bitumen felt. (Figure 7).
- 7.8. Three of the four existing automatic openable vent roof windows present on the building have been fitted into raised surrounds which stand above the surrounding roof lines. The reason for this is unclear, but the upstands have simply been protected by bitumen felt. Again, although the external finish could be replaced, it is likely to have a shorter lifespan than the slate coverings and would result in access being required to the roof more regularly.

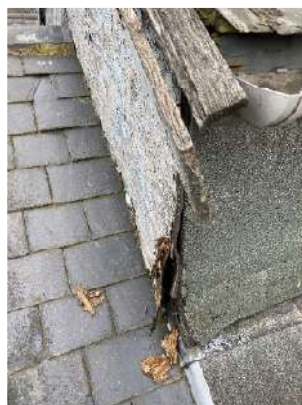
- 4.9 Felt finishes around raised automatic smoke vent windows are simply applied onto the slates around the base which could result in water ingress around these frames if the bitumen felt begins to fail around these areas.
- 4.10 The timber cladding finish to the monitors is particularly heavily weathered. In some cases the timber cladding has only been protected by a painted finish which has now weathered away.
- 4.11 The weathering of the timber barge boards of the monitors has resulted in deterioration of the sarking boards and failure of the roof coverings over the monitors (Figure 8).

*Figure 8 - Weathered timber finishes to monitor (E)*

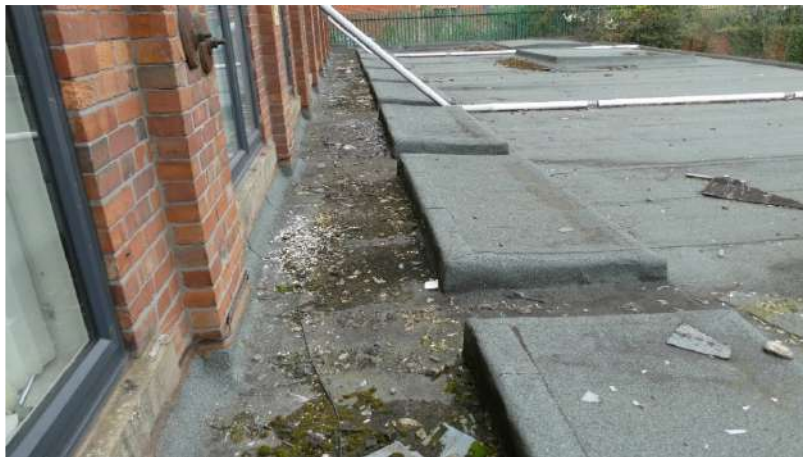
- 4.15 There are raised upstands to this roof which are simply formed with a timber frame below. Their purpose is unclear. It is suspected that they once had roof windows present. These upstands restrict the flow of water towards the gutter along the edge of the roof and cause debris to build up behind them. This increases the risk of water ingress in these areas as freeze thaw actions of standing water will accelerate failure of laps between bitumen.

*Figure 9 - Upstands to flat roof over single storey extension*

- 7.15. The raised upstands to the existing flat roof of the extension serve no visible purpose and only restrict the flow of water to the rainwater outlets with debris collecting behind them. Although access is more readily available onto this roof, the removal of these raised sections would be preferable and allow a continuous fall to be provided to the gutter along the edge of the roof. It is noted that these upstands cannot be seen behind the existing parapet to the front (south) of the extension so it is hoped that these could be considered as minor amendments while flat roof coverings are replaced. The flat roof covering will be replaced with a new bitumen felt finish to match the existing.
