# Wentworth Castle, Stainborough

## Bat Survey Report

8<sup>th</sup> January 2021

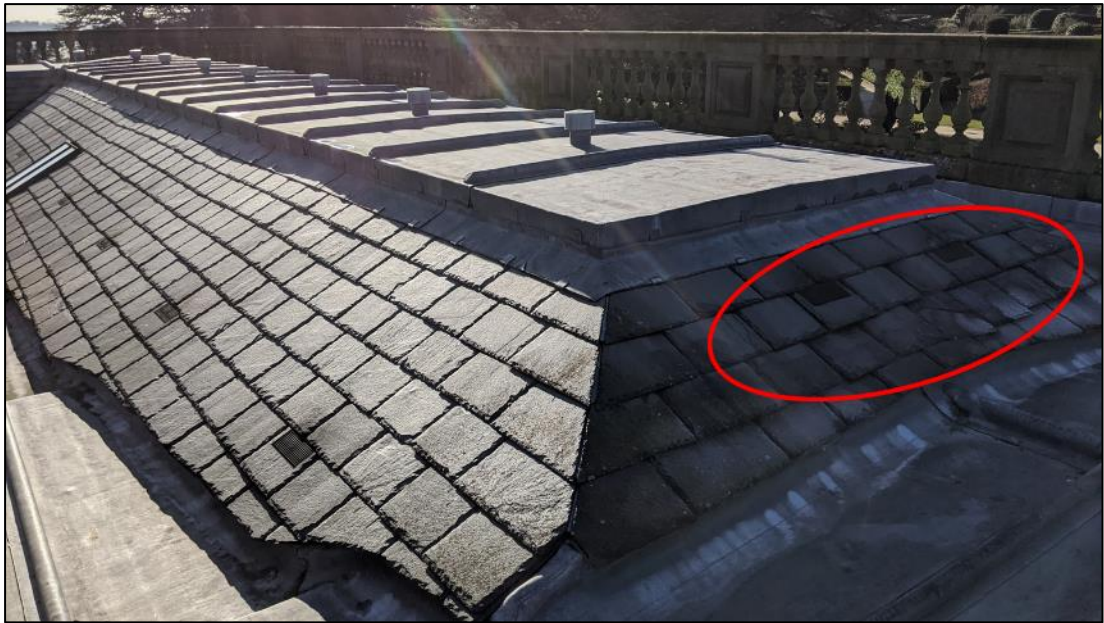
- 1.1.5 The roost in the Cutler House roof will not be impacted by the proposed works. The second roost in a roof void on the western side of the building could be impacted, were slates in the adjacent sections of roof (Plate 3) re-fitted, or the broken slate in this area replaced. For this reason, it is advised that no slate repair/replacement works should take place in this location without further survey.

**Plate 3. Close view of pitched roof at west side of Wentworth Castle showing generally good state of repair. Bat access point to identified roost circled in red**

- 6.3.6 This element of works may not be able to take place. Certainly, one area of roof with slightly uneven slates and one broken slate (Plate 3) appears to be used by roosting bats.
- 6.3.7 It is advised that no slate or lead repair be undertaken without first being checked and signed-off by a licensed bat worker.

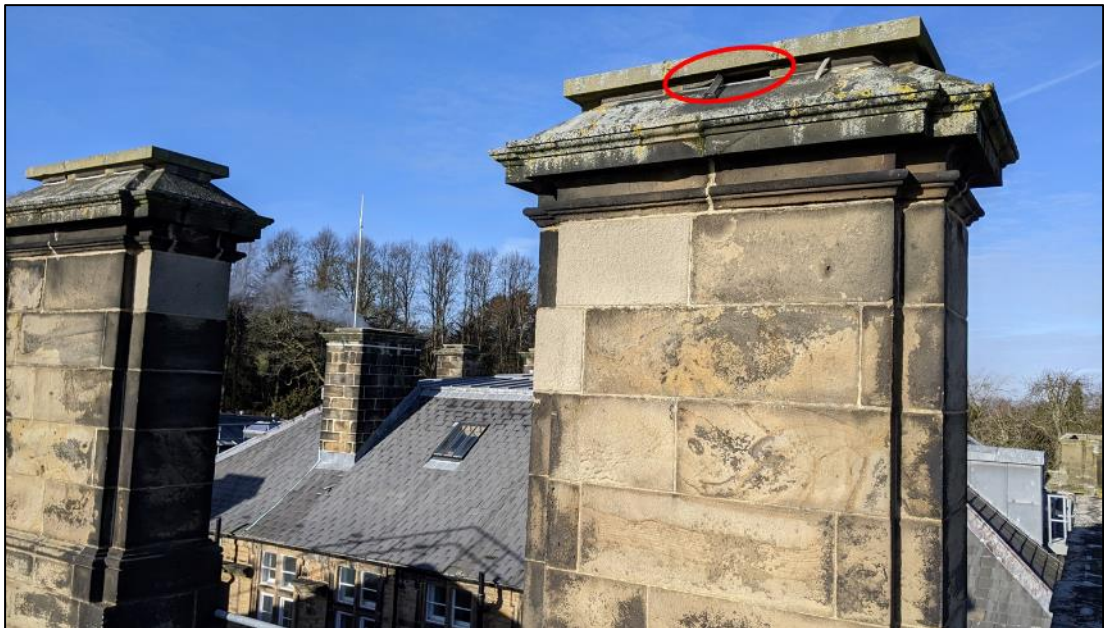
- 5.2.7 The stone chimneys generally lack open masonry joints, however, bats can potentially access the interior of chimneys via missing mesh bird screens (Plate 4). Bats are considered unlikely to roost within the interior of the chimneys, due largely to their recent complete meshing at the time of the last re-roof. It is however not possible to rule out bat roosting in the interior of chimneys and these locations cannot be accessed for direct inspection.

**Plate 4. Example of chimney with damaged bird proof screen circled in red**

6.3.3 It is considered that at this time, bird screens can only be reinstated across chimney openings if bat access to these areas is retained. It is considered this could be achieved by designing the mesh covering to stop 25mm from the end of each rectangular opening, as shown in Figure 4. An opening of this size will be too small for jackdaws but large enough to facilitate bat access.

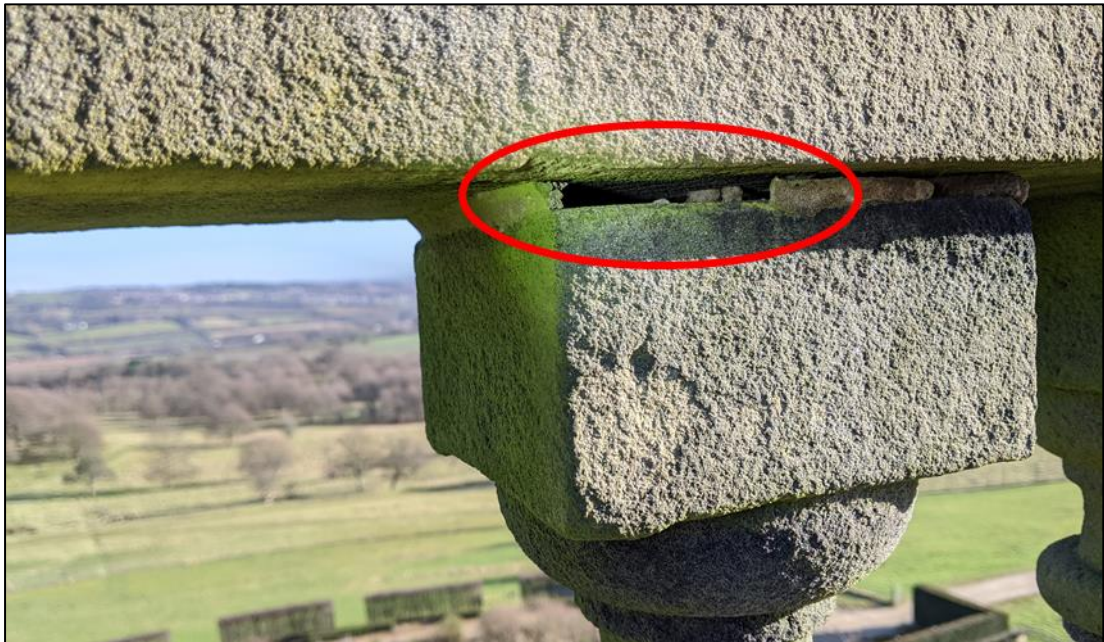
- 5.2.8 The balustrades were all subject to close inspection from the roof. No evidence of current or historic bat roost usage was recorded from any location on the balustrades although a number of narrow open joints up to c.7mm in width were present (Plate 5). Whilst the open joints were generally too narrow for use by roosting bats and no bats or droppings were present at the time of inspection, the possible use of the wider of these joints in the future could not be fully ruled out.

**Plate 5. Missing mortar on balustrade joint**

- 6.3.11 All areas of pointing will need to be checked and signed off by a licensed bat worker prior to this work being undertaken. All workers involved in pointing should be subject to a bat Toolbox Talk.

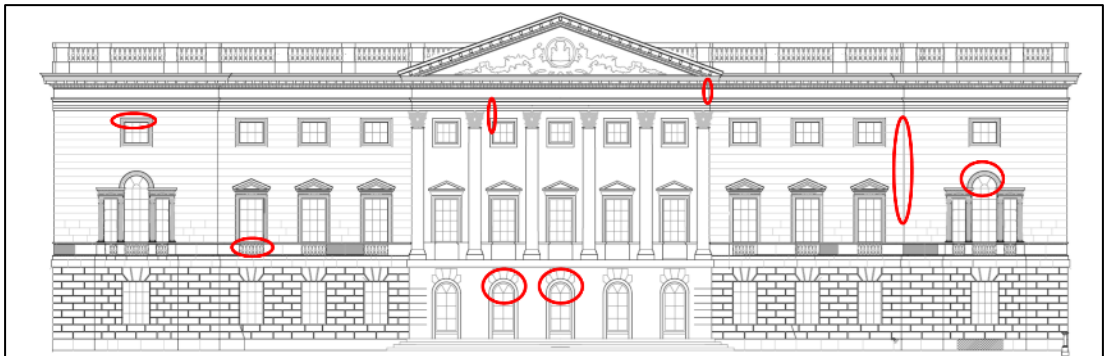
- 5.2.12 One of the identified potential roosting features on the south elevation comprised a crevice between a wooden window frame and the adjacent masonry at the west end of this elevation.

Figure 2. Crevices in south elevation masonry, visible from ground, which are considered to display bat roost potential

- 6.3.9 All areas of pointing will need to be checked and signed off by a licensed bat worker prior to this work being undertaken. All workers involved in pointing should be subject to a bat Toolbox Talk.

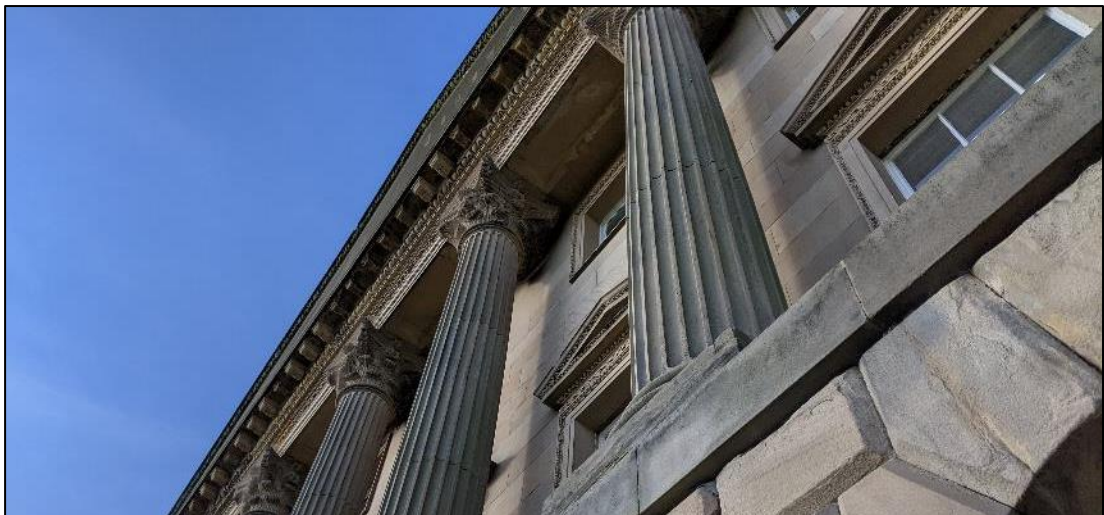
- 5.2.11 The bird netting associated with the top of the Corinthian columns has clearly been breached by birds as evidenced by large stick nests, however, there does not appear to be any bat roost potential associated with these features (Plate 7).

Plate 7. Looking up at Corinthian columns on south elevation

- 6.3.5 The renewal of birdproof netting to the south elevation appears unlikely to impact roosting bats as no potential roost locations can be seen behind netting. It is however difficult to view all associated areas from the ground and consequently, as a precaution, it is recommended these areas are checked by a licensed bat worker from the scaffold (or alternative access mechanism) prior to netting being replaced.

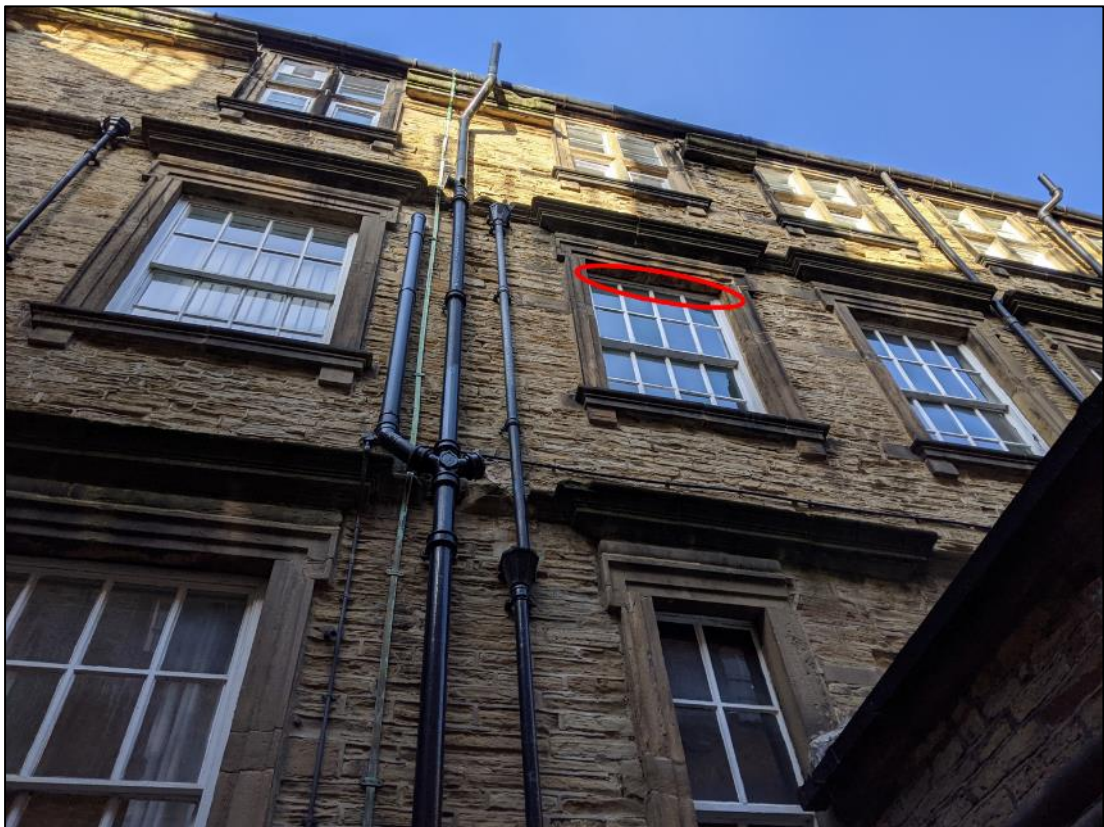
- 5.2.13 There were no visible bat roosting opportunities associated with the location of the proposed new gutter into the courtyard.
- 5.2.14 A single cracked lintel within the courtyard has been identified for repair. A close inspection of this location highlighted the presence of a vertical crevice between the wooden frame and the stone lintel (Plate 8). This was inspected with a torch and binoculars so far as was possible, however, a full inspection could not be achieved from the ground.

**Plate 8. Crevice between damaged lintel and frame within courtyard**

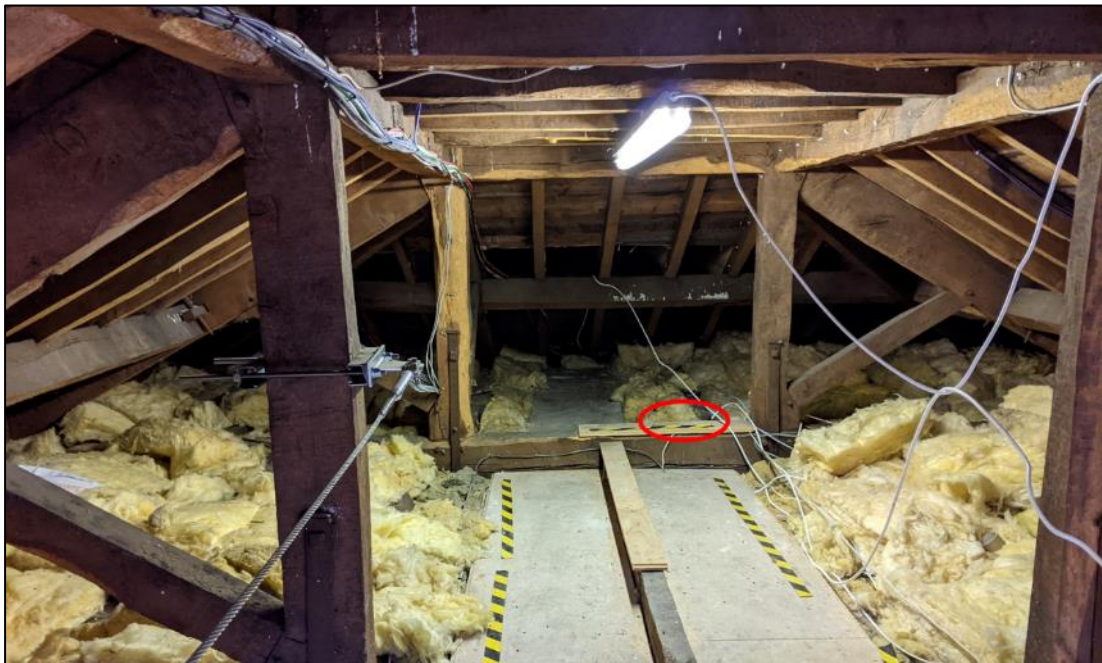
- 5.2.17 The roof voids were clean and as a result could be easily inspected for bat droppings and/or feeding remains. Two defined areas of bat droppings were recorded (Figure 3). At the northern end of a roof void on the west side of the building (Plate 3; Figure 3), two closely located clusters of c.50 droppings were recorded beneath roof timbers. The droppings were small in size and have been sent for DNA analysis to determine their species of origin, however, on the basis of dropping size and location they are suspected to originate from whiskered bat. One cluster was close to the point where a ventilation slate passed through the sarking. It appears that bats pass through crevices between slightly uneven slates (Plate 3) into the void between slates and membrane/sarking. It is thought the bat/bats then move into the roof void via an opening between the ventilation slate and wooden sarking. A second loose scatter of c.10 droppings was recorded from a section of roof space above Cutler House (Figure 3). The potential access point to this roost was not investigated as there does not appear to be any way in which this roost could be impacted by the proposed works. The number of droppings present in the two roost locations indicates use by a low number of bats only, although more droppings may be present in the void between slates and felt/sarking.

**Plate 9. Location of cluster of c.50 bat droppings circled in red.**

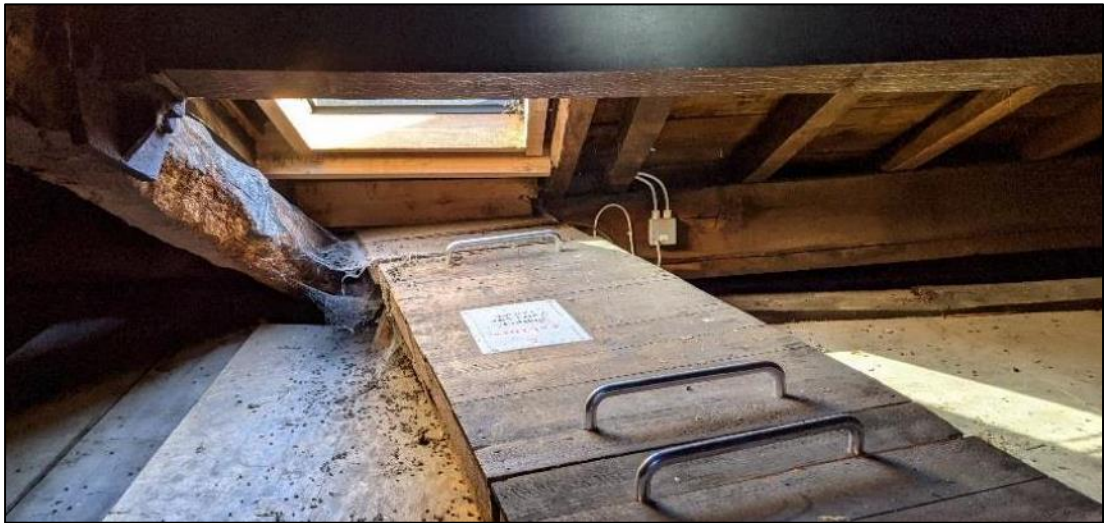
internal launders. The launders have wooden covers (Plate 10). These covers were lifted to inspect the interior. Bird nest material and droppings were present within some launders; however, no evidence of bats was visible. Wooden launder covers would prevent bats accessing the interior of the roof voids, assuming that broken or missing bird screens had first allowed bat access from the roof exterior into the interior of the launder.

Plate 10. Typical covered section of launder as it passes through roof

- 6.3.4 The covers present on launders are expected to prevent any bats moving from the interior of launders into the adjacent roof space. In addition, the overwhelming majority of roof spaces appear not to be used by bats. The only roost present in a roof with a launder has a clear access point between slates. For these reasons it is considered that bird screens on launders can be replaced without further nocturnal survey. It is however recommended that prior to bird screens being fitted, launder covers are first lifted to check for any birds that may be trapped in the launders at that time.

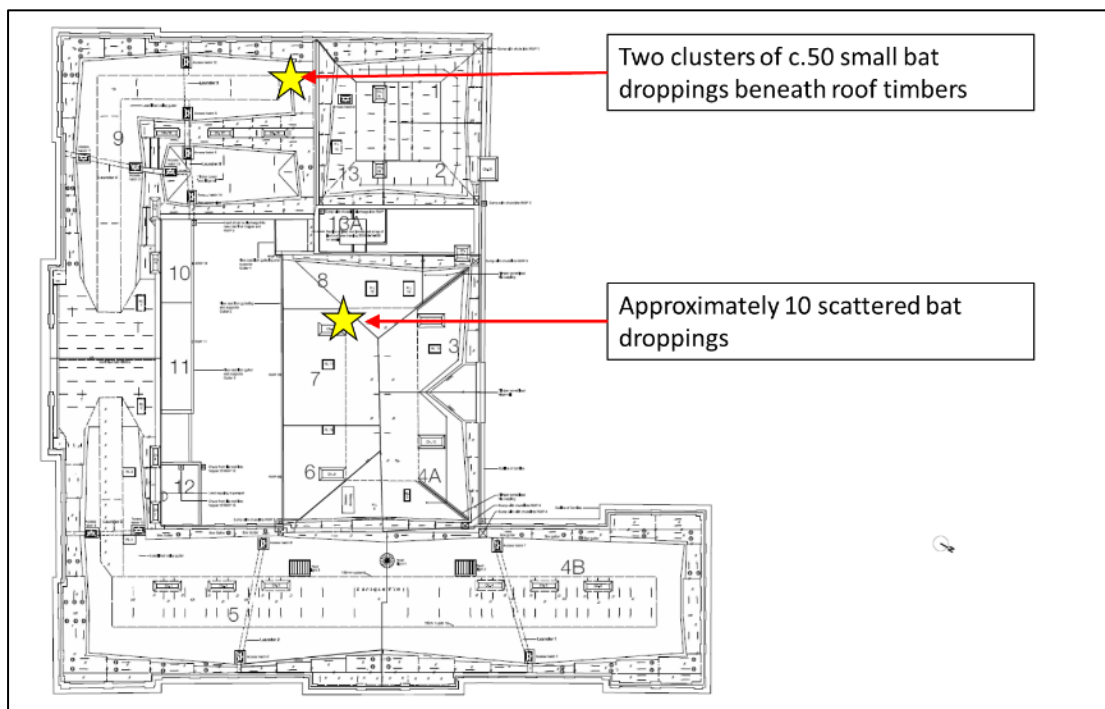
Figure 3. Evidence of bats recorded from Wentworth Castle roofs

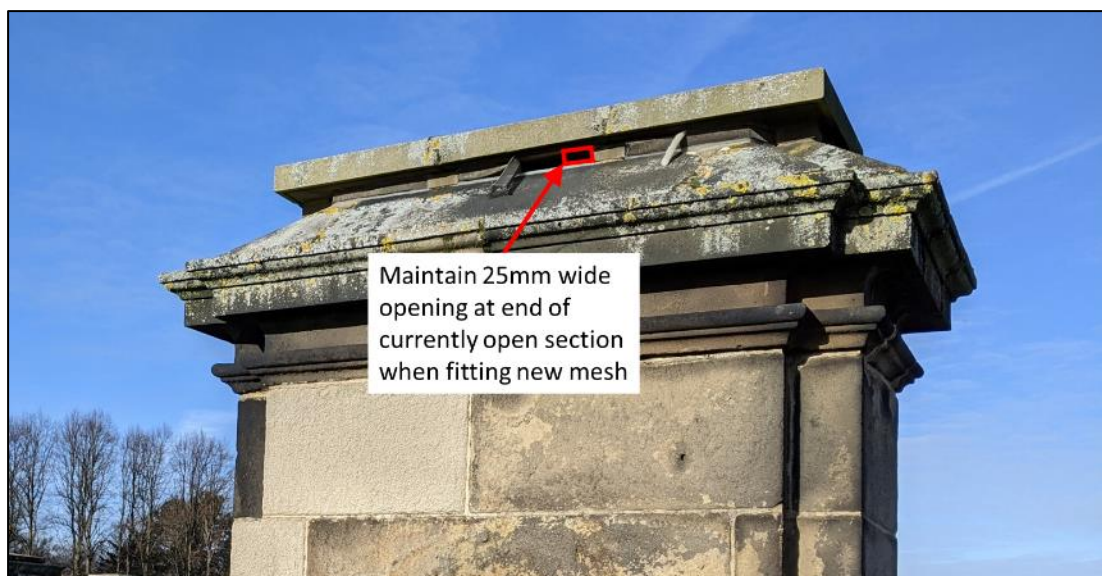
**Figure 4. Chimney bat access requirement**
