RANAM STONE  
SHEFFIELD  
S36 4 HJ

<p>John Newton &amp; Partners <b>jnp group</b> Consulting Engineers www.jnpgroup.co.uk Chesham • Bingham • Harlepool • Leamington Spa • Sheffield Tel: 01928 889555 Email: leamingtonspa@jnpgroup.co.uk</p>	<b>JNP Group Typical Details</b>		Date: 04/17
	Detail No: SK2	Scale: 1:20	
	Detail Title: Typical Crack Repair	User notes: 1. Details to be checked by engineer for specific site

<p>John Newton &amp; Partners <b>jnp group</b> Consulting Engineers www.jnpgroup.co.uk Cresham • Blythhouse • Haleswood • Leamington Spa • Sheffield T: 01926 859255 Email: leamington@jnpgroup.co.uk</p>	<b>JNP Group Typical Details</b>		Date: 04/17
	Detail No: SK1	Scale: 1:20	
	Detail Title: Typical Crack Repair	User notes: 1. Details to be checked by engineer for specific site

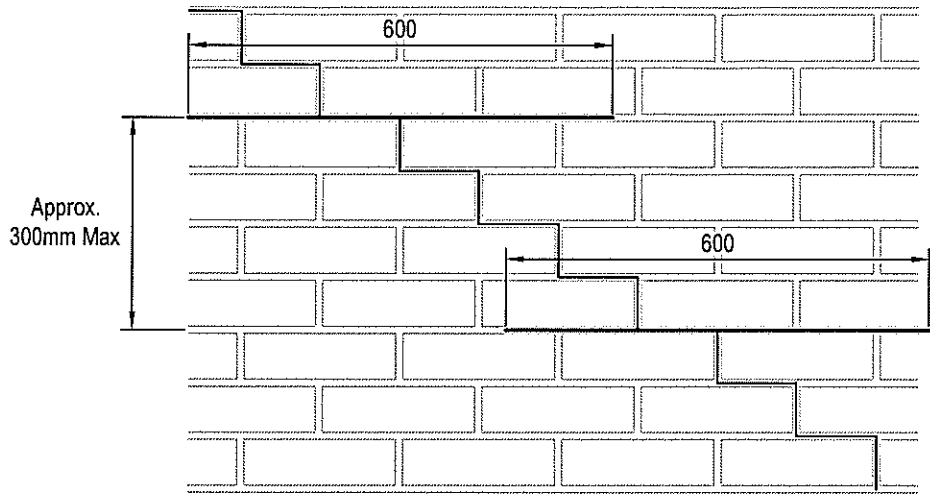
### ELEVATION ON CRACK

ELEVATION ON CRACK SHOWING REINFORCEMENT 600mm LONG TO CONSIST OF 6MMØ STAINLESS STEEL THREADED BARS AT 300mm TO 400mm CTS

- 1) Rout or drill out mortar joint to approximately 50mm to ensure good brick to brick (stone to stone) bond
  - 2) Remove all dust from the work area by vacuum and using tubing
  - 3) Mix specialist grout in accordance with manufacturers instructions and insert bead of grout to back of joint
  - 4) Insert Stainless Steel bar \*
  - 5) Further bead of epoxy grout leaving 15/20mm space for pointing
- \* 6mm threaded bar or Helibar

Note:  
Epoxy grout by Helifix Ltd (Helibond), Alternatively Thor P by Fischer or Brie Bond by Resin Renovation Ltd
