## Coal Mining Risk Assessment

| <b>LOCATION</b> | New house at Plot 4 (adjacent to the Gate Inn and house No 75) Chapel Road, Pilley, Tankersley, Barnsley, S75 3AR |
| <b>ISSUE DATE</b> | 31 <sup>st</sup> August 2017 |
| <b>OUR REF.</b> | G17364 |

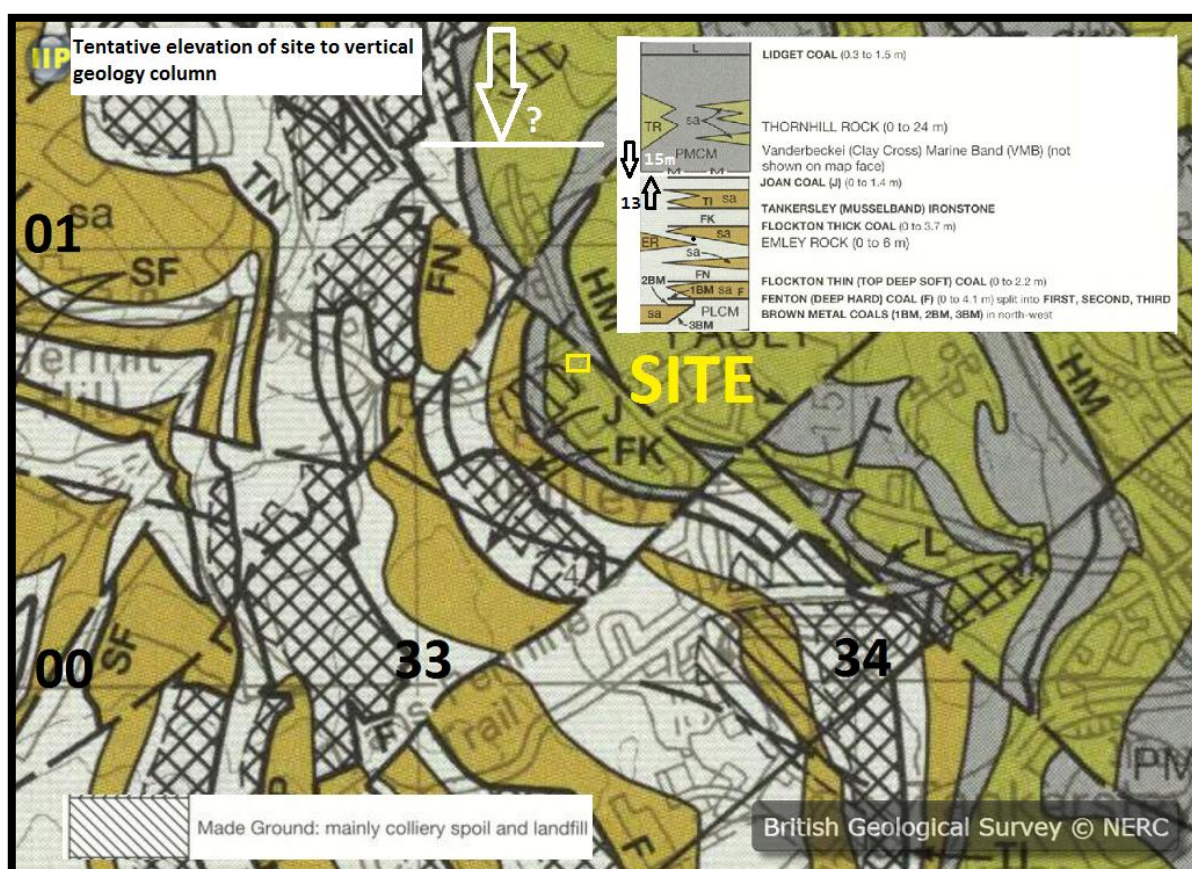
### EXTRACT OF BGS GEOLOGY MAP

5. The location of the site is shown on the extract of BGS geology map Sheet 87 Barnsley presented in Appendix C.
6. The tentative elevation of the site relative to the vertical geology column is shown on the map inset.

12. The vertical geology column indicates that the Joan (J) Coal seam (of 0 to 1.4m thickness) may lie some 13m above the Tankersley Ironstone. Therefore if workings exist in the J coal seam they might lie at only 13m below the surface in which case they may impact the stability of the new development.

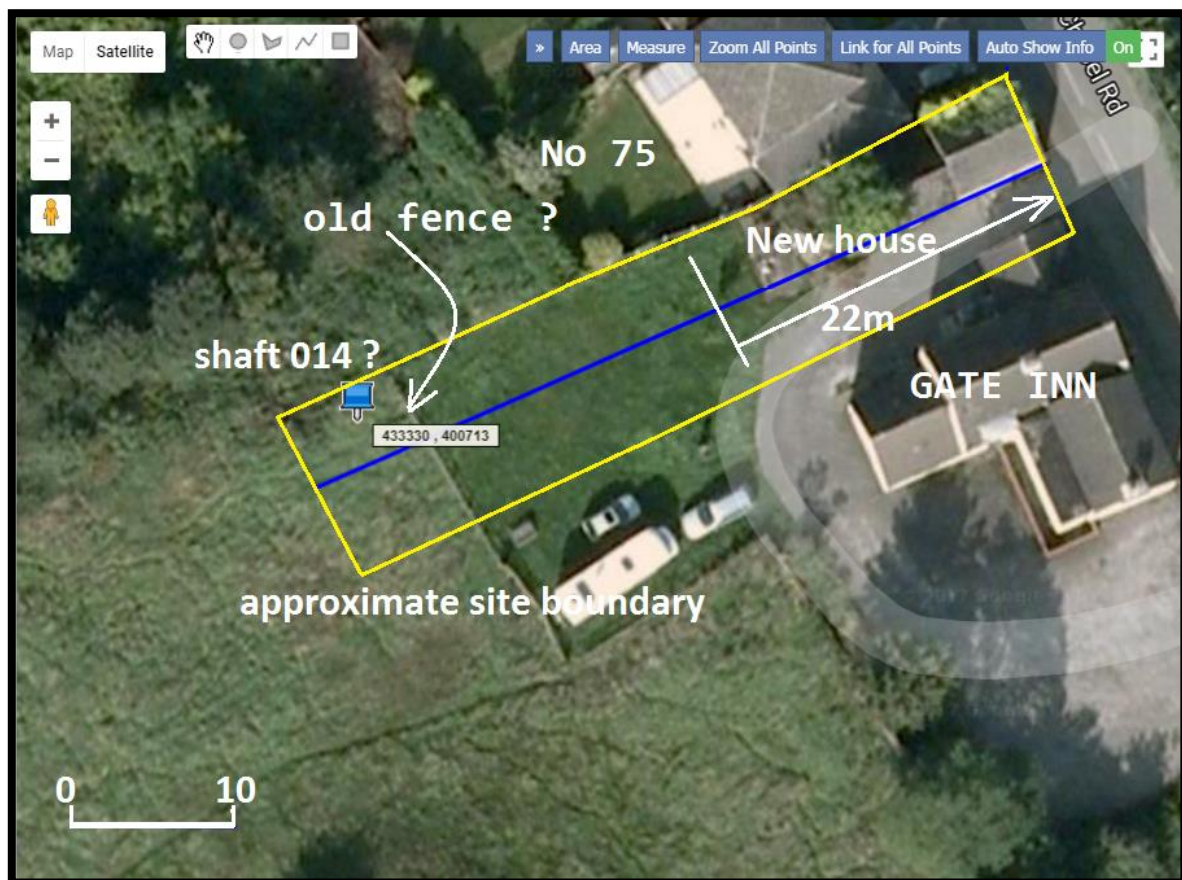
## APPENDIX D SITE & MINE SHAFT 014

18. No mine entries are recorded by the CA within 20m distance of the new house.
19. Ironstone mine shaft (433400-014) is shown in the CA report ON or very close to the sites far northwest corner boundary. The position of shaft 014 shown in Appendix D has been plotted using an online grid reference finding service using the CA coordinates provided. In this instance, the shaft appears to be located within the Plot 4 though there may be some inaccuracy in the position of the site boundary and therefore this position is tentative only.

20. However, assuming the position of shaft 014 to be reasonably reliable then the new building would lie >20m from the shaft in which case given that bedrock is expected to be shallow at the site the stability of the new building is unlikely to be impacted by shaft 014.

28. **Excavation by either trenching or a localised site strip would be required to locate the shaft or to confirm its absence.**
29. **Assuming bedrock is confirmed to lie at or near surface in Plot 4, shaft 014 will not impact the stability of the new house.**

8. Localised site strip or trenching at close spacing will be required if an attempt is to be made to locate shaft 014 in the far northwest corner of the rear garden though it is possible that this shaft may not be found by such effort or it may occur outside the plot in the neighbouring field.
