Site off Highstone Lane, Worsbrough, Barnsley S70 6SD

**Coal Mining Risk Assessment  
at  
Site off Highstone Lane  
Worsbrough  
Barnsley S70 6SD  
For  
Peter Dimberline**

Client:-  
Peter Dimberline  
Chartered Architect  
2, Tipsey Court  
Staincross  
Barnsley  
S75 6FZ

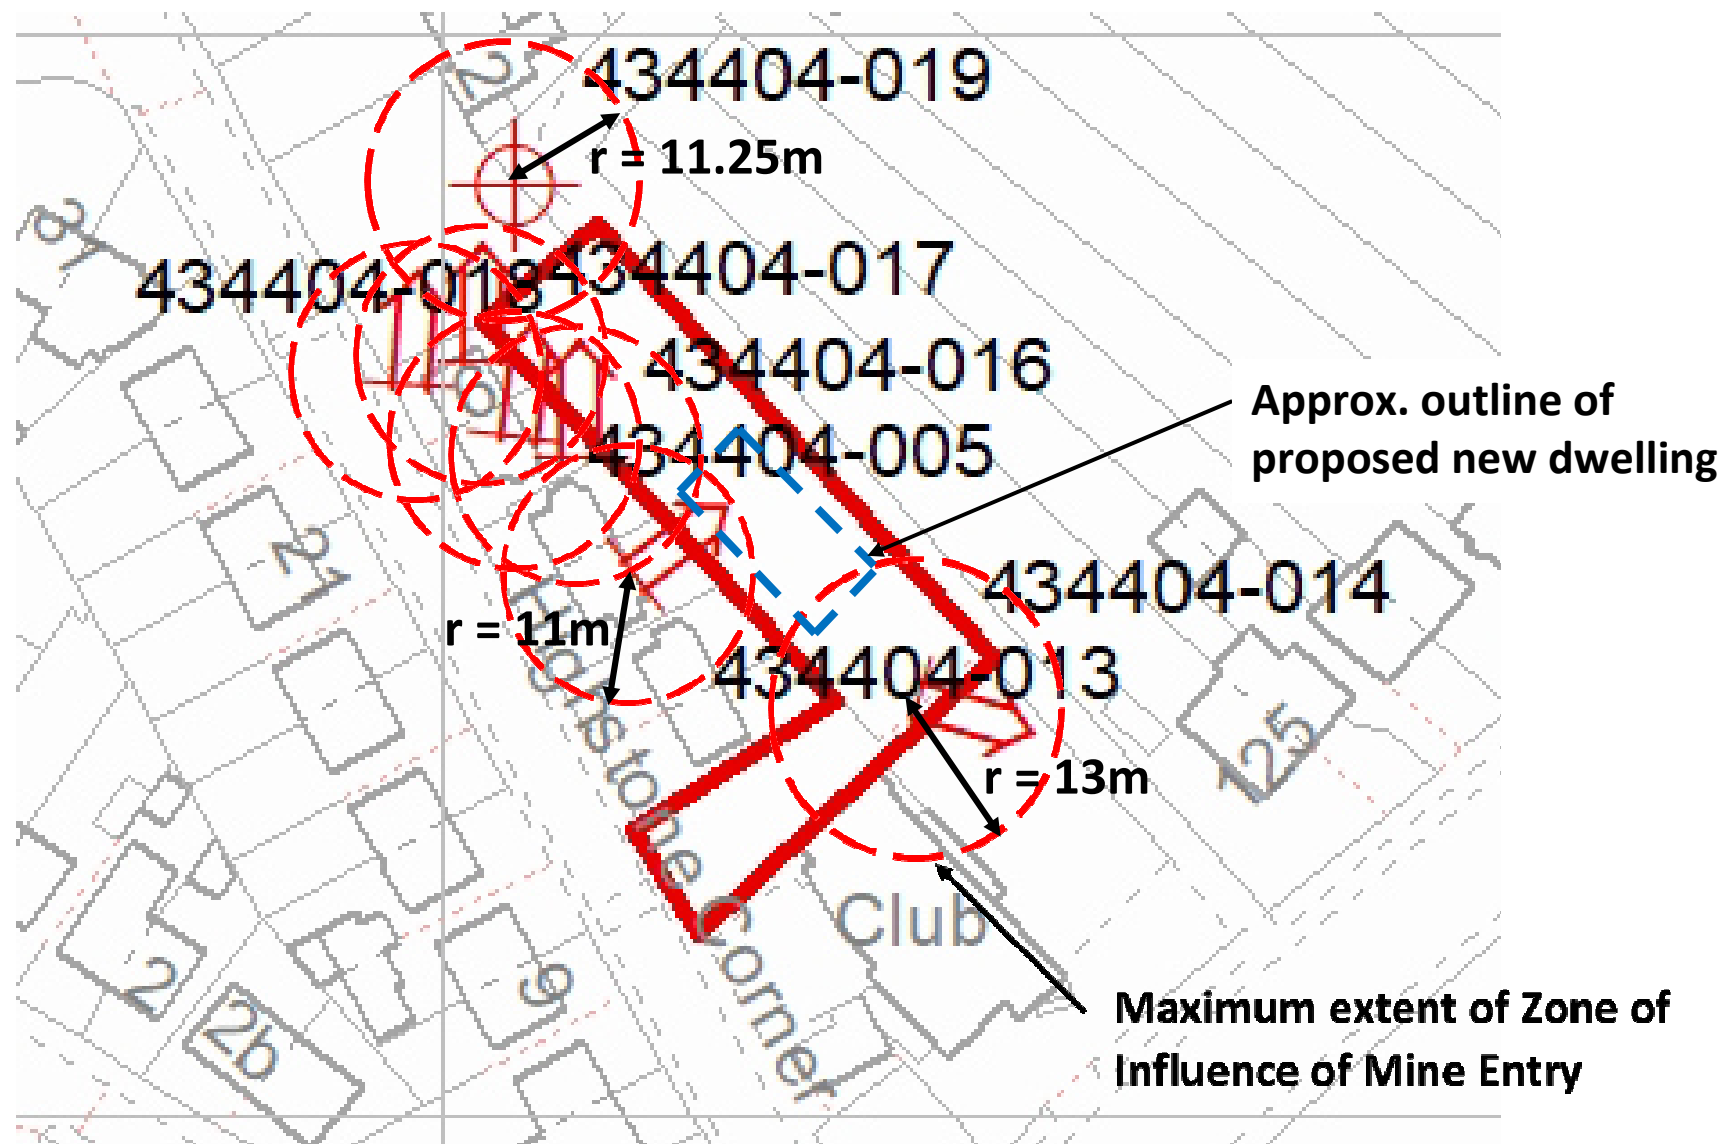
Client:	Peter Dimberline
Job No:	Dit/23/020
Date:	August 2023
Drawn by	JR
Drawing Ref:	23/020/ZOI-001

Drawing 23/020/ZOI-001, included as **Appendix A**, shows the maximum extent of the ZOI of all on site and off site mine entries, allowing for their departure distances and in the absence of any detailed site specific information on their actual locations. Such ZOI extents are a function of the sum of the mine entry radius ( $r=1.0\text{m}$  or  $1.25\text{m}$  re. assumed  $2.0\text{m}$  or  $2.5\text{m}$  diameter adit/shaft), the distance from the outer edge of the mine entry created when a  $45^\circ$  line is subtended to the surface from rockhead (which is assumed to be  $2.0\text{mbgl}$ ) and the departure distance assigned to the mine entry. It is evident that all recorded former adits and the shaft could potentially influence the surface stability beneath the site in the event of a collapse of these features, several of which impact the footprint of the proposed new dwelling.

6.3 The proposed development footprint is assessed as being within the ZOI of the recorded on and off site mine entries and, as such, there is a potential significant risk to surface stability in the event of collapse of these features. However, at this stage, this assessment is based upon the theoretical maximum extent of the ZOI of these former adits and a shaft with respect to the proposed development, which cannot be adjusted or refined until the actual position of these features is positively determined. Intrusive investigation and establishment of the exact position of

these on site mine entries will be necessary with their ZOI re-calculated to assess their respective impact on the proposed development layout. Additionally, unrecorded mine entries may also be present on the site. The possibly of re-locating the proposed layout should be considered in order to mitigate any such risk.

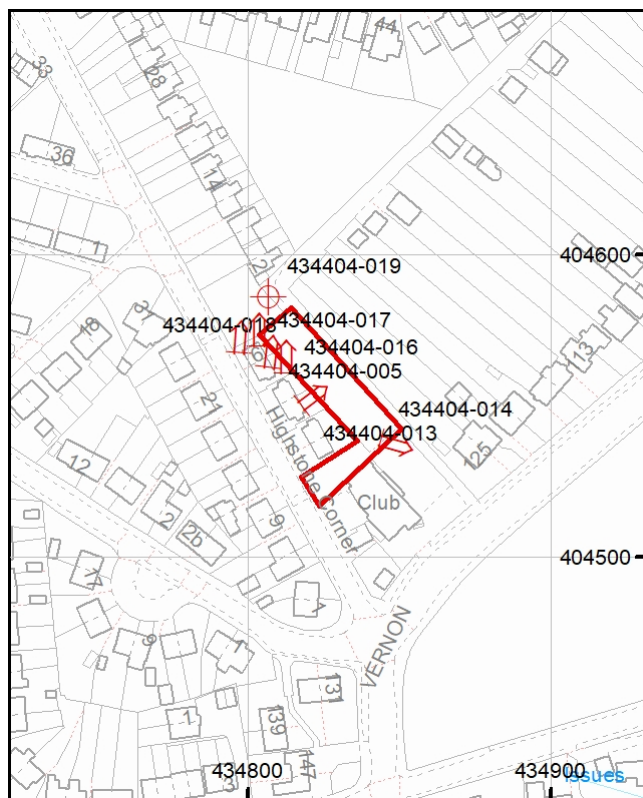
# Enquiry boundary

Within, or within 20 metres of, the boundary of the property there are 7 mine entries, the approximate positions of which are shown on the enquiry boundary plot. For reasons of clarity, mine entry symbols may not be drawn to the same scale as the plan.

There is no record of what steps, if any, have been taken to treat the mine entries.
