**Bat Emergence Survey**  
**Cannon Hall, Cawthorne, Barnsley**

Report reference: R-2560-01.2

July 2016

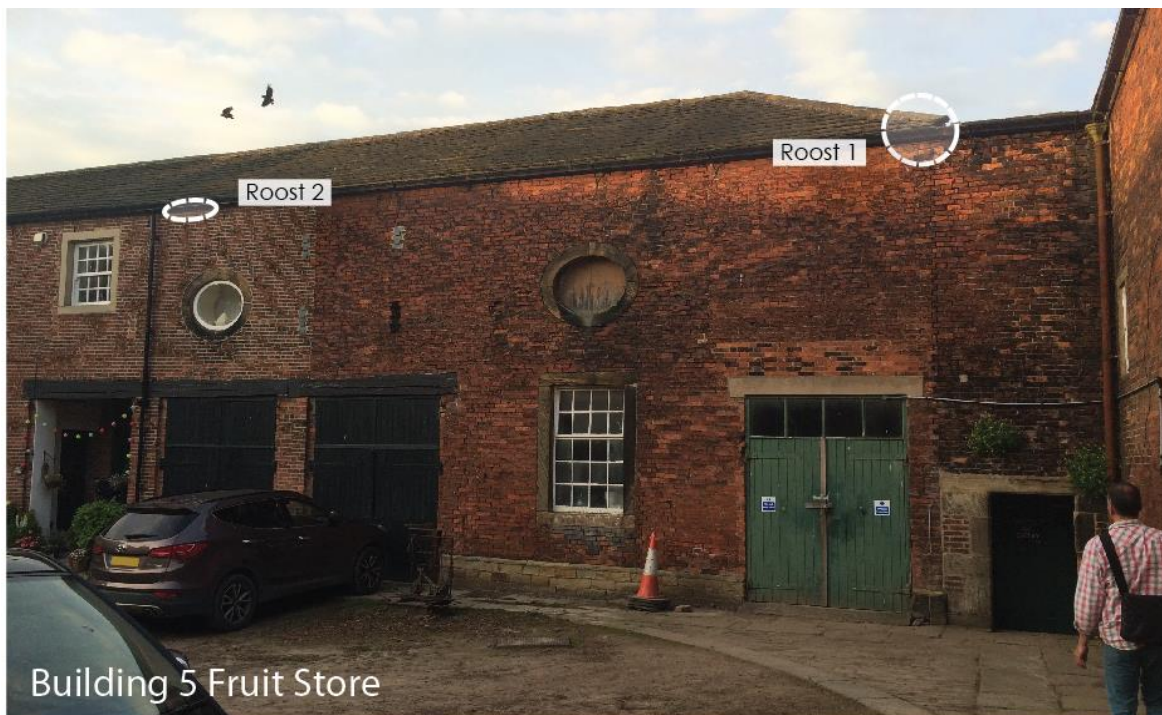
| Ref. | Location | Feature | Details |
|---|---|---|---|
| Roost 1 | Building 5 | Gap along eaves towards southwest corner | 4 common pipistrelles & 1 myotis (suspected Whiskered bat) |
| Roost 2 | Off-site | Gap along eaves - western elevation | Single common pipistrelle |

**Figure 3** Western elevation of Building 5 - Roosts 1 & 2 highlighted

61. For now, no works are scheduled to this building and as such no impacts to Roosts 1, 2 or 8 are envisioned.

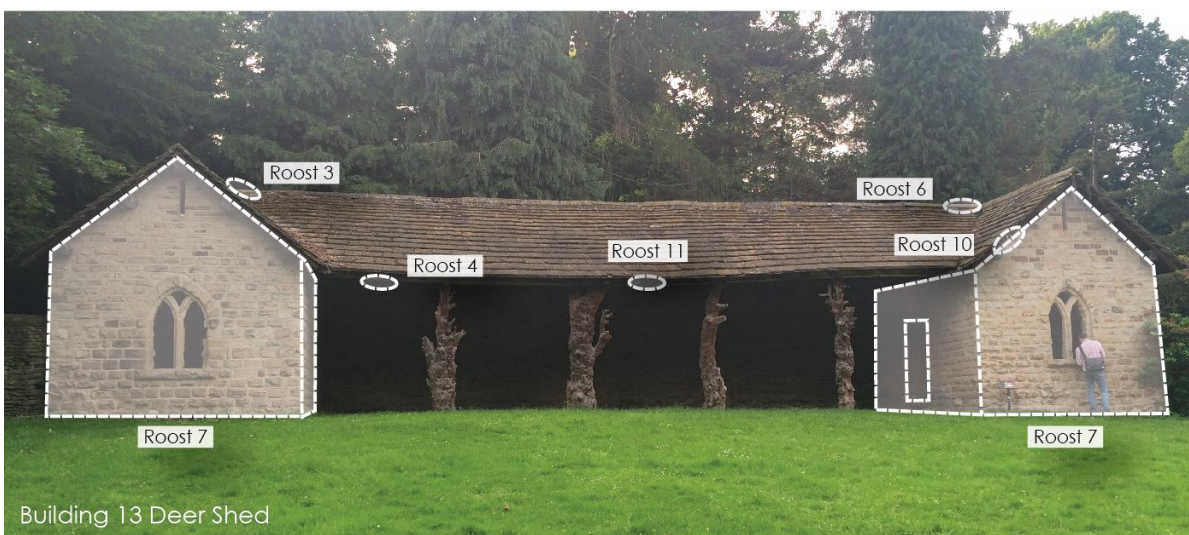
| Ref. | Location | Feature | Details |
|---|---|---|---|
| Roost 3 | Building 13 | Gap beneath roof tile - western end | Single common pipistrelle |
| Roost 4 | Building 13 | Roof structure - interior | Single brown long eared |
| Roost 6 | Building 13 | Gap beneath roof tile - eastern end | Single common pipistrelle |
| Roost 7 | Building 13 | Interior of eastern and western rooms | Brown long eared maternity colony (13 adults) |

**Figure 4** Southern elevation of Building 13 - Roosts 3, 4, 6 & 7 highlighted

63. The proposals include replacing stonework along the verge of the right hand gable, replacing missing/broken stone roof slates and removing / re-bedding ridge tiles. These works are likely to result in the disturbance and temporary (possibly permanent) loss of Roosts 3, 4, 6, 10 & 11, and potentially the disturbance, injury or killing of any bats occupying these roosts when the works are carried out. A licence from Natural England will therefore be required to derogate these offences and allow the proposed repair works to building 11s roof (Roosts 3, 4, 6, 10 & 11) to proceed.

64. Other than minor disturbance caused during the re-bedding of ridge tiles and replacement of broken/ missing roof slates, the proposed works are unlikely to impact significantly on Roost 7 – the brown long eared maternity colony. It is therefore unlikely that a licence will be required for this roost. Instead, work to the roof should be programmed during the winter period, when the roost is vacant, and carried out under the supervision of a suitably experienced and licenced Ecologist following a Bat Method Statement.

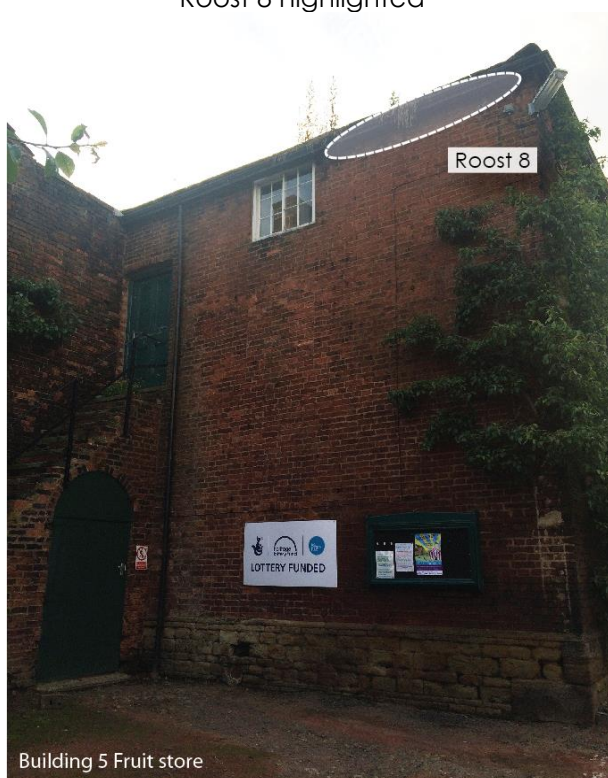
| Ref. | Location | Feature | Details |
|---|---|---|---|
| Roost 8 | Building 5 | Gap along eaves of southern elevation | Single common pipistrelle |

**Figure 6**  
Southern elevation of Building 5 –  
Roost 8 highlighted

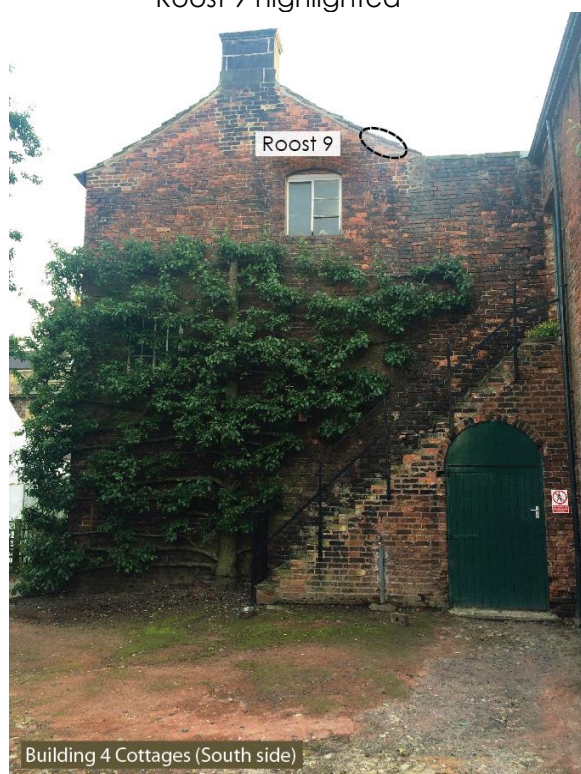
| Ref. | Location | Feature | Details |
|---|---|---|---|
| Roost 9 | Building 4 | Gap along verge of eastern elevation | Single common pipistrelle |

**Figure 7**  
Eastern elevation of Building 4 –  
Roost 9 highlighted

60. The proposals include a complete roof strip and replace. These works will result in the disturbance and temporary (possibly permanent) loss of Roost 9 and potentially the disturbance, injury or killing of any bats occupying the roost when the works are carried out. A licence from Natural England will therefore be required to derogate these offences and allow the proposed works to building 4 (Roost 9) to proceed.
