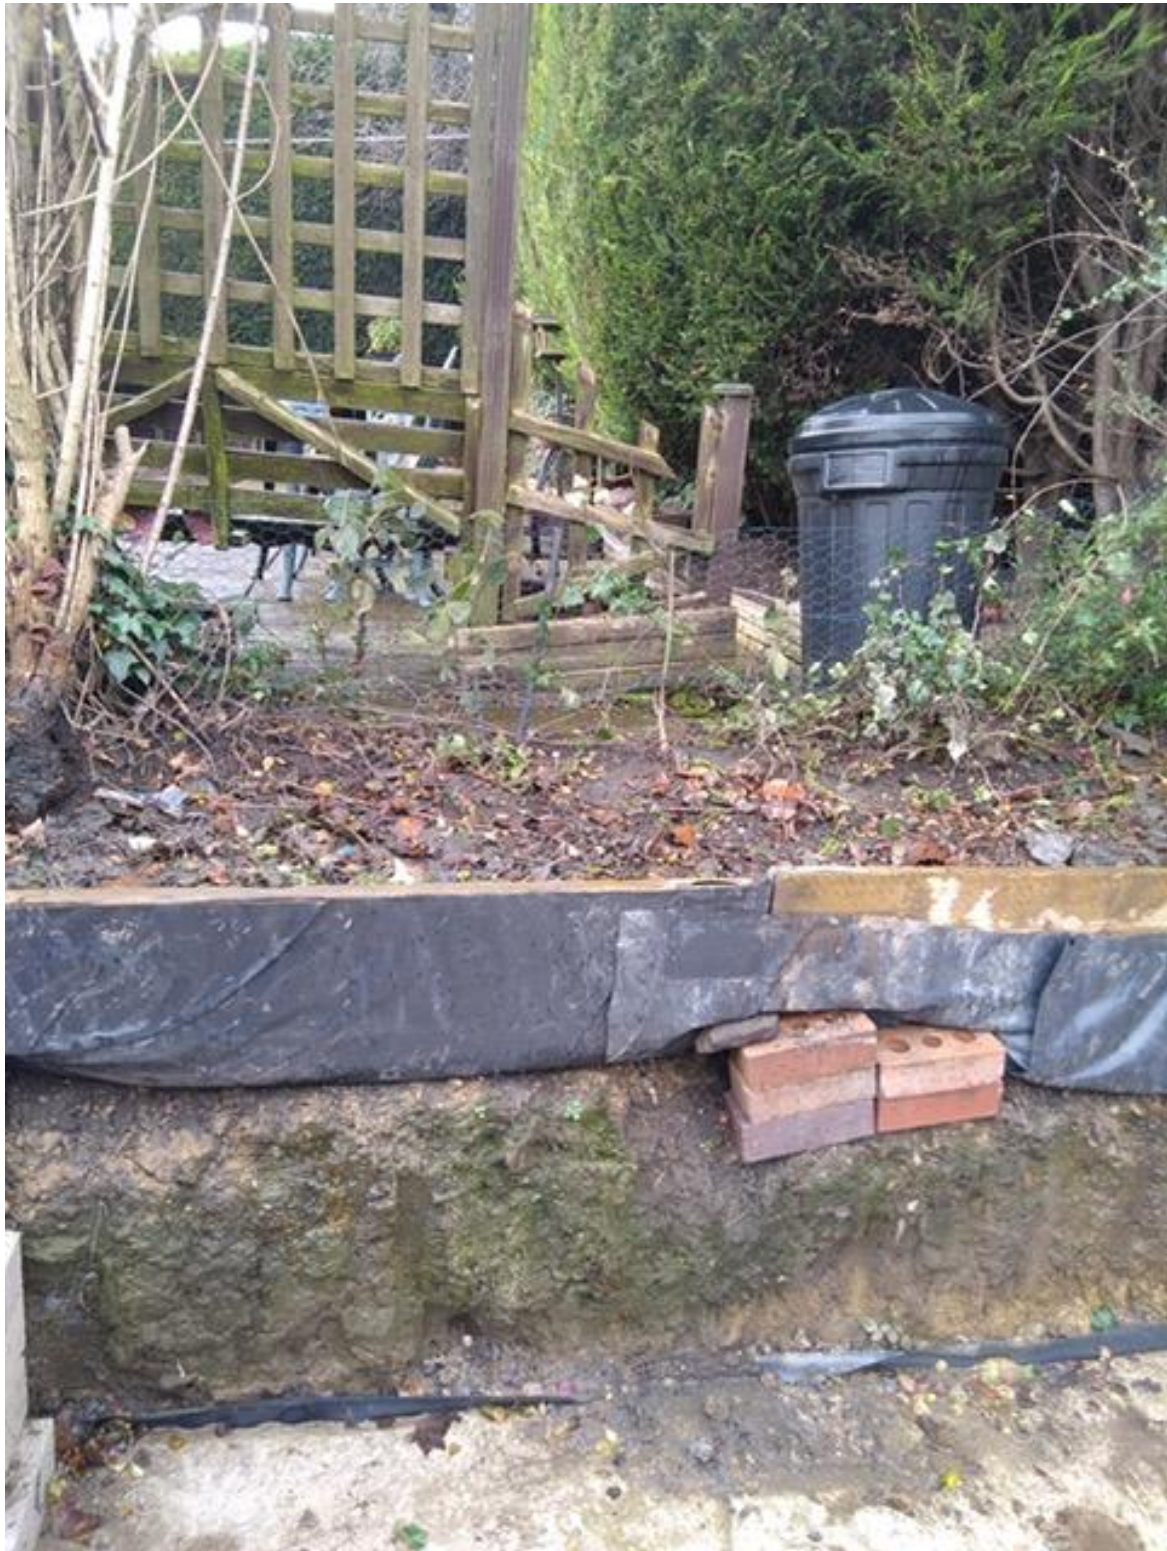
**PHOTOGRAPH 1**

THE EXISTING SURVEYED GROUND, WITHIN THE CURTILAGE SHOWING THE WOODEN PLANK AND VISQUEEN RETAINING THE LOOSE SOIL, PRIOR TO THE CONSTRUCTION OF THE EXTERNAL WALL OF THE BUILDING.

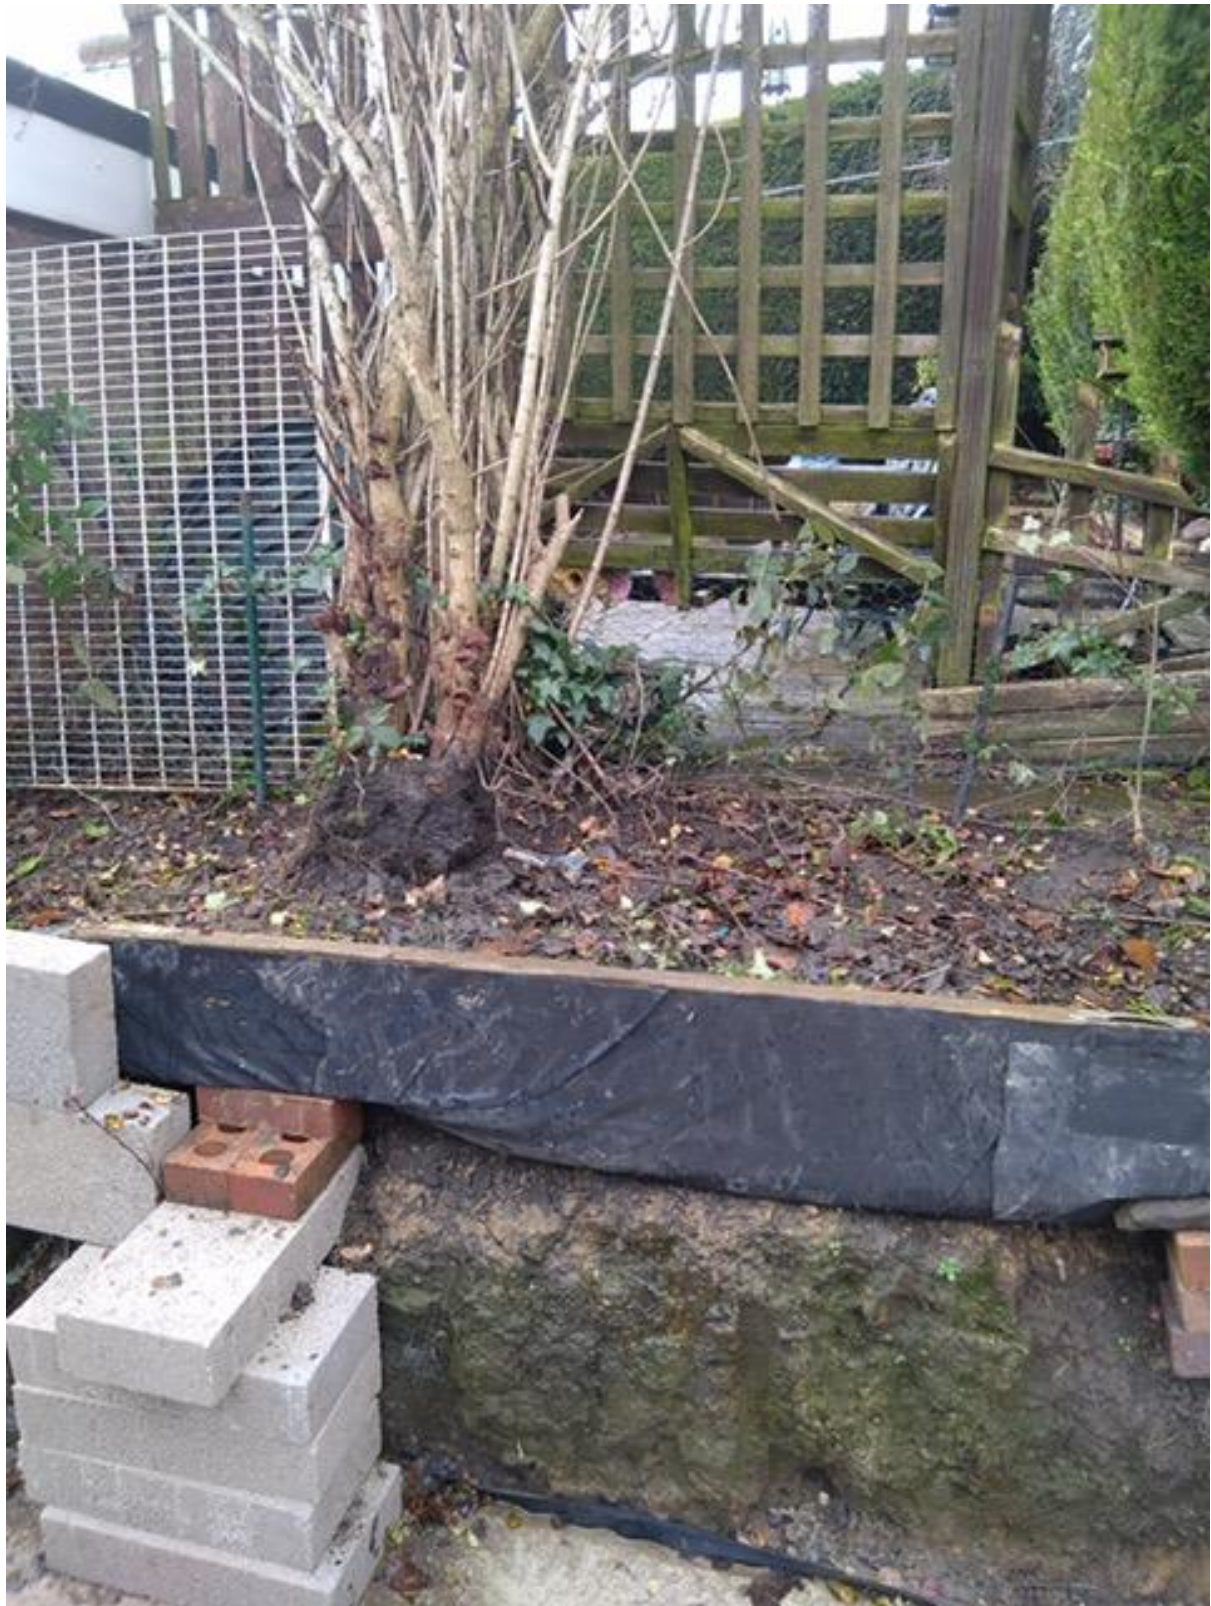
**PHOTOGRAPH 2**

THE EXISTING SURVEYED GROUND, WITHIN THE CURTILAGE, SHOWING THE WOODEN PLANK AND VISQUEEN RETAINING THE LOOSE SOIL, PRIOR TO THE CONSTRUCTION OF THE EXTERNAL WALL OF THE BUILDING.

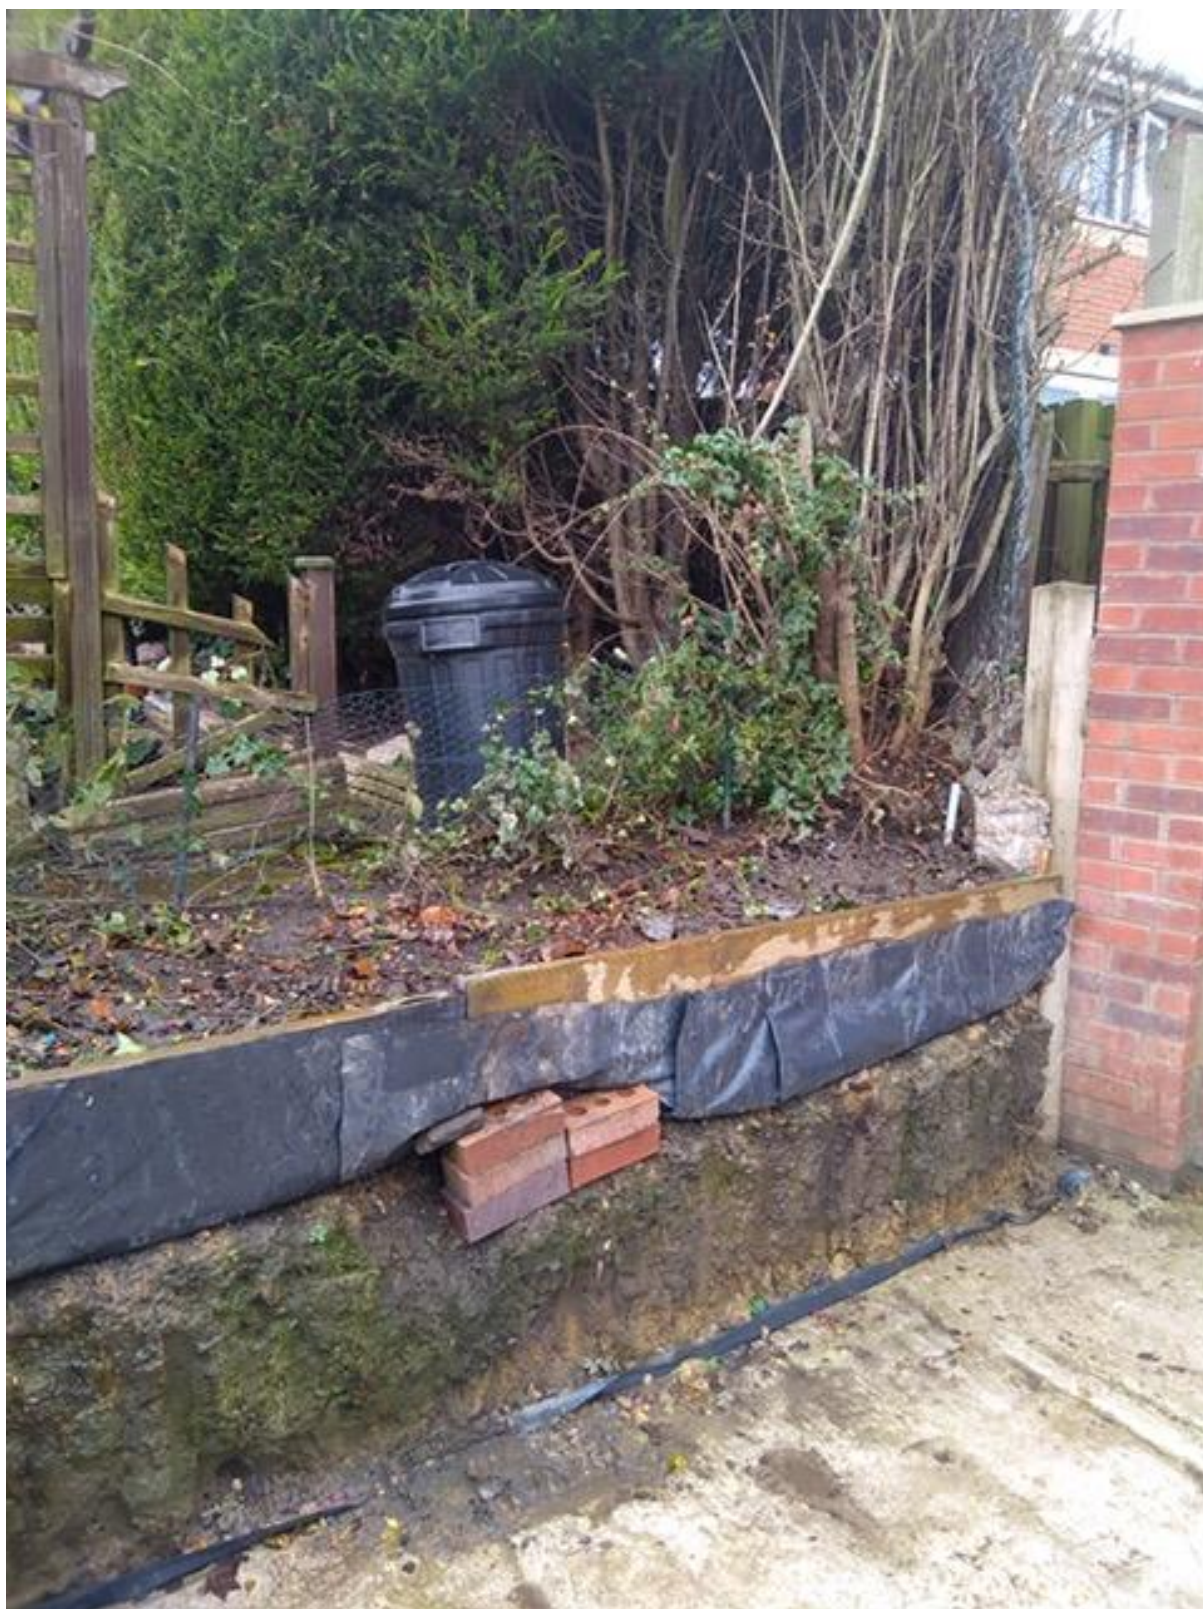
**PHOTOGRAPH 3**

THE EXISTING SURVEYED GROUND, WITHIN THE CURTILAGE, SHOWING THE WOODEN PLANK AND VISQUEEN RETAINING THE LOOSE SOIL, PRIOR TO THE CONSTRUCTION OF THE EXTERNAL WALL OF THE BUILDING.

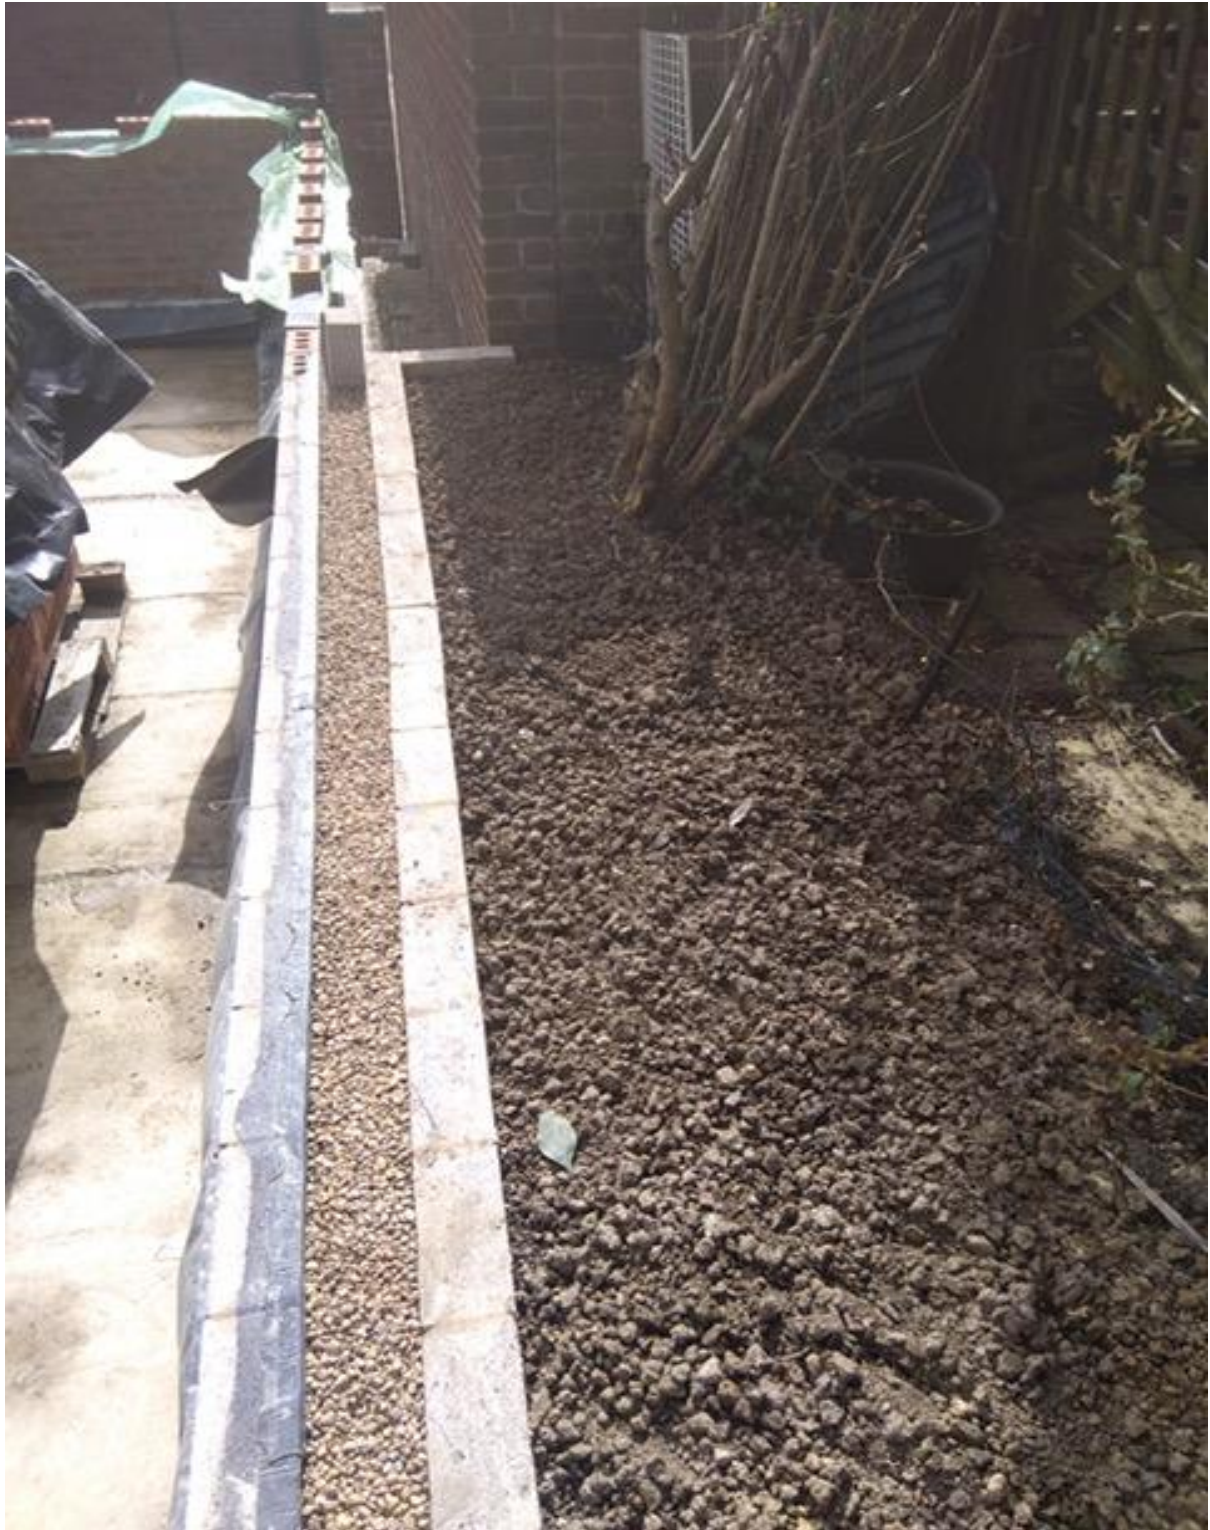
**PHOTOGRAPH 4**

THE EXISTING GROUND, WITHIN THE CUTILAGE, ADJACENT TO THE EXTERNAL WALL OF THE BUILDING, FOLLOWING WEEDING & PREPARATION FOR SPRING PLANTING. THIS WAS OBSERVED BY MR PAUL DOHERTY AND MR ROBERT TOLLYFIELD ON THEIR SITE VISIT OF 12/3/21, TOGETHER WITH THREE WITNESSES WHO WERE IN ATTENDANCE AT THAT TIME. THIS EXISTING GROUND HAS ALSO BEEN OBSERVED BY SIR STEPHEN HOUGHTON ON HIS SITE VISIT OF 8/4/21.

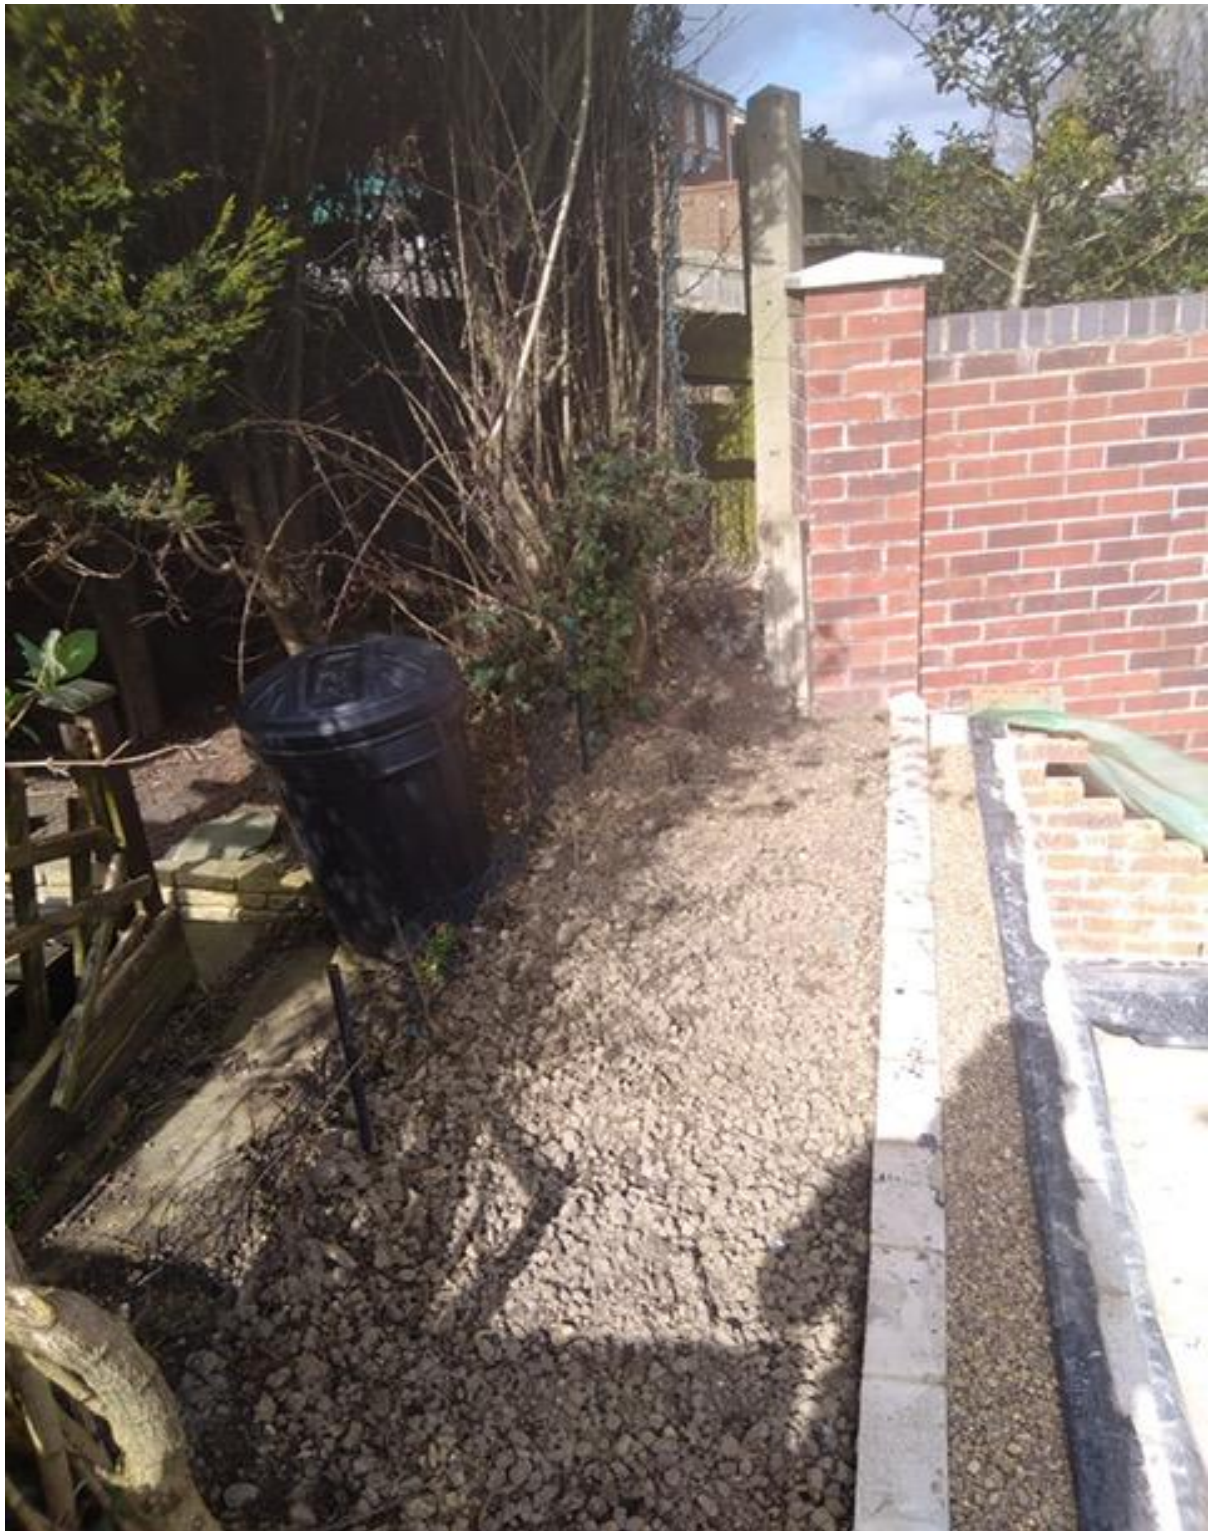
**PHOTOGRAPH 5**

THE EXISTING GROUND, WITHIN THE CURTILAGE, ADJACENT TO THE EXTERNAL WALL OF THE BUILDING, FOLLOWING WEEDING AND PREPARATION FOR SPRING PLANTING. THIS WAS OBSERVED BY MR PAUL DOHERTY AND MR ROBERT TOLLYFIELD ON THEIR SITE VISIT OF 12/3/21 TOGETHER WITH THREE WITNESSES WHO WERE IN ATTENDANCE AT THAT TIME. THIS EXISTING GROUND HAS ALSO BEEN OBSERVED BY SIR STEPHEN HOUGHTON ON HIS SITE VISIT OF 8/4/21

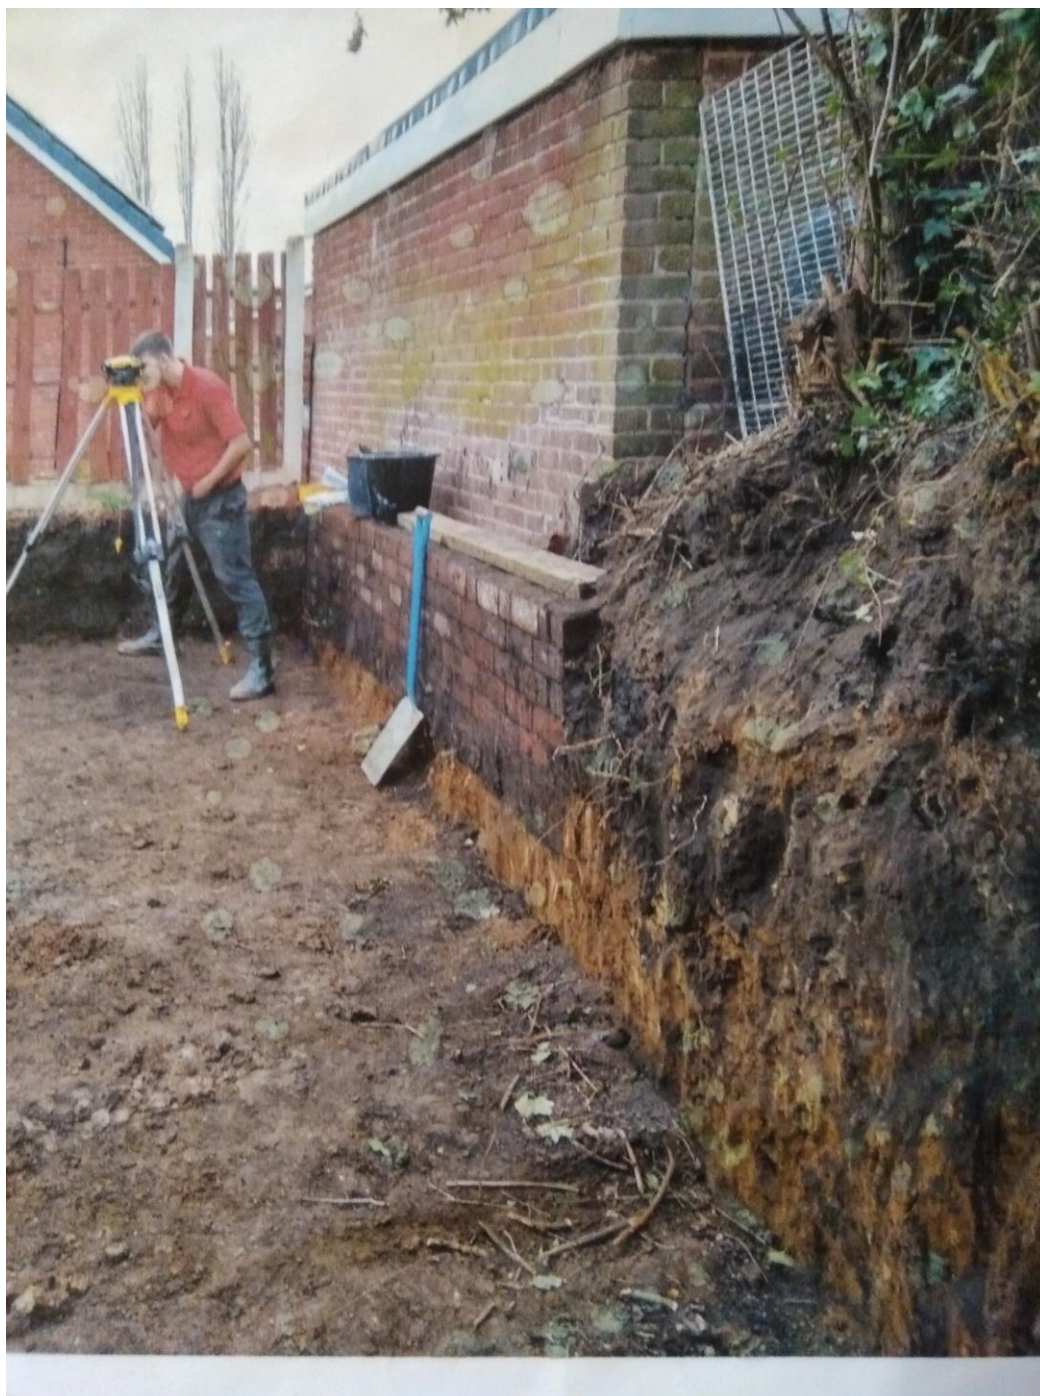
**PHOTOGRAPH 6**

TAKEN BY MR PAUL DOHERTY (ENFORCEMENT OFFICER LPA) IN MARCH 2019. SHOWING UNDISTURBED LAND WITHIN THE CURTILAGE ADJACENT TO THE PROPOSED BUILDING. THIS IS THE AREA OF LAND THAT MR ANDREW BURTON (LPA PLANNING OFFICER) HAS REQUESTED TO SEE(ref e/mail 5/6/2020 15.28 to Mr Robert Agus.). THIS IS THE SAME AREA OF LAND, AS SHOWN IN PHOTO NUMBER TWO, PRIOR TO IT BEING WEEDED AND SURVEYED IN DECEMBER 2020. THE SHRUB AND WHITE PAINTED FENCE PANEL CAN BE SEEN CLEARLY ON BOTH PHOTOS.

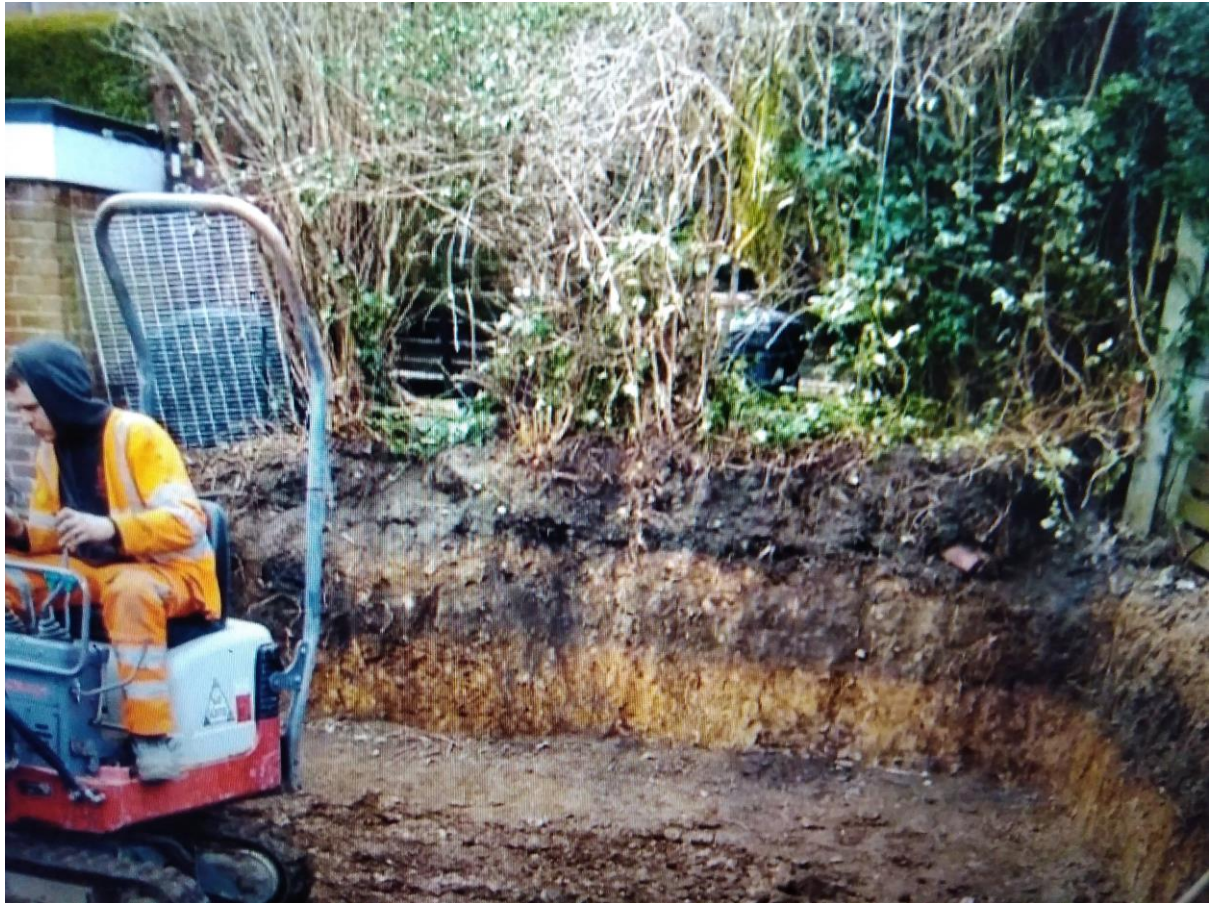
**PHOTOGRAPH 7**

TAKEN BY MR PAUL DOHERTY (LPA ENFORCEMENT OFFICER) IN MARCH 2019, SHOWING UNEXCAVATED LAND, WITHIN THE CURTILAGE, ADJACENT TO THE PROPOSED BUILDING. THIS IS THE AREA OF LAND THAT MR ANDREW BURTON (LPA PLANNING OFFICER HAS REQUESTED TO SEE (ref. e/mail 5/6/2020 15.28 to Mr Robert Agus.) THIS IS THE SAME AREA OF LAND, AS SHOWN IN PHOTO NUMBER THREE, PRIOR TO IT BEING WEEDED AND SURVEYED IN DECEMBER 2020. THE PLASTIC BLACK BIN CAN BE SEEN ON BOTH PHOTOS.

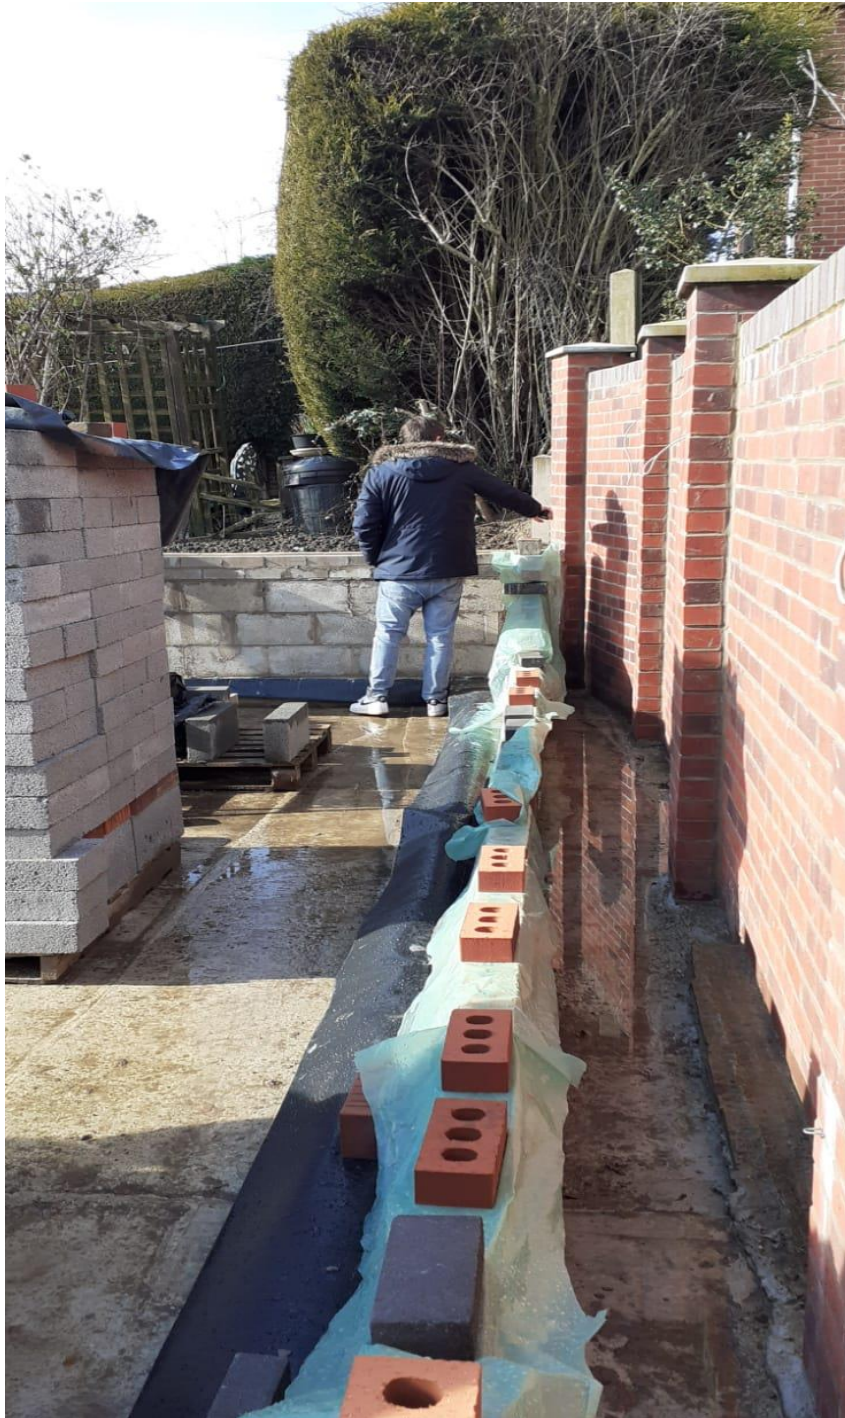
PHOTOGRAPH 8  
MR ROBERT TOLLYFIELD PLANNING OFFICER, ON HIS SITE VISIT ON 12/3/21, EXAMINING THE  
EXISTING GROUND, WITHIN THE CURTILAGE, ADJACENT TO THE EXTERNAL WALL OF THE BUILDING.

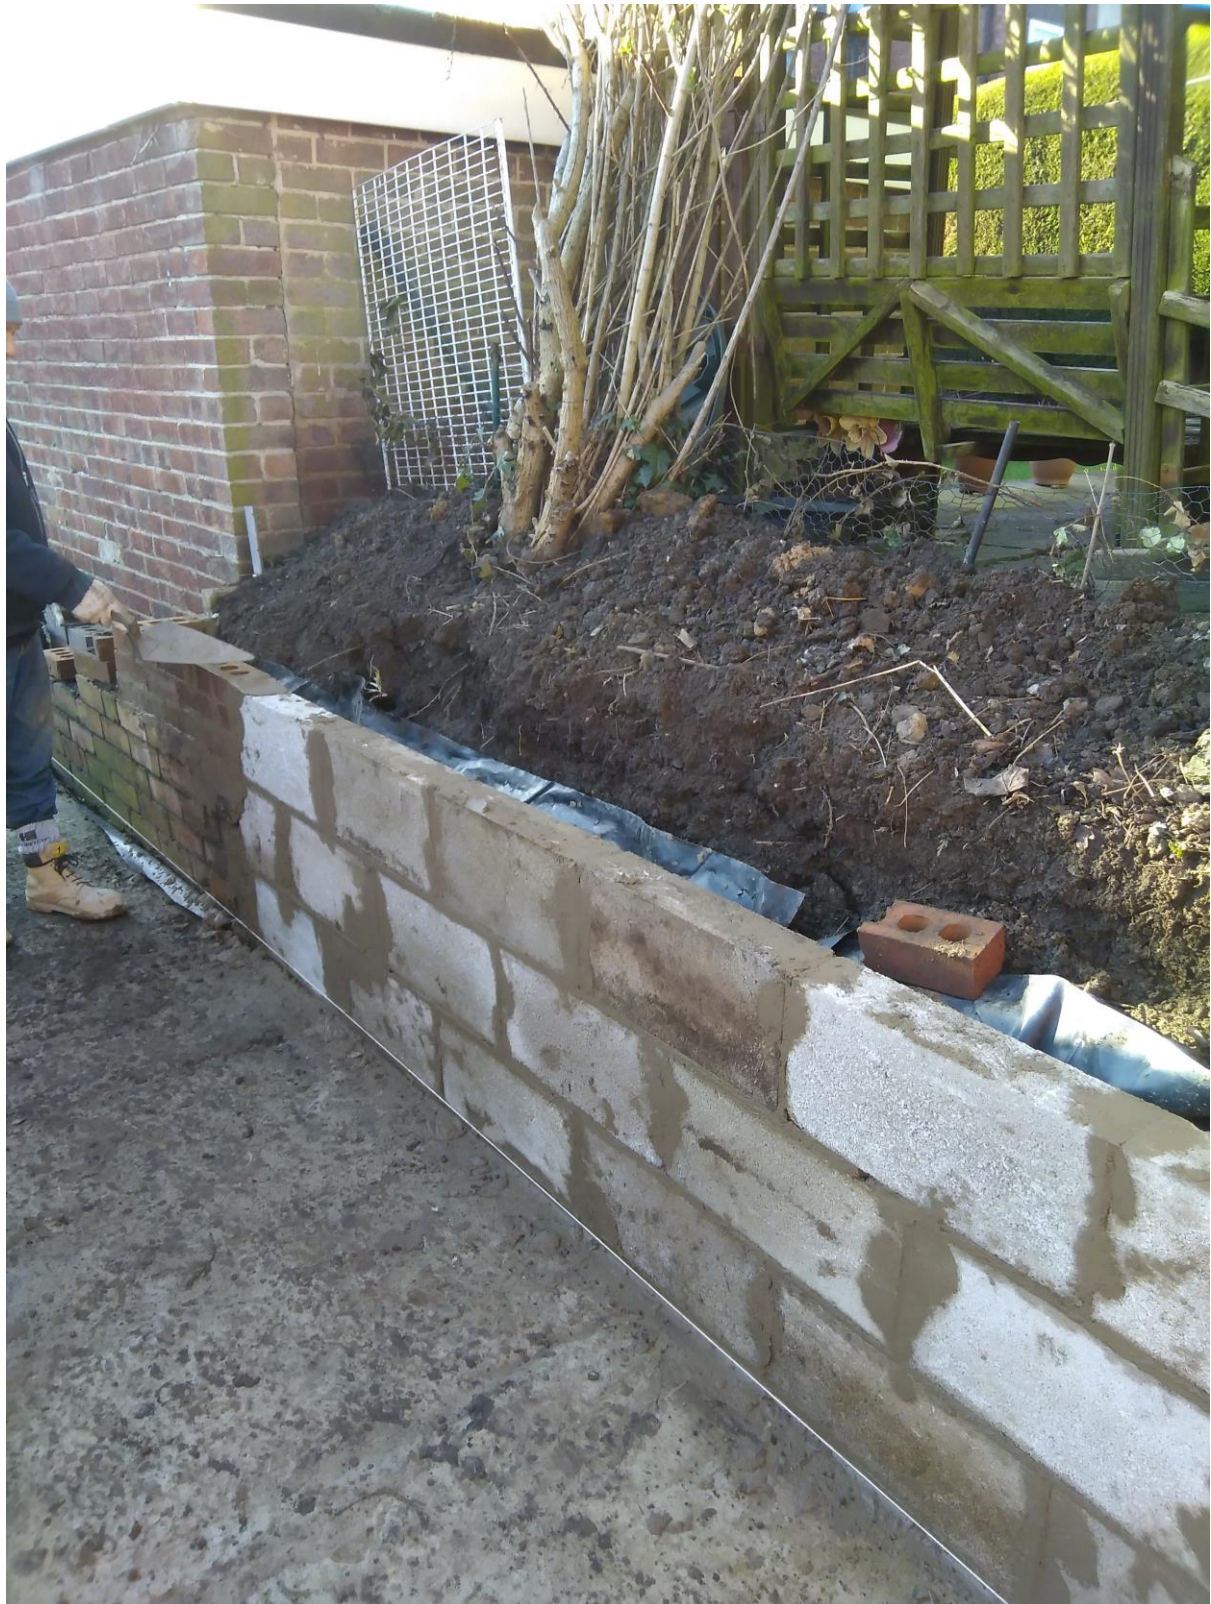
**PHOTOGRAPH 9**

SHOWING WORK ON GOING TO THE EXTERNAL WALL OF THE BUILDING, ADJACENT TO THE EXISTING LAND, WITHIN THE CURTILAGE, WITH NO GAP. THE SHRUB AND WHITE PAINTED FENCE PANEL THAT APPEARS IN MANY OF THE PHOTOS CAN CLEARLY BE SEEN.

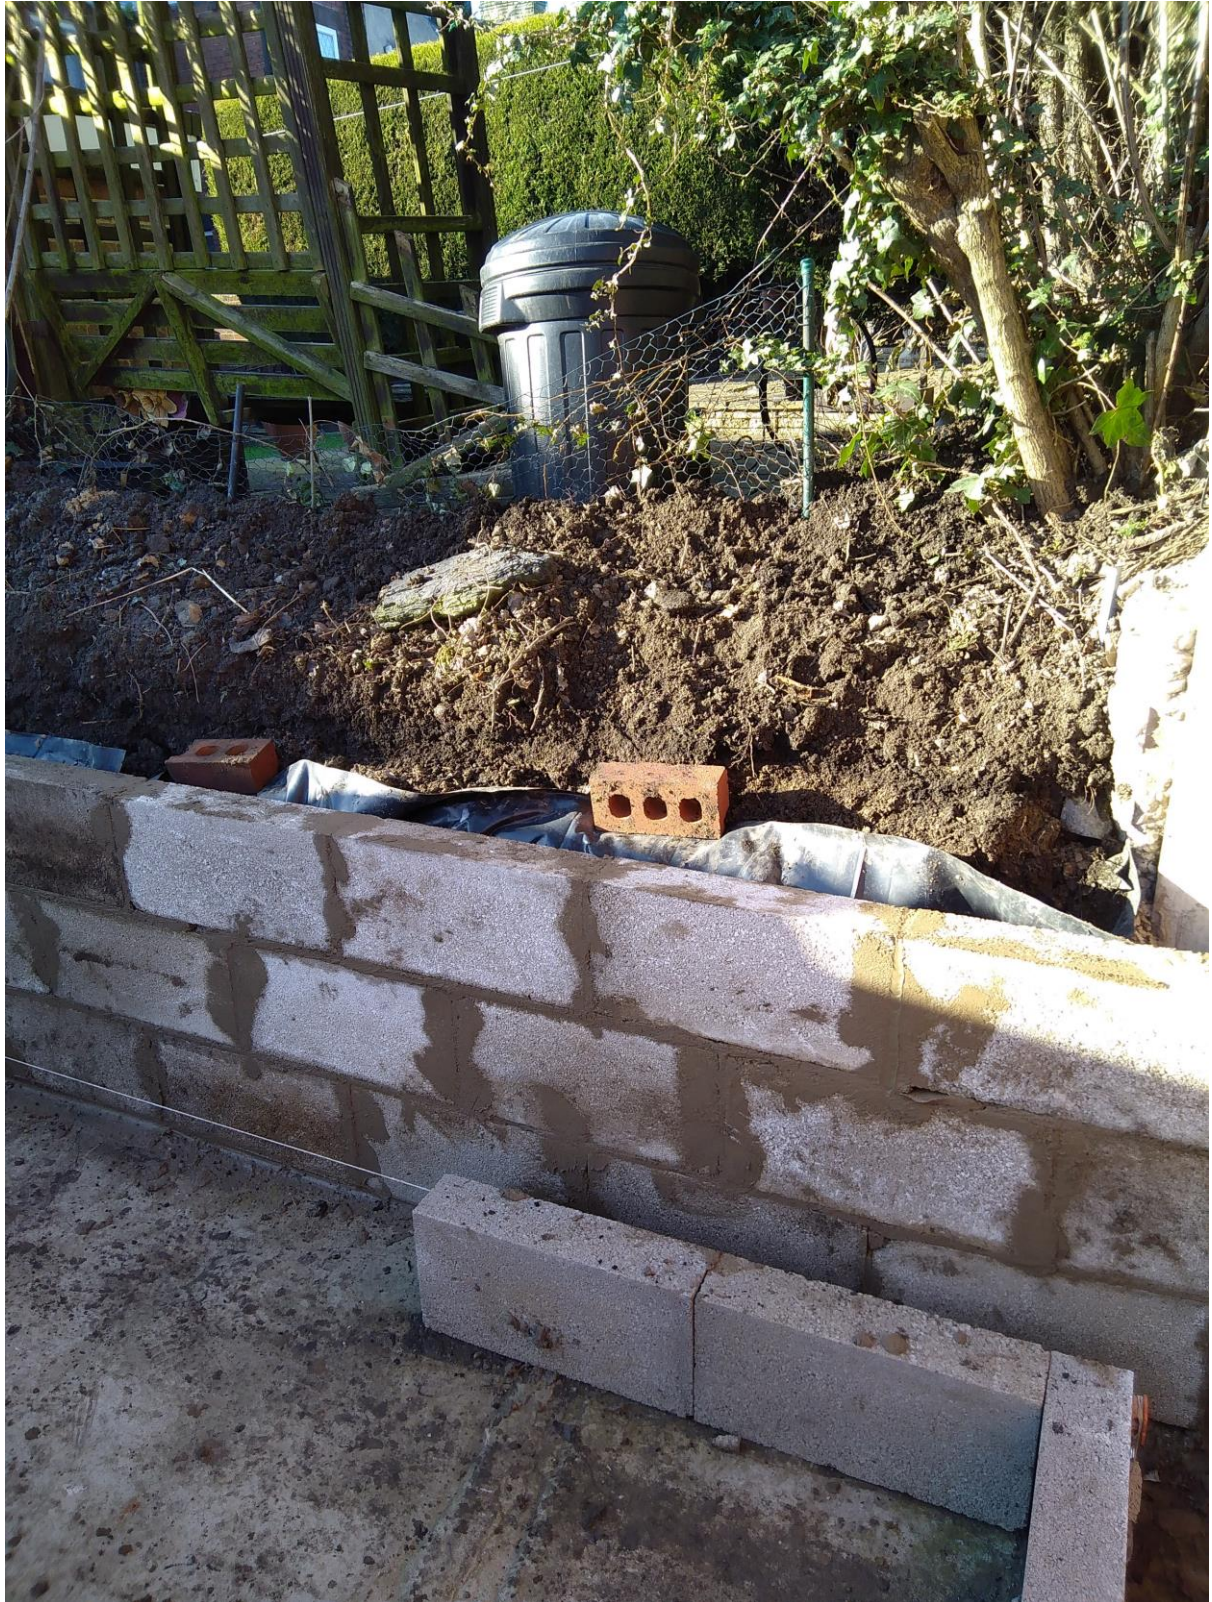
PHOTOGRAPH 10  
SHOWS THE ONGOING WORKS TO THE EXTERNAL WALL OF THE BUILDING, ADJACENT TO THE  
EXISTING LAND, WITHIN THE CURTILAGE, WITH NO GAP. THE BLACK BIN THAT APPEARS IN MANY OF  
THE PHOTOS CAN CLEARLY BE SEEN.
