ARBORICULTURAL REPORT

to BS5837:2012 at:

Land at
Keresforth Hill Road,
Dodworth,
Barnsley,
South Yorkshire
S75 3PP

Reference: *AWA2145*

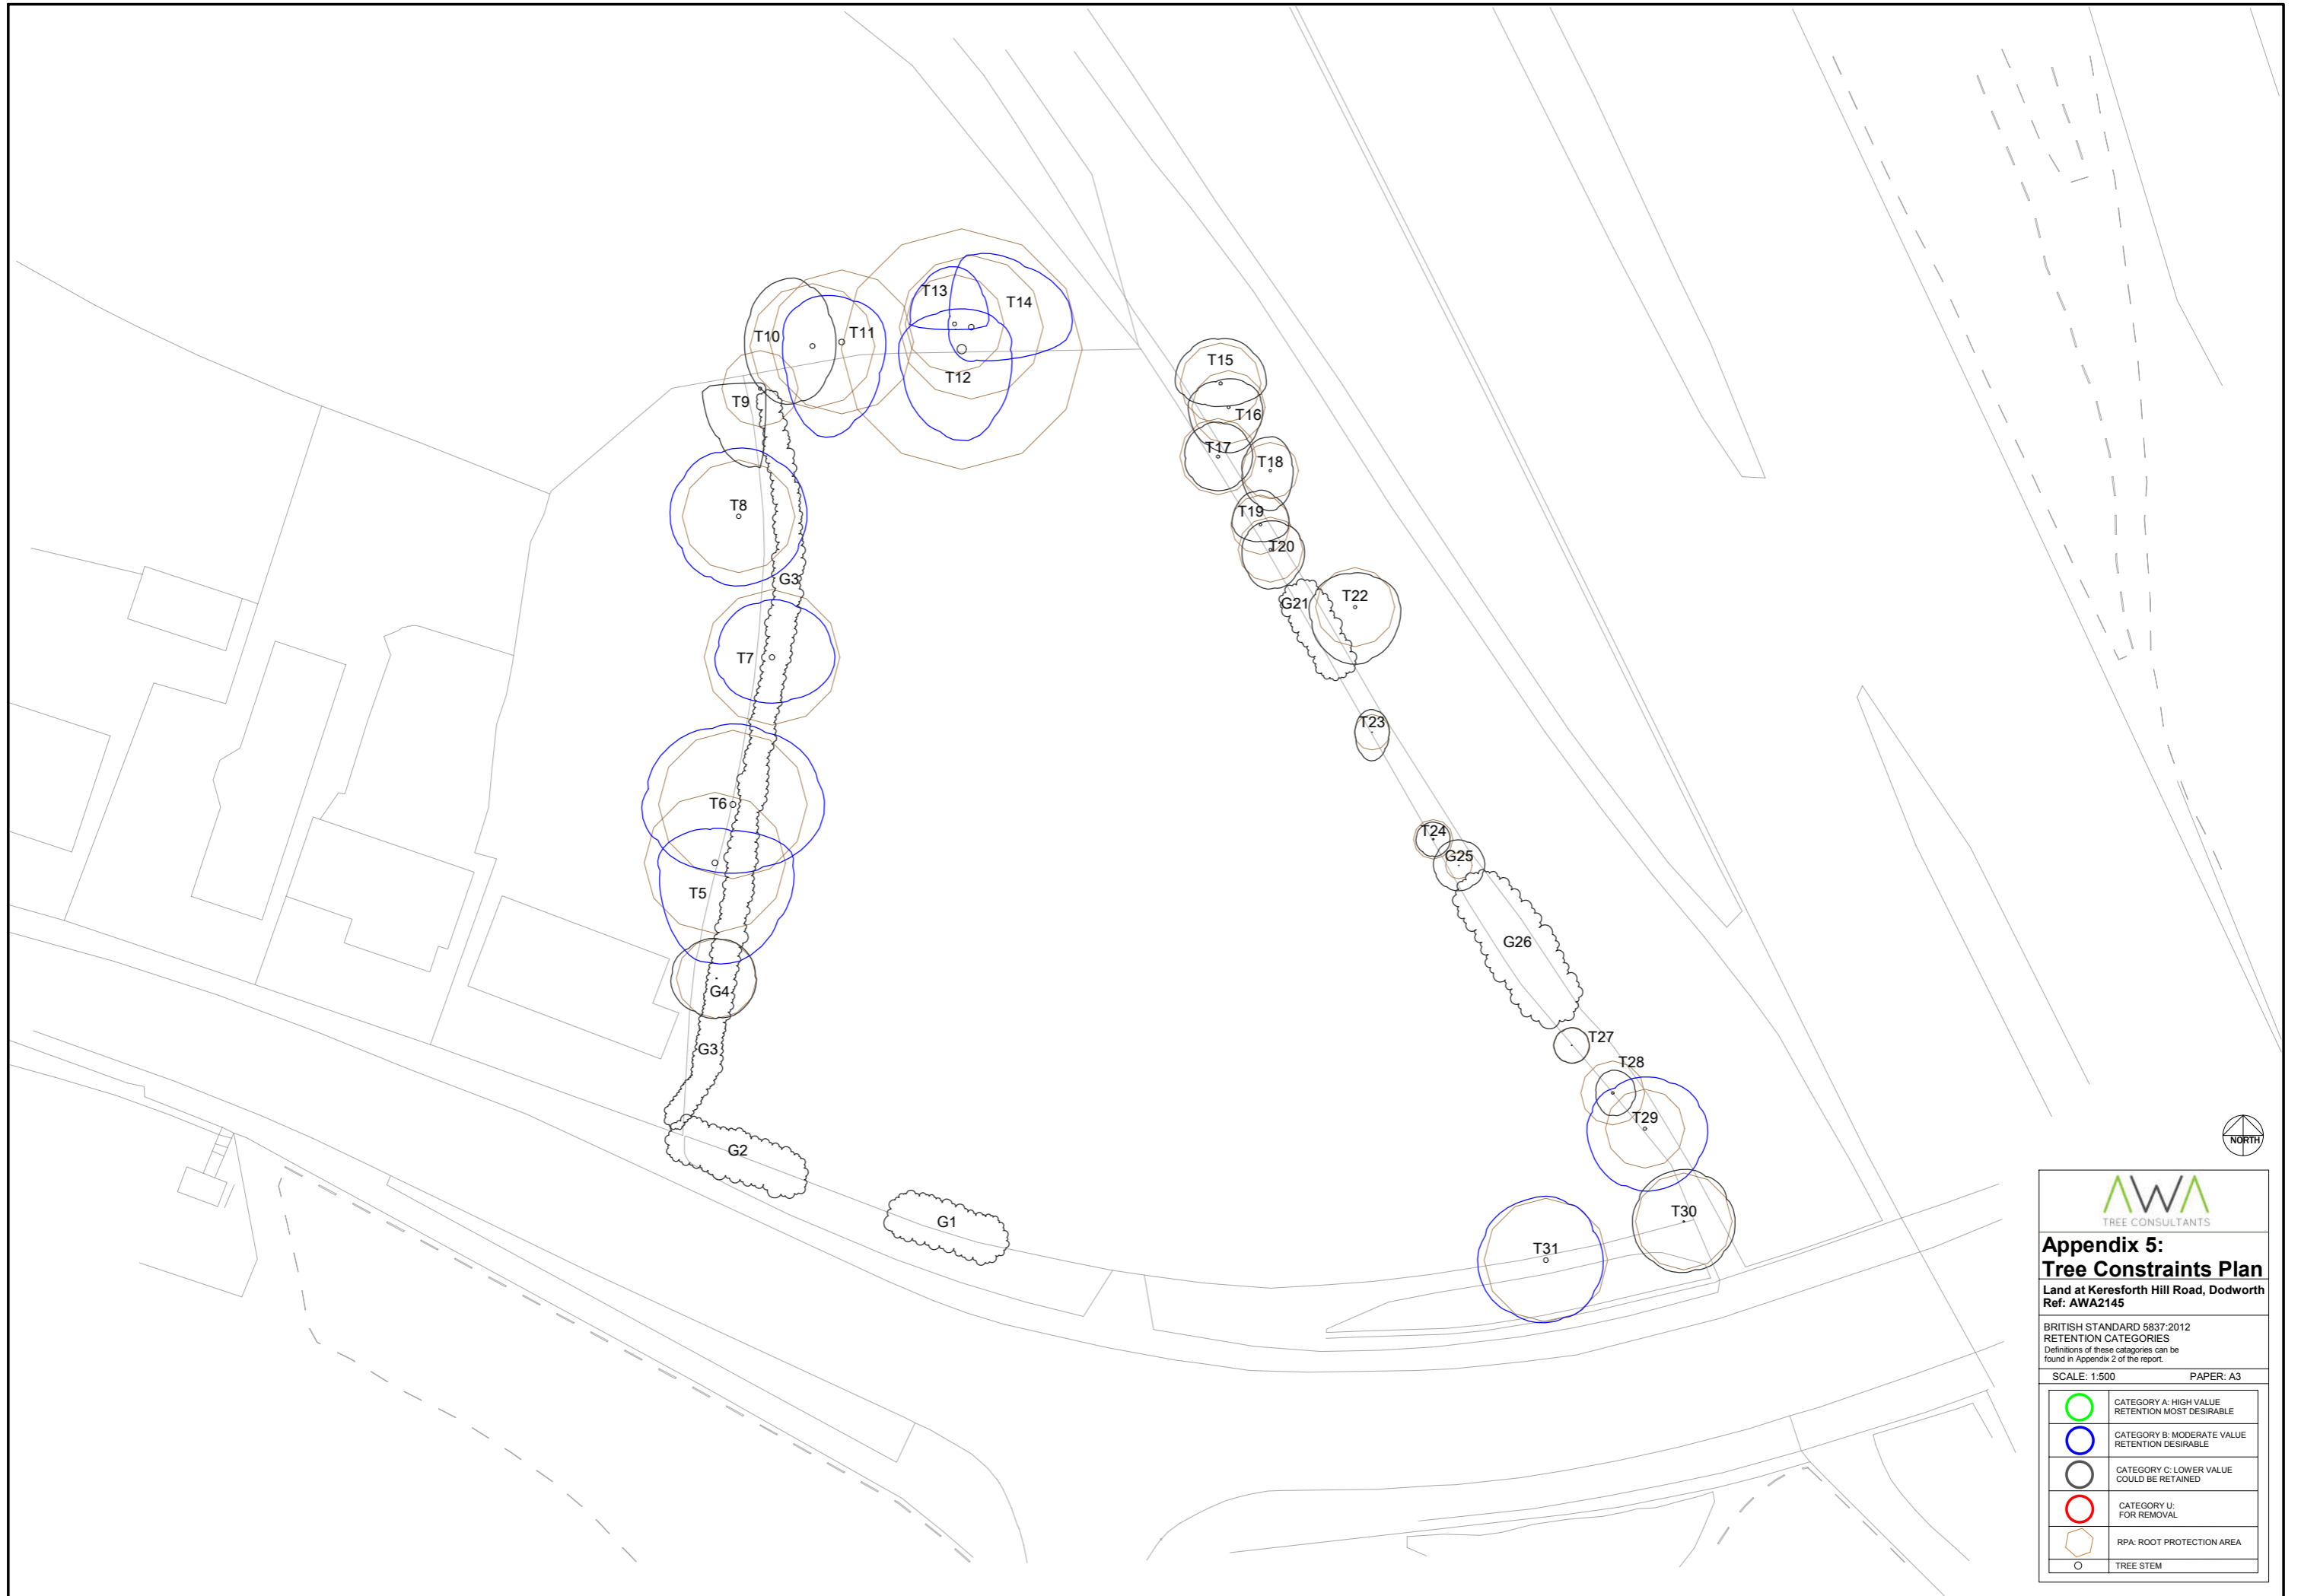
**Appendix 5:
Tree Constraints Plan**

- 3.2.3 The site's most significant trees are predominantly situated along its western and northern boundaries (G4 to T14).
- 3.2.4 The trees along the site's northern boundary form the southern edge of an adjacent woodland group (T10 to T14). The woodland group collectively provides high amenity value to the site and the wider surrounding area; however, the surveyed trees are only of moderate individual value.

- 3.2.5 The trees and shrubs G4 to T9 provide screening between the site and the neighbouring residential property to the west. Access to many of the trees along this boundary was limited, with many of the trees situated either within the neighbouring garden or within a dense hedge. The Ash T9 is in

fairly poor structural condition, with considerable damage to its main stem with some associated decay. It also has a significant lean to the west, over the neighbouring property's garden and would likely be unsuitable for retention close to a new development at the site.

- 3.2.10 The tree Root Protection Area (RPA) is detailed on the Tree Constraints Plan at Appendix 5. The RPA for each tree has been plotted as a polygon centred on the base of the stem. Due to the presence of roads, structures, topography (and past tree management) the RPA is likely to be a simplified representation of the tree roots actual morphology and disposition.

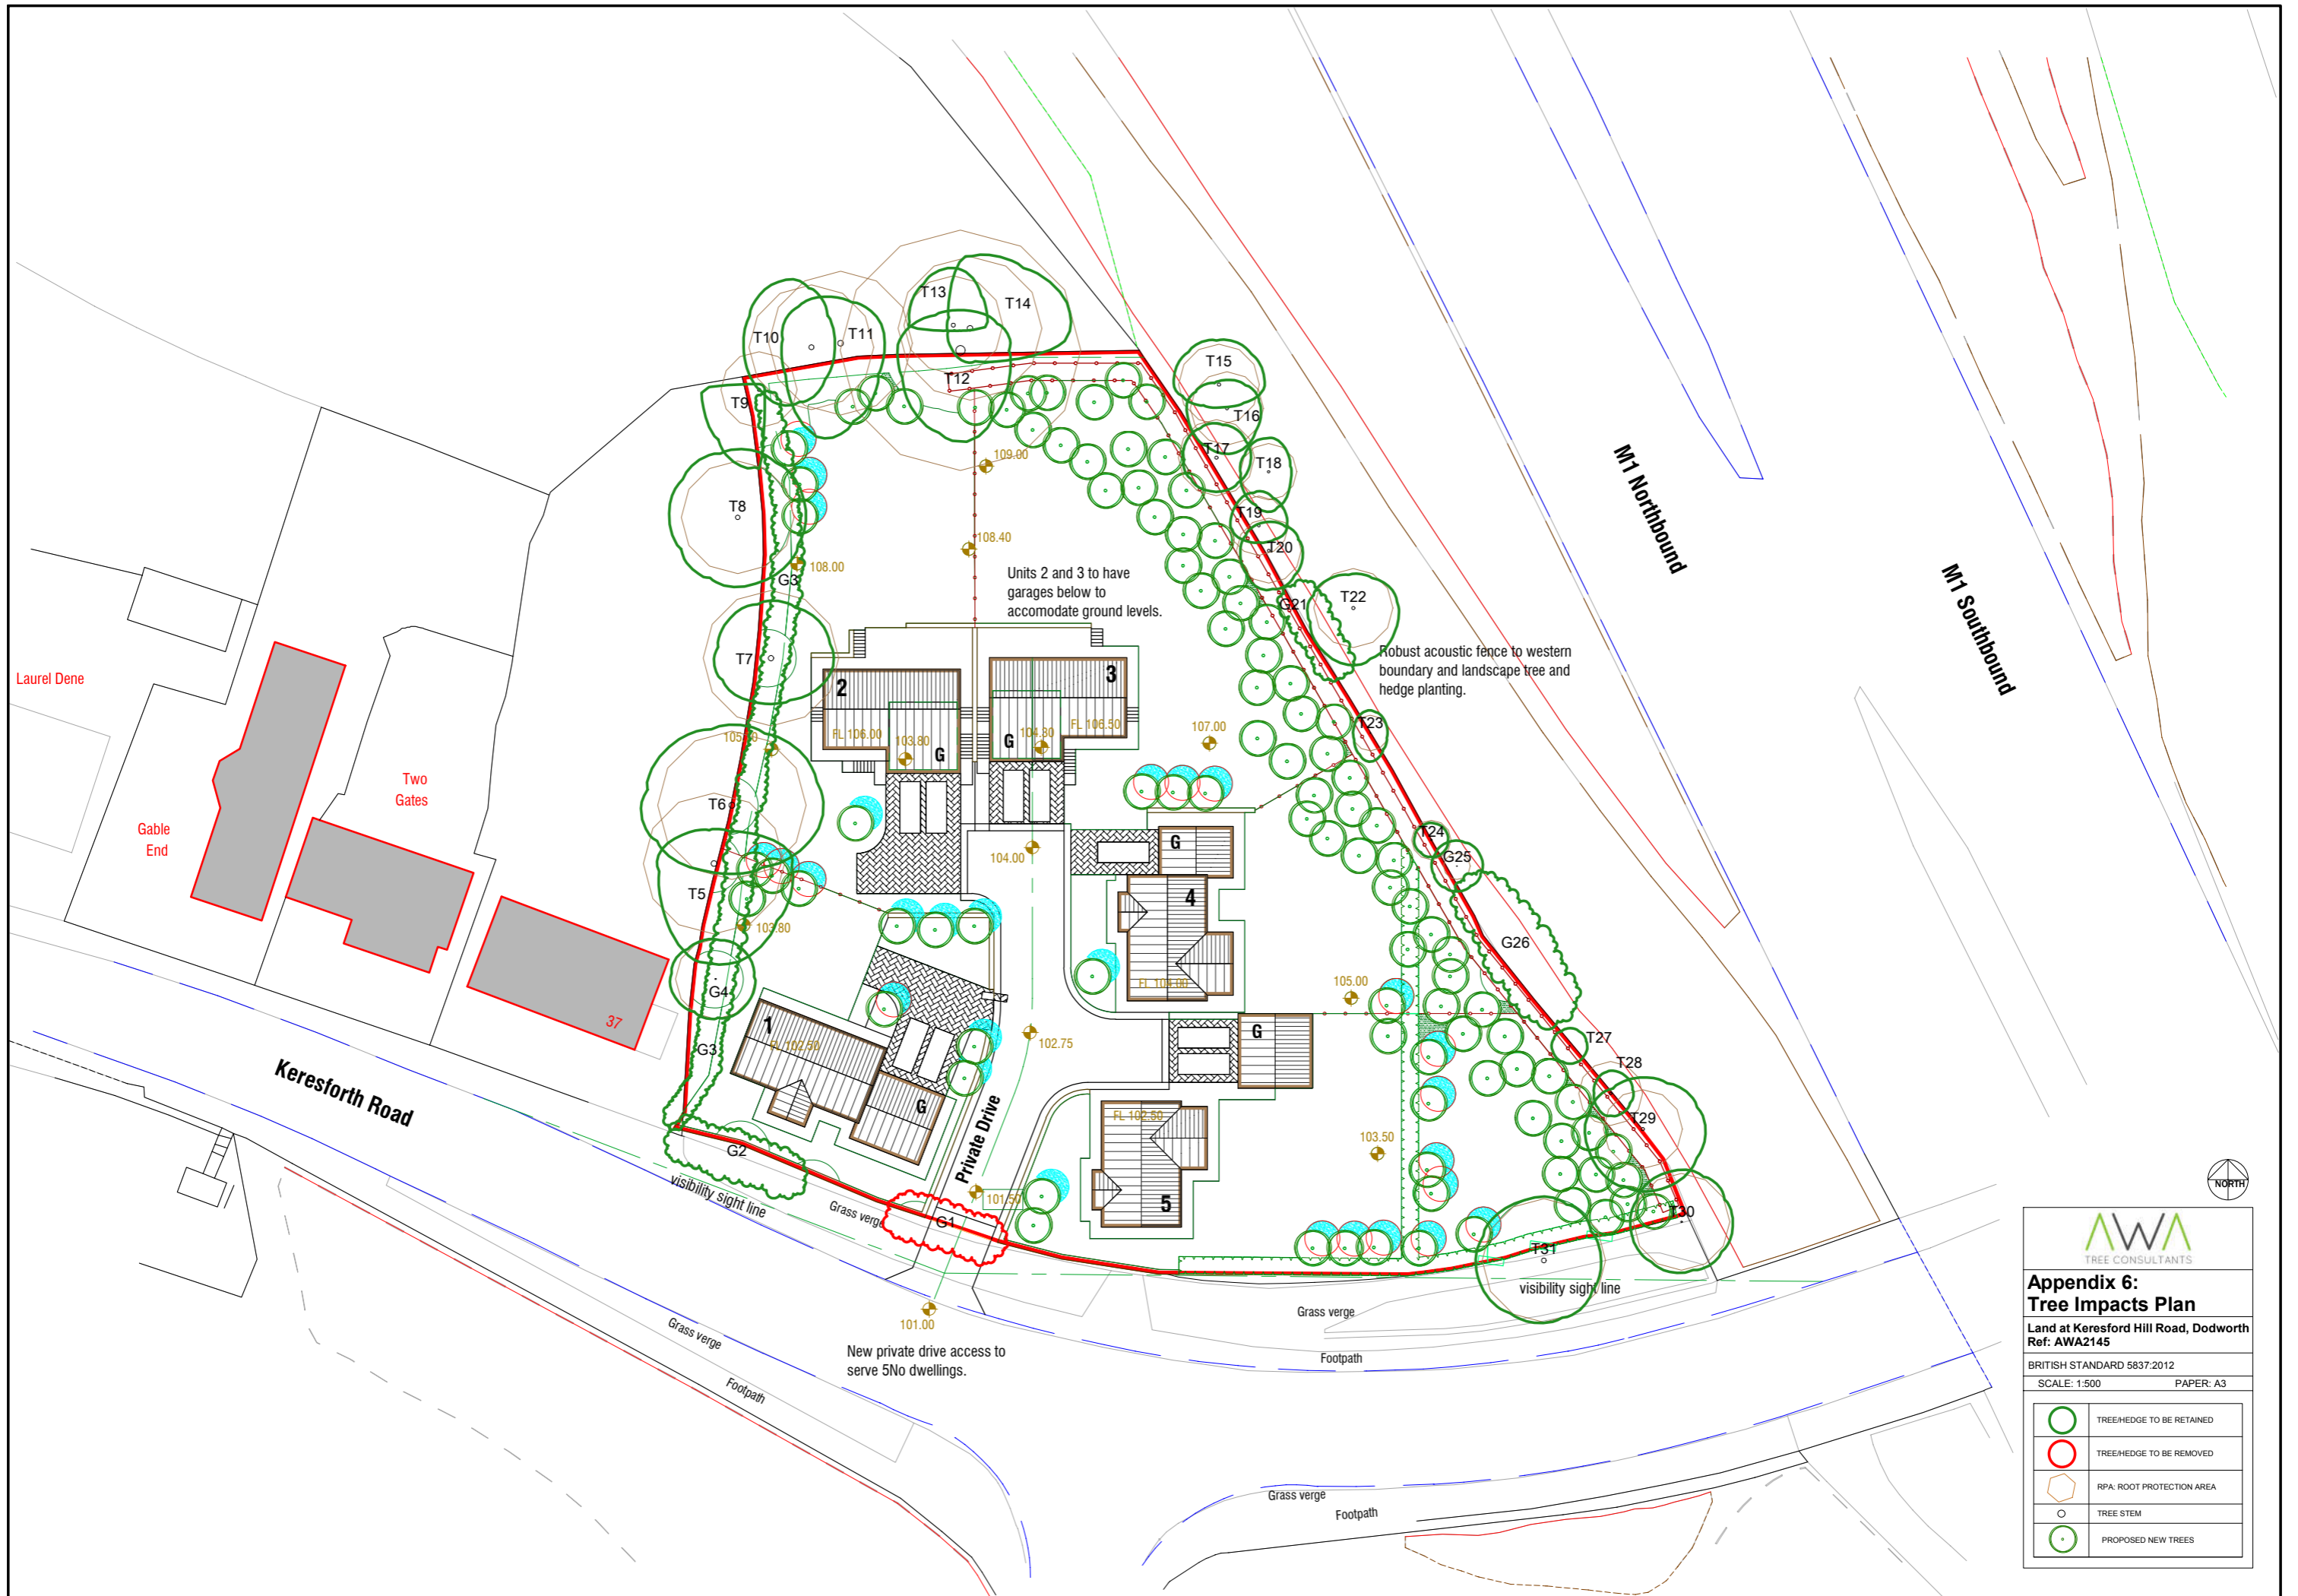
**Appendix 6:
Tree Impacts Plan**

4.2.1 From assessing the new development proposals, 1 tree group will require removal as it is situated in the footprint of the development or its retention and protection throughout the development is not suitable.

4.2.2 The group requiring removal is a low value group of Ash G1. This group has previously been topped at 1m and has only limited long term prospects.

4.3.2 The new residential building (listed as no. 2 in Appendix 6) encroaches slightly into the edge of the RPA of T7. If it is possible to adapt the development proposals by moving the residential building by approximately 2.5m to the east, this would cause the RPA of T7 to be outside the footprint of the building and avoid any impact to the tree.

4.2.4 Further to the removals, the canopy of the Field Maple T7 will require the eastern extent of the canopy reduced by up to 2m to facilitate the new development. All branches should be pruned to appropriate growth points according to BS3998 - 2010 *Tree Work - Recommendations*

4.3.3 Alternatively, the digging of test pits is would ascertain whether significant tree roots are present in this area. If this is the case it should be possible to employ special foundation design such as mini/micro pile and suspended

beam or a cantilevered foundation, in order to overcome or minimise any negative impact on the tree roots.
