# **DAYTIME BAT SURVEY OF TREES AT FORMER BOLTON HALL NURSING HOME, CARRHEAD LANE, ROTHERHAM**

**2017**

**RACHEL HACKING ECOLOGY**

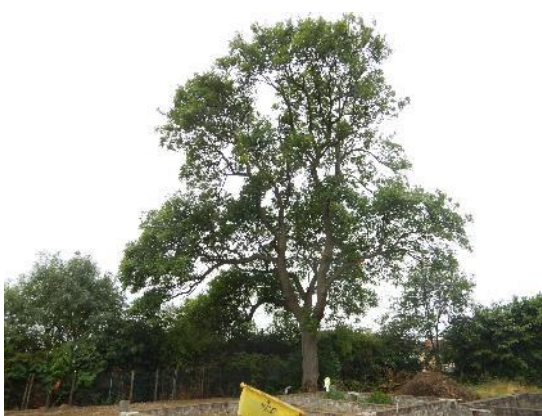
| T27 ASH TREE - Potential Roosting Features (PRF) | |
|---|---|
| | <p>A mature ash tree in the south-west corner of the site. The tree is approximately 18m in height, with a DBH of 90cm. There are three lead stems above 4m, each with a number of features present.</p> <p>The features described below, have a minimum of low potential for use.</p> <p>There are also features present on the tree, which are superficial, and have no potential for use by roosting bats</p> |

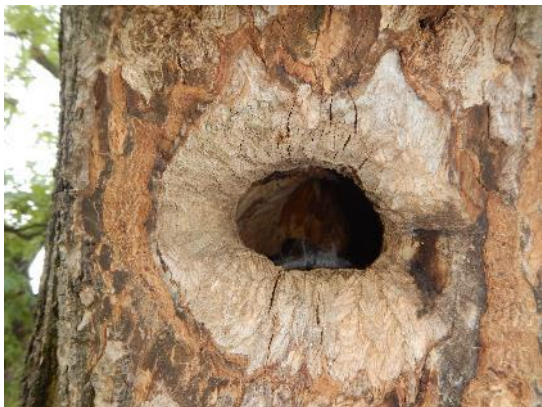
| T27 ASH TREE - Potential Roosting Features (PRF) | |
|---|---|
| | <p>PRF – 1</p> <p>Height - 8.5m</p> <p>Orientation - south</p> <p>Feature type - woodpecker hole</p> <p>Entrance diameter - 10cm</p> <p>Cavity description - cavity in main stem 30cm deep with no upward travel, linked to cavity in branch on north side of stem. Used by nesting birds, and / or squirrels. No evidence of use by bats.</p> <p><b>Low potential</b></p> |

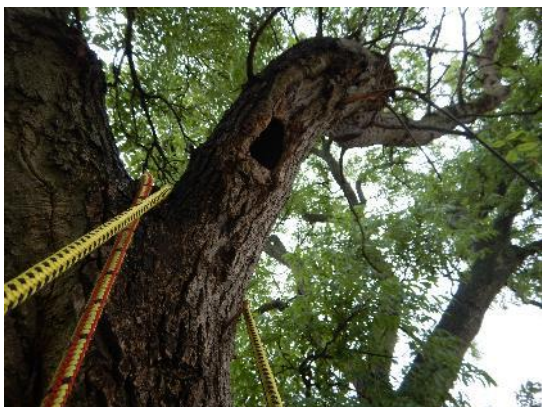
| T27 ASH TREE - Potential Roosting Features (PRF) | |
|---|---|
| | <p>PRF - 2</p> <p>Height - 8.5m</p> <p>Orientation – north</p> <p>Feature type – Series of rot holes in dead branch.</p> <p>Entrance diameter 10cm, 10cm, 15cm.</p> <p>Cavity description – dead branch on north side of stem, hollow from union to tip, series of rot holes and woodpecker holes. Open to the elements.</p> <p>No evidence of use by bats found.</p> <p><b>Low potential</b></p> |

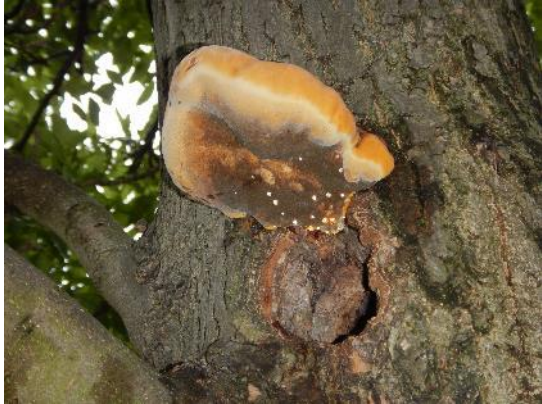
| | <p>PRF – 3<br/> Height – 9.5m<br/> Orientation – southeast<br/> Feature type – woodpecker hole<br/> Entrance diameter – 7.5cm<br/> Cavity description – small 10cm test hole, no upward or downward travel, open to the elements.<br/> No evidence of bat use found.<br/> <b>Low potential</b></p> |

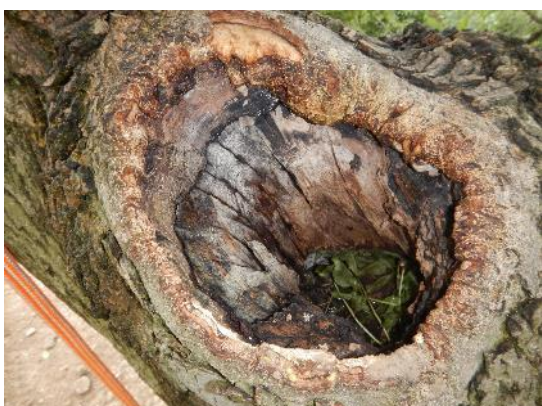
| | <p>PRF – 4<br/> Height – 6m<br/> Orientation – upward, north, and south.<br/> Feature type – x 3 rot holes into main stem.<br/> Entrance diameter – 20cm, 10cm, 15cm<br/> Cavity description – open cavity in main stem, with three entrance holes. No upward or downward travel.<br/> Bird nesting material present. Open to the elements.<br/> No evidence of bat use found.<br/> <b>Low potential</b></p> |

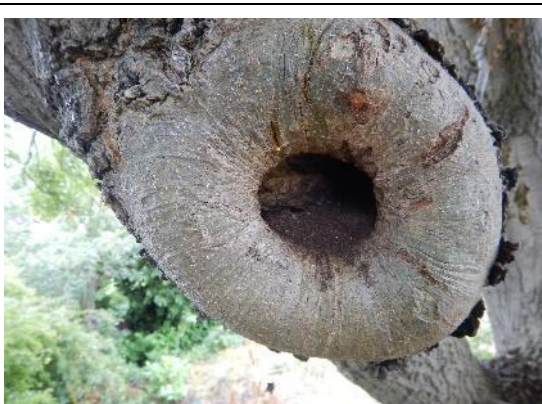
| | <p>PRF – 5<br/> Height – 4.5m<br/> Orientation – south<br/> Feature type – knot hole on underside of horizontal branch.<br/> Entrance diameter – 7cm<br/> Cavity description – knot hole on underside of horizontal branch. Horizontal cavity, 30cm deep, wet, and dusty inside, open the elements.<br/> No evidence of bat use found.<br/> <b>Low potential</b></p> |

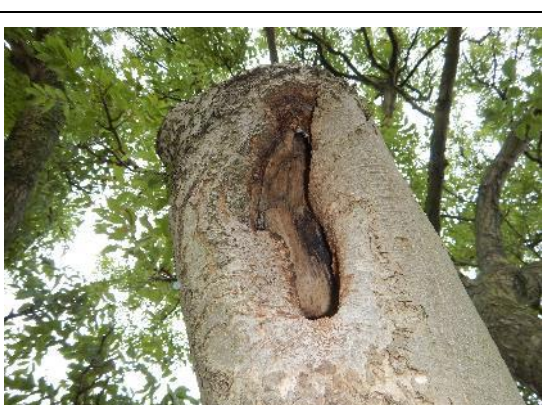
| | <p>PRF – 6<br/> Height – 10.5m<br/> Orientation – north.<br/> Feature type – rot hole in main stem.<br/> Entrance diameter – 10cm x 30cm.<br/> Cavity description – rot hole with small callus roll. Heartwood still present, 5cm of upward travel, above the open part of the feature. Open to the elements.<br/> No evidence of bat use found.<br/> <b>Low potential</b></p> |

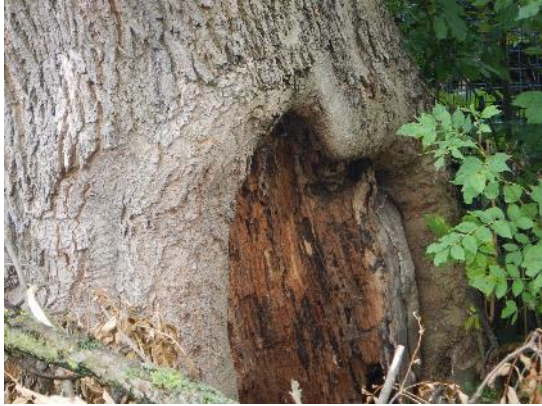
| | <p>PRF – 7<br/> Height – ground level – 1m.<br/> Orientation – northwest.<br/> Feature type – large rot hole in base of main stem.<br/> Entrance diameter – 50cm x 70cm.<br/> Cavity description – large rot hole in base of main stem.<br/> Wet, rotting heartwood present. 30cm of upward travel behind bark, into damp, cavity, slugs and woodlice present.<br/> No evidence of bat use found.<br/> <b>Low potential</b></p> |

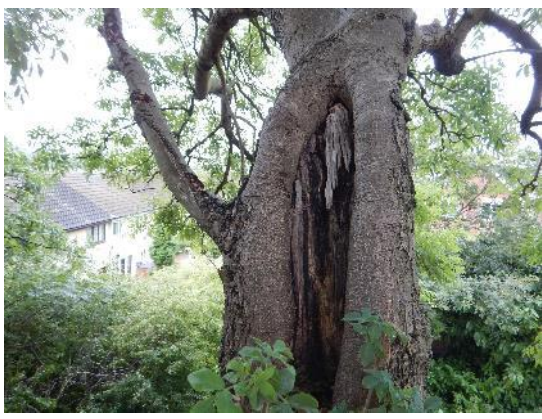
| | <p>No suitable cavity for bats present<br/> <b>Negligible potential</b></p> |

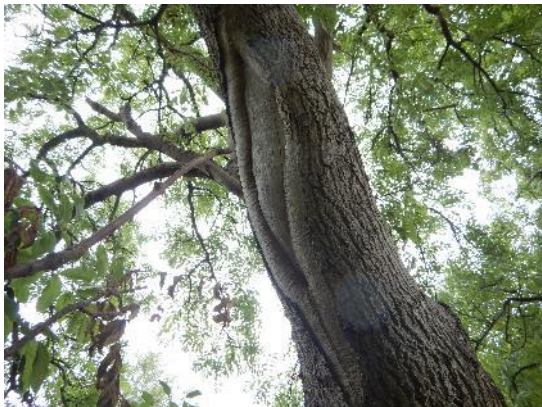
| | <p>No suitable cavity for bats present<br/> <b>Negligible potential</b></p> |

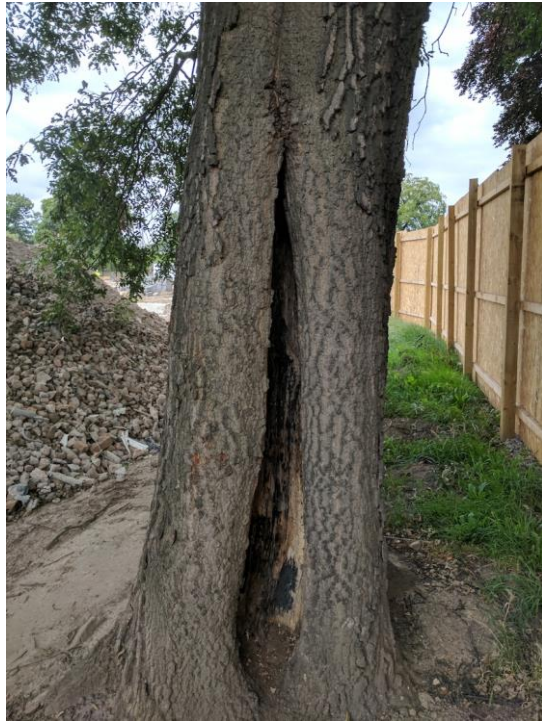
**T33 TURKEY OAK TREE - Potential roosting features**

A mature Turkey Oak tree in the south-east corner of the site. The tree is approximately 20m in height, with a DBH of 80cm.

The trunk splits at 4m.

Significant open cavity from the ground upwards for approximately 2m. Showing signs of decay. This was endoscoped and was found to be damp with slugs and woodlice present.

No other cavities present in the tree. No peeling bark or limb damage present, or other PRF.

No evidence of bat use found.

**Low potential**

- 4.2 It is the opinion of the author of this report that the trees can be felled without the need for further survey work (e.g. bat activity surveys) due to the low/negligible potential of the trees to support bats. This follows best practice guidelines (BCT, 2016). The trees should be felled as soon as possible following this survey. If a significant delay occurs to the felling (i.e. more than a year) then a follow-up survey will be required.

- 4.3 It should be noted that bat absence is very difficult to prove definitively due to their mobility and size, and single or small numbers of bats are able to roost in extremely small spaces. It is recommended that the trees are section-felled.
