# ARBORICULTURAL REPORT

# IMPACT ASSESSMENT

*Land at*  
***Paddock Road***  
***Staincross***  
***Barnsley***  
***S75 6LG***

Reference: *AWA4554*

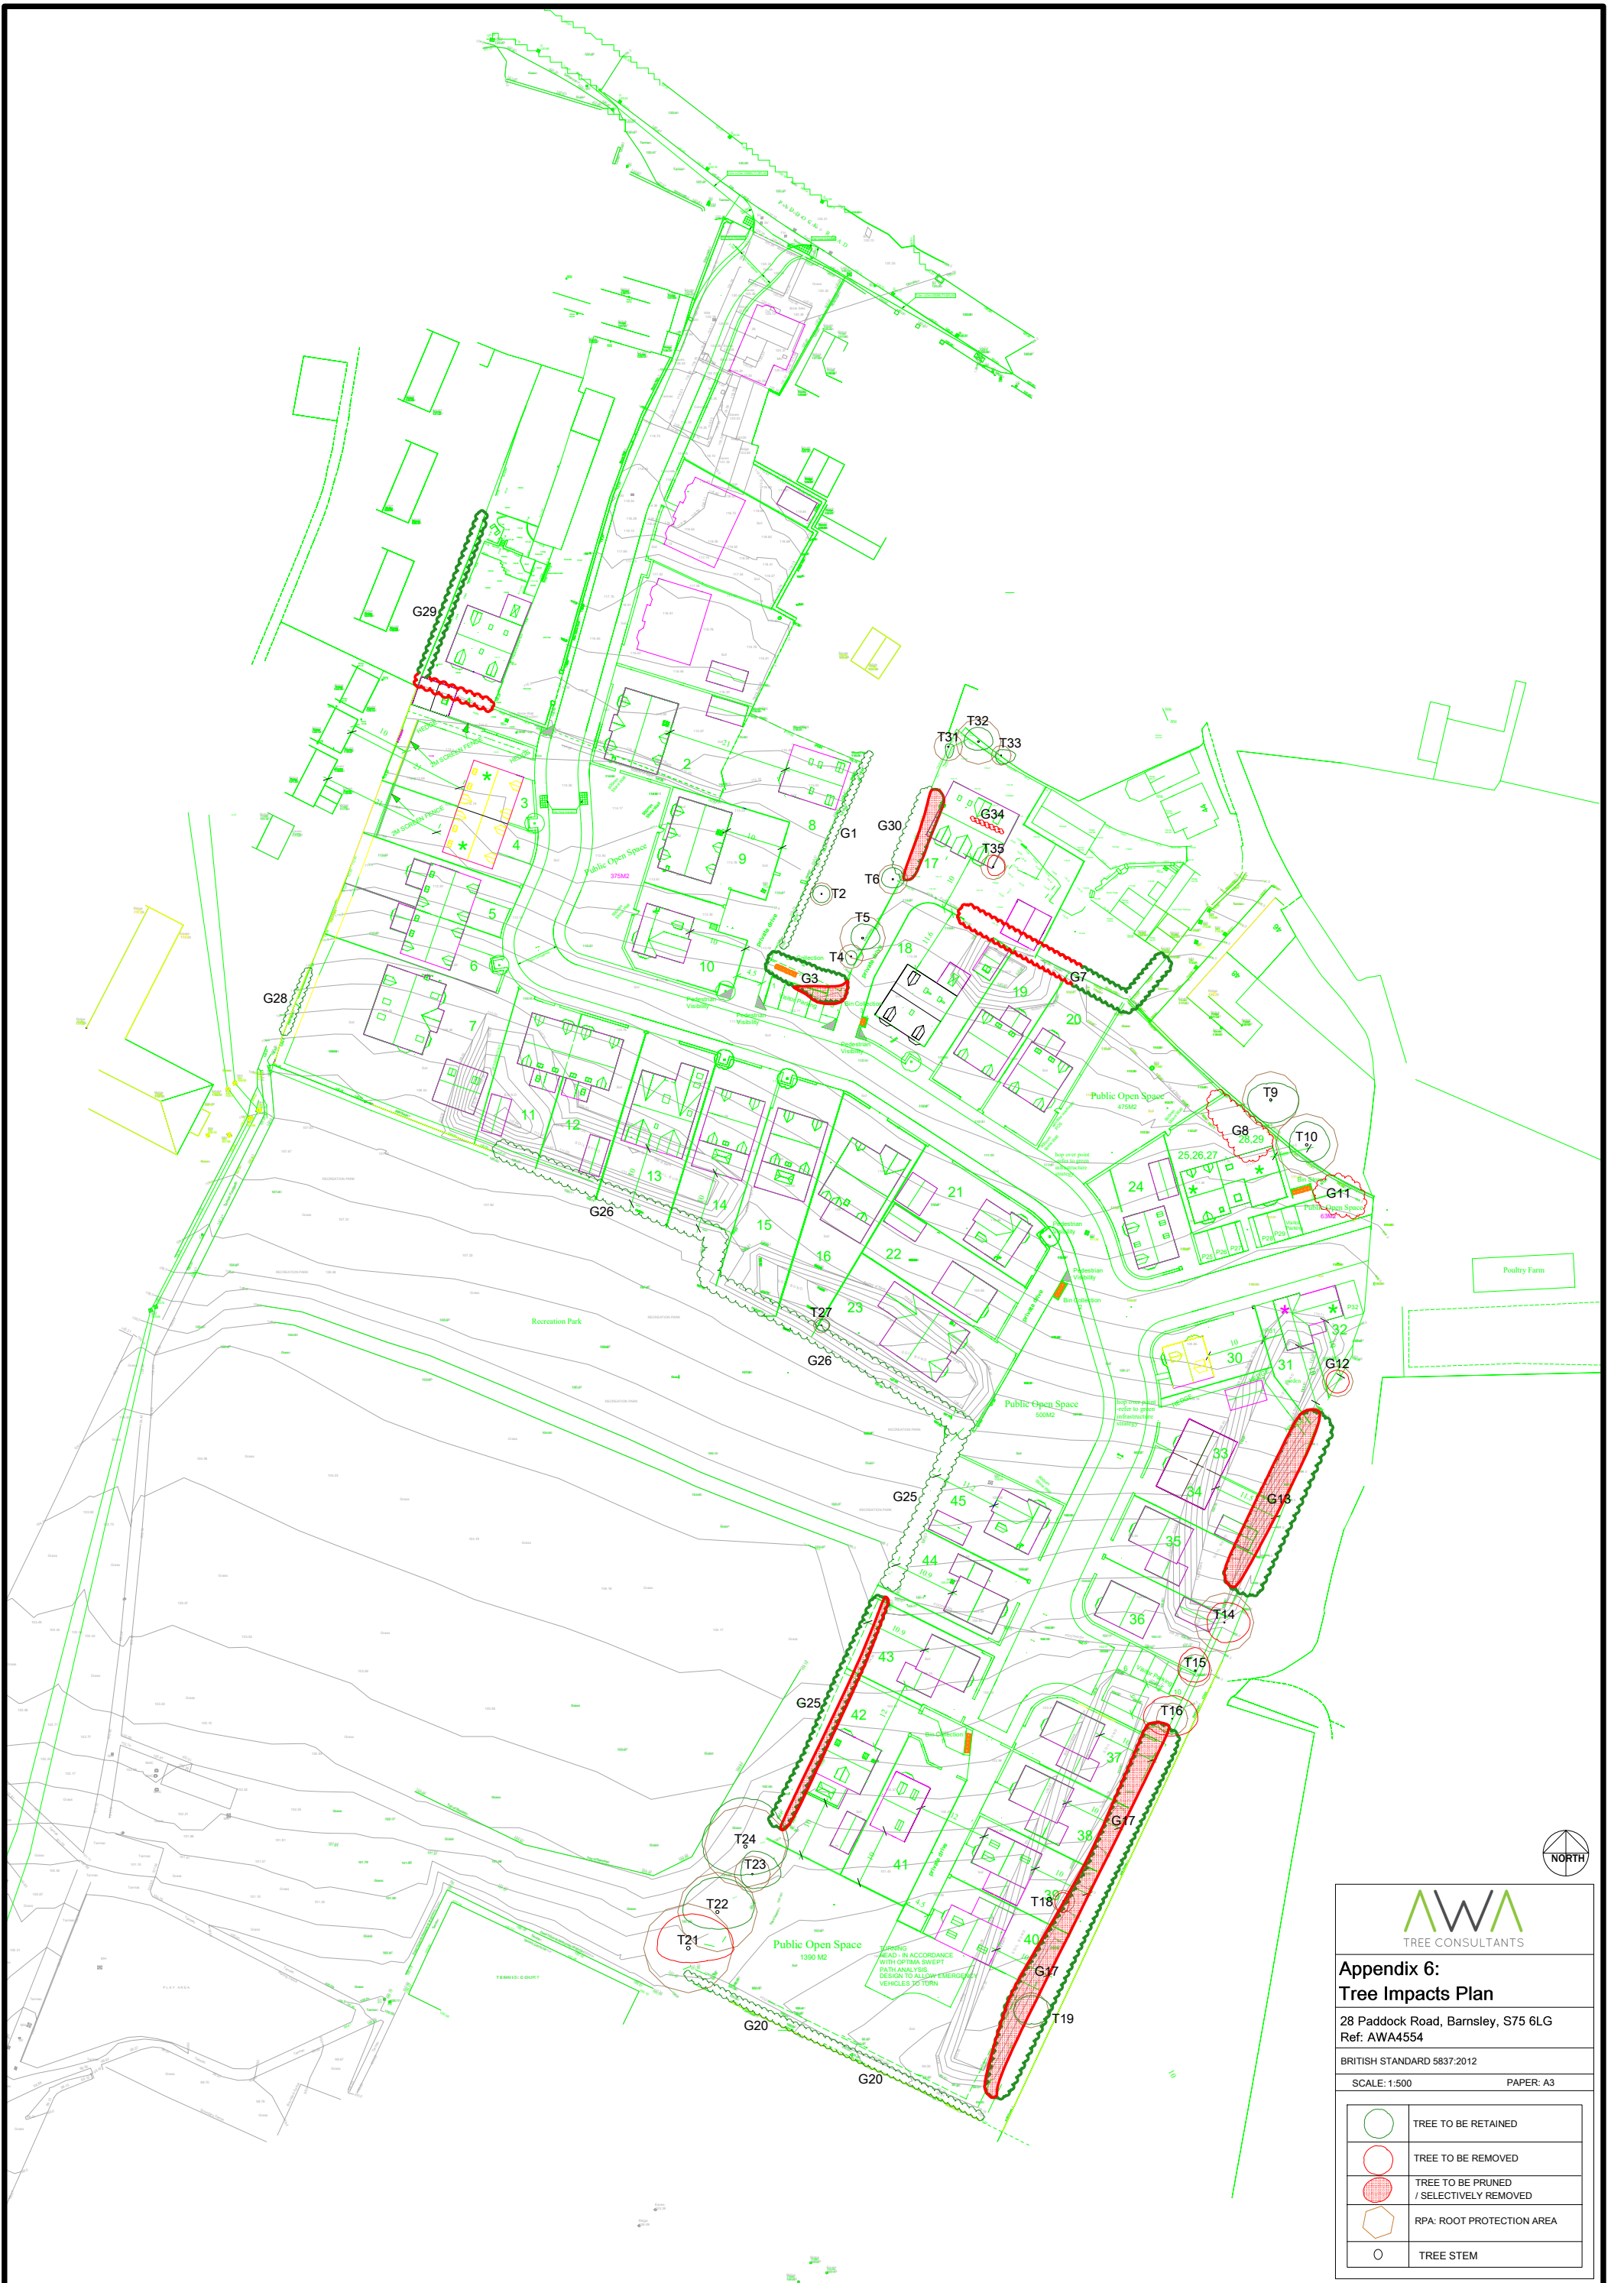
**Appendix 6:**  
**Tree Impacts Plan**  
 28 Paddock Road, Barnsley, S75 6LG  
 Ref: AWA4554

- 4.2.5 The trees/ groups/ hedges that require removal to facilitate the development are G3, T5, G7, G13, G17, G25, G29 and G30.
- 4.2.6 The trees to be removed or pruned are all lower value, retention category 'C'.
- 4.2.7 Due to the low value of the trees to be removed the removals will have only a negligible negative arboricultural impact.
- 4.2.8 The trees to be pruned will readily tolerate the work with little long term negative impact.

- 4.3.2 The new development encroaches close to and into the edge of the RPA of T5 and T6. Construction within the RPA, can have negative impacts on tree roots. However, the encroachment is very minor, and the detailed RPA for these trees is likely to be a slightly exaggerated representation of the trees actual rooting area. As such, it is unlikely that significant roots will be within these areas and the retained tree should remain largely unaffected by the works, provided care is taken during construction.

- 4.5.1 The retained trees will require protection by fencing in accordance with BS 5837: 2012, during the development phase.
- 4.5.2 If required by the Local Planning Authority, an associated Arboricultural Method Statement, detailing protective fencing specifications and construction methods close to the retained trees can be provided.
