# **ARBORICULTURAL REPORT**

## **& Impact Assessment**

***Pine Lodge,  
Stainborough Lane,  
Hood Green,  
Barnsley,  
South Yorkshire  
S75 3EZ***

Reference: AWA4276

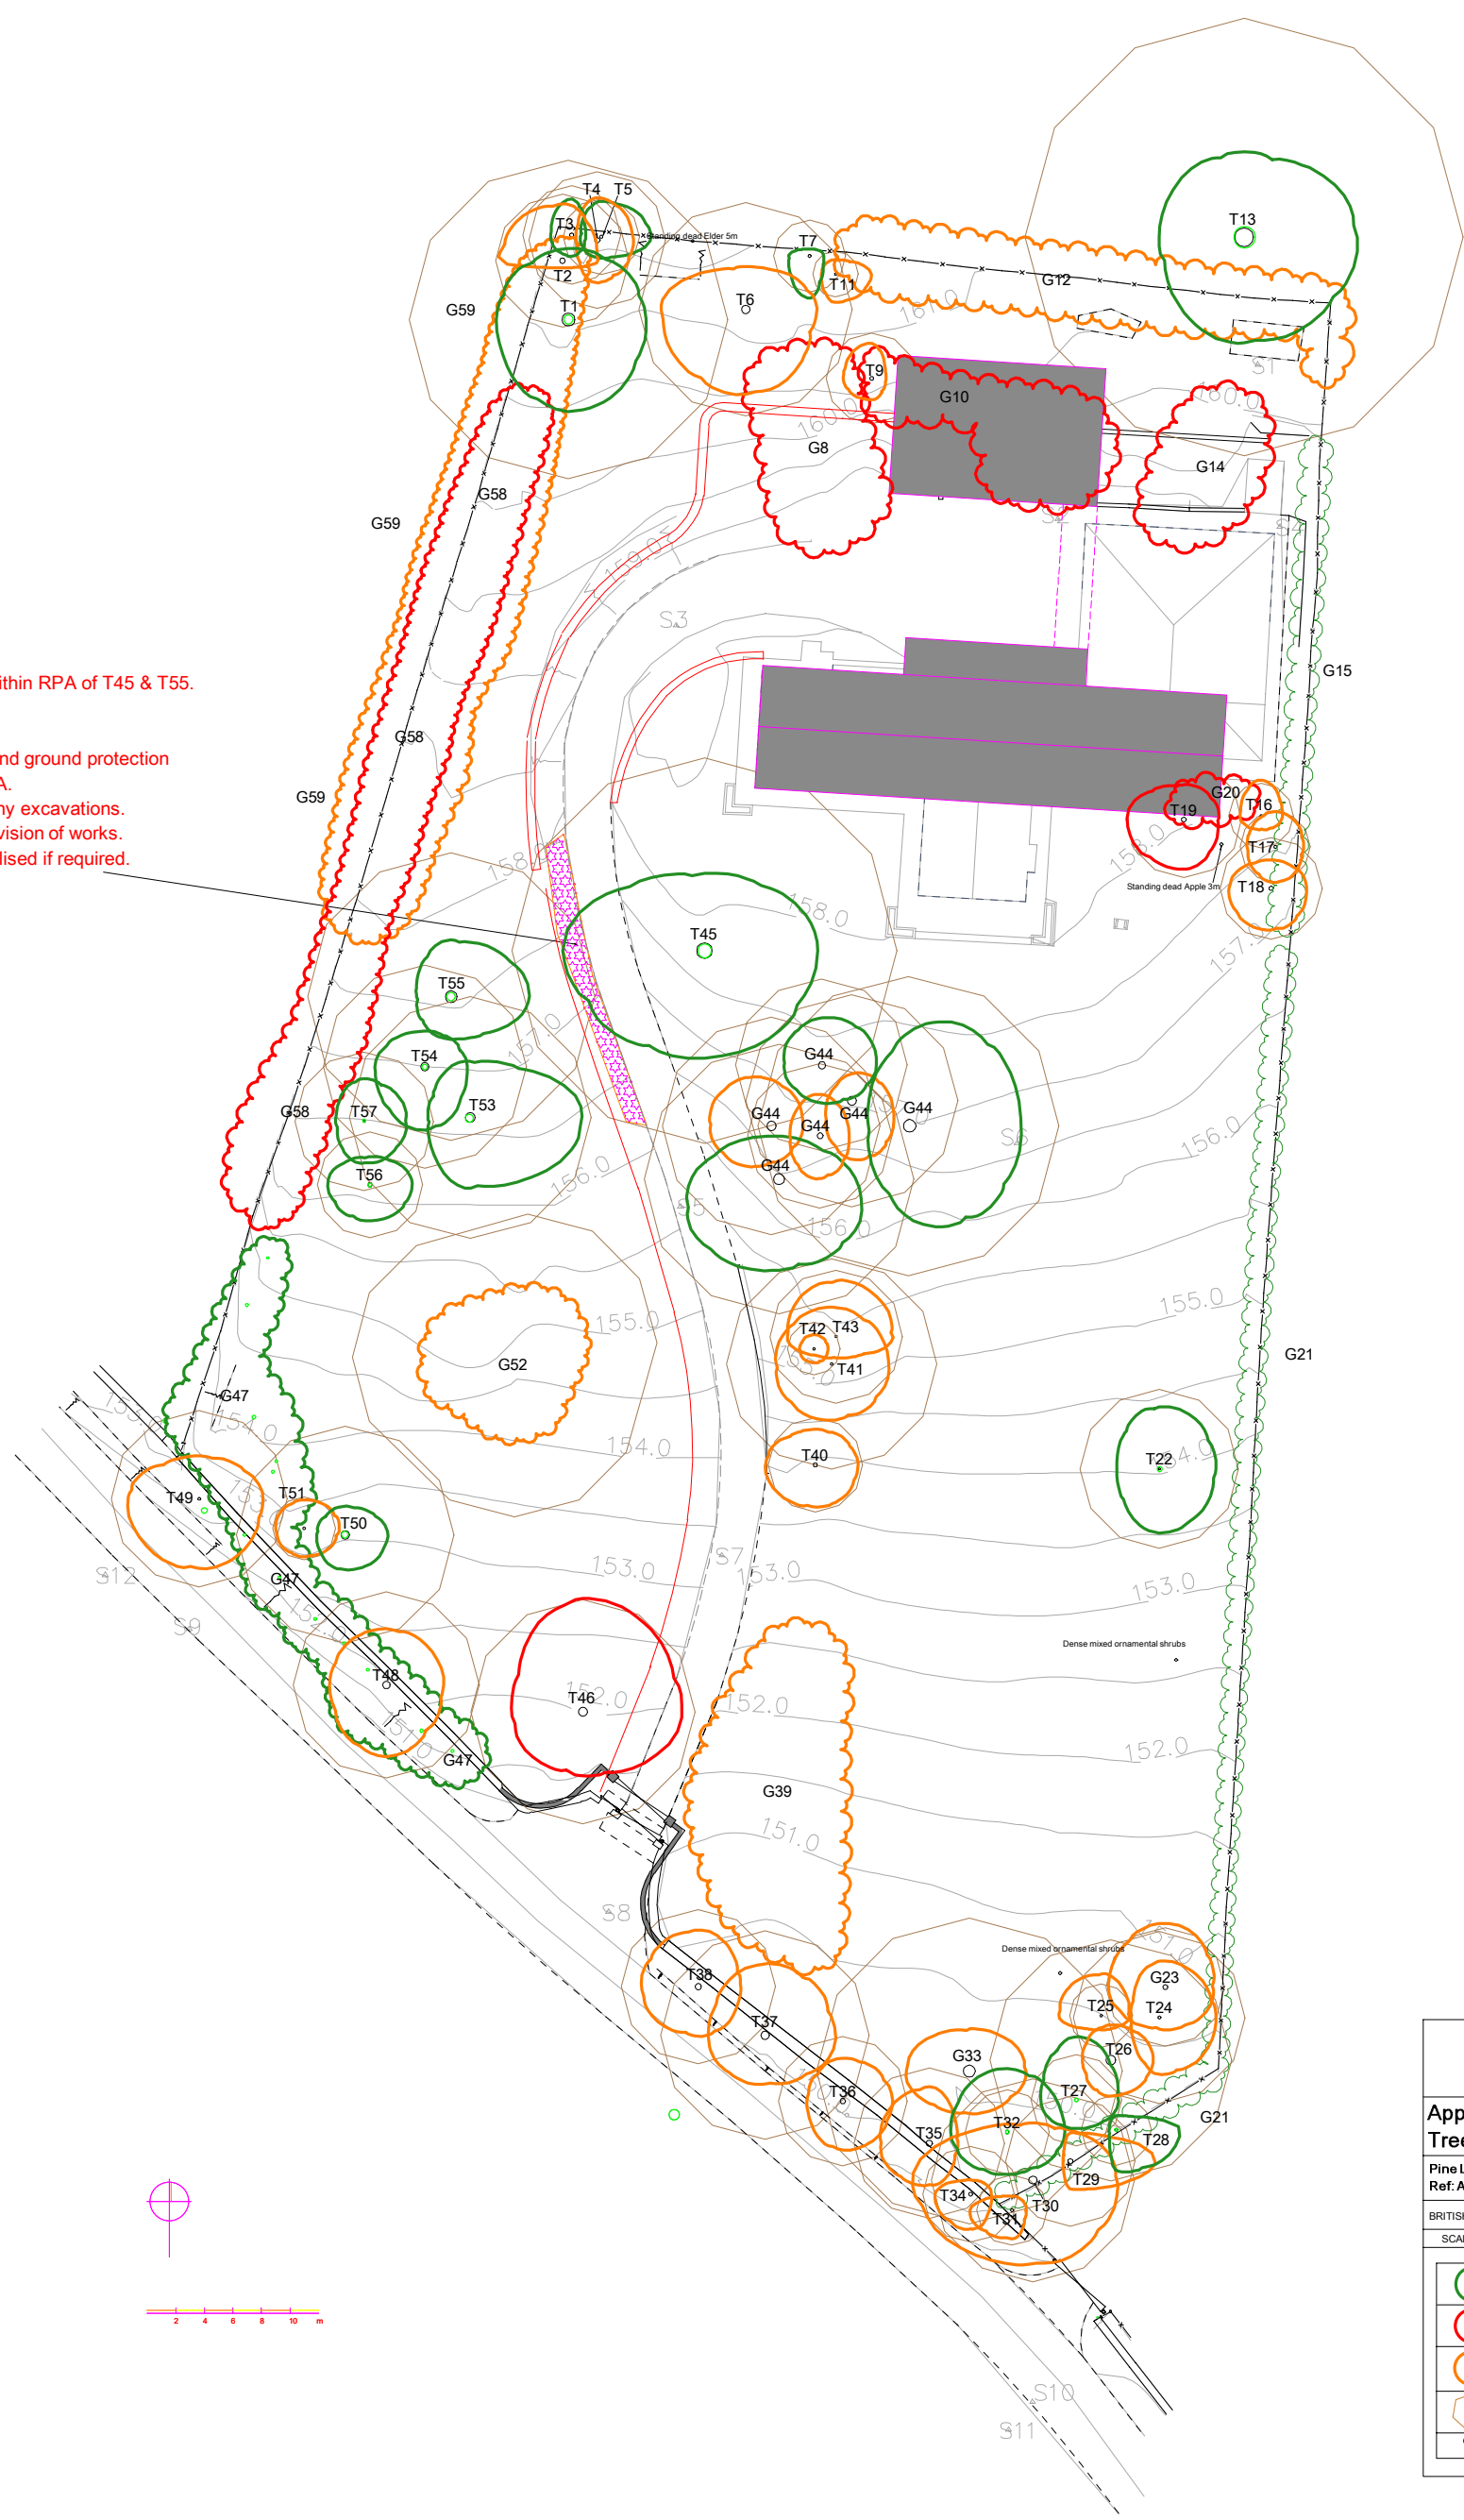
**Appendix 6:**  
**Tree Impacts Plan**

Potential Impact:  
New hard surface within RPA of T45 & T55.

Solutions:  
Protective fencing and ground protection to limit exposed RPA.  
Hand dig used for any excavations.  
Arboricultural supervision of works.  
'No-dig' methods utilised if required.
