Date: 20<sup>th</sup> April 2023  
Your ref: (S75 3AR).  
My Ref: CMRA 00275

**COAL MINING RISK ASSESSMENT (CMRA) - FOR PROPOSED DEMOLITION OF BARN AND DEVELOPMENT OF A DETACHED DWELLING AT IVY HOUSE FARM, CHAPEL ROAD, PILLEY, TANKERSLEY, BARNSELY S75 3AR**

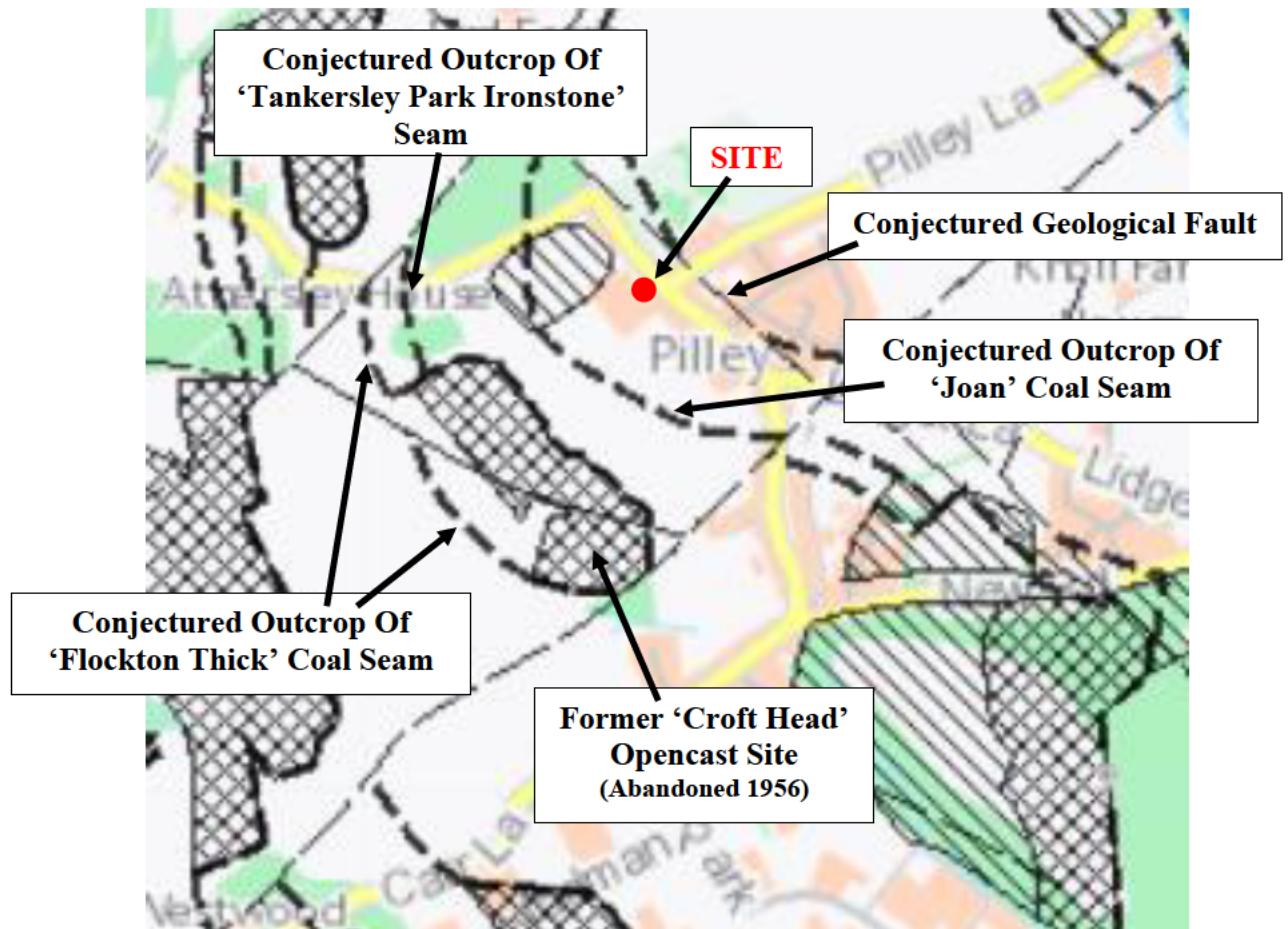
Records indicate the site to be located on sandstones of the Middle Coal Measure series from the Carboniferous formation. No superficial deposits are indicated in the vicinity of the site itself. Strata will dip beneath the land to the ENE in this vicinity at a steady rate of around 1 in 12 (5°). A summary of the surface geology is illustrated on the image below which is an extract from the BGS Onshore Interactive Viewer:

A geological fault is conjectured to pass the site over 60m away to the north-east as indicated above. Although no fissuring of sandstone bedrock is known in the vicinity, the likelihood of natural fissures that could have been opened out by the past deep coal mining in the area should not be precluded.

As outlined on the extract image above from the BGS Onshore Interactive Viewer, the 'Joan' coal seam (of around 500mm thickness) is conjectured to outcrop some 145m away to the south-west of the site. At the current development position, given the lay of the land (around 7m in gained height from the coal outcrop position) this would make for the Joan coal to be estimated at circa 19m deep.

No opencast coal operations are known within the site itself. The former 'Croft Head' opencast is located around 200m away to the south-west, as illustrated on the above image. This site worked the Tankersley Park Ironstone and Flockton coal seam until 1956 when the operations were abandoned. These operations proved the Flockton coal as 1.76m in thickness (but which included two dirt bands of 200mm and 450mm).

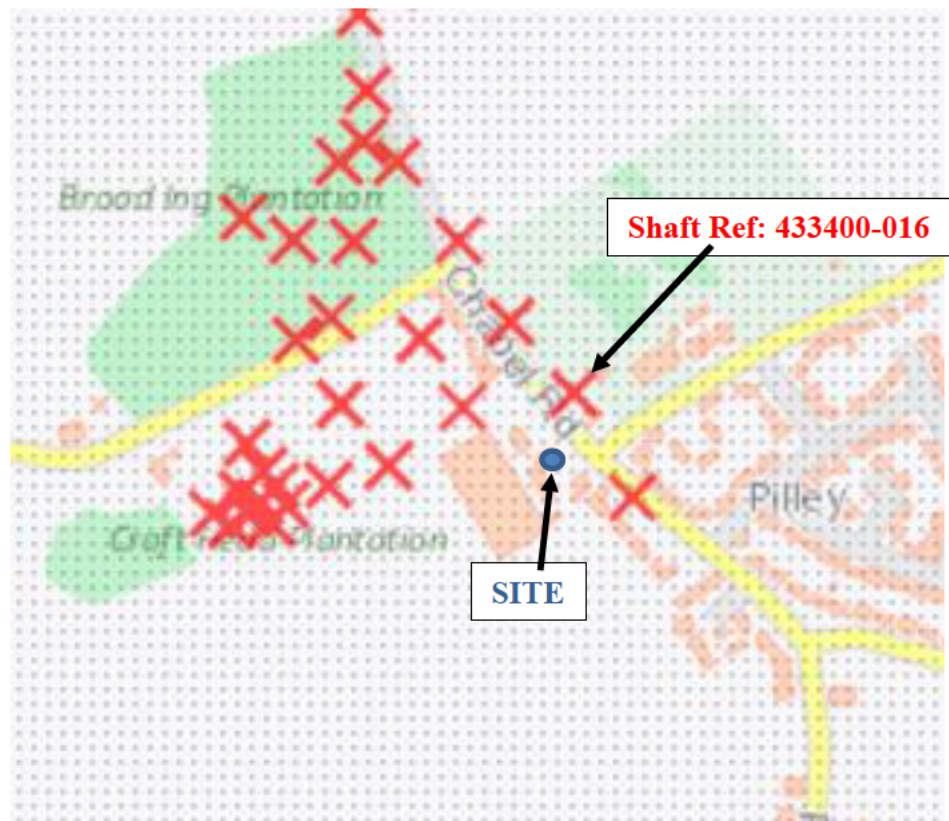
No mine entries are known within 20m of the site itself. The closest is an old shaft some 42m away to the NNE – CA Ref: 433400-016 – as shown in the following image which forms an extract of the Coal Authorities Interactive viewer. The shaft is detailed as ironstone workings, with no information shown as to treatment or depth. The various other known shafts in relation the workings of the Tankersley Ironstone are also shown in the slightly wider vicinity.

Given the above, a slight potential will exist for other historic 'bell pit' shafts being encountered which there are no records. Grey circular areas of fill material within bedrock/natural ground would be an indication of such.

- 3) The possibility of old 'bell pit' shafts being present however would be a more tangible risk. It would be recommended that a watching brief is employed throughout future ground/foundation works for any such signs – grey circular areas of fill within bedrock for example. The general rule of thumb for stability is that no building or structure should be sited within 45° from where the shaft side intersects rockhead. If such a feature is encountered then the Coal Authority should be first consulted (although they may not be liable should it be purely related to ironstone); repositioning and/or appropriate stability/gas precautions may be required.

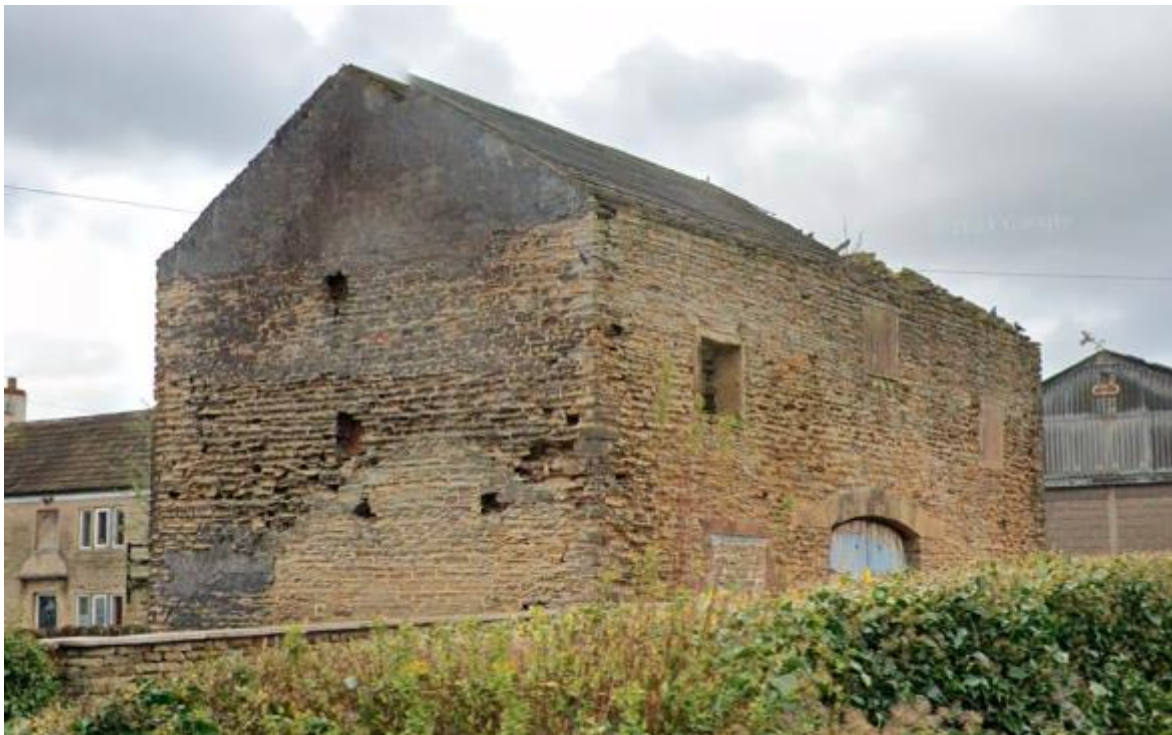
According to the historical records, no nearby indications of any mining or quarrying activities are noted in the immediate vicinity of the site itself. An inspection of the existing barn, which although been in a relatively poor state of repair given its age, reveals no apparent indications of any substantial settlement issues - as illustrated in the following image.
