**ARBORICULTURAL IMPACT ASSESSMENT  
to BS 5837:2012  
at  
Plumpton Lodge  
Manchester Road  
Thurlstone  
South Yorkshire  
S36 9QP**

**JCA Ref:**  
18647a/RB – Rev 1

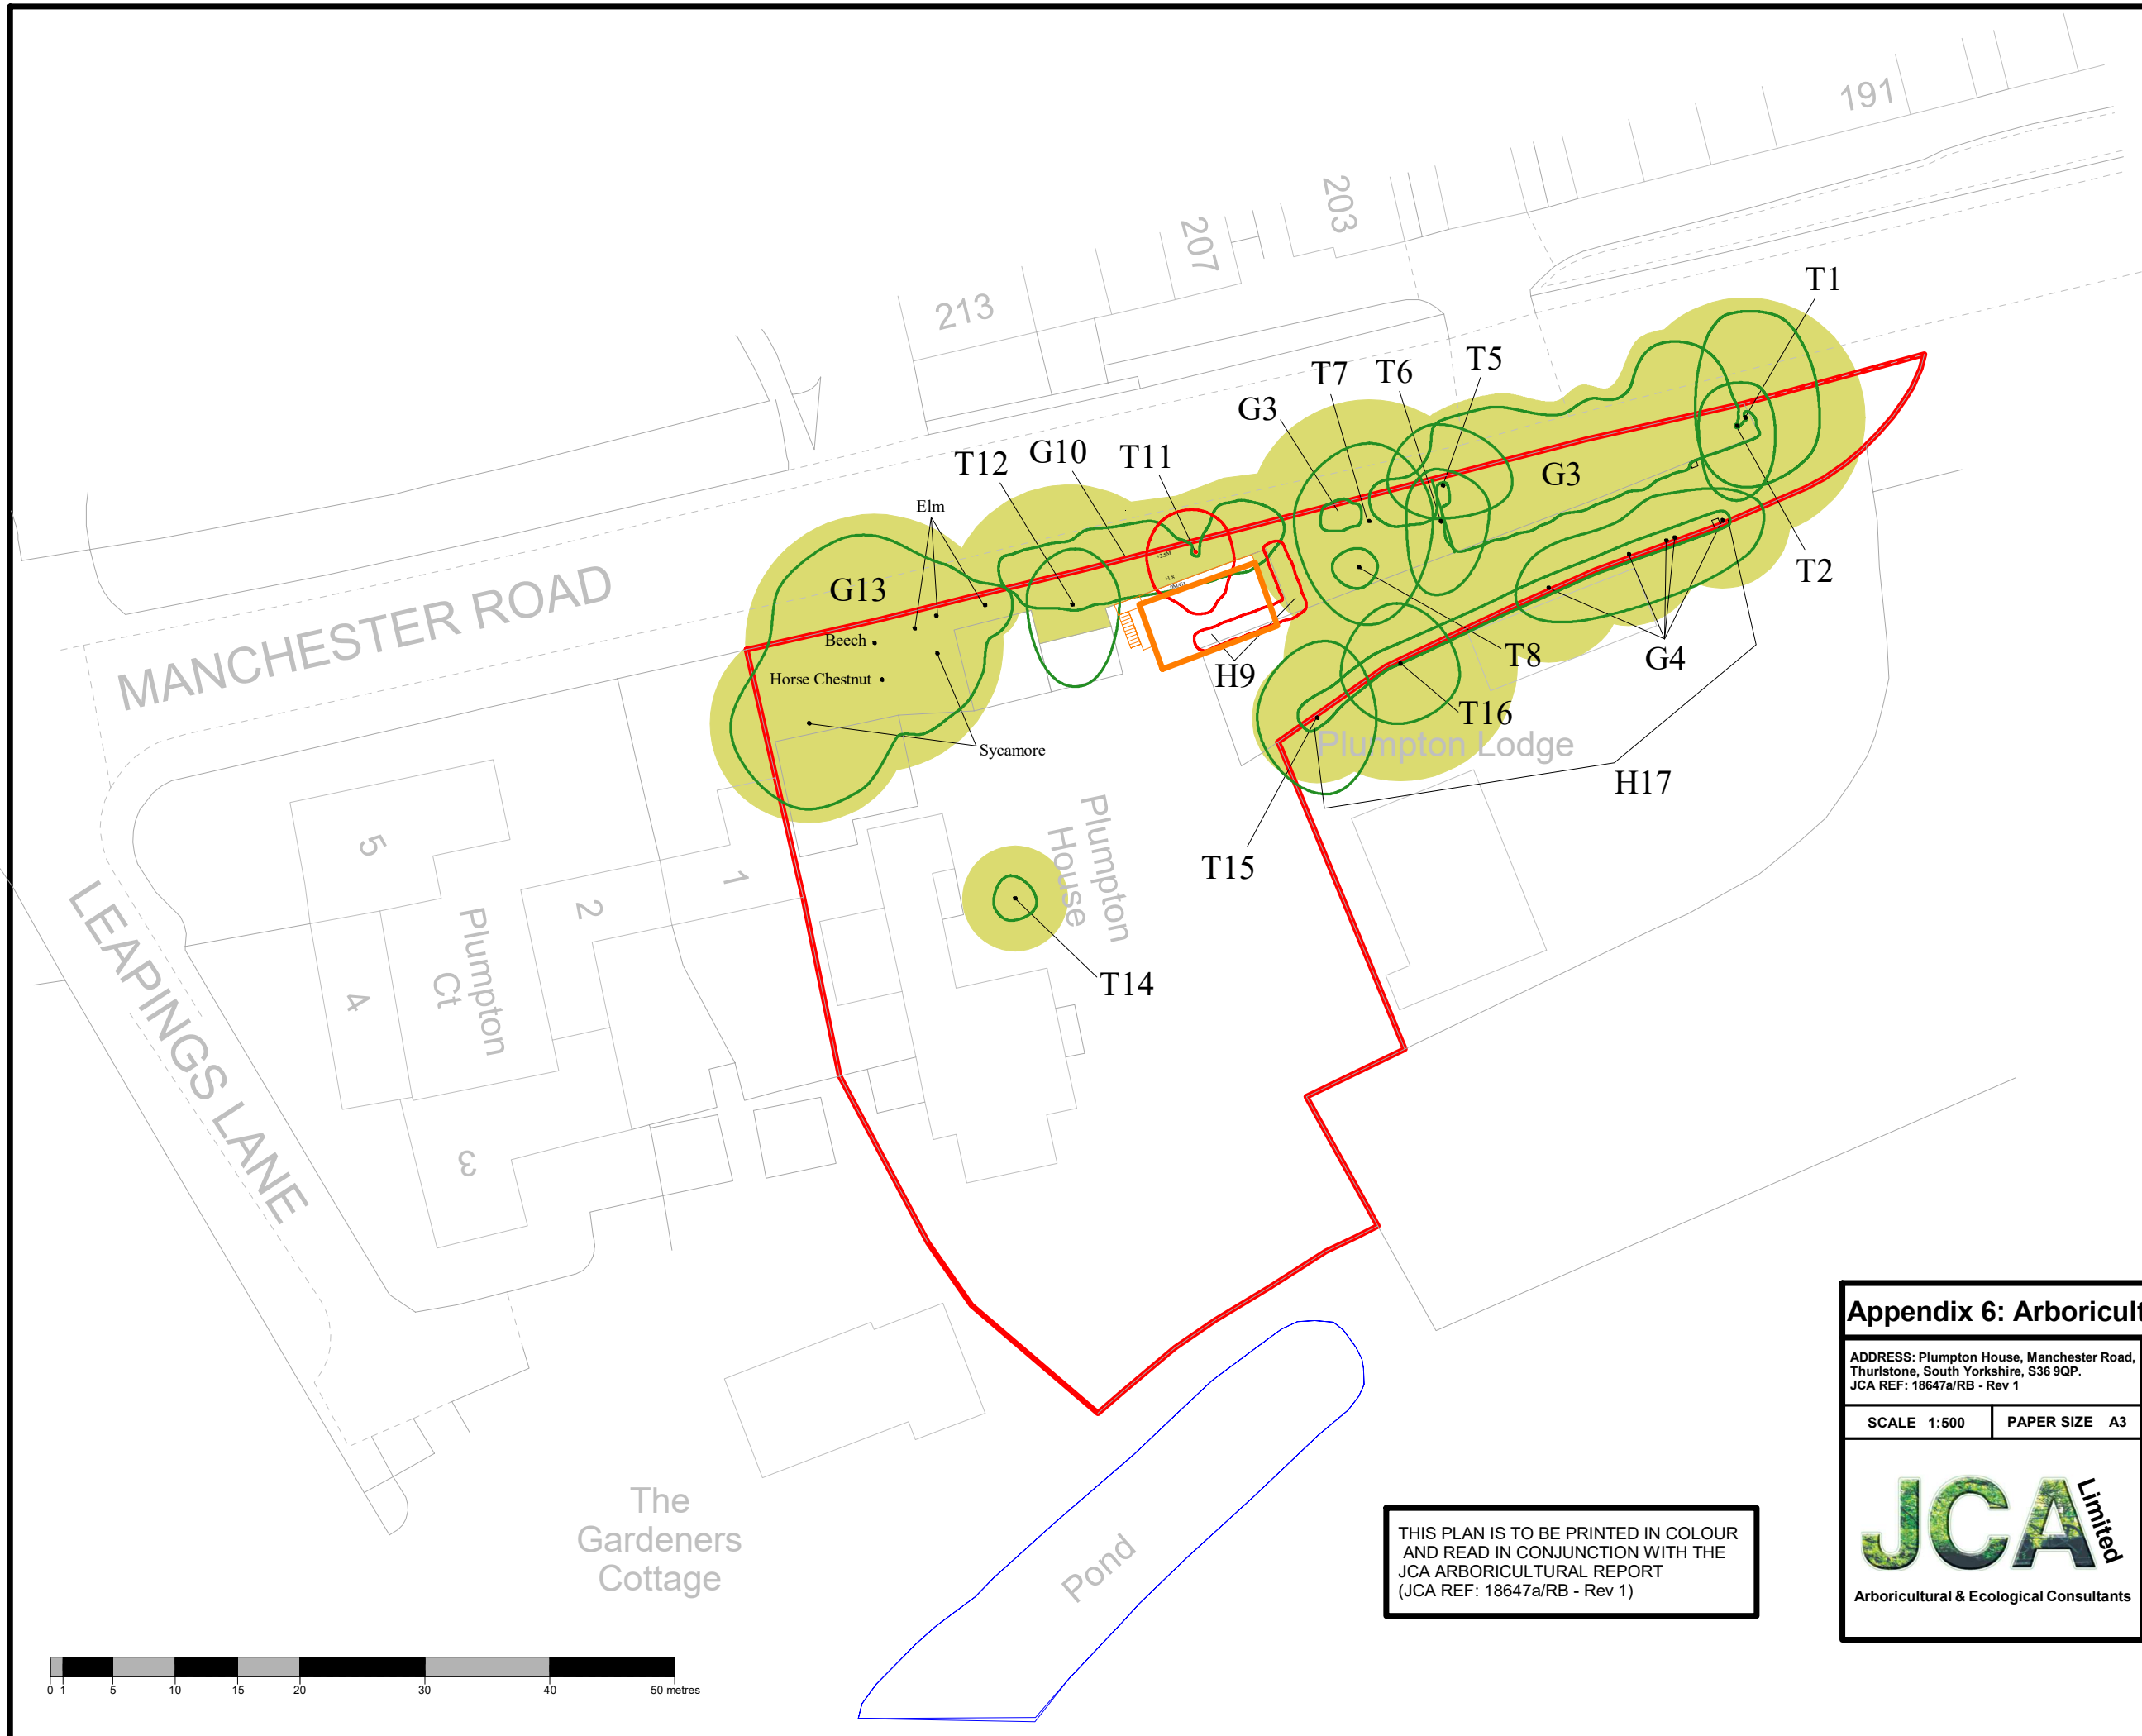
### Appendix 6: Arboricultural Implications Plan

- 3.2.1 **H9** and **T11**, both retention category ‘C’ items of vegetation, require removal to accommodate the proposals.
- 3.2.2 **H9** has a limited capacity to be viewed from outside of the site whilst **T11** is a low-quality specimen growing amongst the boundary vegetation; this tree also appears to be in decline with a limited future. **H9** and **T11** can therefore be removed without significantly affecting the visual amenity of the surrounding area.
- 3.2.3 The removal of trees for development can often be mitigated (either partially or entirely) by the planting of suitable specimens within a landscaping scheme. Whilst not always necessary, the planting of trees can improve the aesthetic value of the surrounding area and may be conditioned in the usual manner.

- 3.3.1 To accommodate the proposals, it will be necessary to prune **T1, G3, G4, T6, T7, G10, T15** and **T16** to provide suitable access and working distances for pedestrians and vehicles, and to afford reasonable clearances from the new building.
