**REPORT C9470 Rev A
MAY 2022**

PRELIMINARY APPRAISAL (DESK STUDY)

**of land off
DODWORTH GREEN ROAD, DODWORTH, BARNSELY**

**prepared for
NEWETT HOMES LTD**

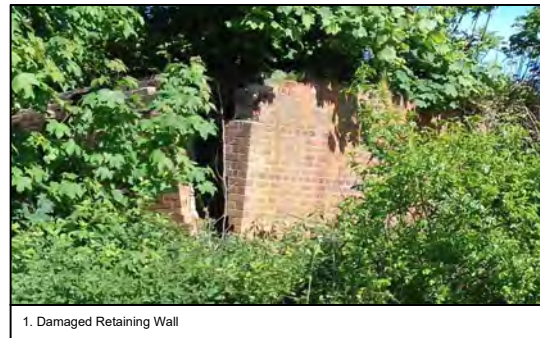
1. Damaged Retaining Wall

It should be noted that both new and existing retaining walls may be affected by shallow mine workings and mine entries, and hence require stabilisation during development works.

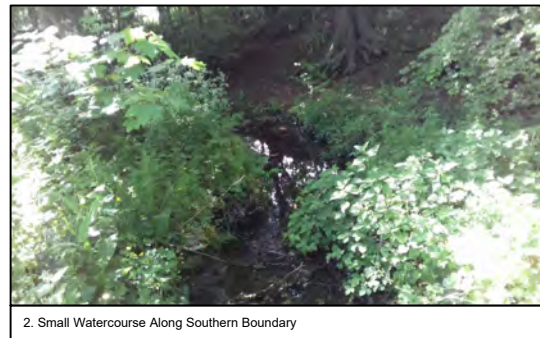
2. Small Watercourse Along Southern Boundary
