# Bat Scoping Survey to Berry Moor House Farm

Pinfold Lane  
Silkstone Common  
S75 4RF

22<sup>nd</sup> August 2019

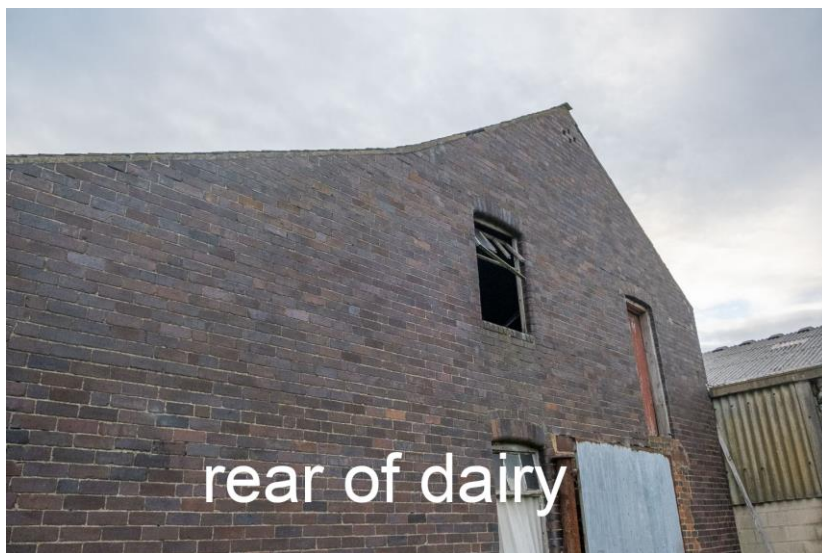
rear of dairy

This building is a large brick unit with pitched slate roof. The building has only a small upper floor at the east end and is largely an open chamber with the rafters exposed and visible. There are light panels in the roof allowing some daylight into the building but the small upper floor at the east end is blocked by a dividing wall and is less subject to light ingress. The ridges in this building are much cleaner and have far less cobwebs than the other buildings. Although there were no accumulations of moth wings or other prey items and no obvious droppings, brown long-eared bats were recorded inside this building at dusk. Barn owl was not seen but may have been disturbed by the presence of the surveyors but there was obvious fresh droppings and owl pellets suggesting at least one roosting barn owl.

- 11.2 Alterations and reroofing works to the dairy would directly impact a nursery roost of brown long-eared bats unless a comprehensive method statement and mitigation is prepared. With good planning and a phased approach to the conversion of the outbuildings, it should be possible to convert the buildings while allowing their continued use by bats.

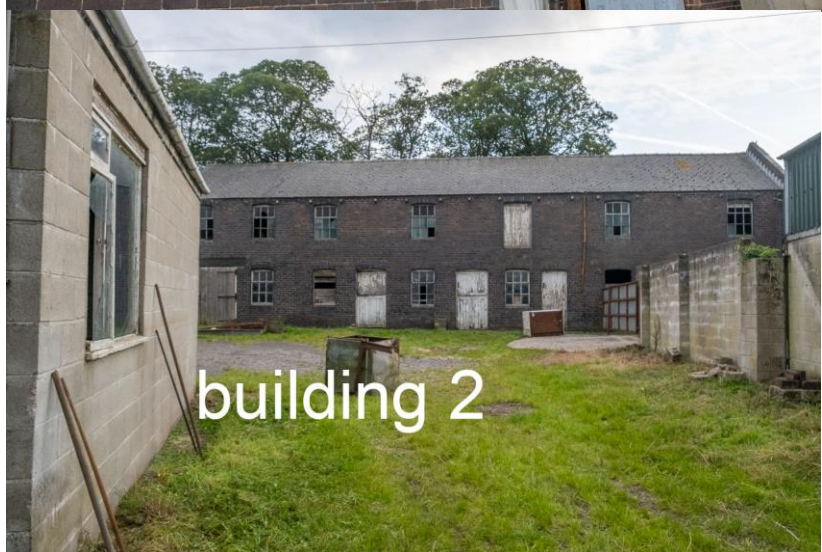
building 2

This is a long run of outbuildings and cattle stalls and has two stories to the buildings. The roof has a blue slate covering and is unlined. Internally, all ridge sections are heavily covered with cobwebs and show no signs of use by bats. The floors did not have any scattered prey remains of droppings. The brick walls are sound and do not have structural cracks or crevices but the walls do have a cavity which may be accessible from the wall tops. There are no fascia or soffits that would provide roosting sites and the dry verges are sound.
