Report No: C312/1  
Date: April 2018

**GEOENVIRONMENTAL APPRAISAL AND  
REMEDIATION STRATEGY**  
for land at  
**COCKLE EDGE FARM, INGBIRCHWORTH, PENISTONE,  
SOUTH YORKSHIRE**

| <b>REPORT TYPE:</b> | Geoenvironmental Appraisal and Remediation Strategy | | |

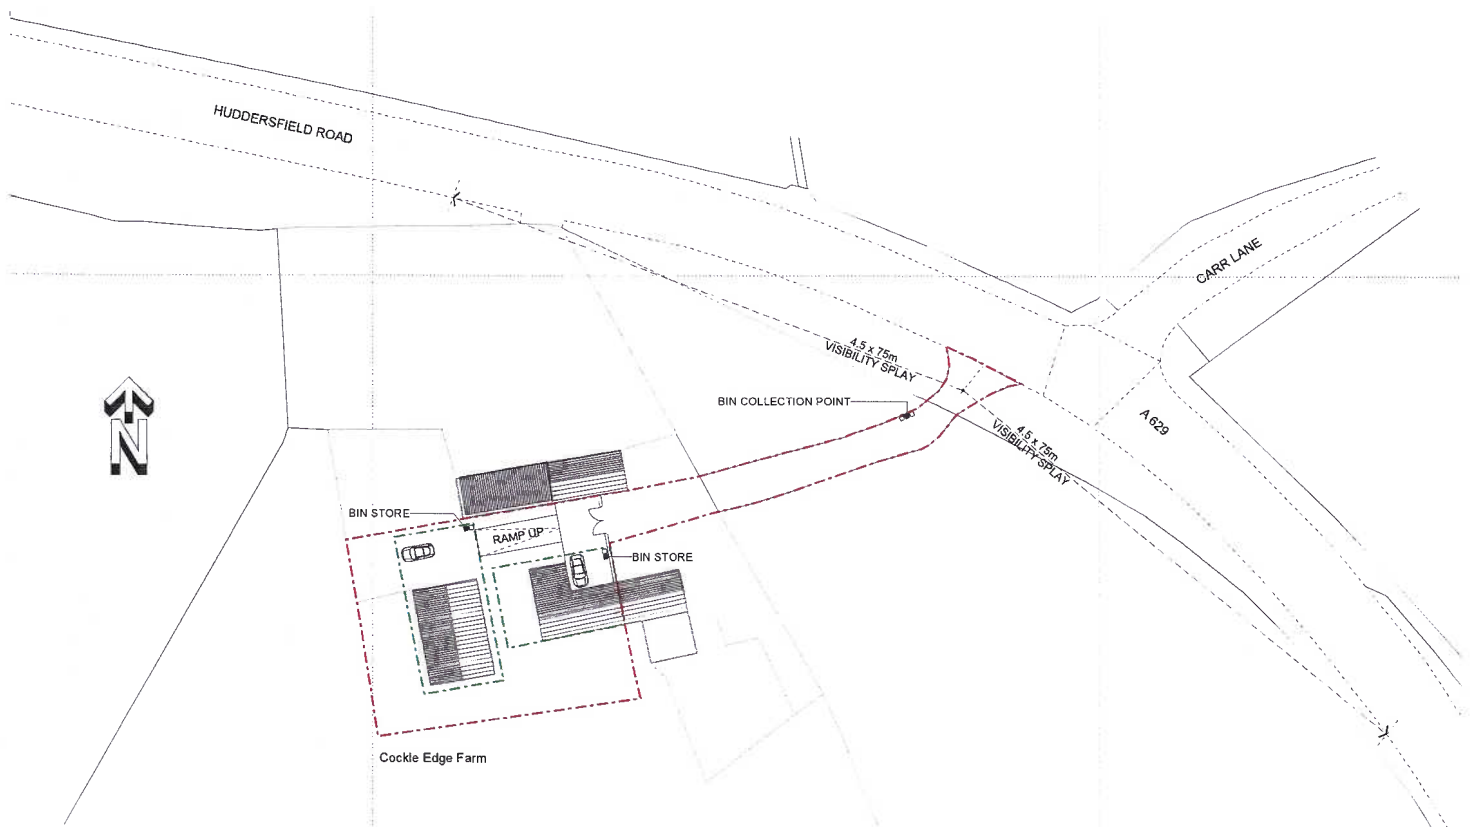
| MR & MRS E BROOK | | BLOCK PLAN - PROPOSED | | | |

A schematic layout drawing for the proposed development is shown on Drawing No 1023/1, dated 9<sup>th</sup> May 2017 by Gable Design Ltd, a copy of which is presented in Appendix A of this report

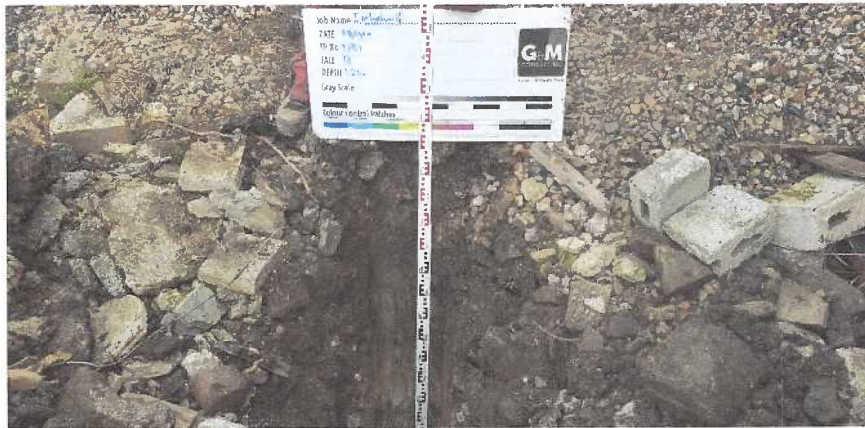
**Trial Pit TP1**

Granular material was encountered in TP1 and TP6 and consisted of gravel size fragments of limestone, concrete and brick proved to a depth of 0.6 m and 0.1m in TP1 and TP6 respectively. Underlying this material in TP6 was black gravel of clinker and tarmacadam fragments with fines of ash proved to a depth of 0.6m. This material had a slight smell of creosote.

A slight seepage of water was recorded in trial pits TP1 and TP2 at a depth of 1.0m. No groundwater was encountered in the other trial pits during the fieldwork.

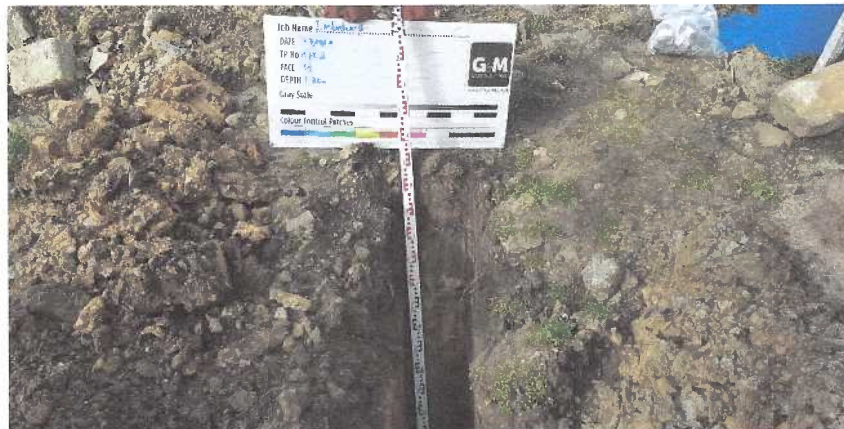
**Trial Pit TP2**

The made ground is underlain by firm yellow and light grey mottled clay proved to completion depth in the trial pits. In TP 2 lithorelicts of mudstone were noted in the clay below a depth of 1.1 m. In TP4 the lithorelicts were noted throughout the clay to completion depth.

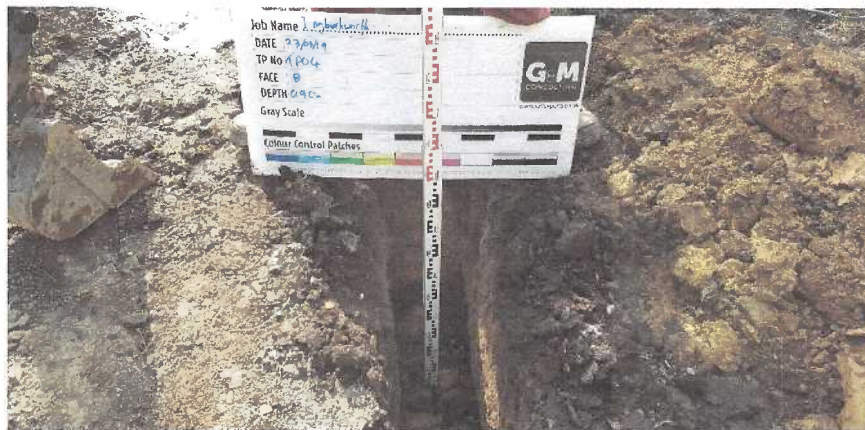
### Trial Pit TP4

The remaining trial pits encountered made ground comprising gravelly clay, sandy in places. The gravel content consisting of fragments of brick, concrete and limestone. In TP4 some black carbonaceous material was noted.

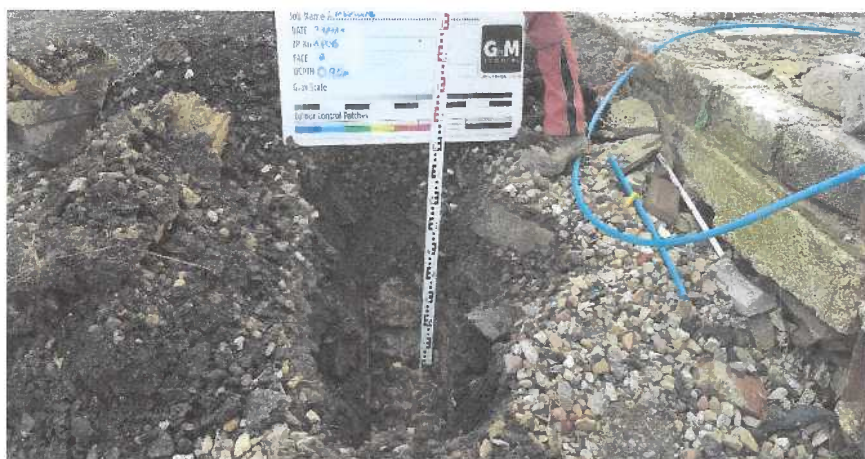
### Trial Pit TP6

Ash and clinker were noted in TP6 together with a slight smell of creosote. In the remaining trial pits brick and concrete fragments were noted which can produce elevated concentrations of certain contaminants, such as toxic and phytotoxic metals, sulphate and PAH.

The elevated concentrations of chromium and PAH were all recorded in one sample of made ground from TP6 at 0.30m. This sample was described as containing ash and clinker and with a slight creosote smell noted.
