**Wentworth Castle Gardens | Battlements**

**Photographic Recording Document**

2025

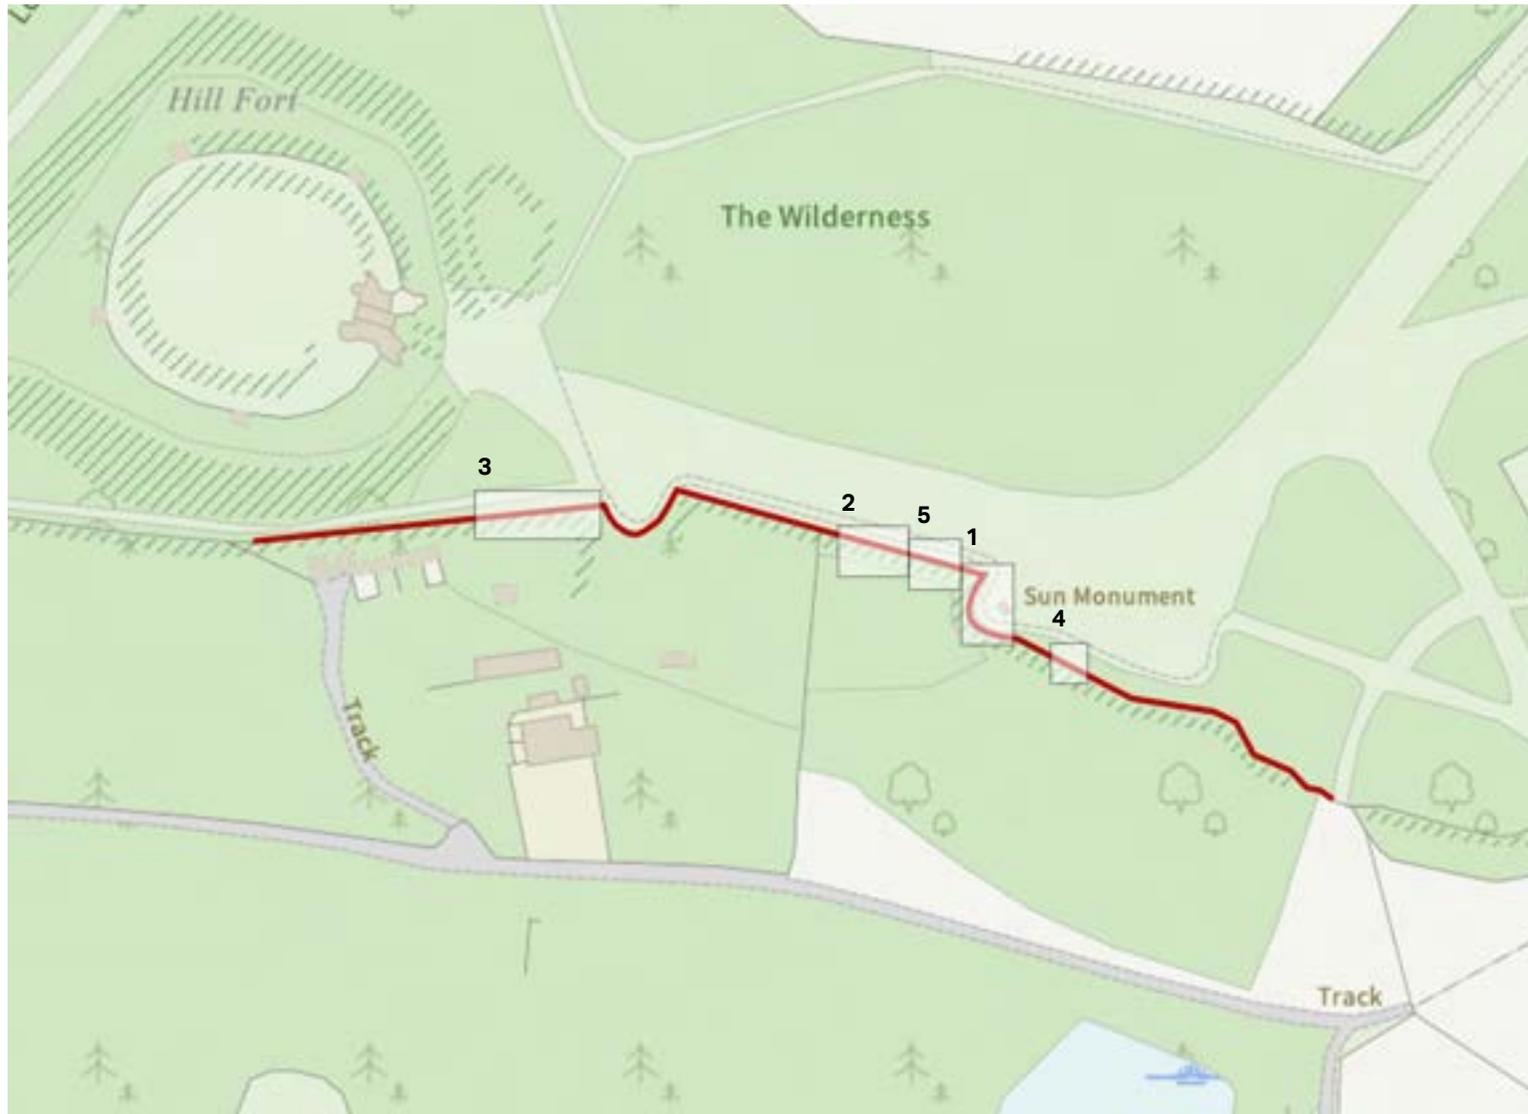
**Section 1:** *South Bastion*  
April 2023 - March 2024

**Section 2:** *12m Section*  
June 2023 - June 2024

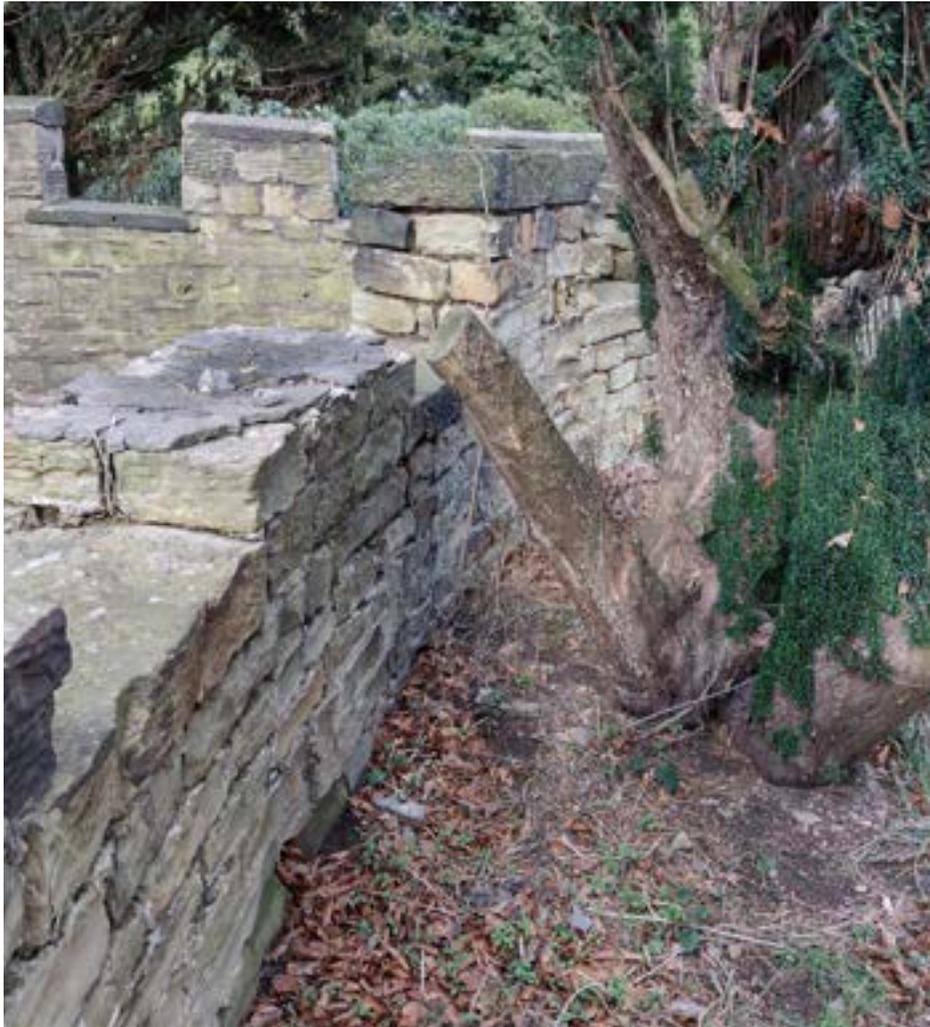
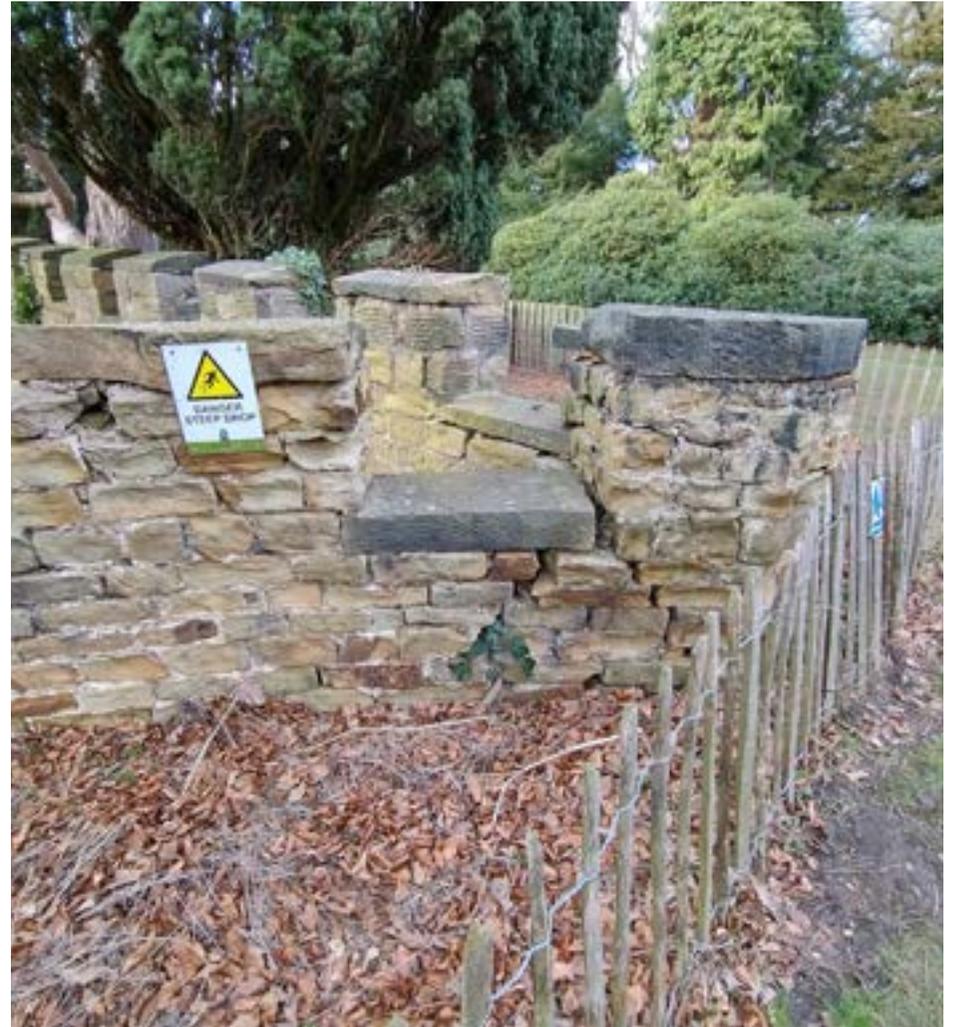
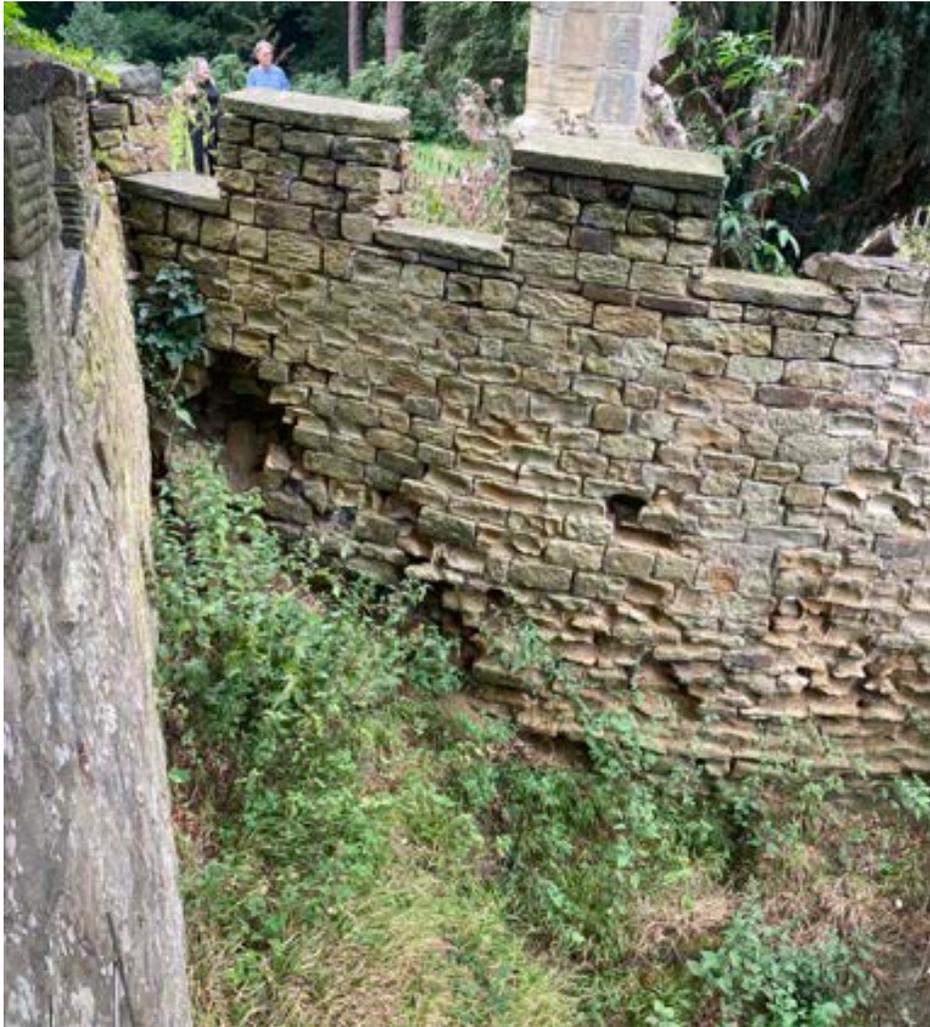
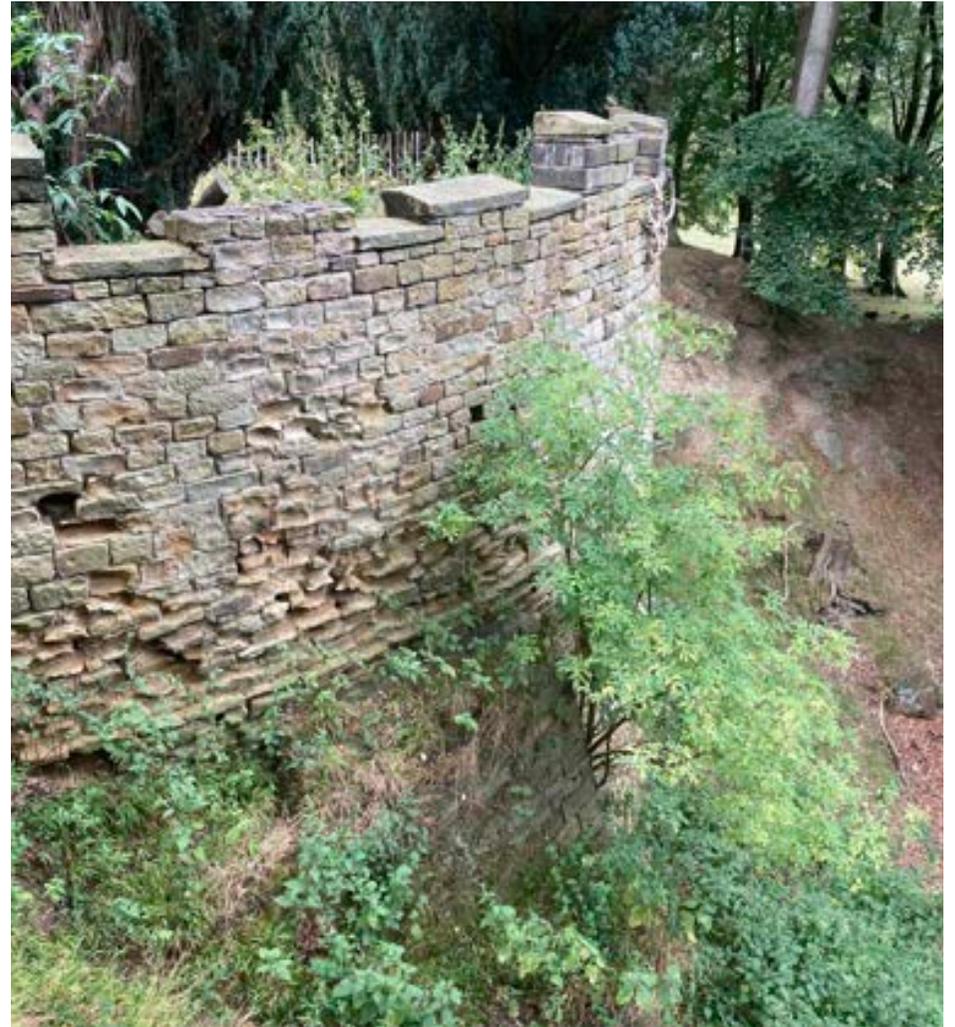
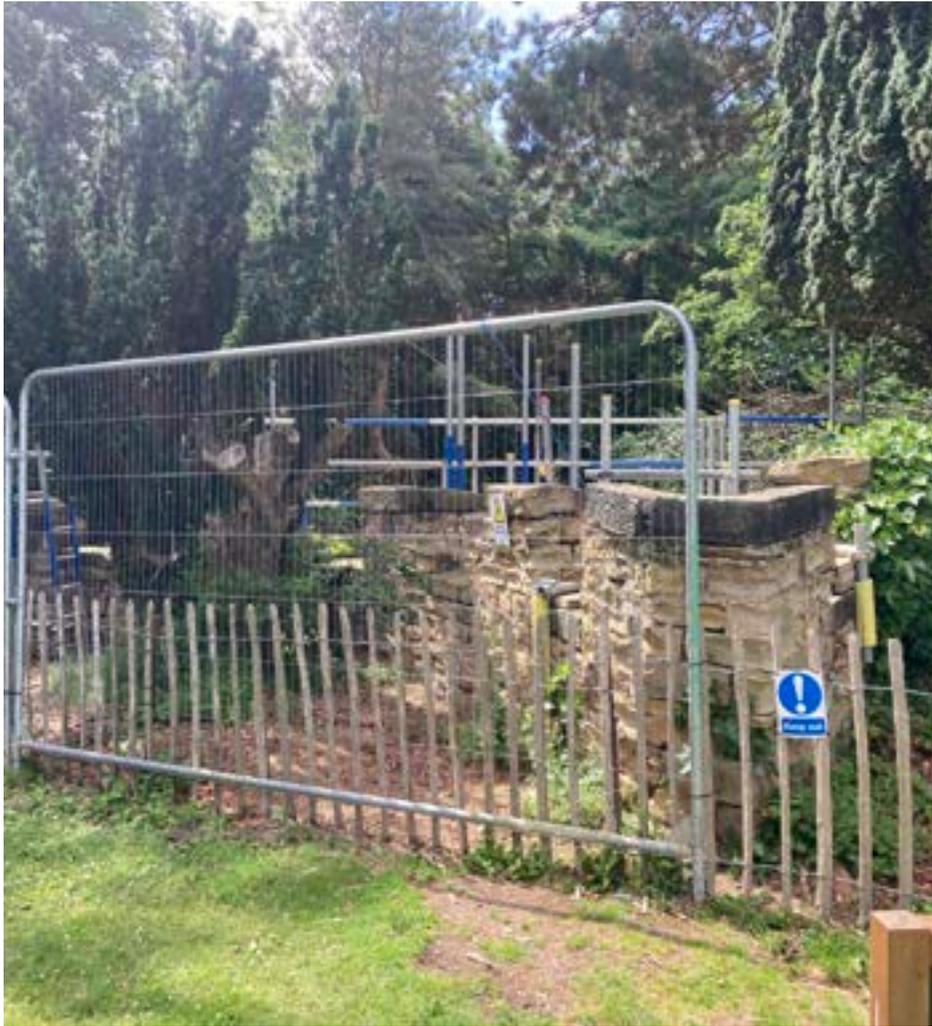
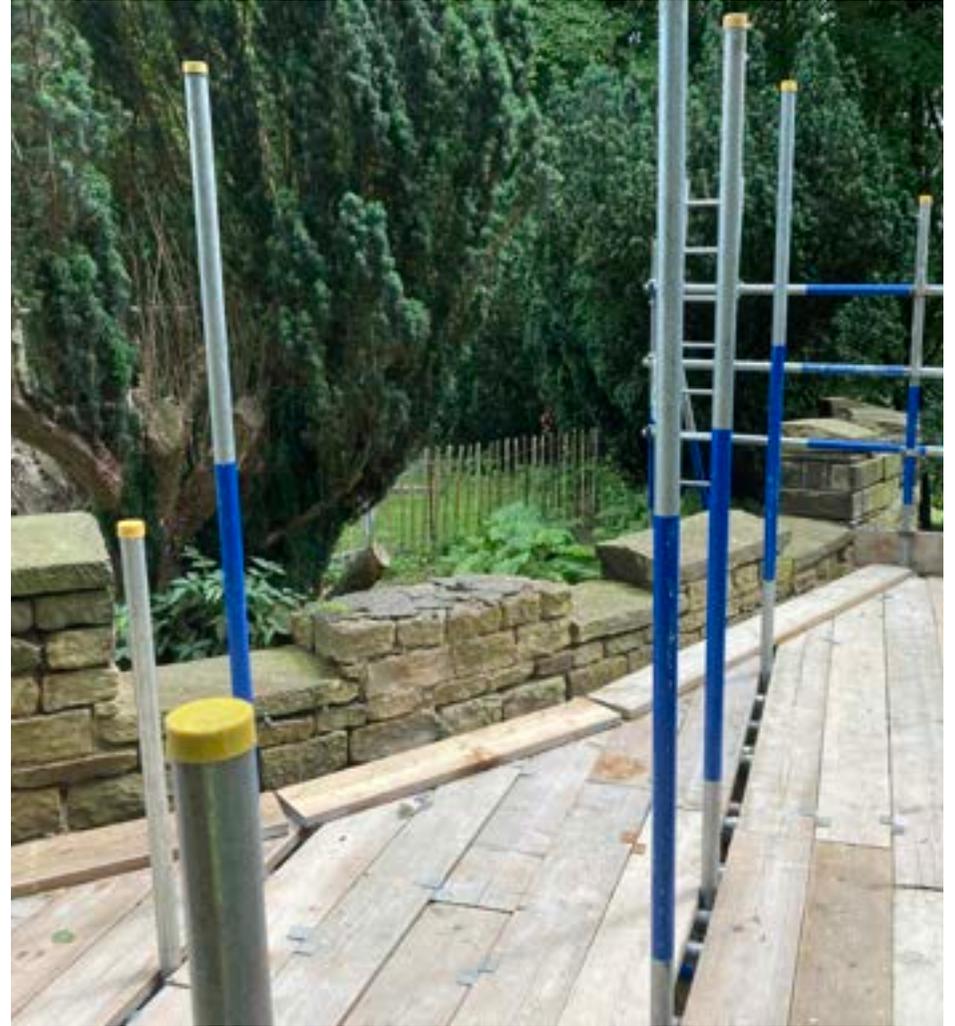
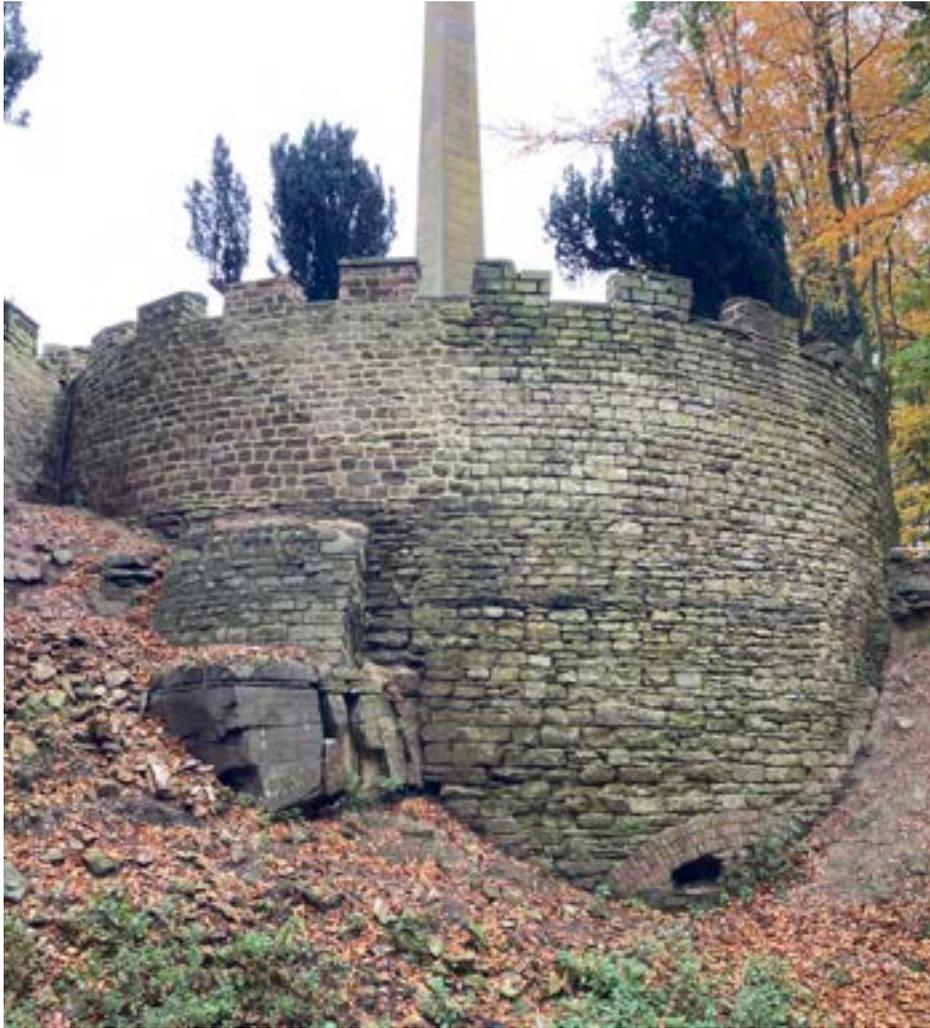
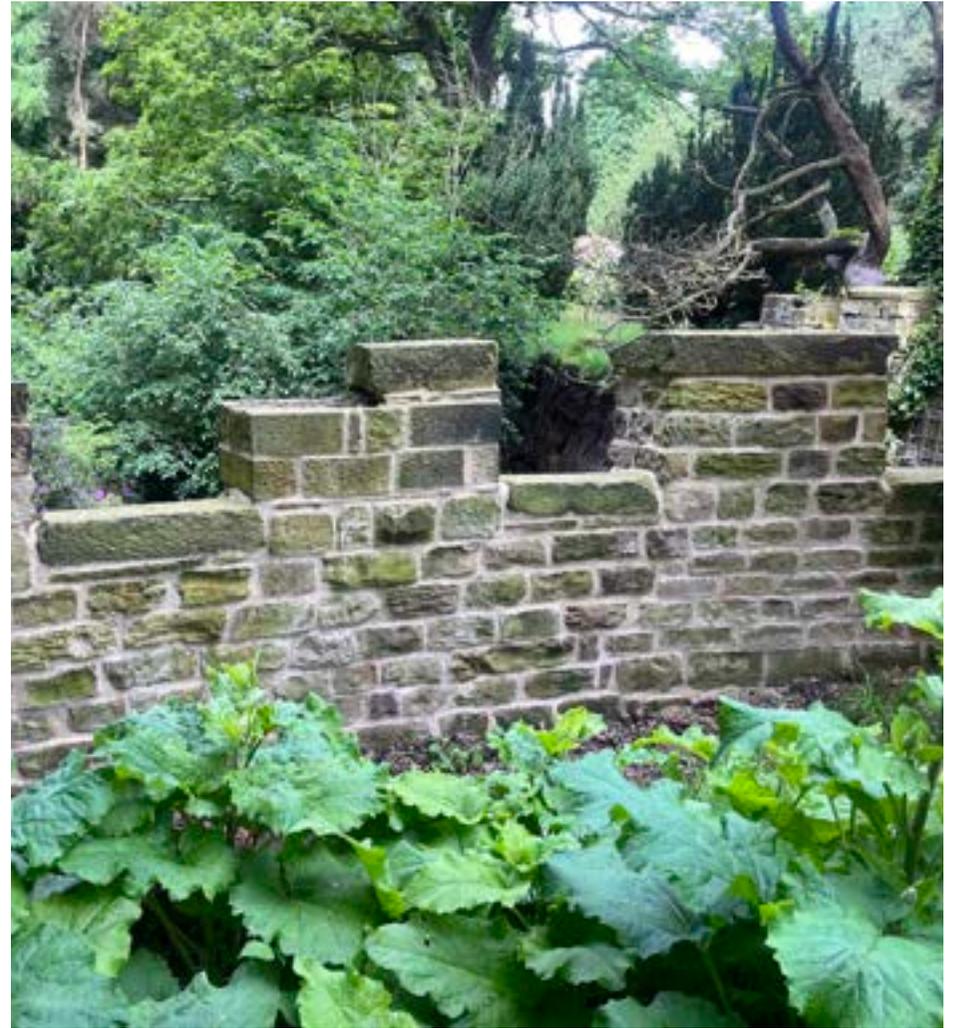
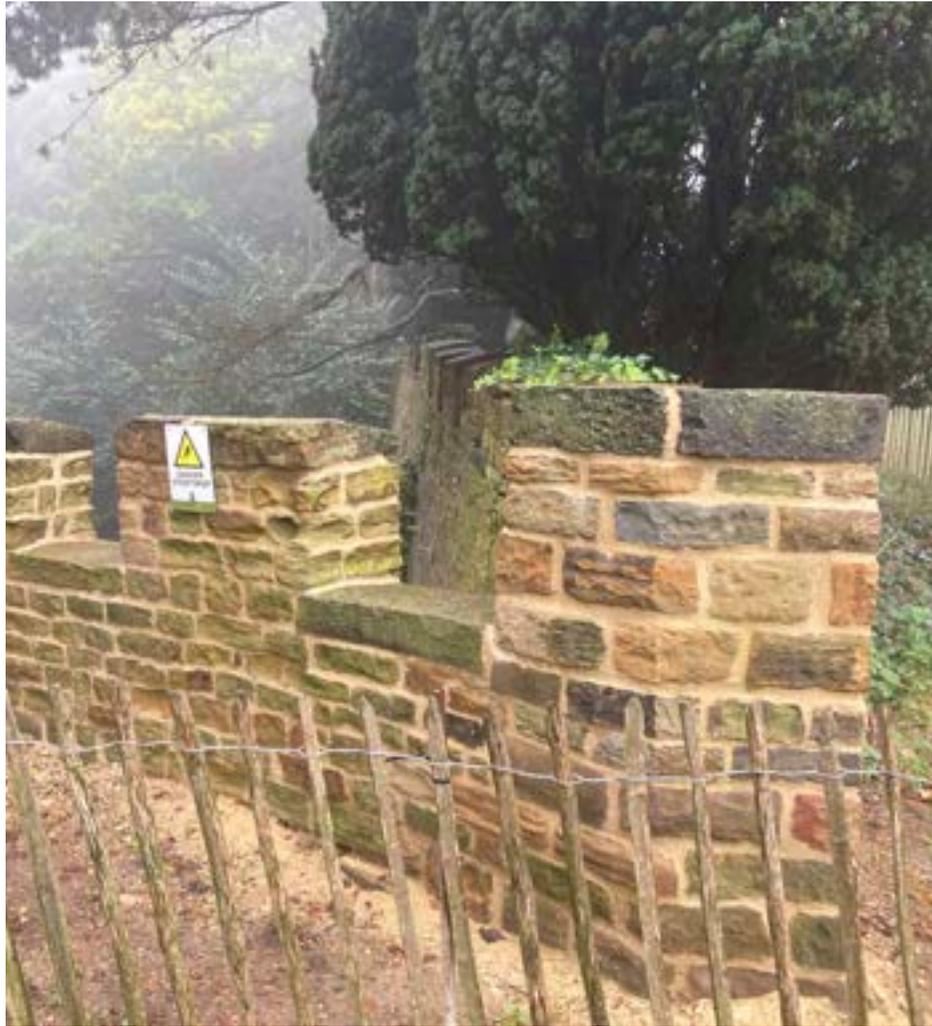
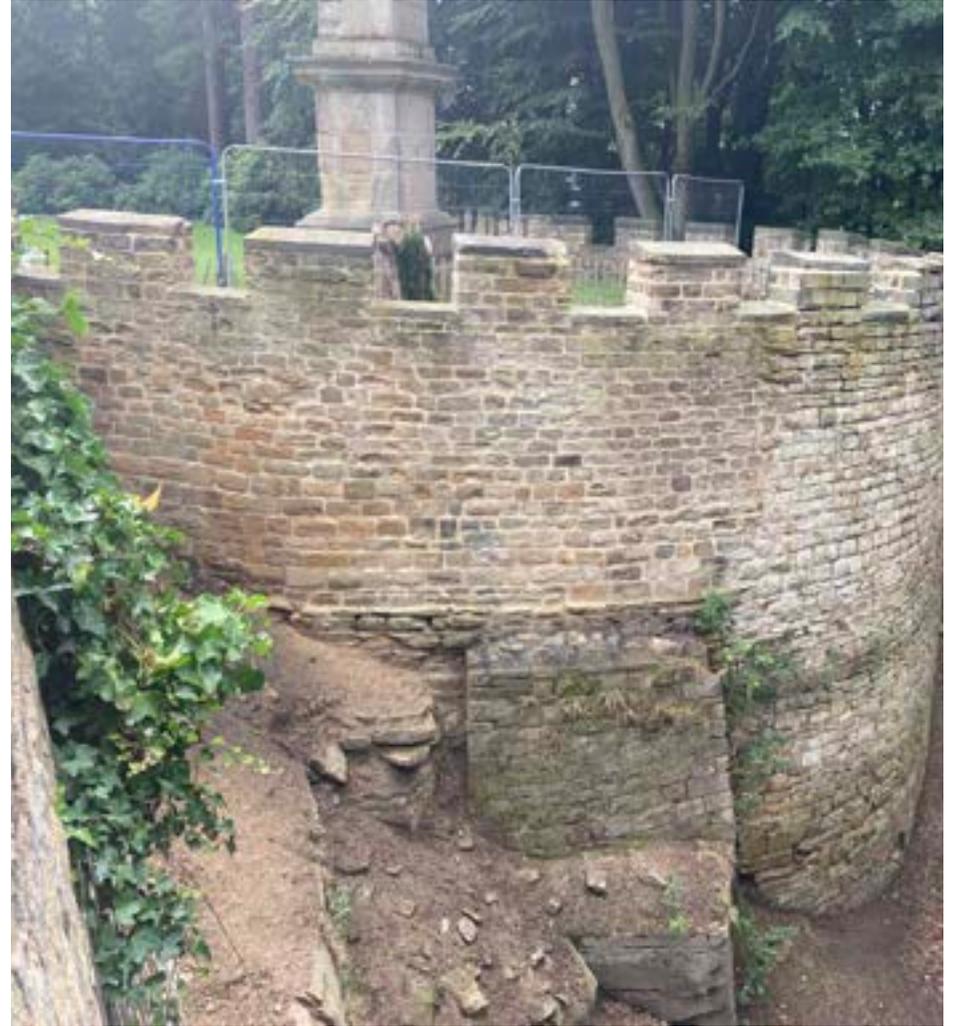
The South Bastion had deteriorated significantly, exhibiting eroded stonework, missing merlons and coping stones, cementitious mortar, and areas of displaced or fallen masonry. The remedial works comprised the replacement of damaged stones, which were carefully tooled to match the existing fabric. Merlons were repaired and reinstated, and existing coping stones were reset. Crenellations were reinstated to reflect the original size, style, and proportions of the historic merlons and embrasures. A cracked junction between the bastion and adjoining walling was rebuilt. Missing stonework was reinstated using matching stone and lime mortar. All elevations were cleared of vegetation, and open joints were repointed in lime mortar.

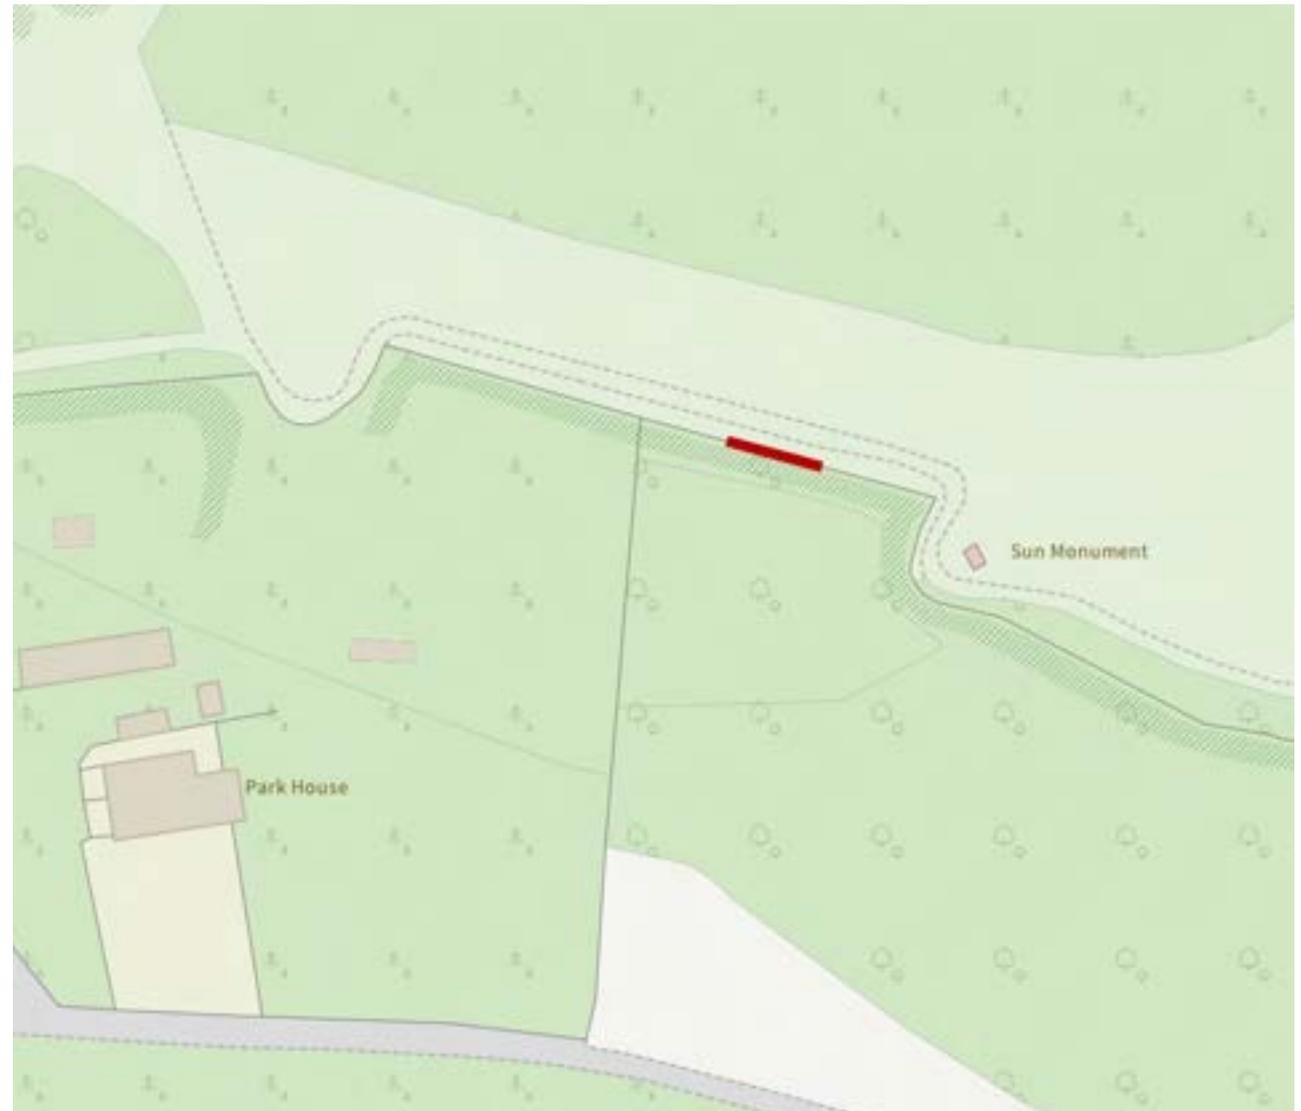
Section Two Location Plan (Historic England)

A 12-metre section of walling was identified in the condition survey as being in very poor condition, which was further substantiated upon commencement of site works. The stonework, compounded by cementitious mortar and mature tree growth, had resulted in significant bulging. Initially, the scope of works included repointing and minor stone repairs, including the rebuilding and reinstatement of merlons. However, following vegetation clearance, the extent of deterioration necessitated a more substantial intervention, including partial wall reconstruction.

Existing stones were carefully dismantled, catalogued, and reinstated in their original positions. This approach, although involving rebuilding, remained like-for-like due to the reuse of original materials and the application of lime mortar, consistent with the methodology used for merlon reconstruction. Weep holes were introduced to facilitate rainwater management. A movement gap was left between this section and the adjacent collapsed area to prevent possible movement from compromising the newly rebuilt wall. This gap was subsequently closed and pointed in lime mortar, in conjunction with the reconstruction of the collapsed section.
