**Wentworth Castle Gardens | Battlements**

**Photographic Recording Document**

2025

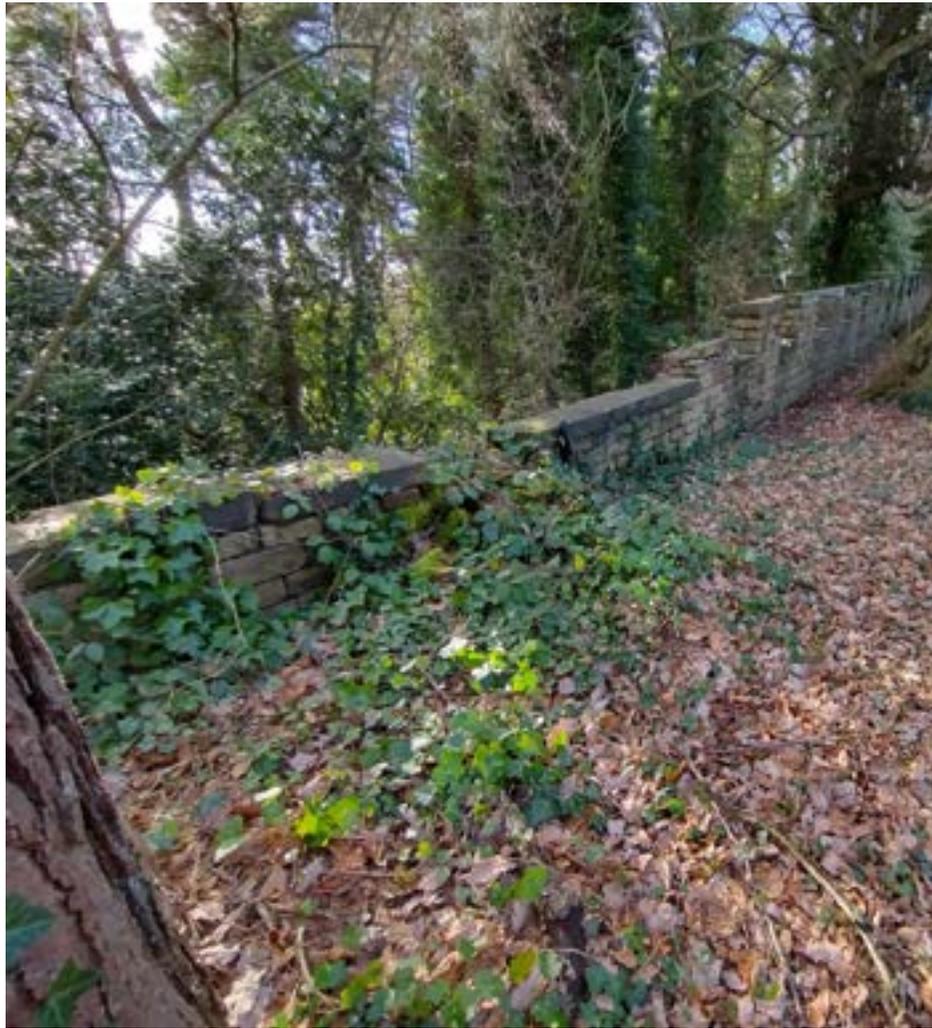
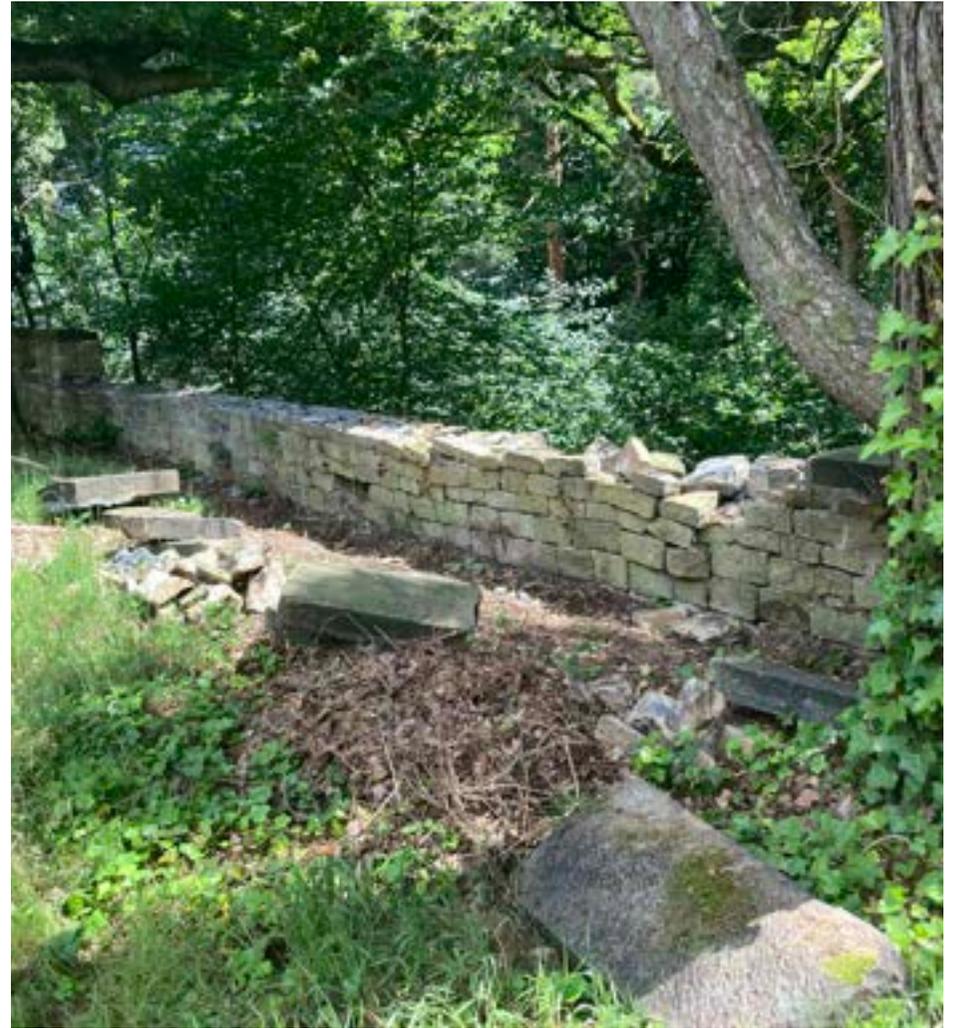
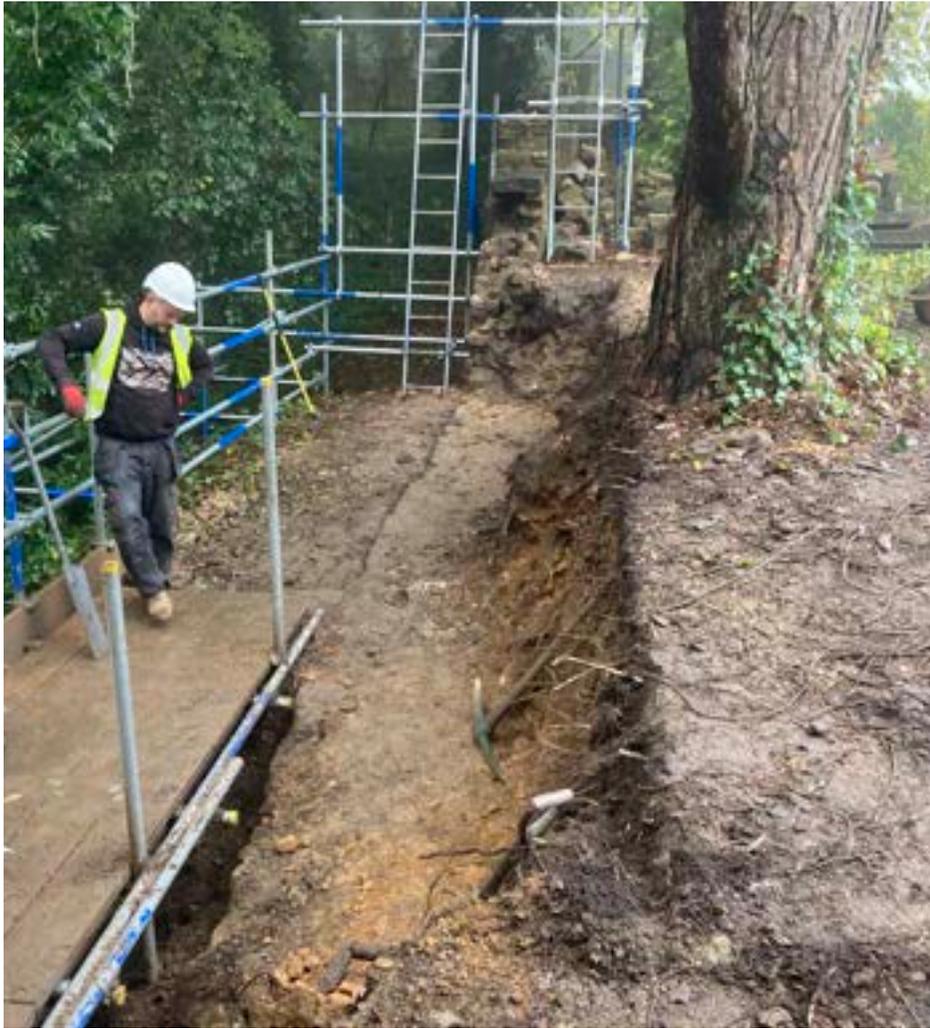
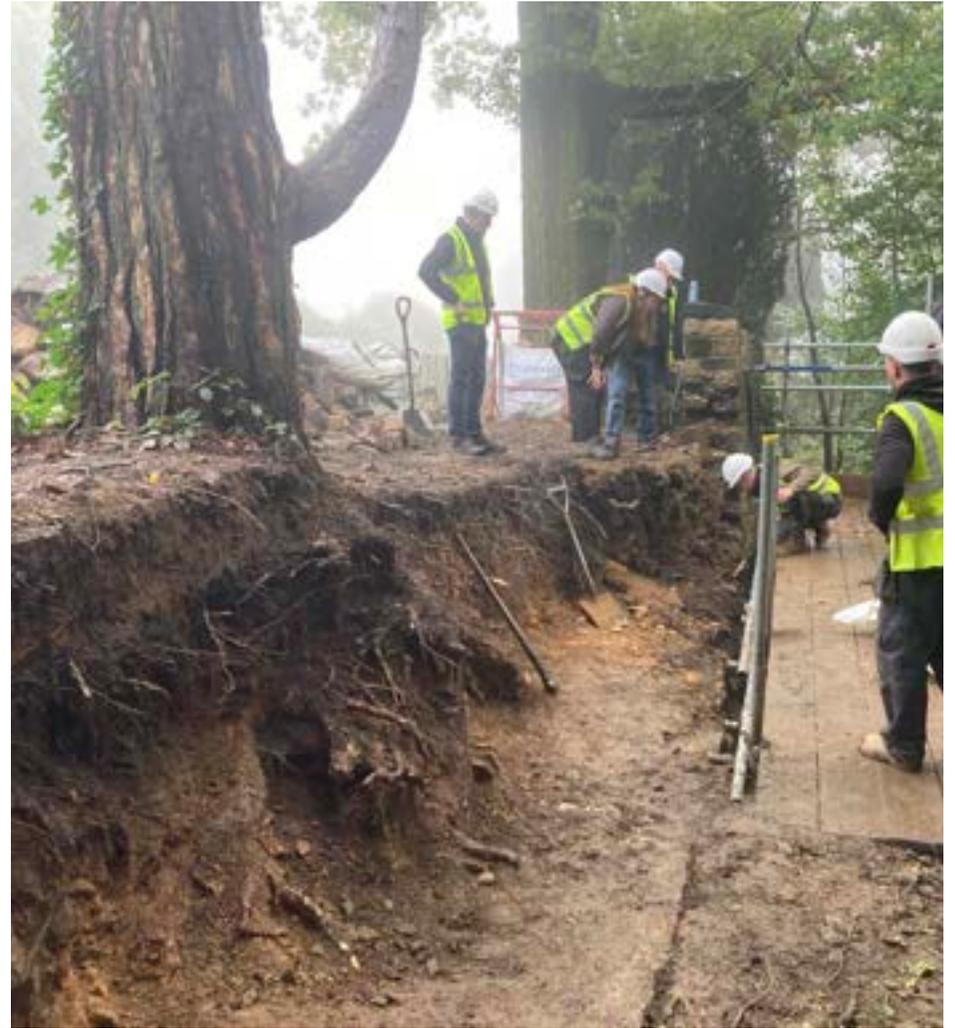
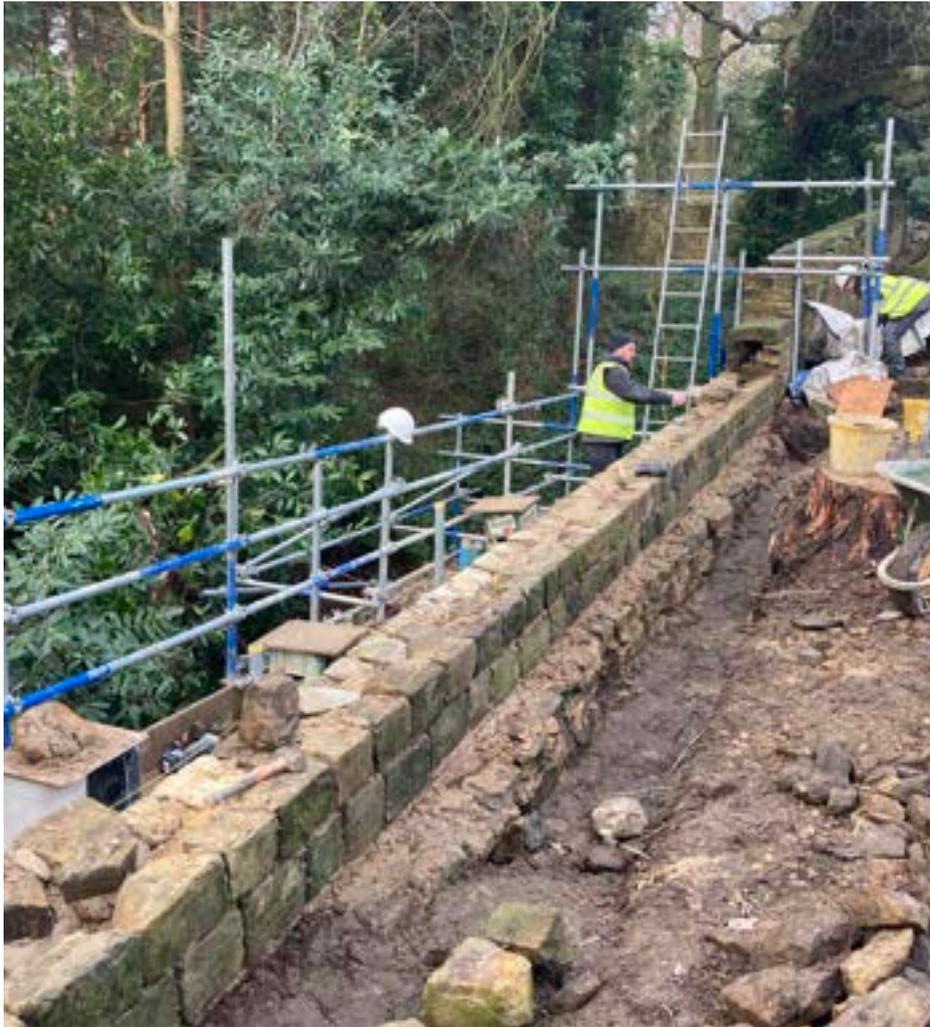
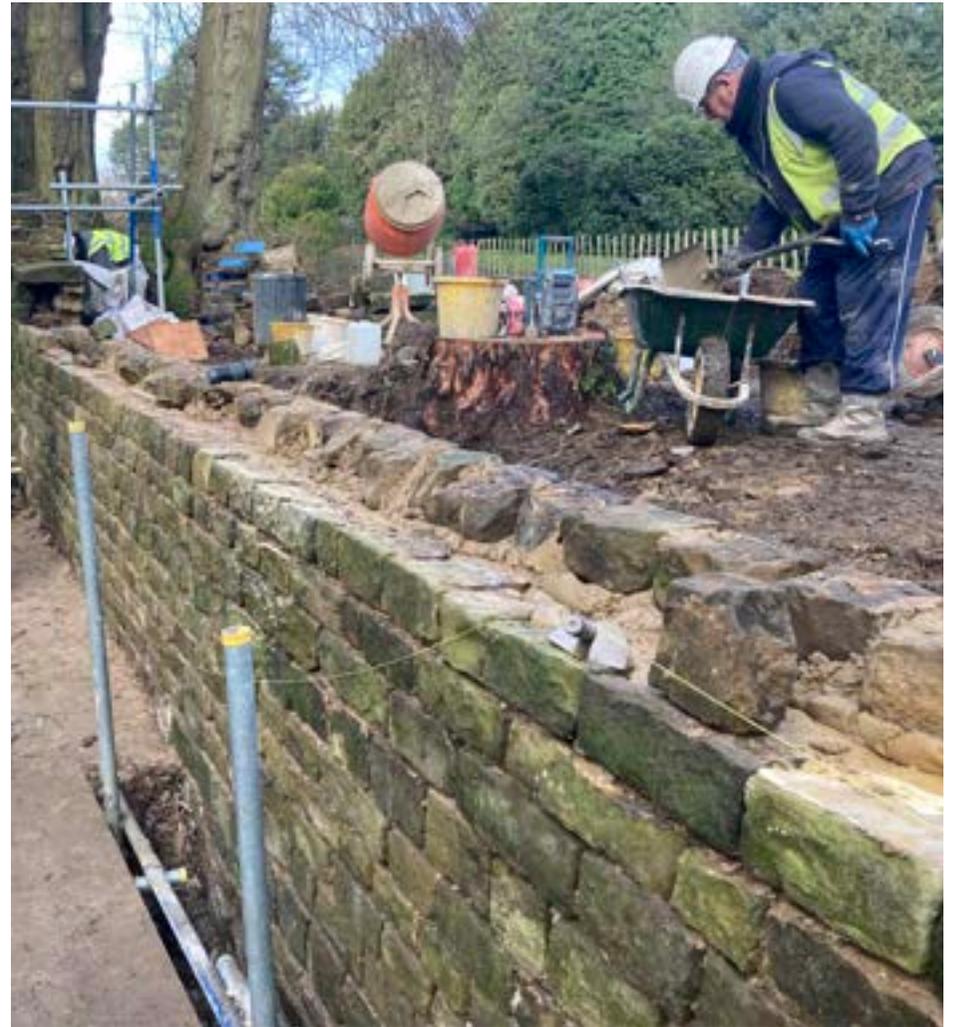
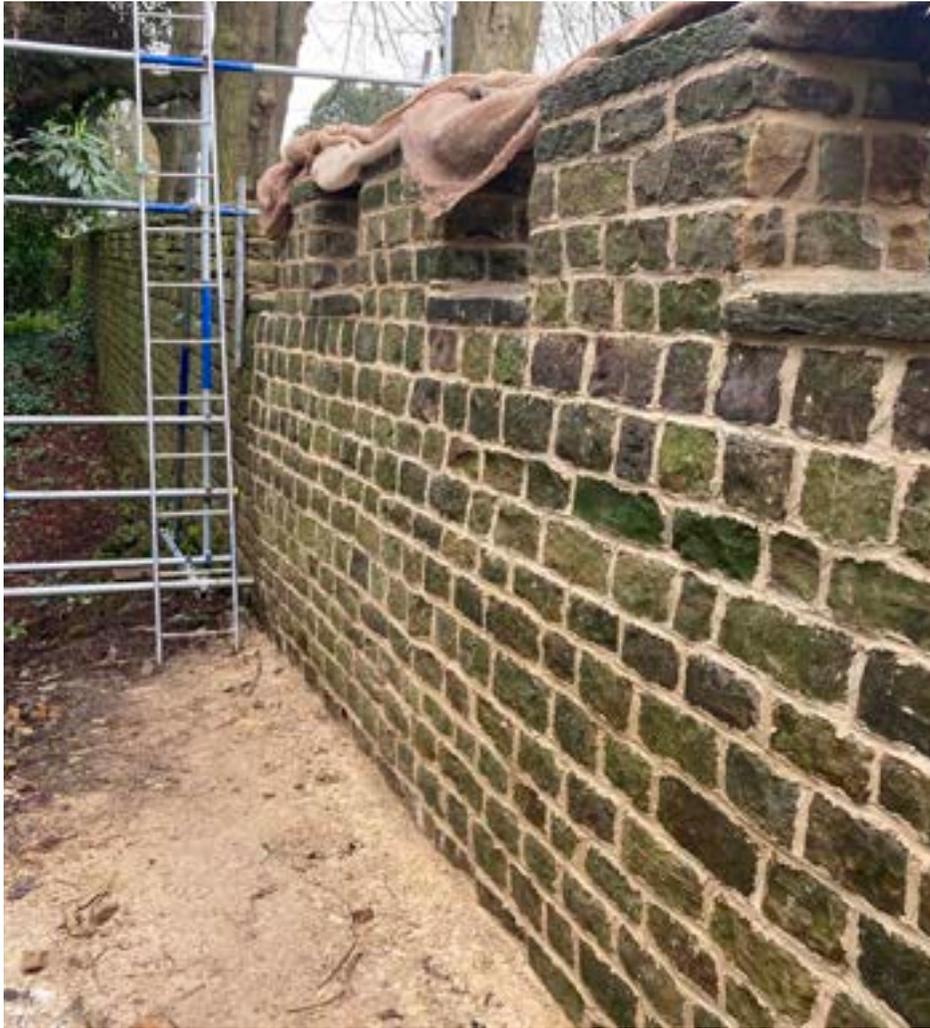
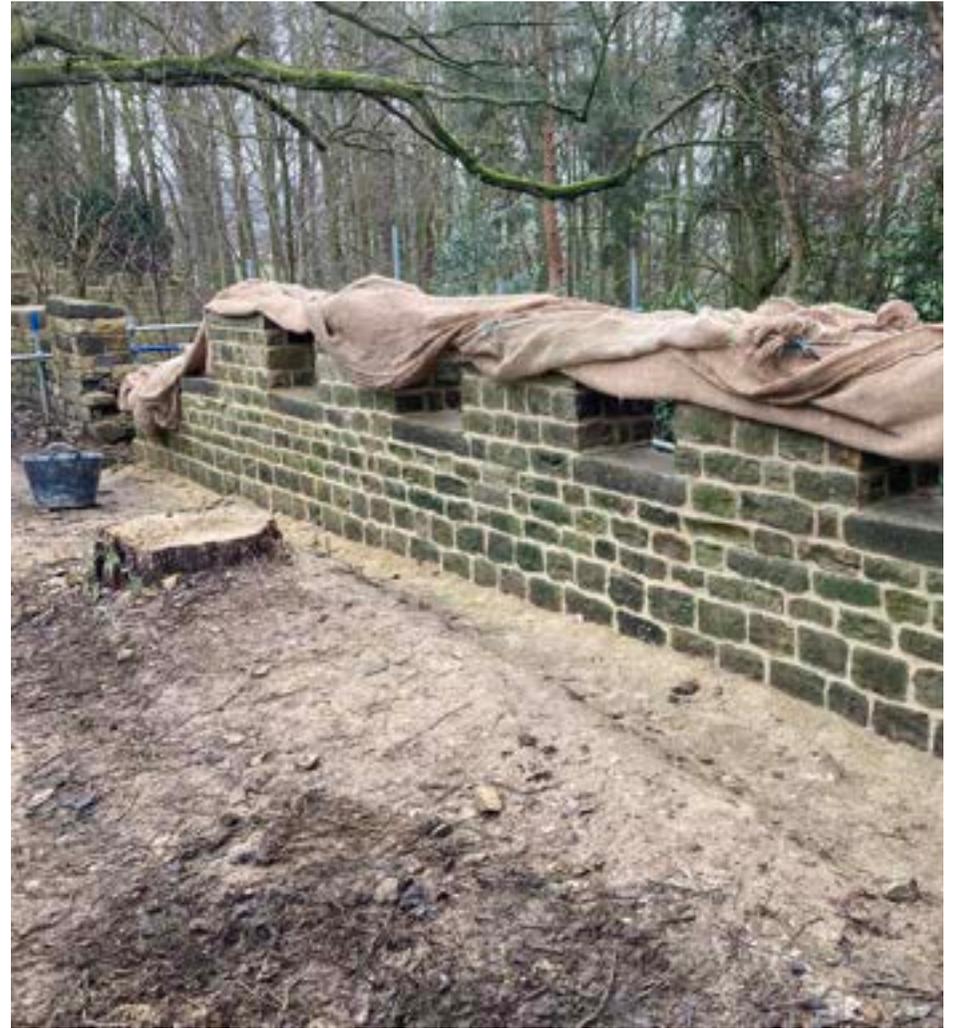
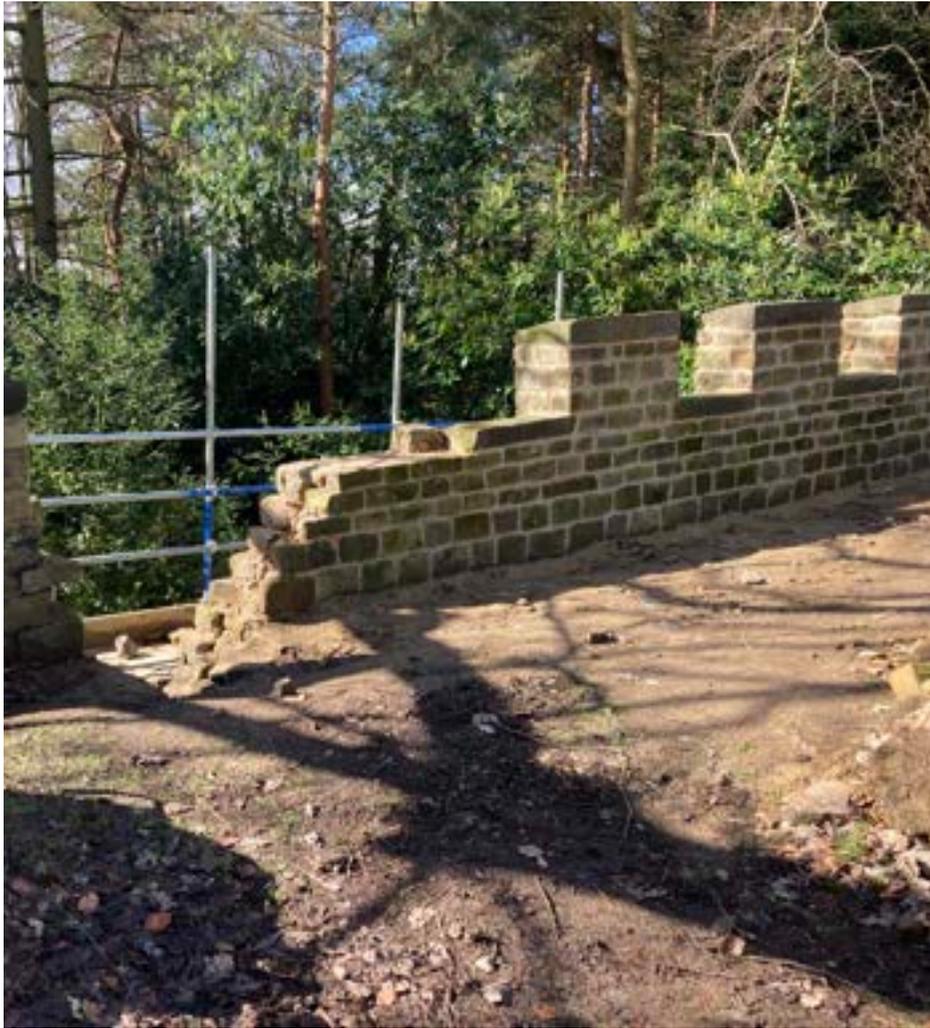
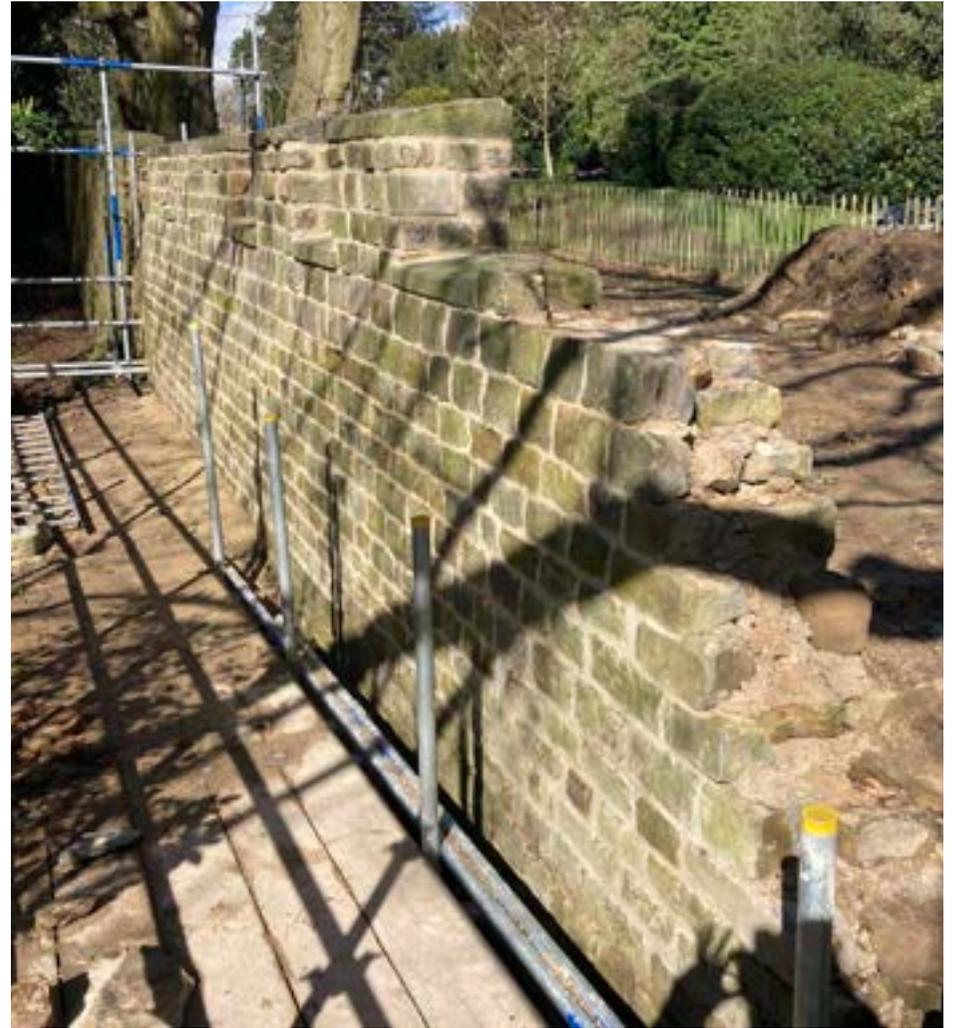
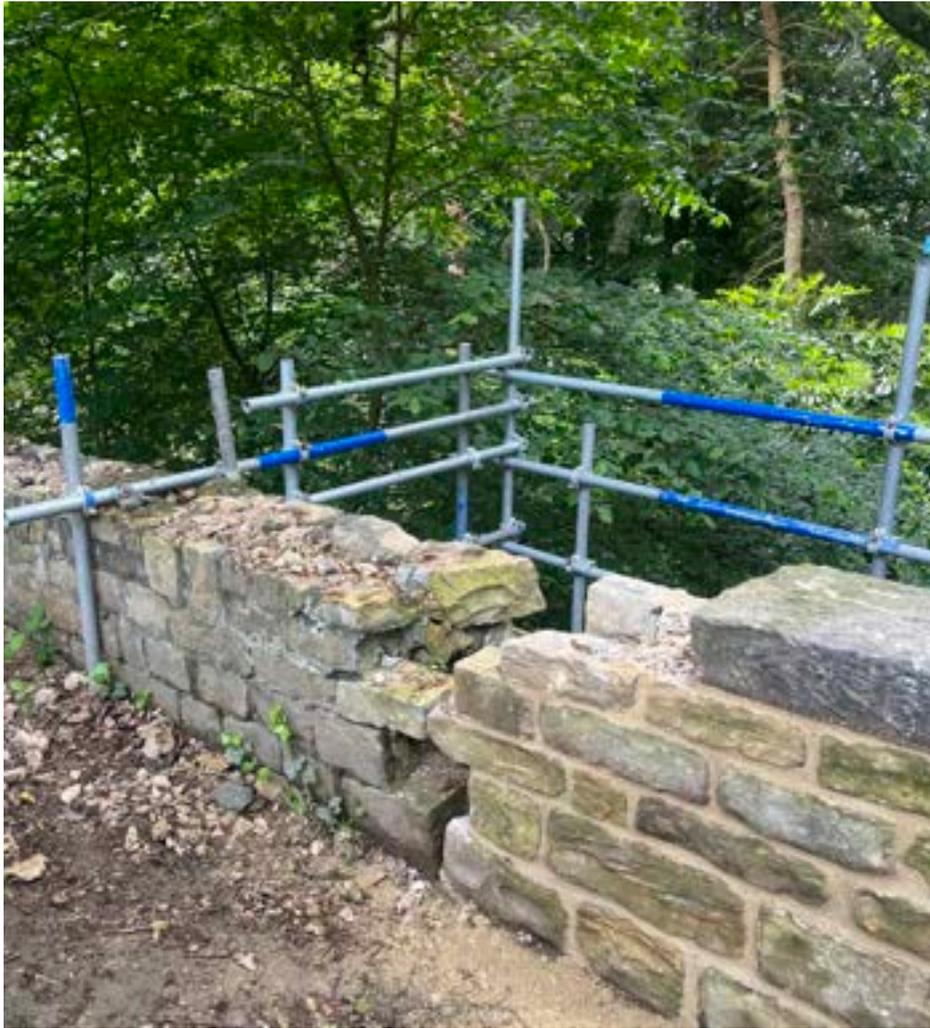
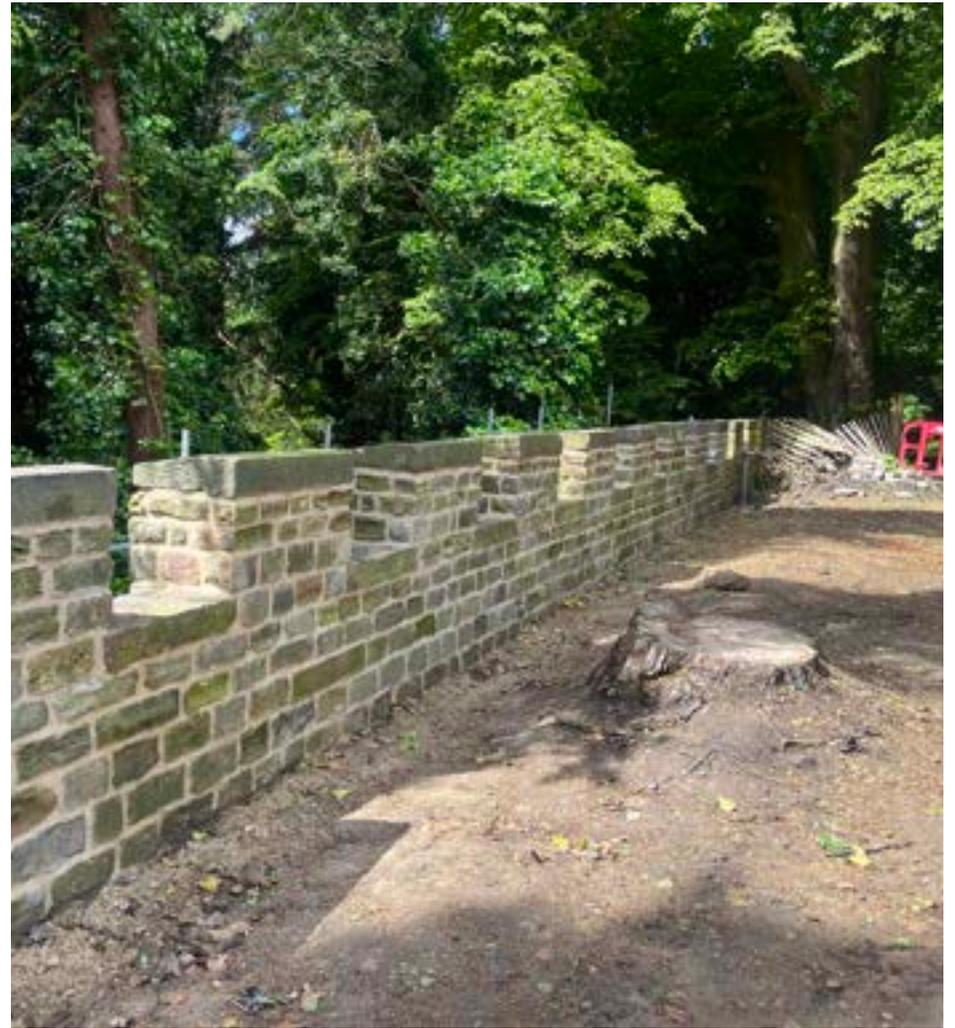
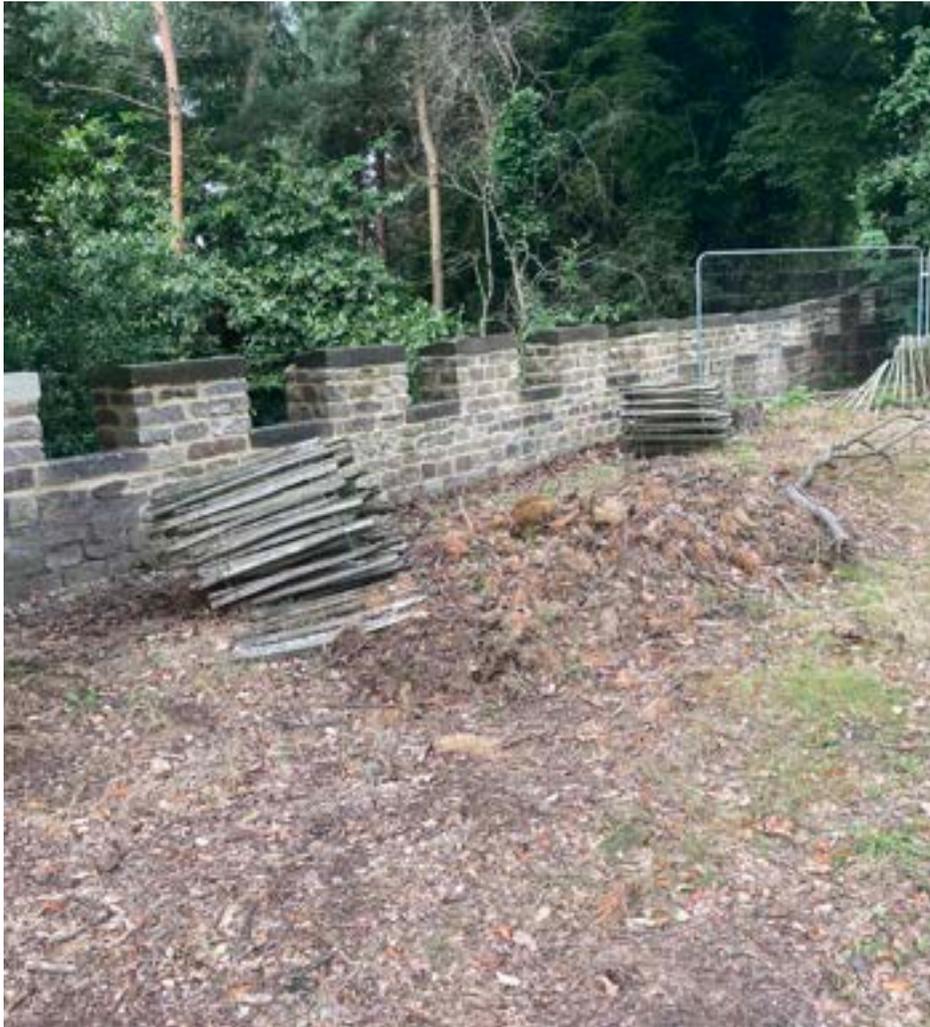
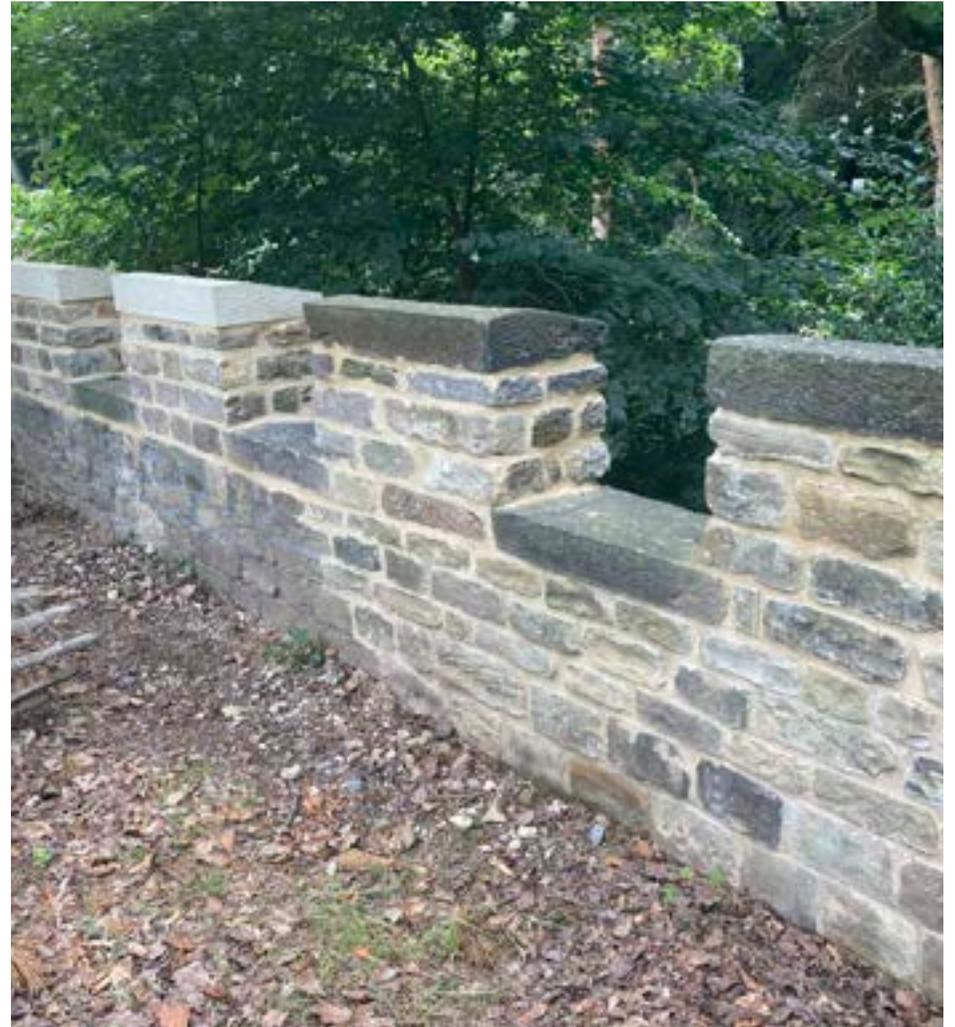
A 12-metre section of walling was identified in the condition survey as being in very poor condition, which was further substantiated upon commencement of site works. The stonework, compounded by cementitious mortar and mature tree growth, had resulted in significant bulging. Initially, the scope of works included repointing and minor stone repairs, including the rebuilding and reinstatement of merlons. However, following vegetation clearance, the extent of deterioration necessitated a more substantial intervention, including partial wall reconstruction.

Existing stones were carefully dismantled, catalogued, and reinstated in their original positions. This approach, although involving rebuilding, remained like-for-like due to the reuse of original materials and the application of lime mortar, consistent with the methodology used for merlon reconstruction. Weep holes were introduced to facilitate rainwater management. A movement gap was left between this section and the adjacent collapsed area to prevent possible movement from compromising the newly rebuilt wall. This gap was subsequently closed and pointed in lime mortar, in conjunction with the reconstruction of the collapsed section.

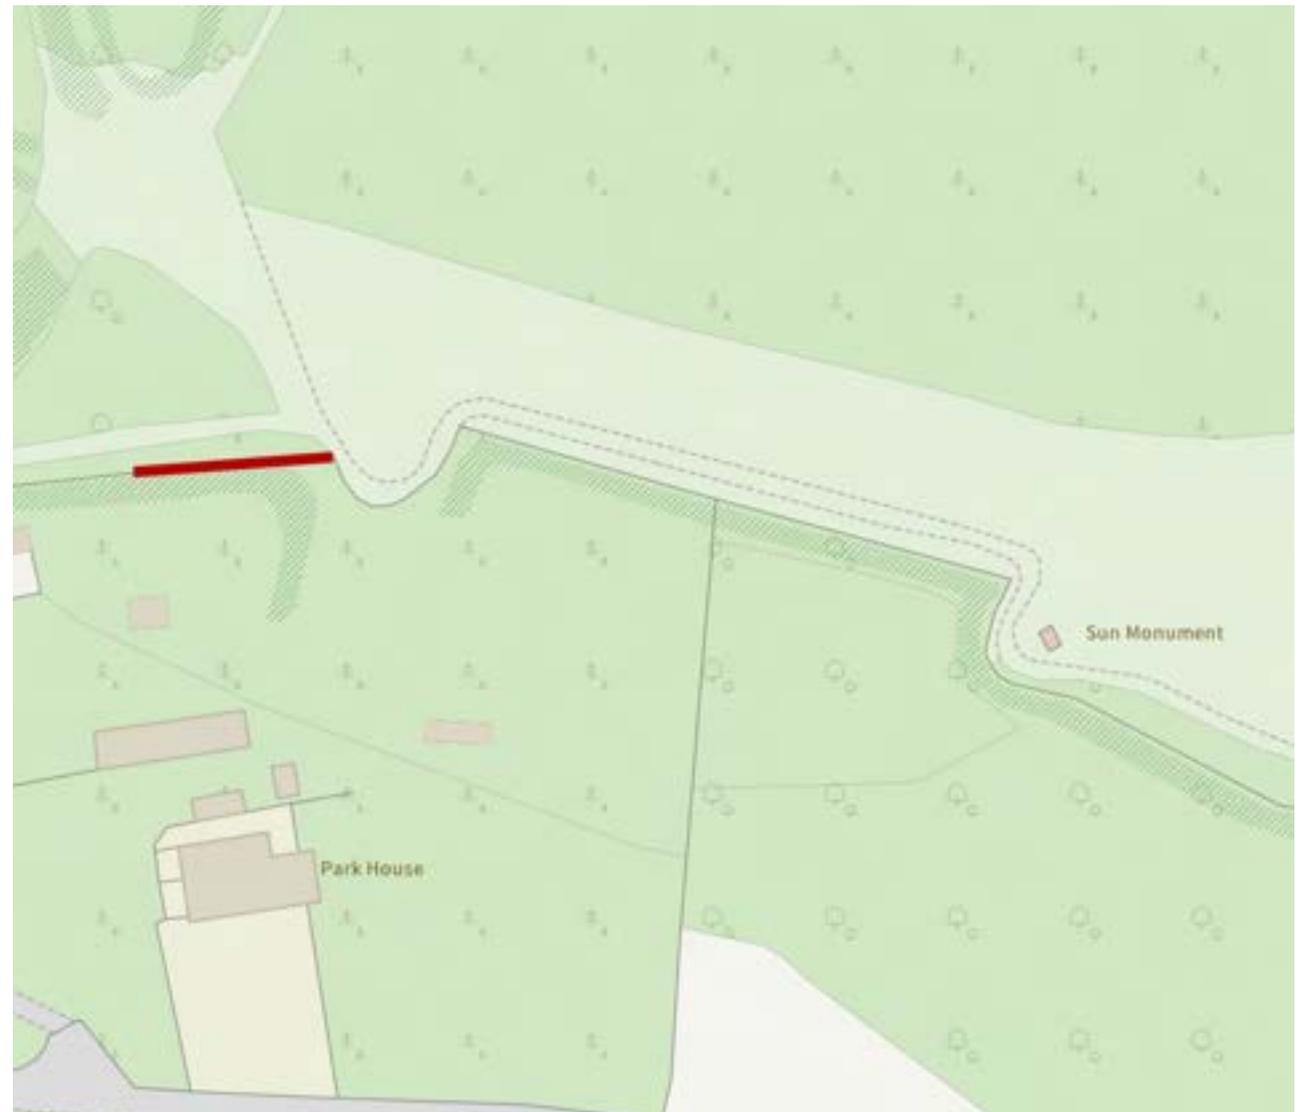
Section Three Location Plan (Historic England)

A 21-metre section of walling was also identified as being in very poor condition, with severely eroded stonework and the presence of cementitious mortar and vegetation contributing to poor structural integrity and the collapse of a number of merlons. The initial repair strategy involved repointing and stonework repairs, including the rebuilding and reinstatement of merlons. However, the condition was found to be worse than anticipated, necessitating partial reconstruction.

Stones were carefully removed, sorted, and reinstated in their original positions where possible, particularly to the public-facing east elevation. Where stonework on the west-facing elevation was beyond salvage, reclaimed stones were introduced. This ensured that the east elevation retained its original appearance, utilising as much existing material as possible with reclaimed material where necessary. Merlons were rebuilt, and existing coping stones were reinstated using lime mortar.
