**Wentworth Castle Gardens | Battlements**

**Photographic Recording Document**

2025

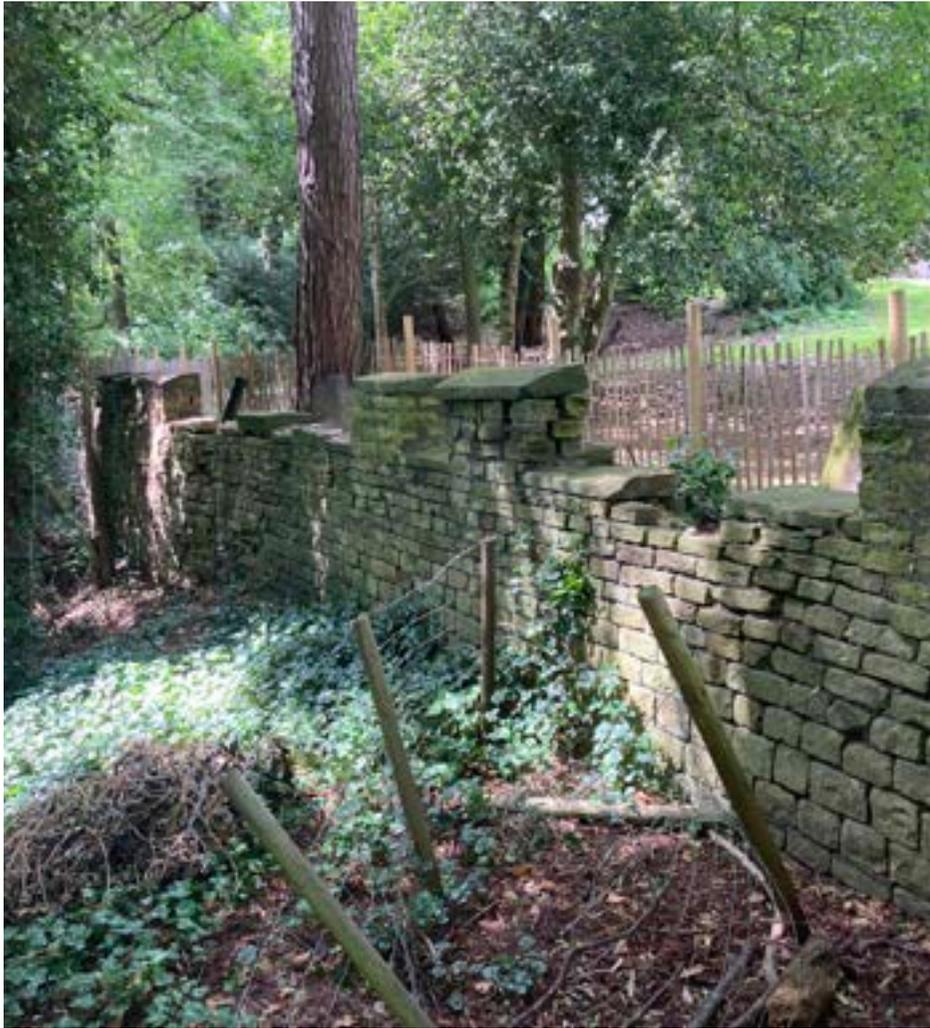
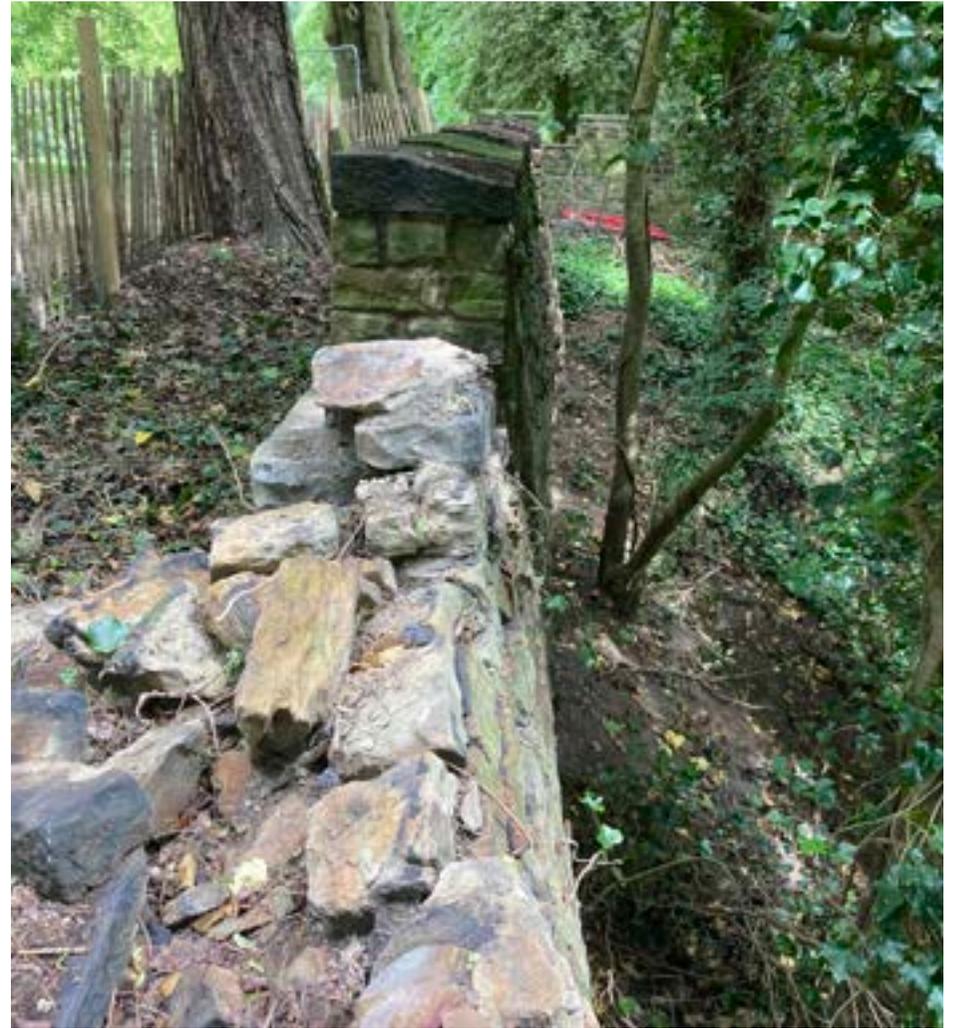
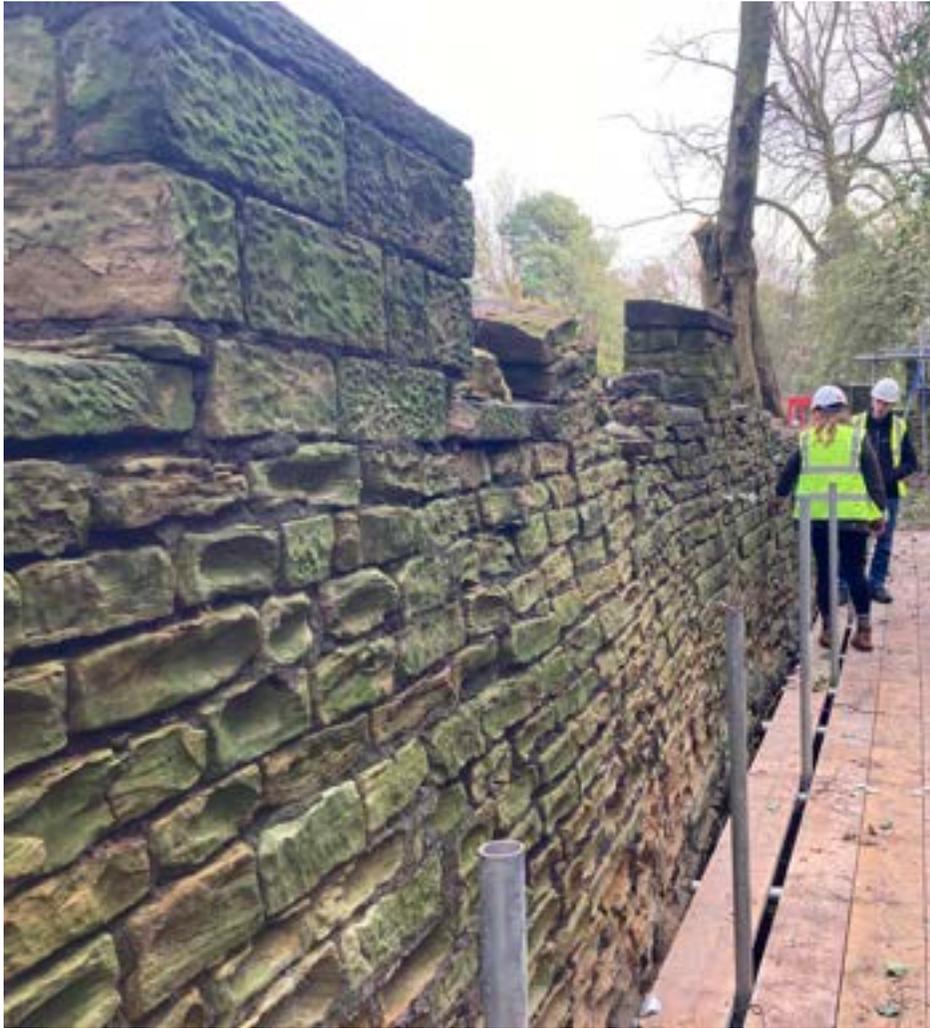
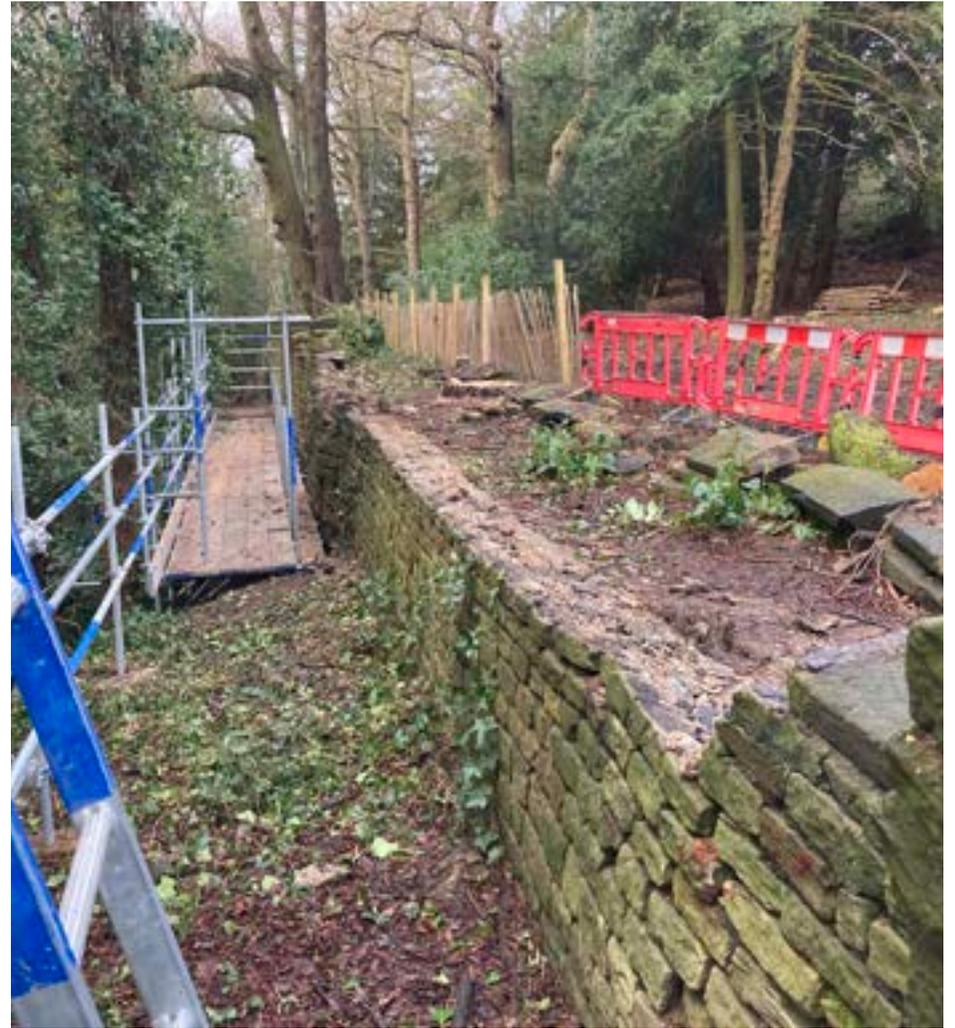
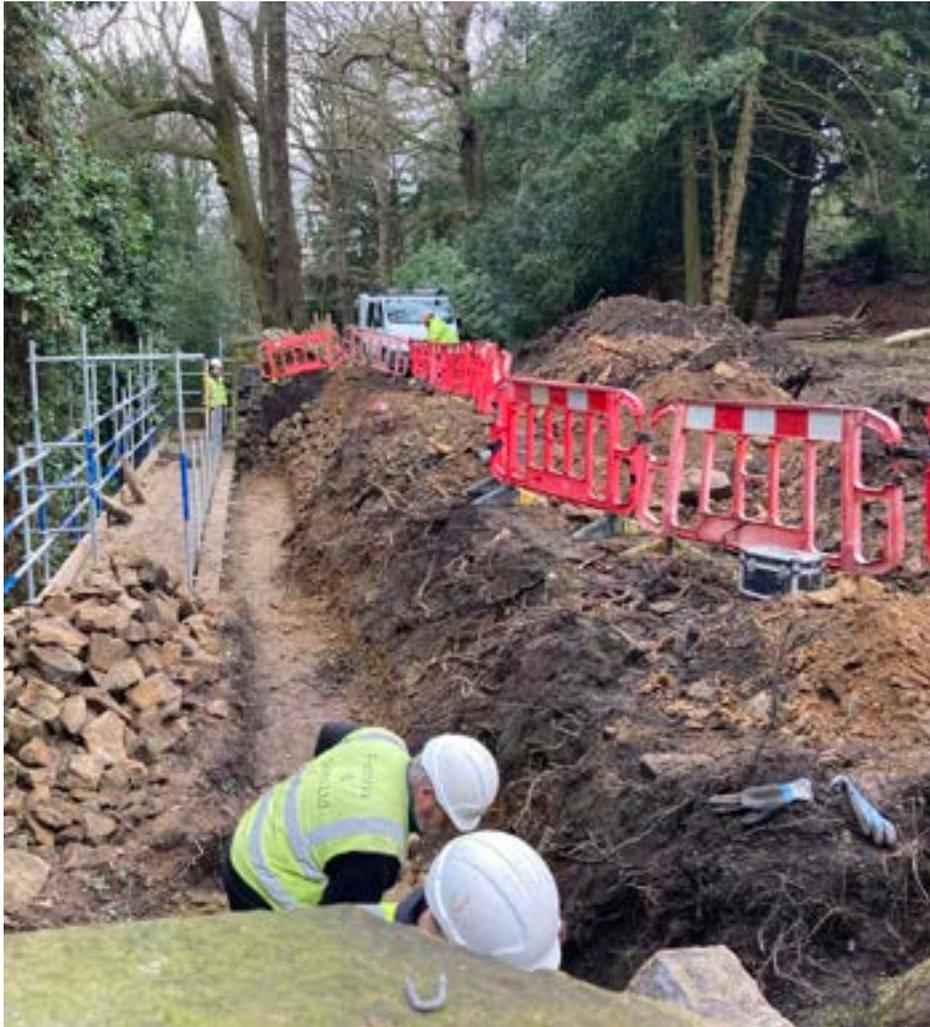
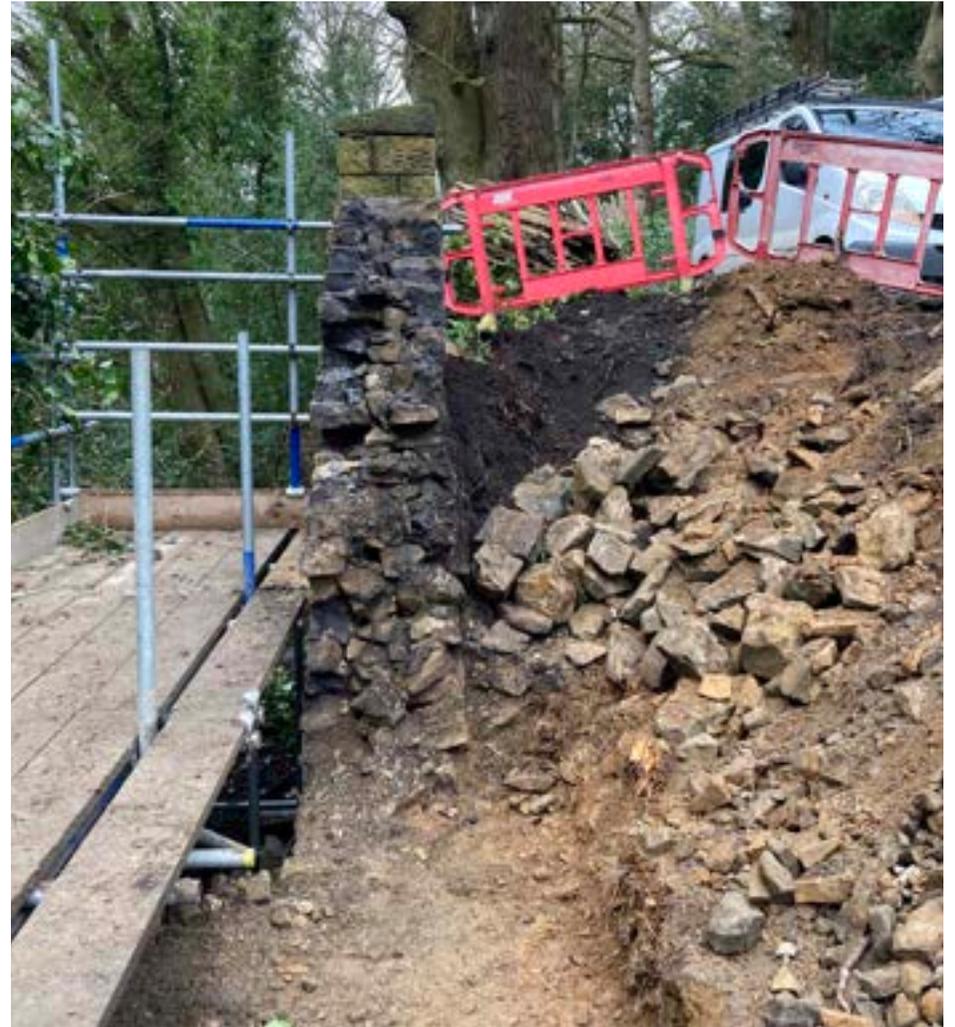
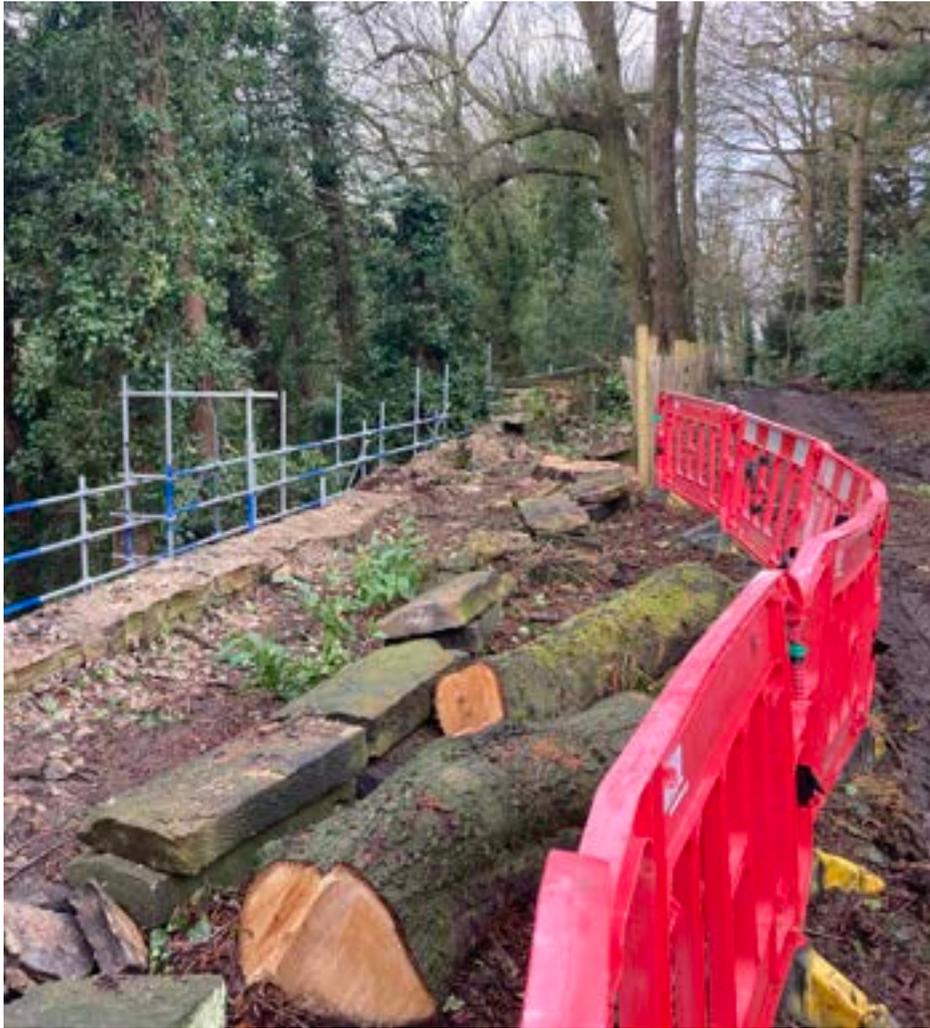
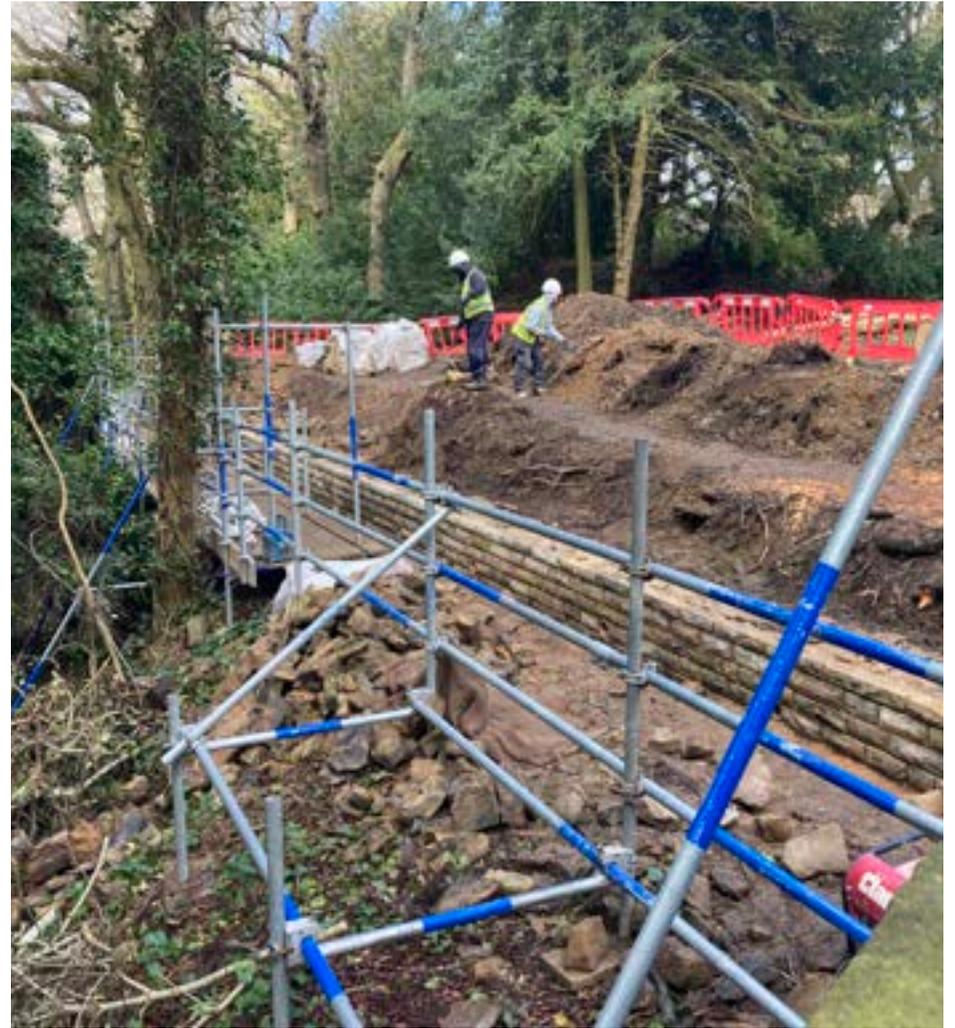
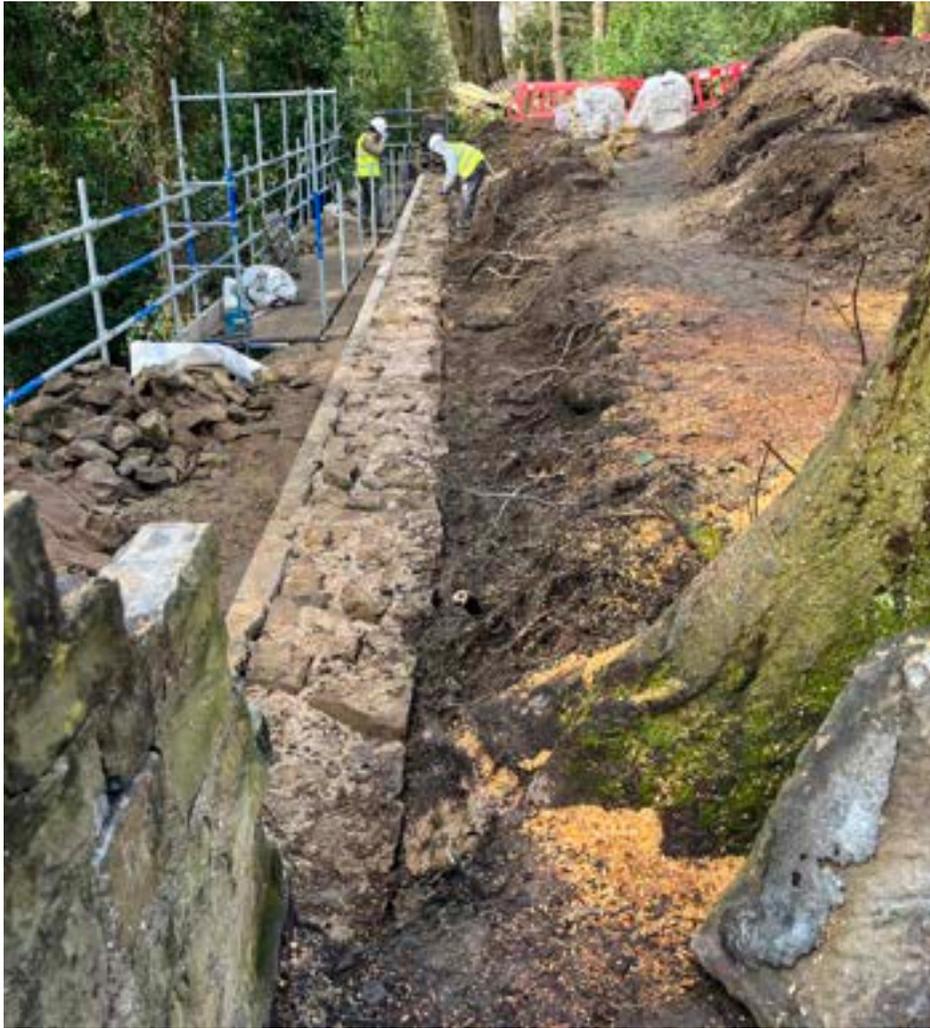
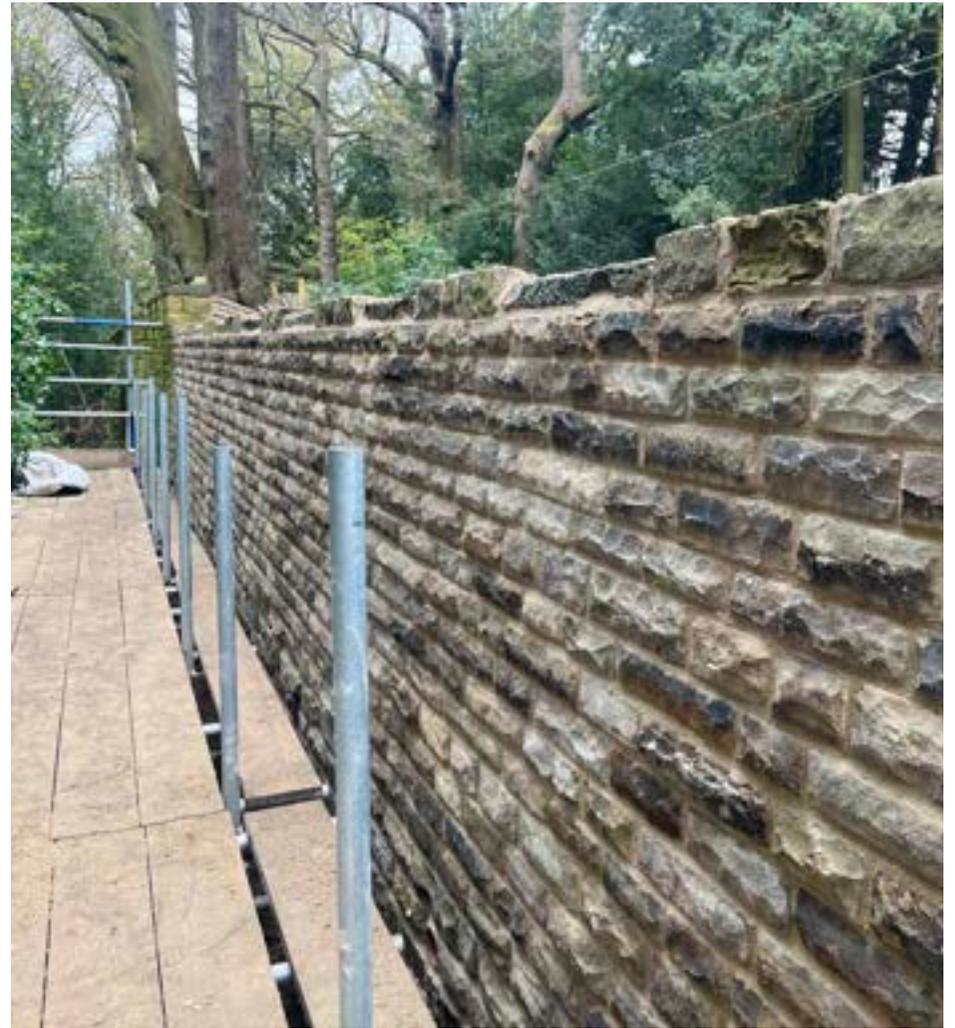
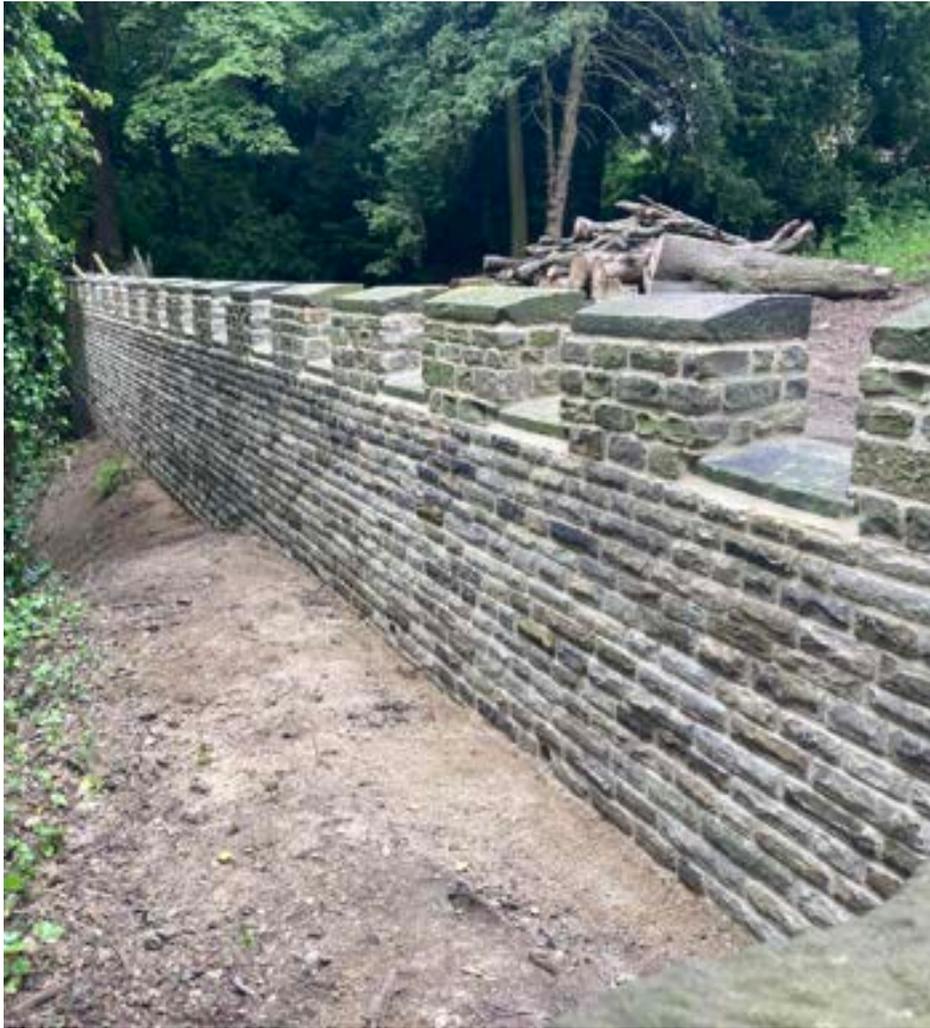
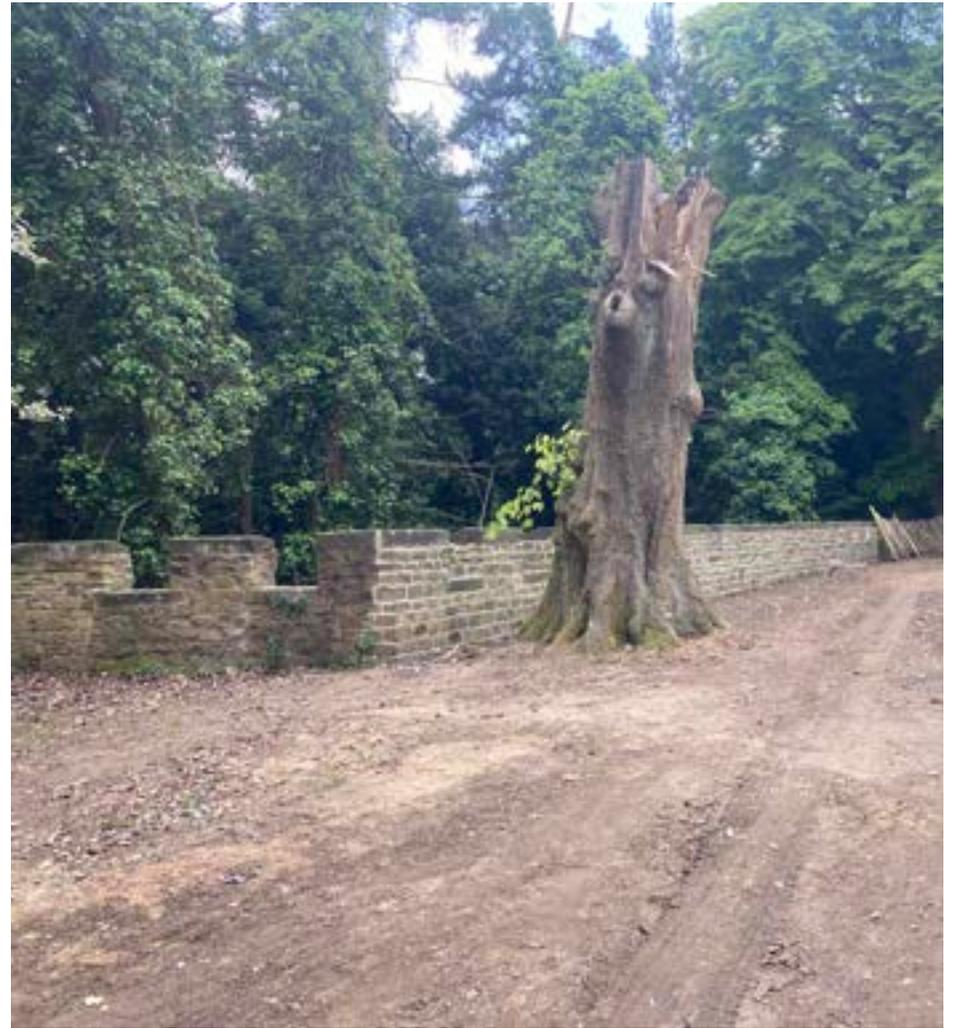
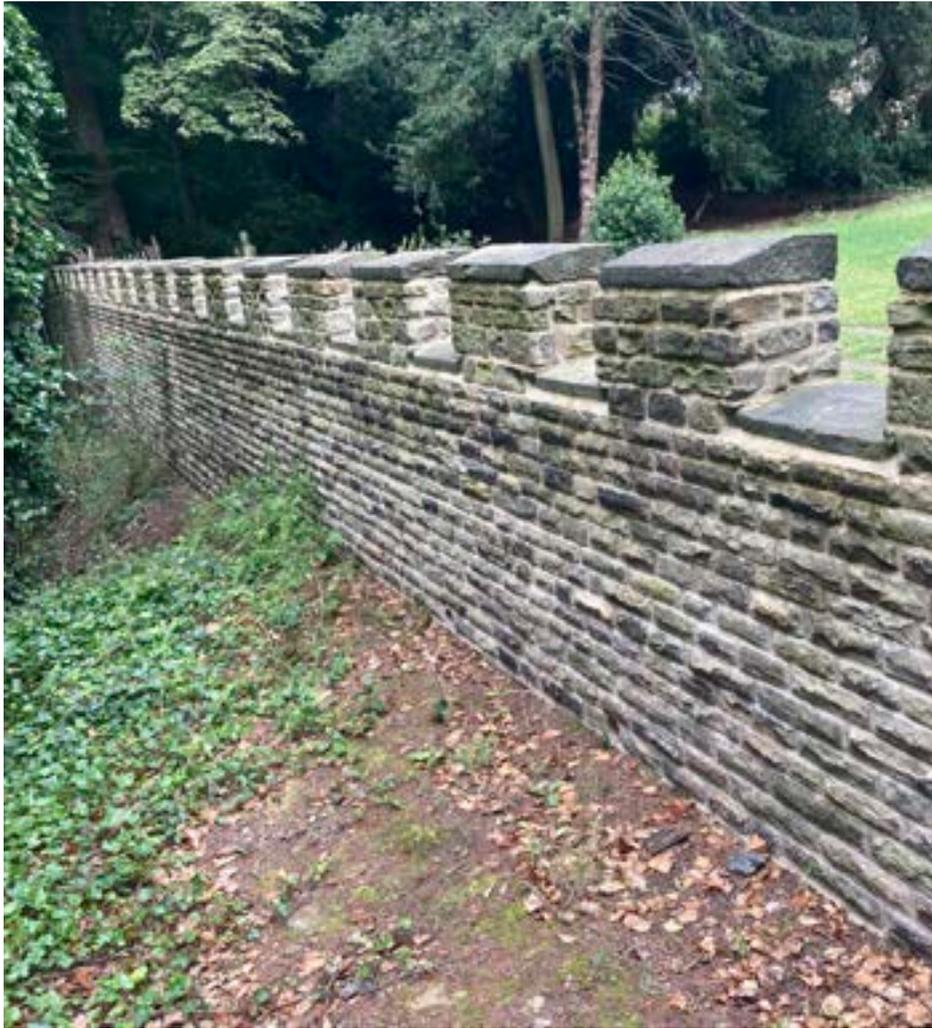
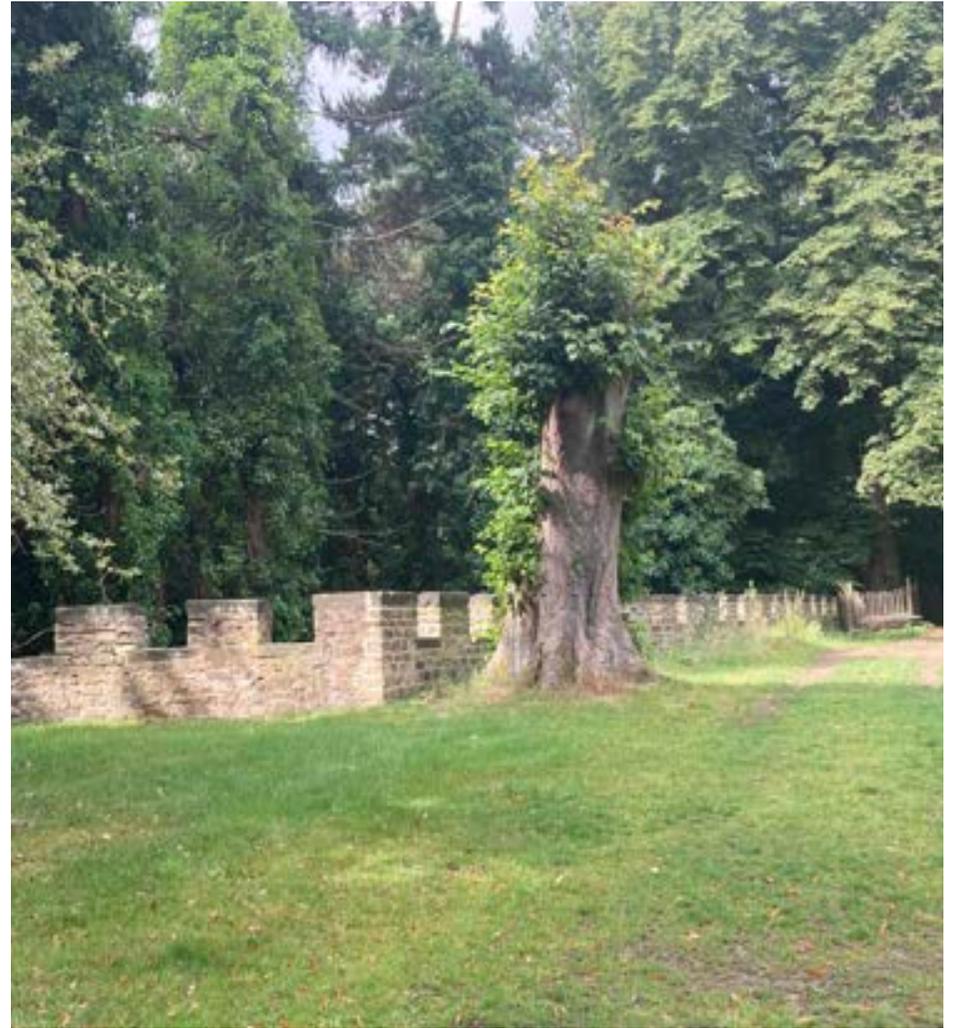
A 21-metre section of walling was also identified as being in very poor condition, with severely eroded stonework and the presence of cementitious mortar and vegetation contributing to poor structural integrity and the collapse of a number of merlons. The initial repair strategy involved repointing and stonework repairs, including the rebuilding and reinstatement of merlons. However, the condition was found to be worse than anticipated, necessitating partial reconstruction.

Stones were carefully removed, sorted, and reinstated in their original positions where possible, particularly to the public-facing east elevation. Where stonework on the west-facing elevation was beyond salvage, reclaimed stones were introduced. This ensured that the east elevation retained its original appearance, utilising as much existing material as possible with reclaimed material where necessary. Merlons were rebuilt, and existing coping stones were reinstated using lime mortar.

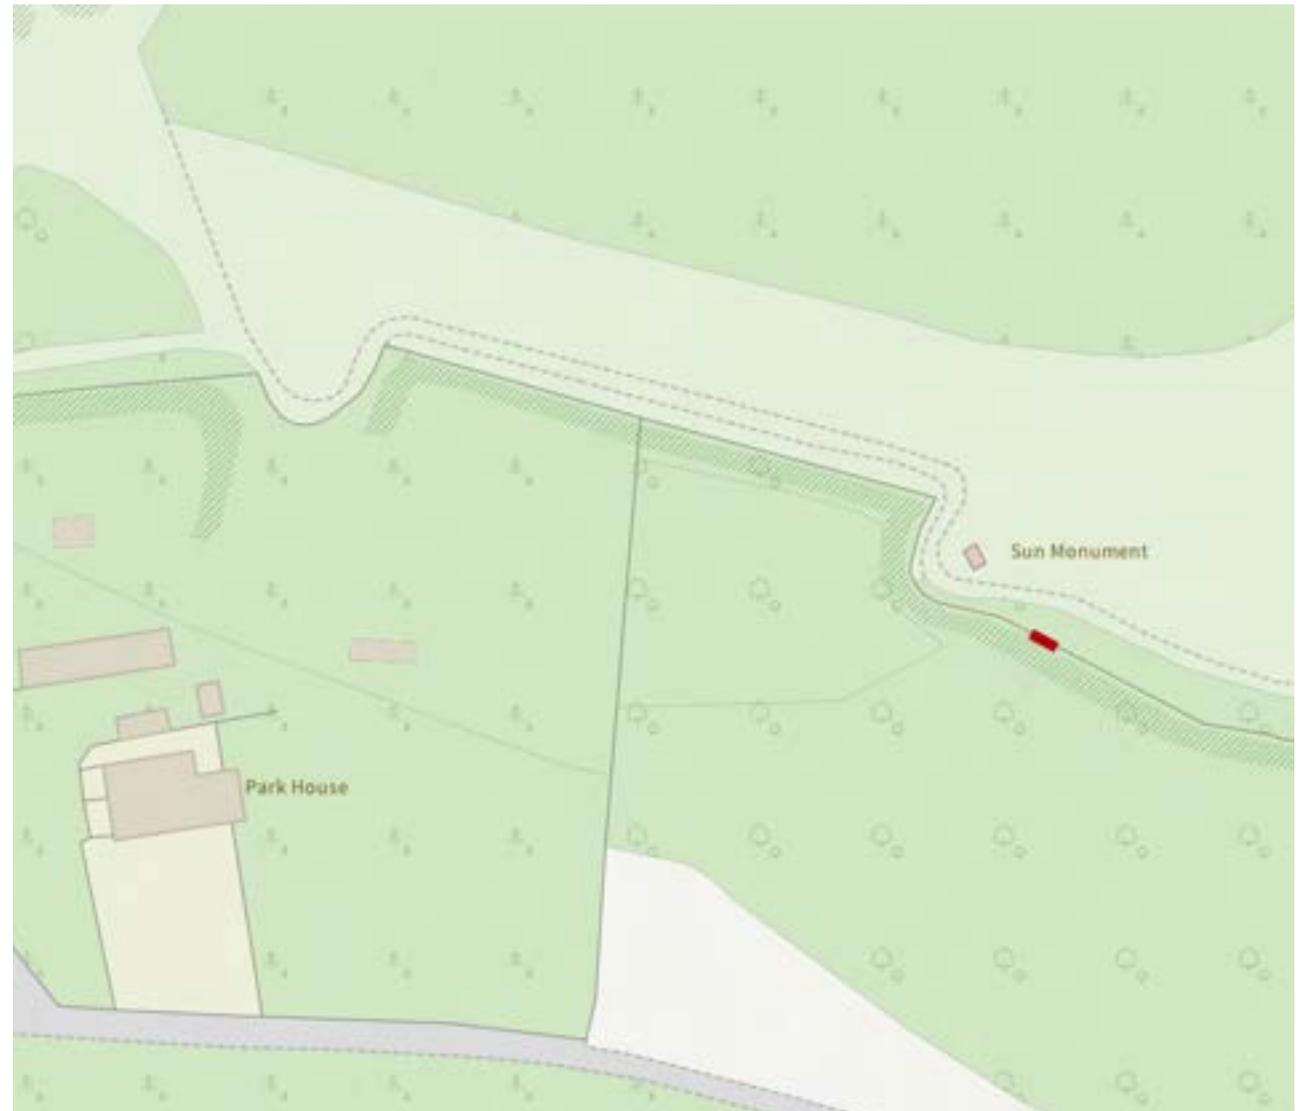
Section Four Location Plan (Historic England)

A ground-level section of the battlement wall was found to be in poor condition, exhibiting bulging, missing stones, and cementitious mortar. The proposed works included minor stone repairs and repointing in lime mortar. The lower bulging section was rebuilt and consolidated using lime mortar, ensuring all voids were fully packed to maintain structural integrity.

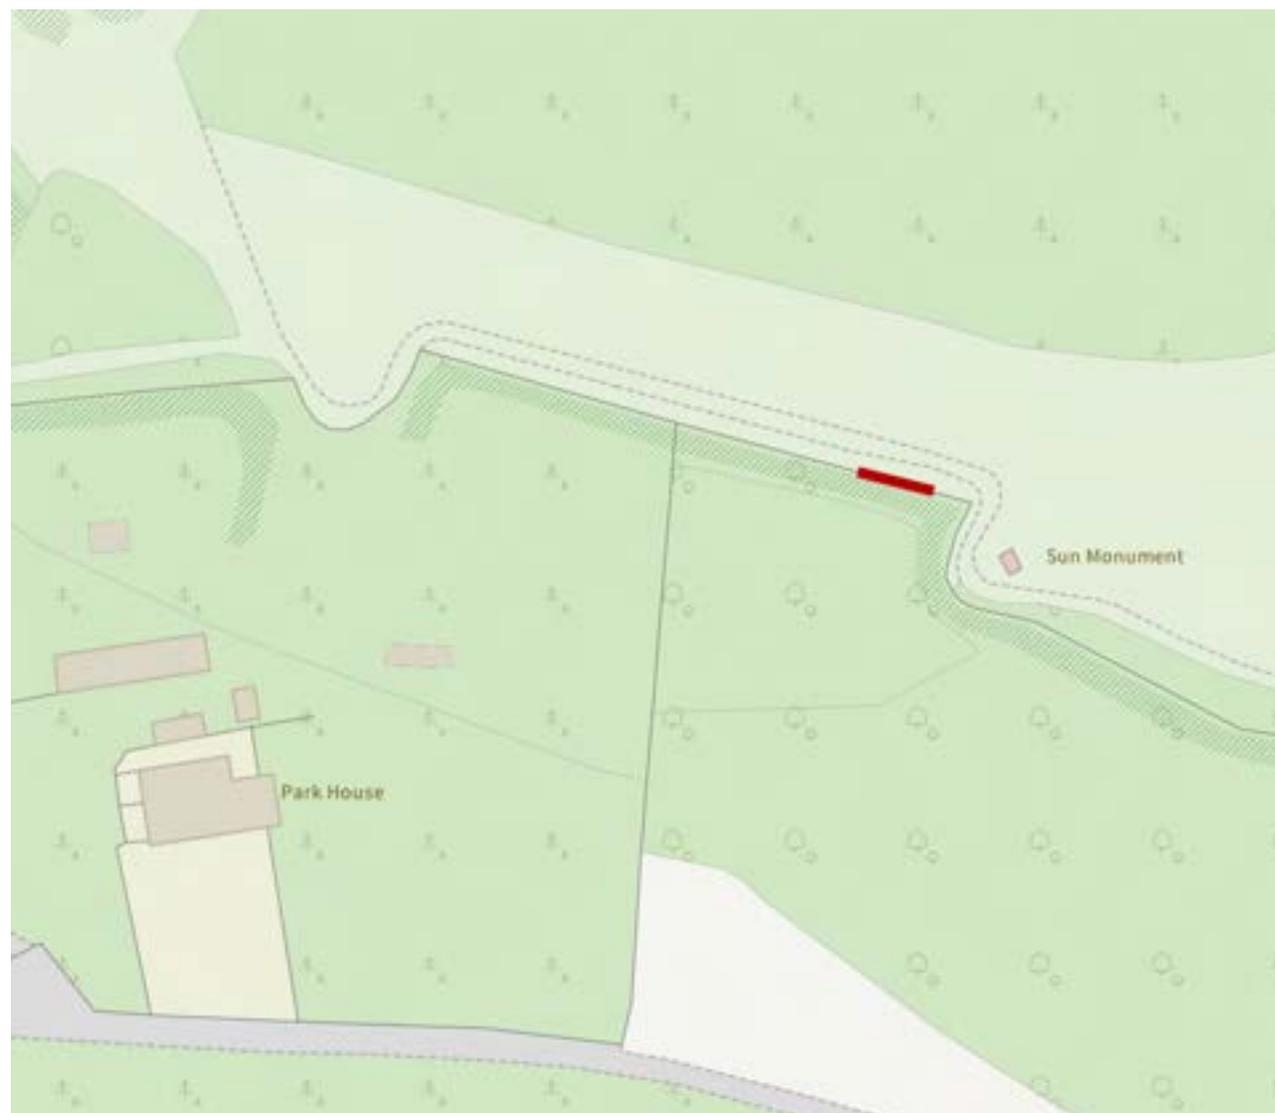
Section Five Location Plan (Historic England)

A section of the battlements collapsed in November 2023. The collapse was attributed to pressure exerted by nearby mature trees and waterlogged ground, exacerbated by cementitious pointing which had trapped moisture within the structure.

Following clearance, an inspection by the contractor and structural engineer revealed that the original wall had been constructed directly onto bedrock, which in places was insufficient to bear the required loads. A concrete kerb was therefore installed at the base of the affected section to provide a stable and continuous foundation. This kerb was positioned below ground level and remains concealed, preserving the visual and historic character of the battlements.

To address drainage concerns, the wedge between the soil-facing side and the dry-stone wall was filled with Type 3 aggregate, enclosed within a Terram geotextile membrane. This configuration allows water to percolate through to a perforated drain and weep holes at the base of the wall. Merlons were rebuilt and all new works were carried out using lime mortar and matching stone, in keeping with the traditional materials and character of the battlements.
