**Wentworth Castle Gardens | Battlements**

**Photographic Recording Document**

2025

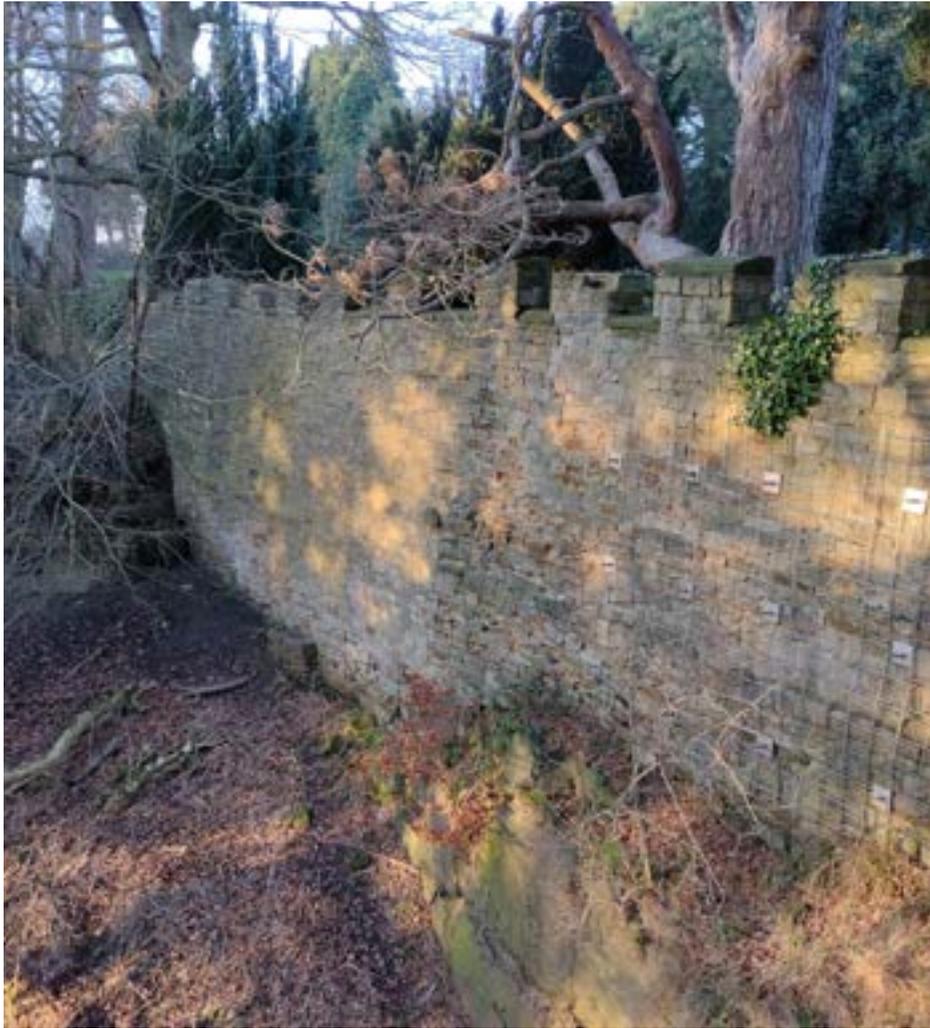
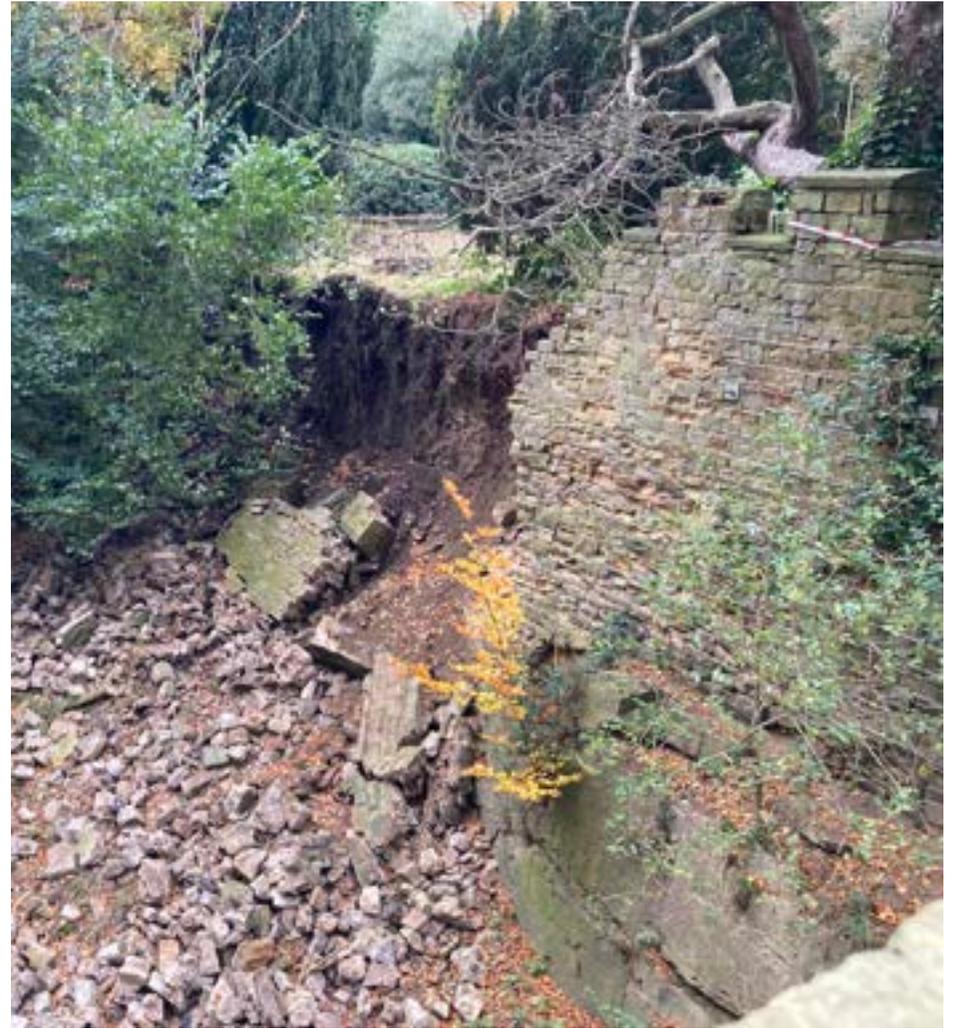
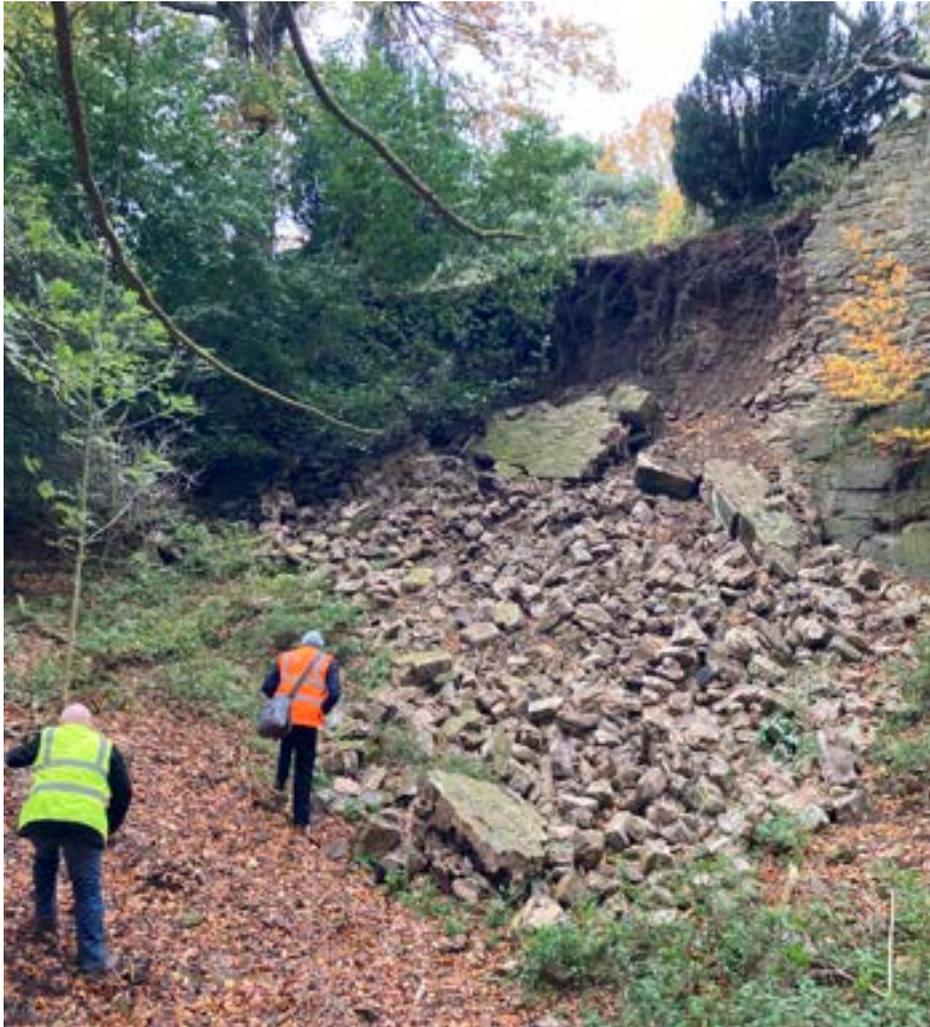
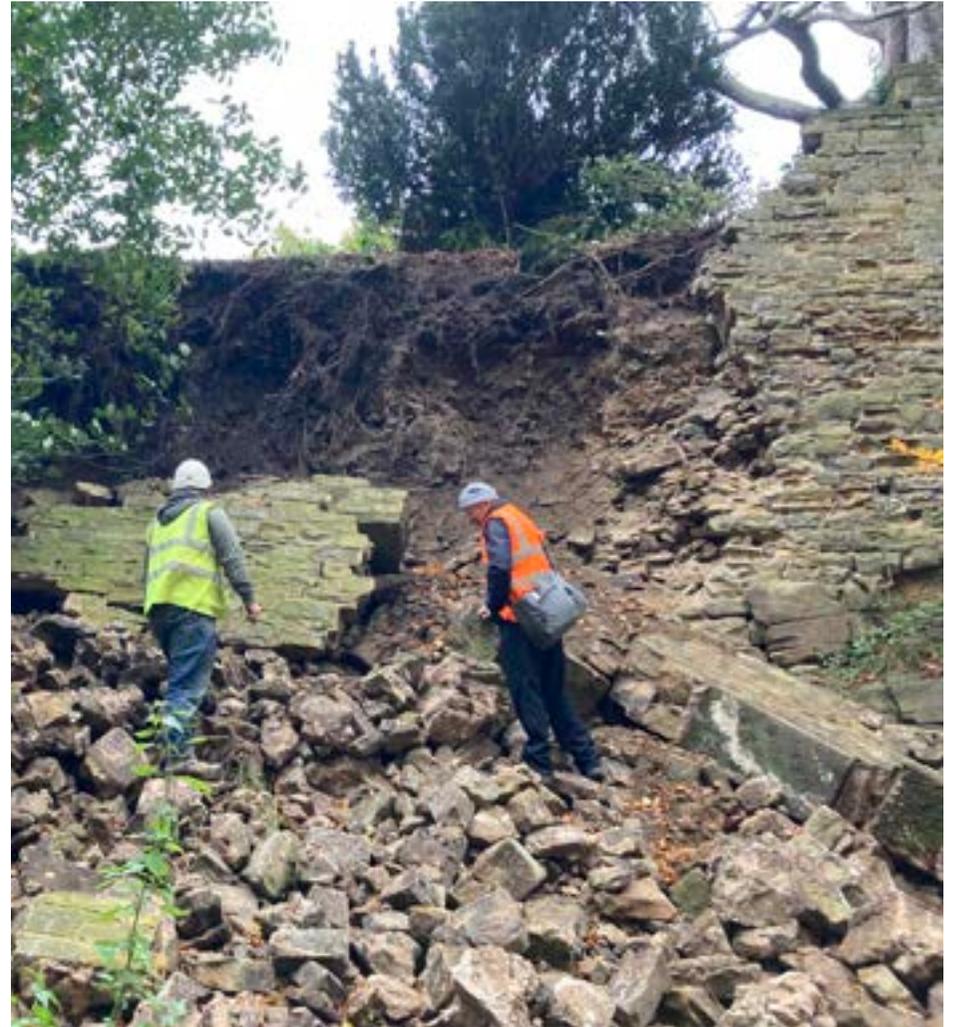
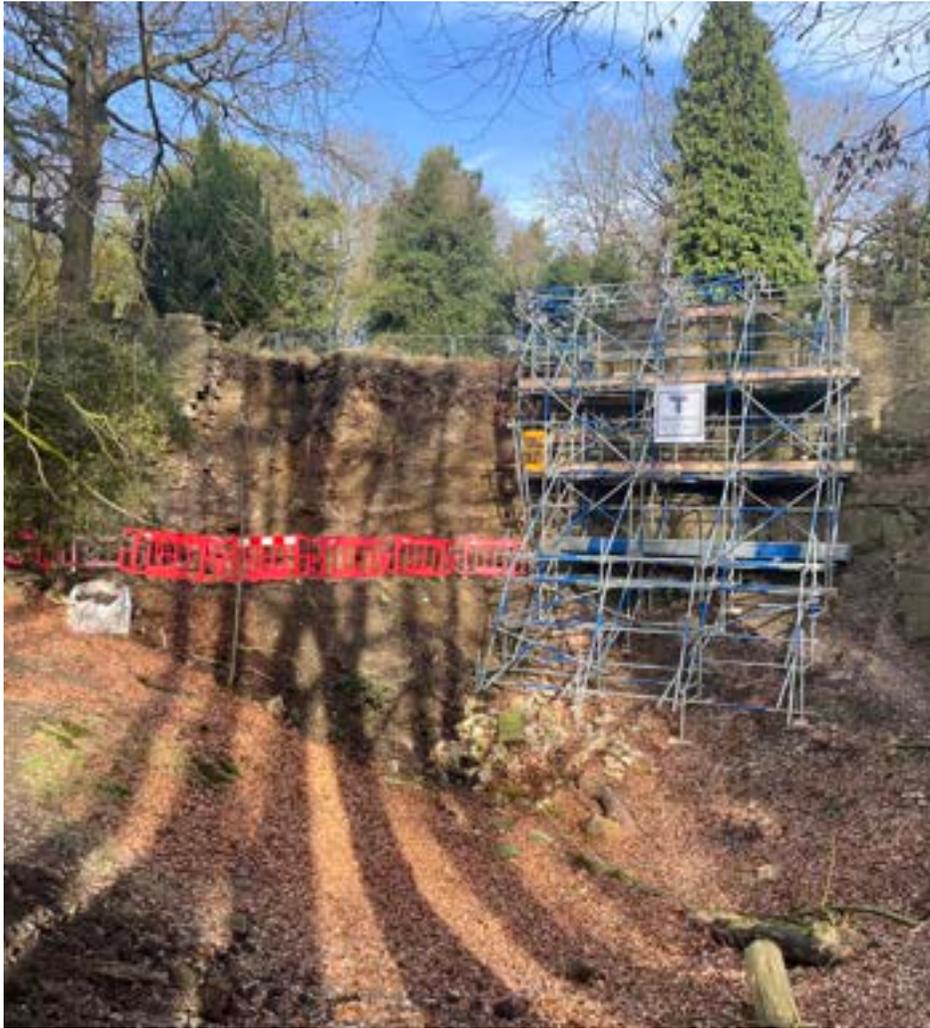
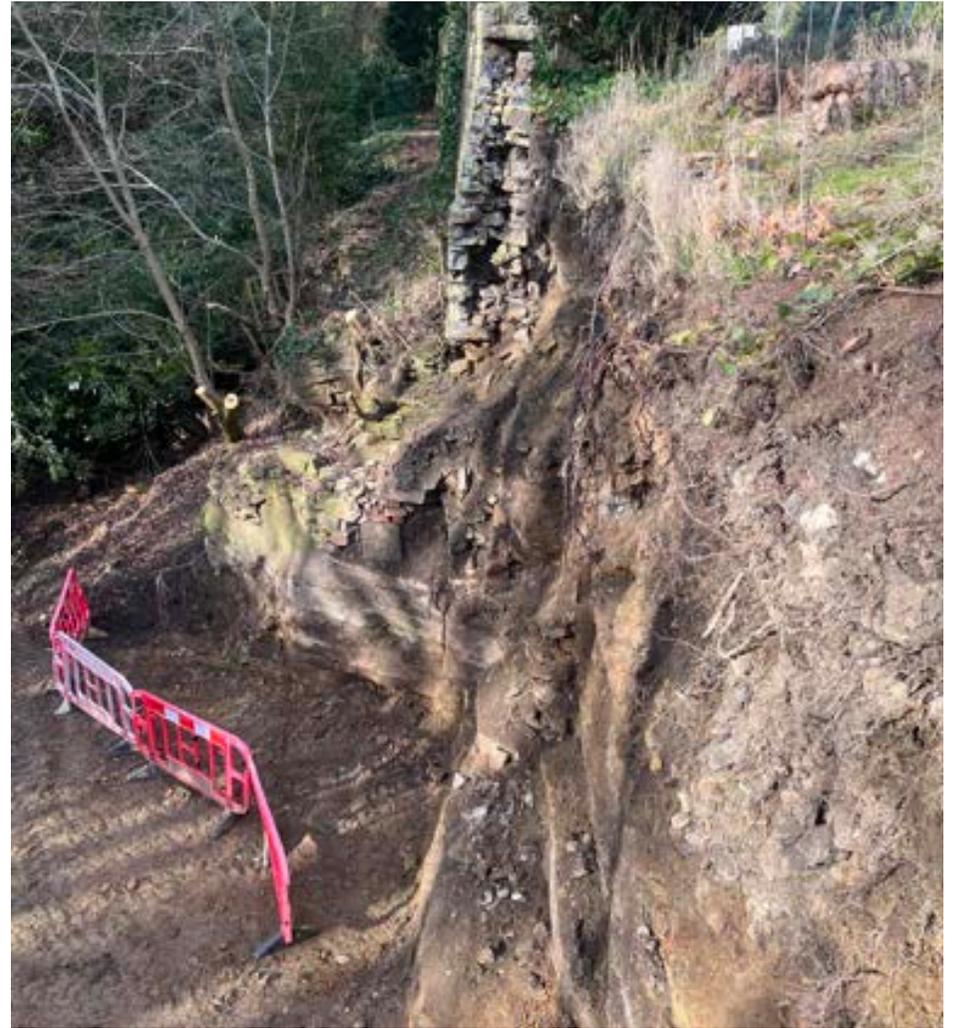
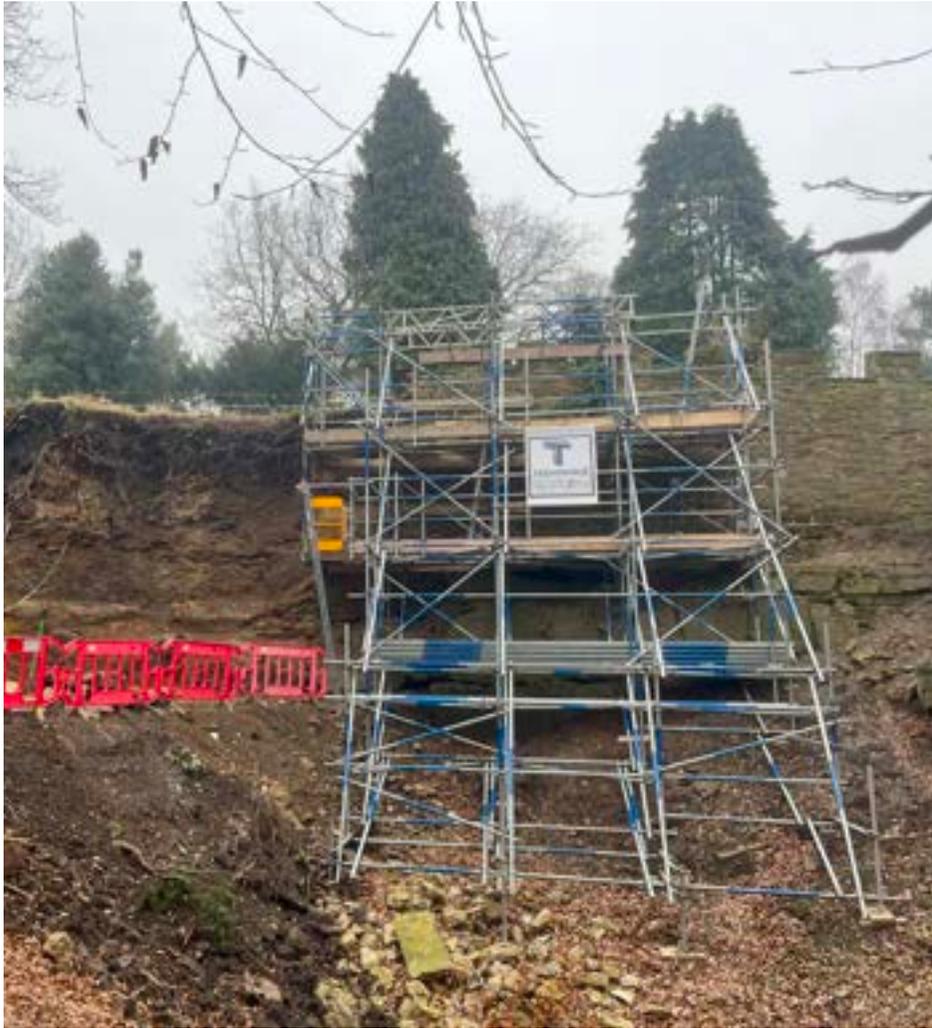
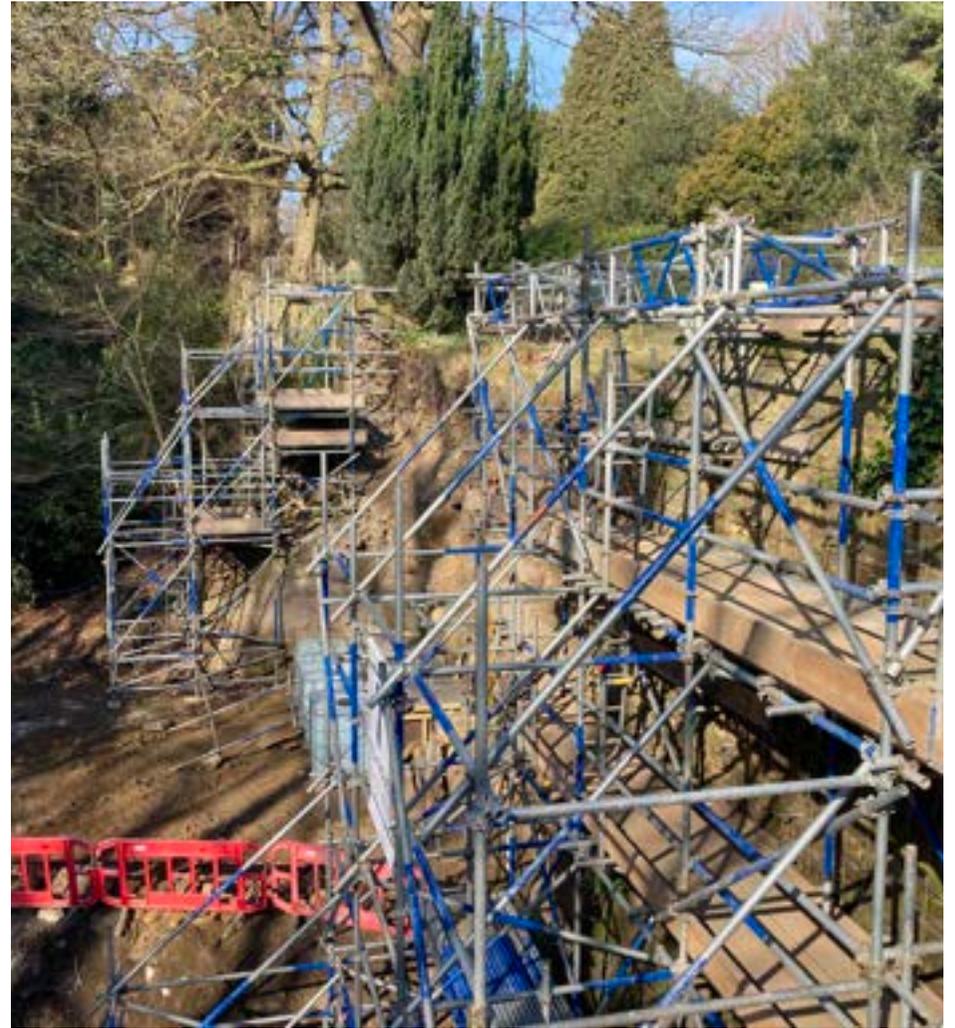
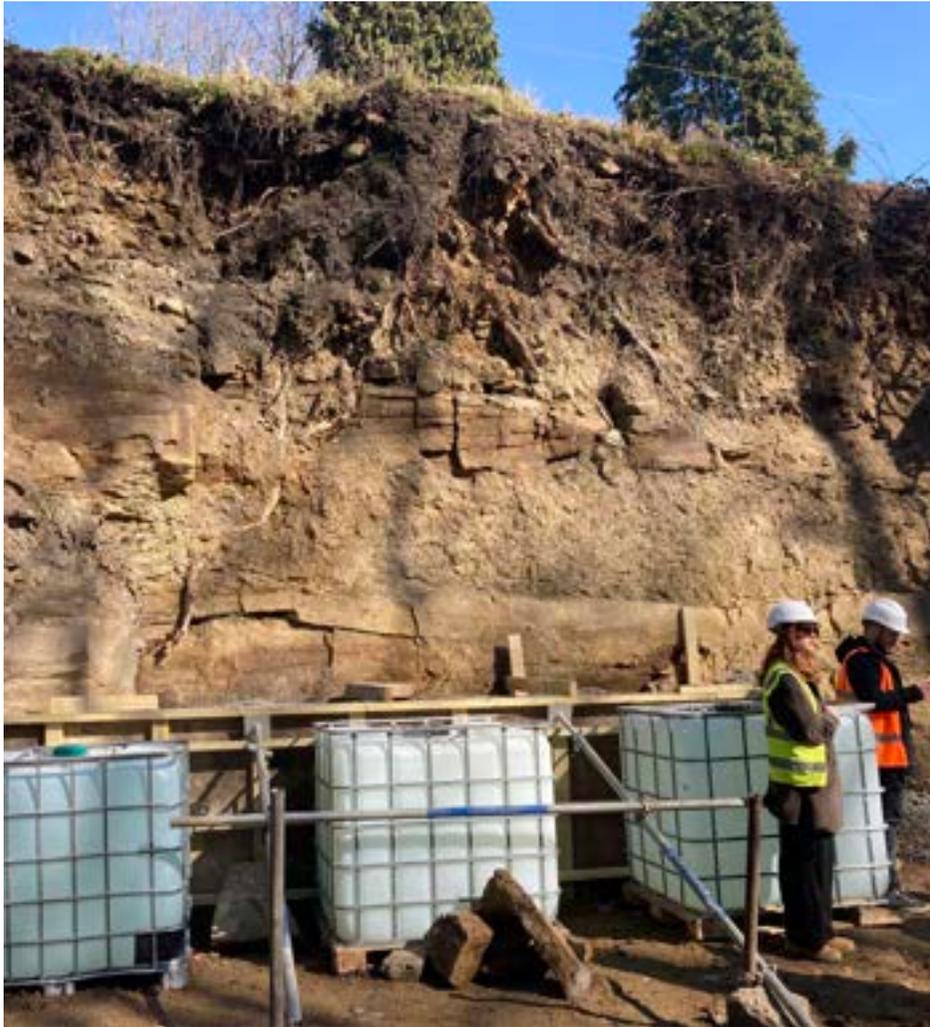
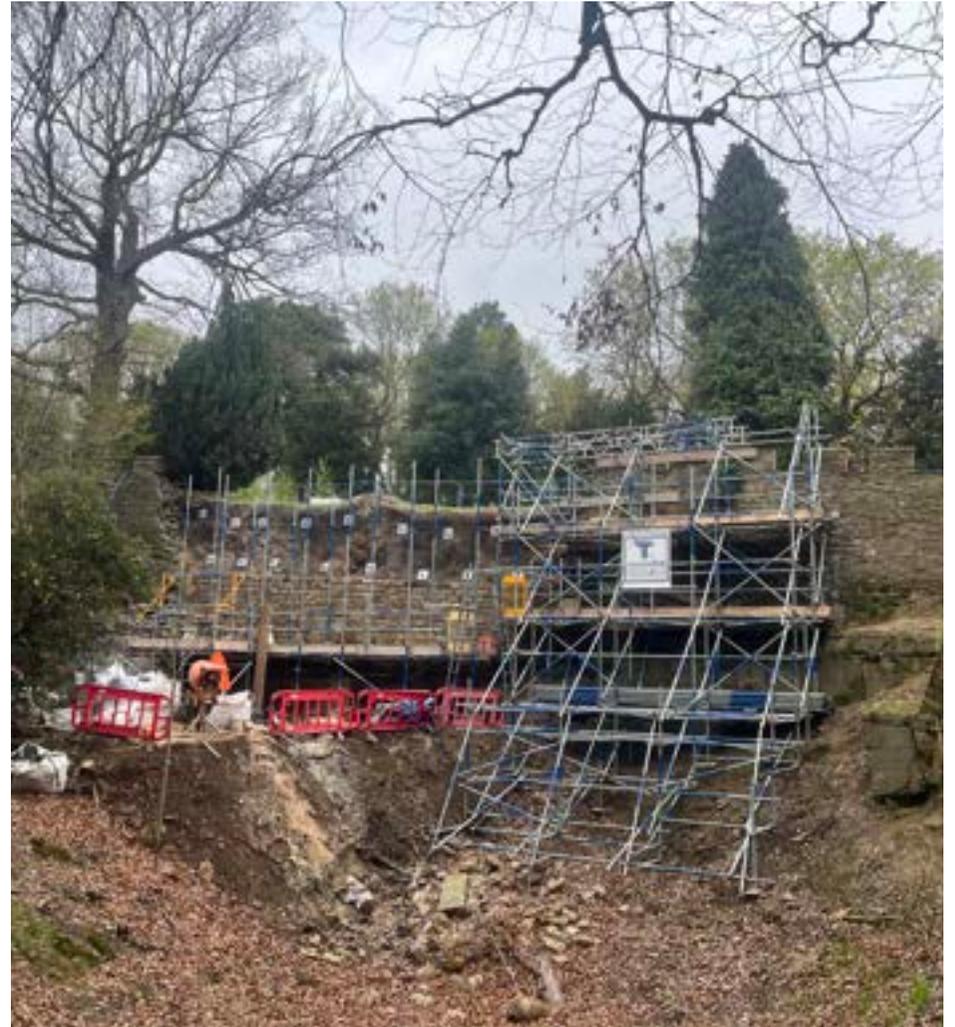
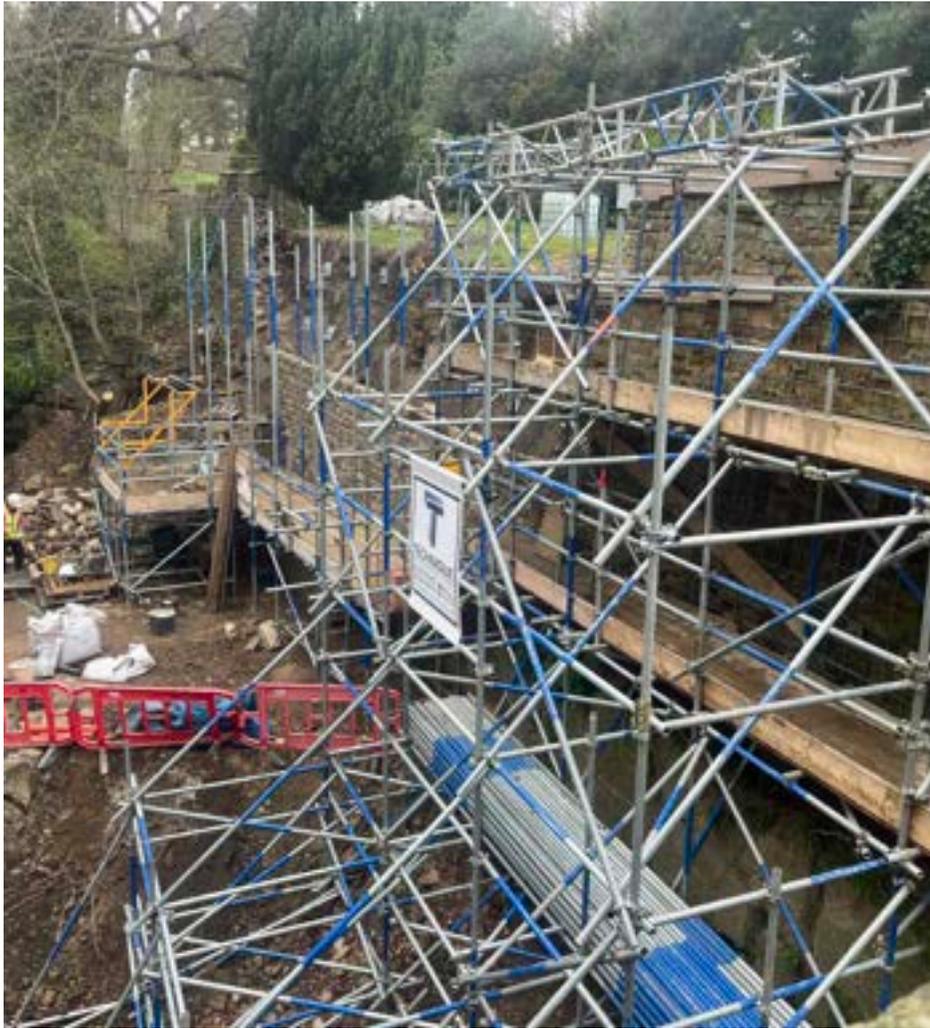
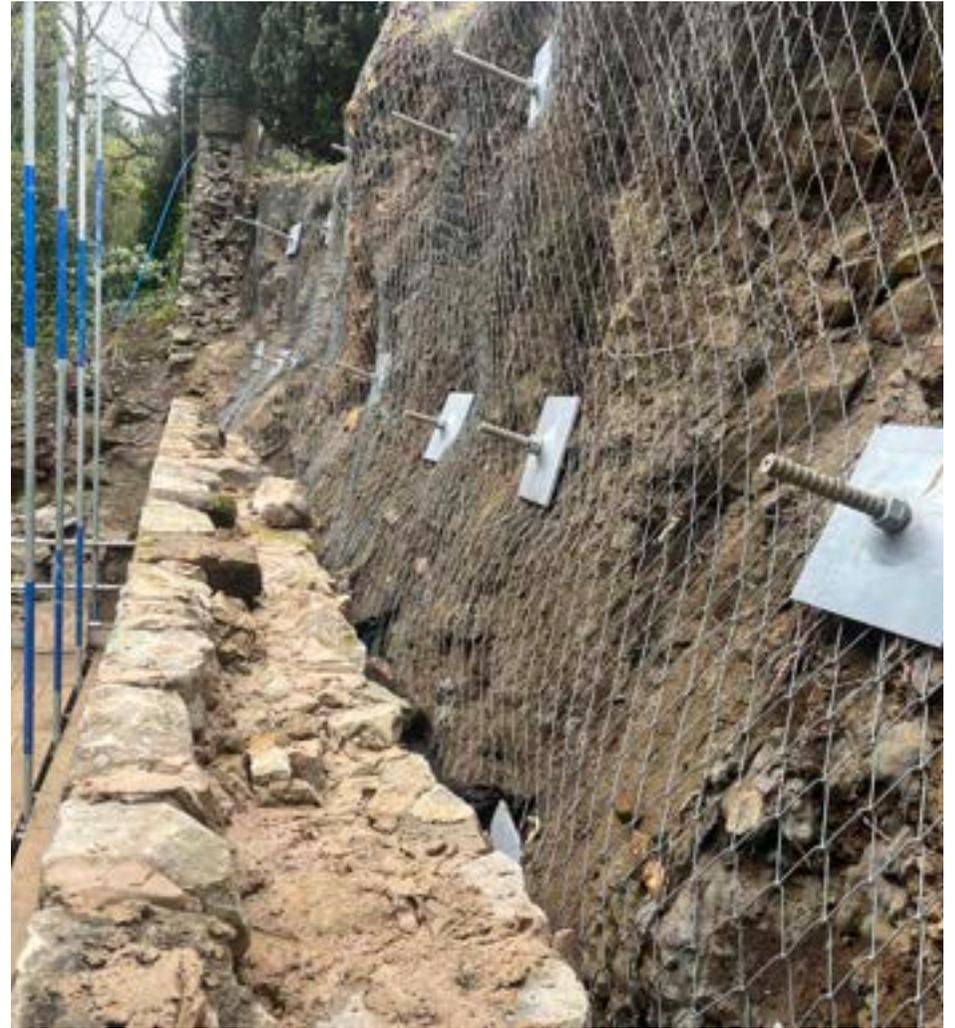
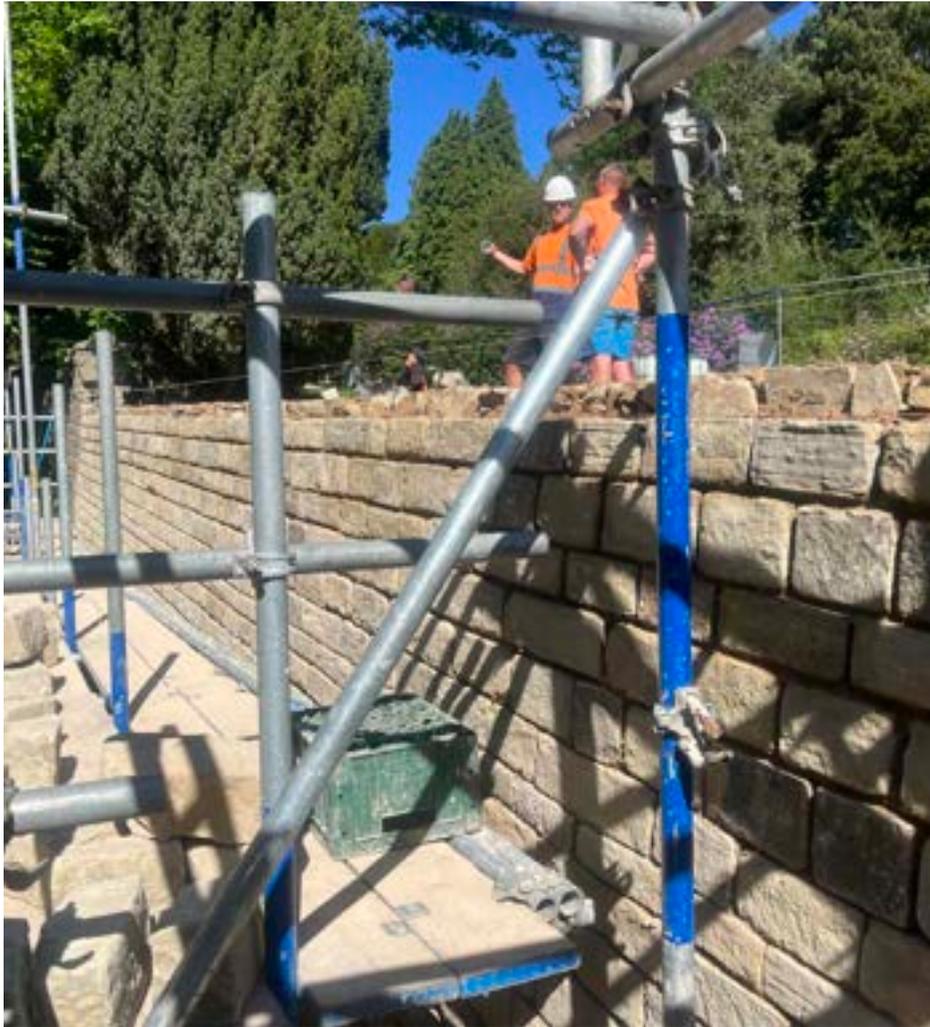
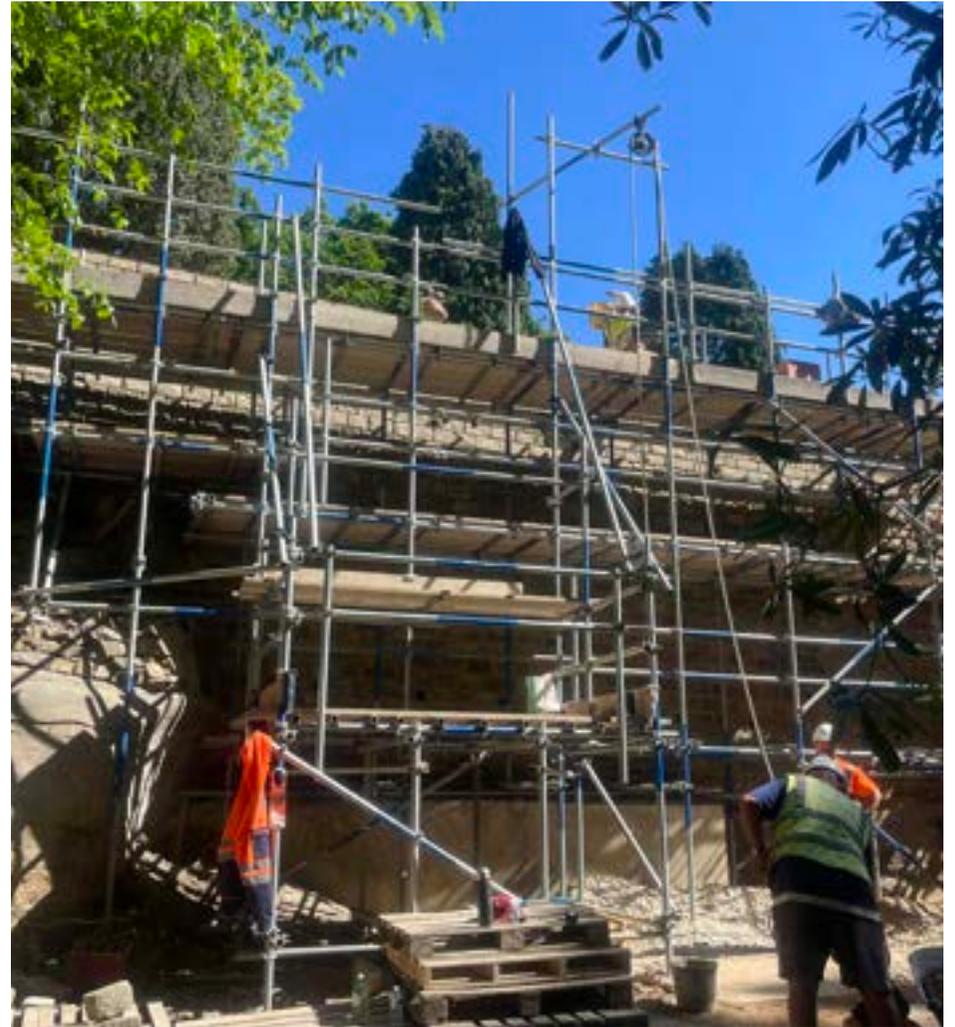
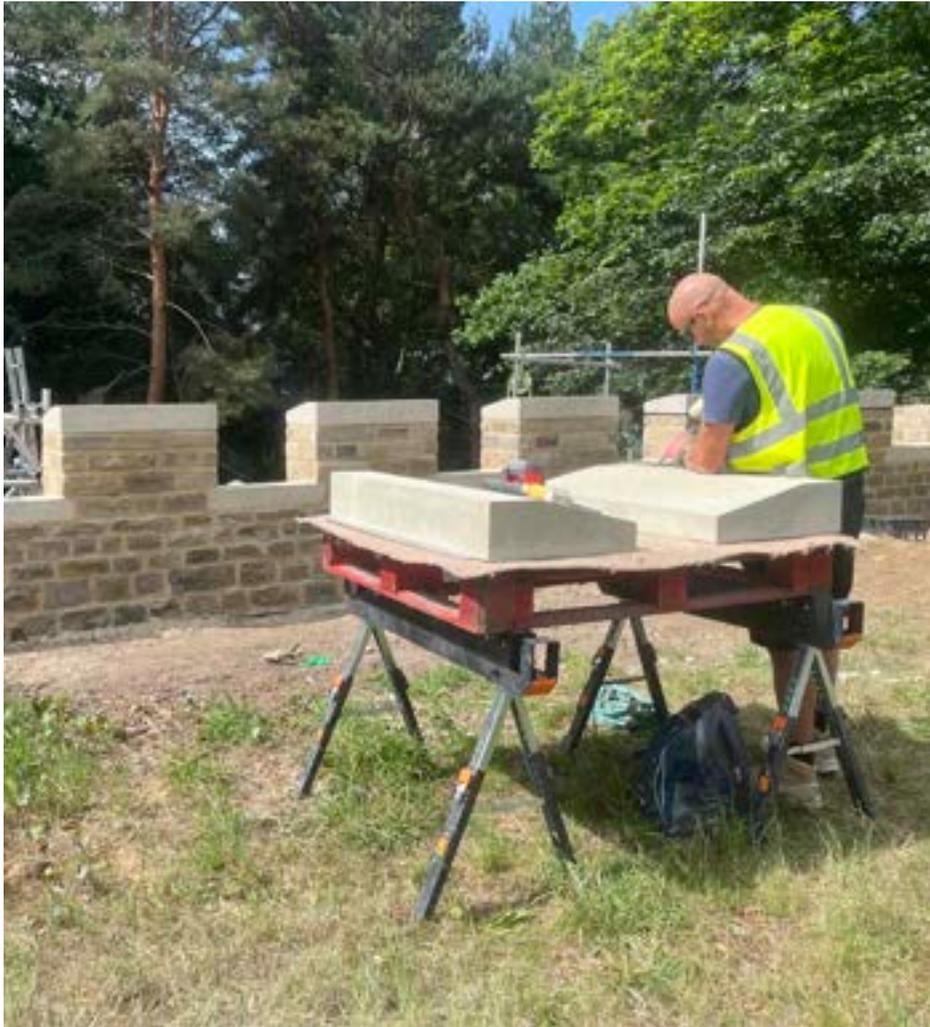
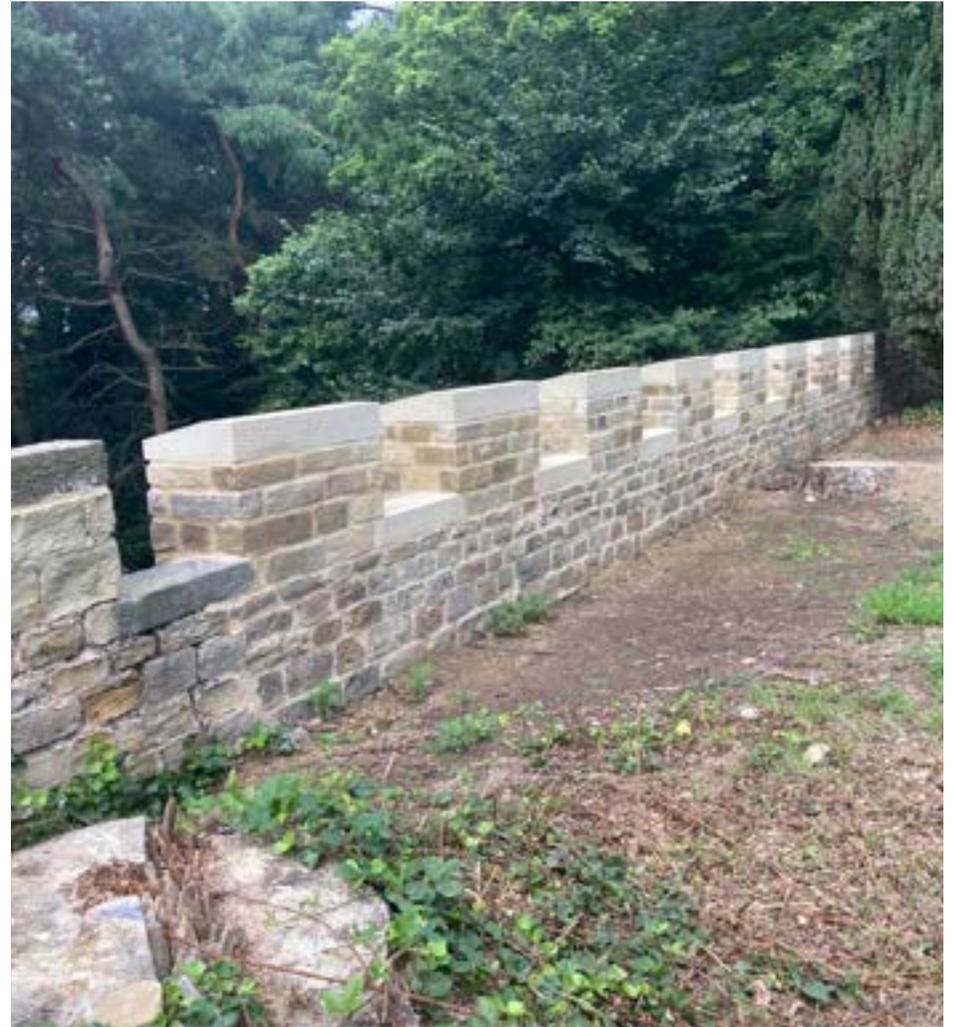
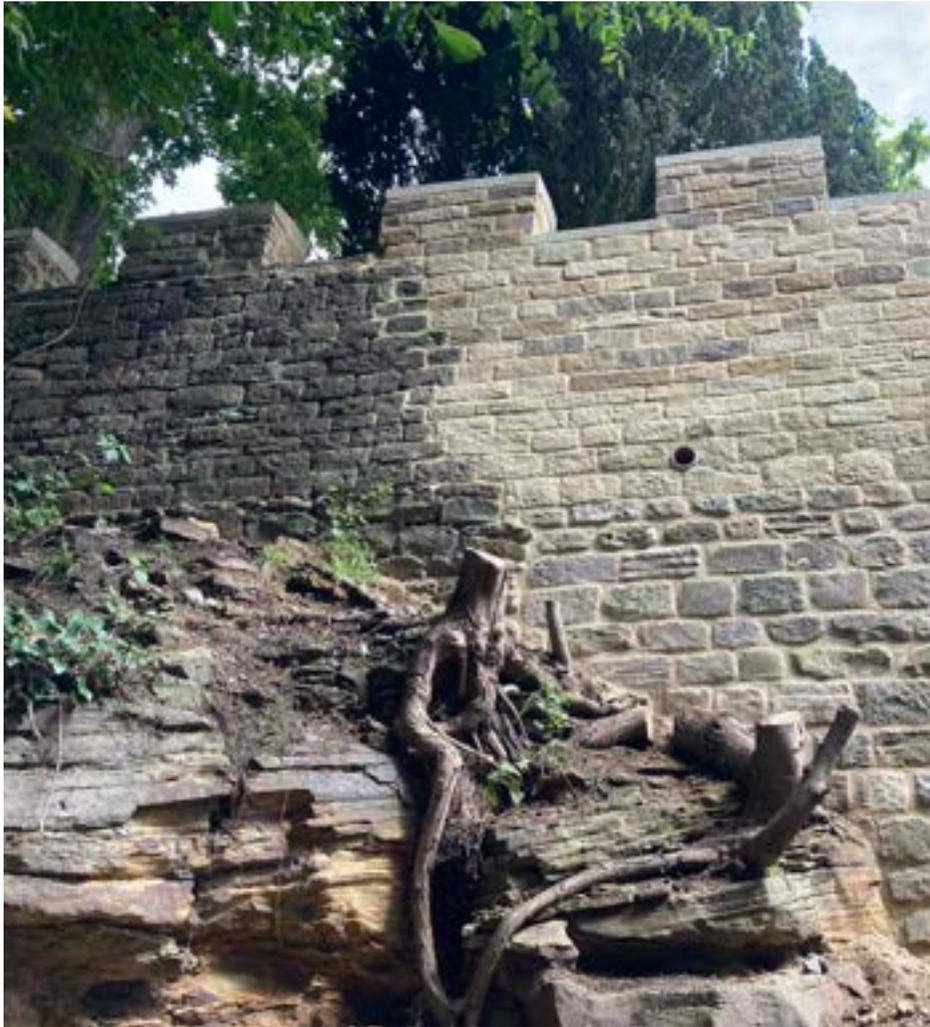
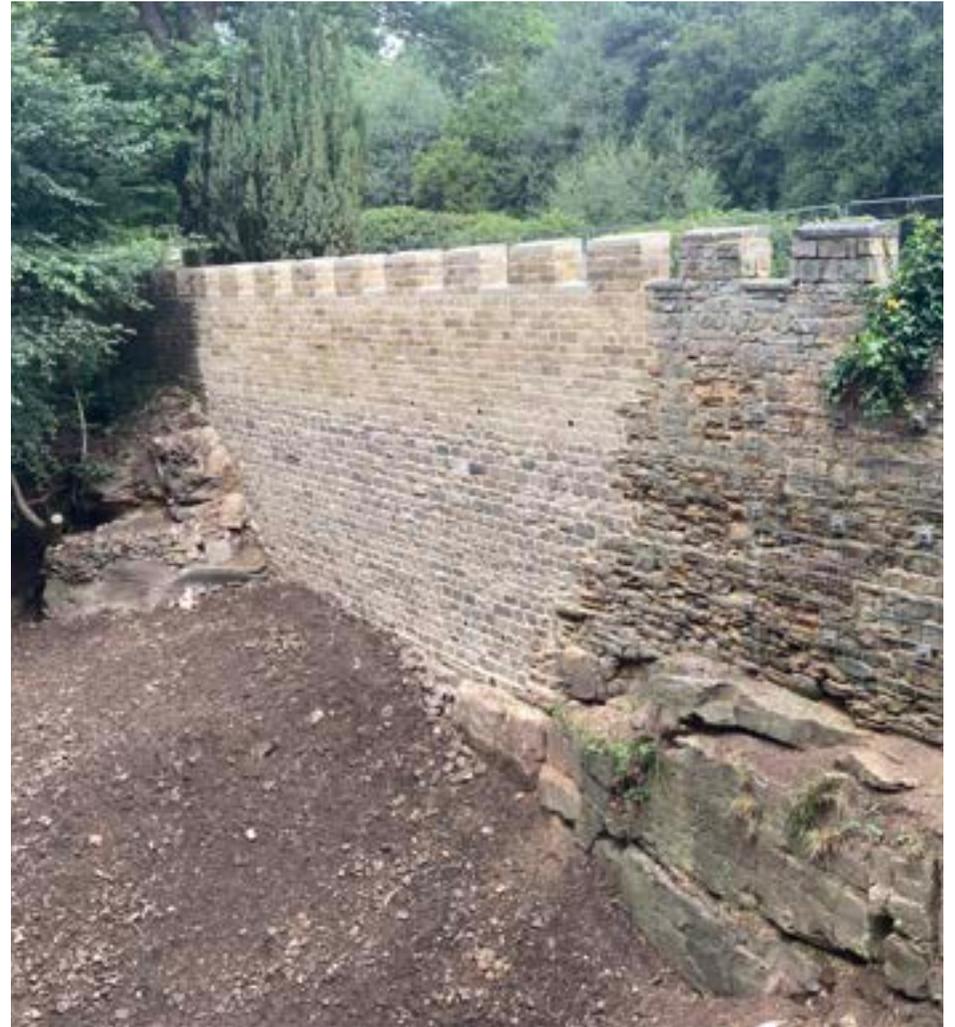
A section of the battlements collapsed in November 2023. The collapse was attributed to pressure exerted by nearby mature trees and waterlogged ground, exacerbated by cementitious pointing which had trapped moisture within the structure.

Following clearance, an inspection by the contractor and structural engineer revealed that the original wall had been constructed directly onto bedrock, which in places was insufficient to bear the required loads. A concrete kerb was therefore installed at the base of the affected section to provide a stable and continuous foundation. This kerb was positioned below ground level and remains concealed, preserving the visual and historic character of the battlements.

The solution incorporated soil nails for stabilisation and to restrain the newly rebuilt dry-stone masonry wall atop the existing bedrock. This approach mirrored a previous intervention undertaken circa 1970 on an adjacent section. Debris from the collapse was carefully removed and sorted prior to commencement of works.

To address drainage concerns, the wedge between the soil-facing side and the dry-stone wall was filled with Type 3 aggregate, enclosed within a Terram geotextile membrane. This configuration allows water to percolate through to a perforated drain and weep holes at the base of the wall. Merlons were rebuilt and all new works were carried out using lime mortar and matching stone, in keeping with the traditional materials and character of the battlements.

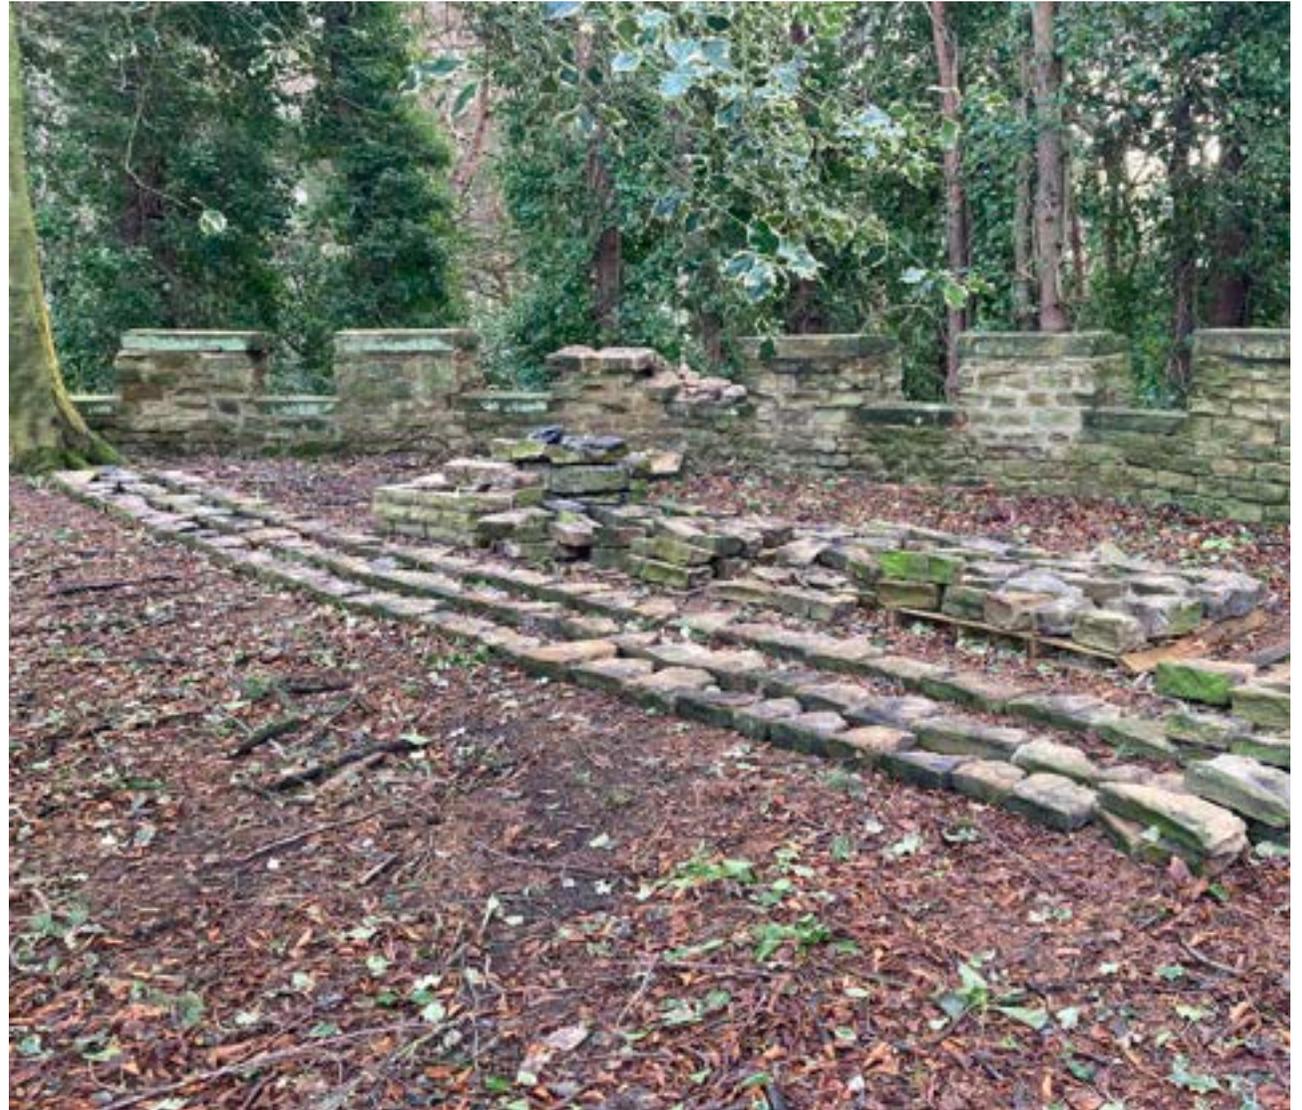
*Sorting of Existing Stonework*
