Niftylift, Hoyland
Bat and Bird Survey Report
9th April 2024

| Document ref: MBE/BAT/2024/034/01 | | | | |

- 1.1.1 Middleton Bell Ecology Ltd were commissioned to produce a Preliminary Roost Assessment of a section of the Niftylift premises at their Hoyland factory by Brendan Foster of JHA Architecture Ltd on behalf of the client on 2nd April 2024.

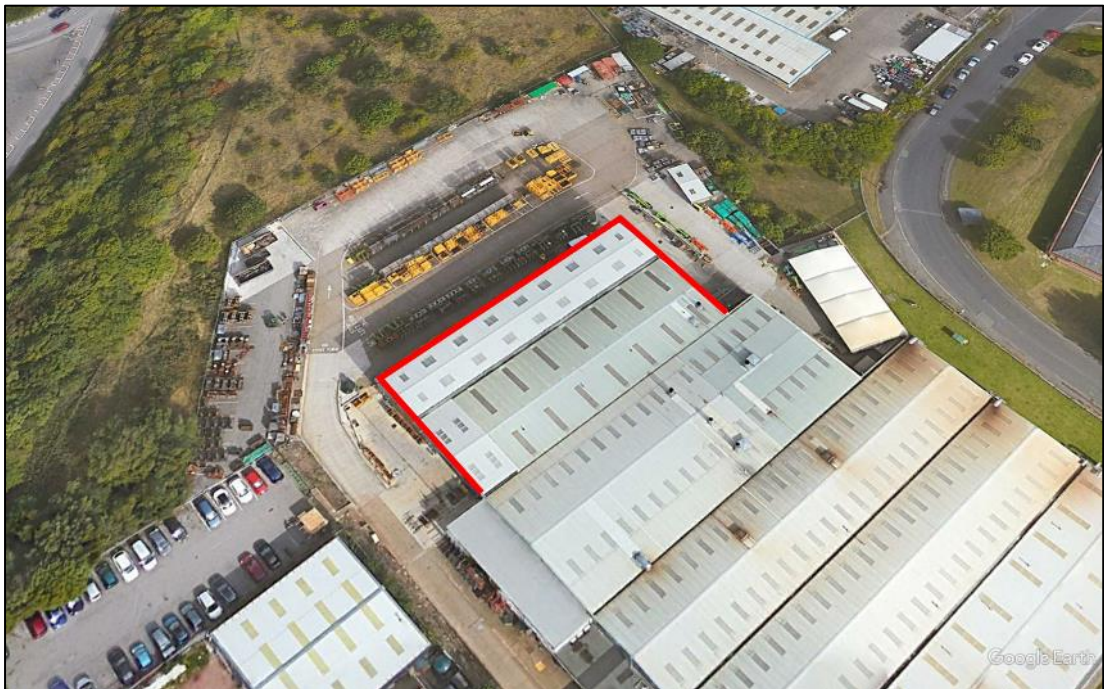
- 4.2.1 The preliminary roost assessment survey was undertaken by Robert Bell (MCIEEM; Class license WML-A34-Level 4, 2016-25236-CLS-CLS) on 5th April 2024.
- 4.2.2 The survey undertaken was restricted to the northwest end of the existing factory and adjoining sections of the northeast and southwest elevations (each approximately 25 m in length (see Figure 2). These comprised the only sections of the existing factory potentially impacted by the proposed extension.

Figure 2. Sections of Niftylift factory subject to survey, as indicated in red

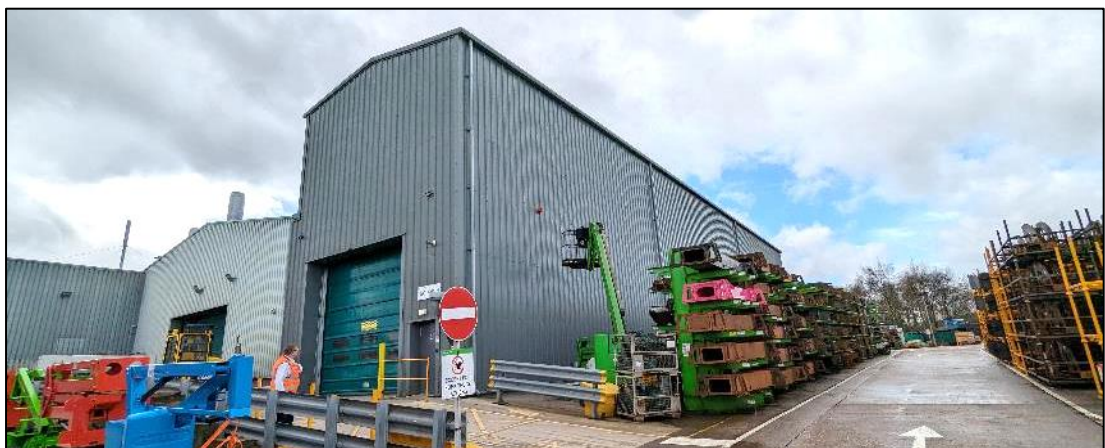
- 5.2.2 The surveyed section of building was mainly constructed between 2018-2020. It comprised a large steel framed section of factory with corrugated metal sheet cladding and a multi-pitched corrugated metal sheet covered roof (Plates 1-4). Wall construction comprised two sheets, with a corrugated metal outer sheet and a c.3 cm insulated inner metal sheet. The building was accessed via large roller shutter doors and security lighting was installed at half wall height across all elevations. It was reported that the security lighting was lit for the full night.

Plate 1. Northern corner of Niftylift premises with northwest elevation (to be extended) on right of image

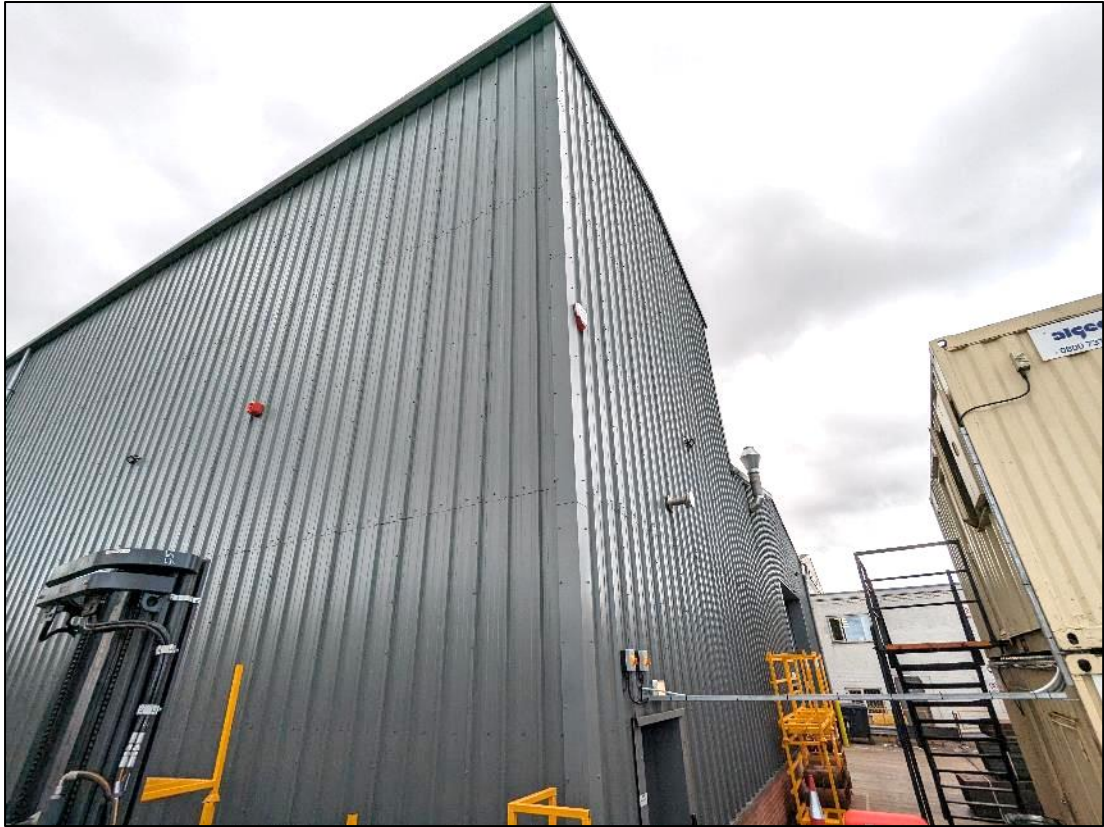
Plate 2. Western corner of Niftylift premises with northwest elevation (to be extended) on left of image

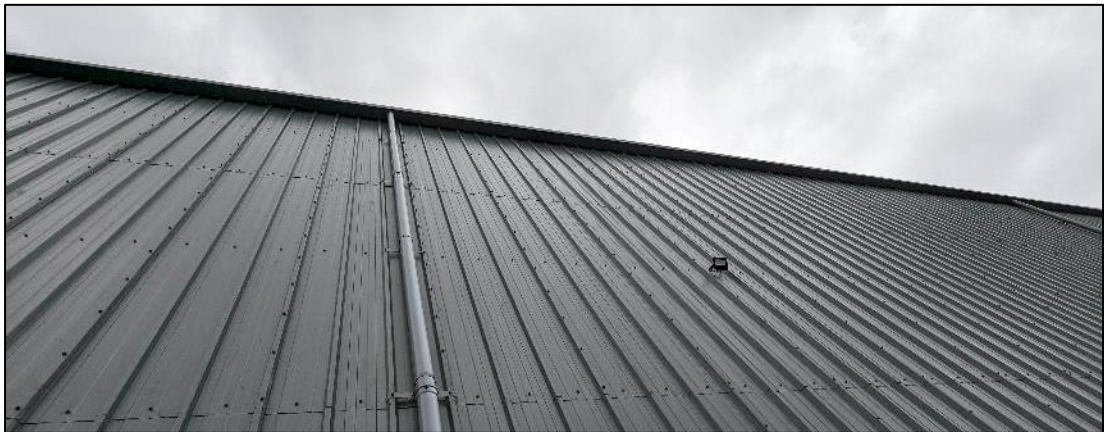
- 5.2.3 No potential roost features were recorded from the building exterior.

Plate 3. Looking up at cladding on northwest elevation

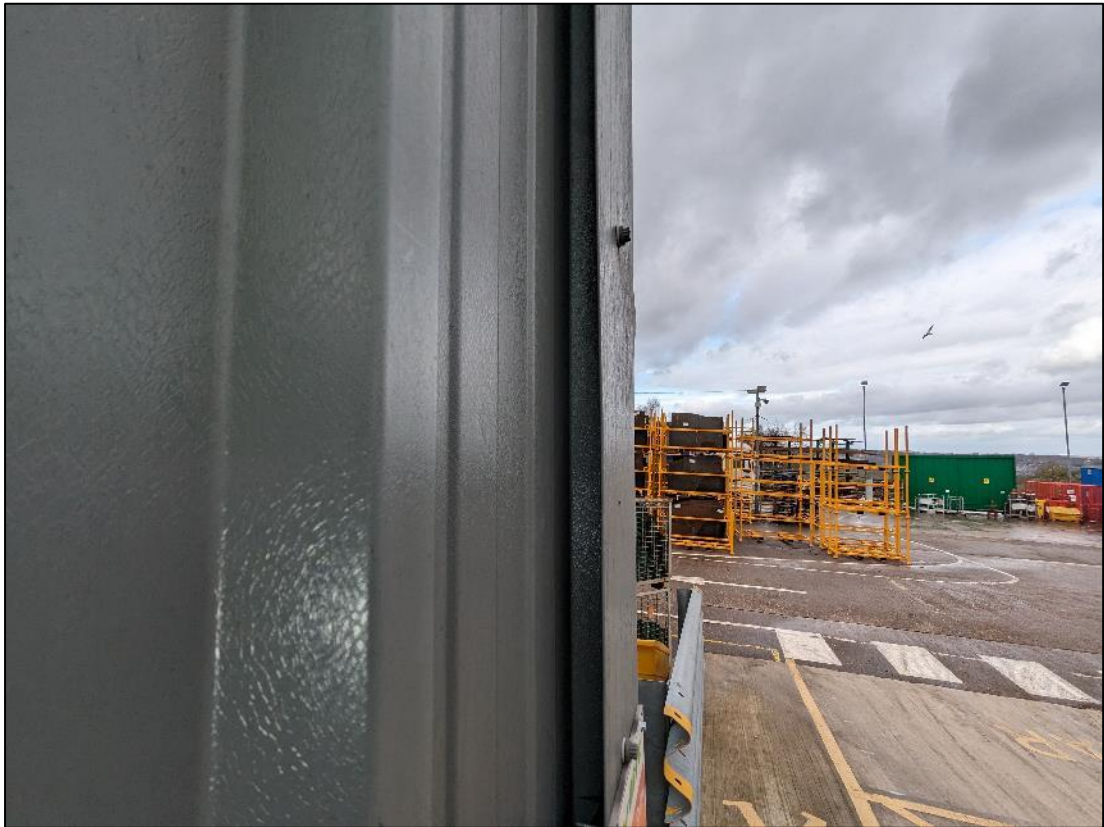
Plate 4. Close view of corner cladding pieces fixing to main cladding panels

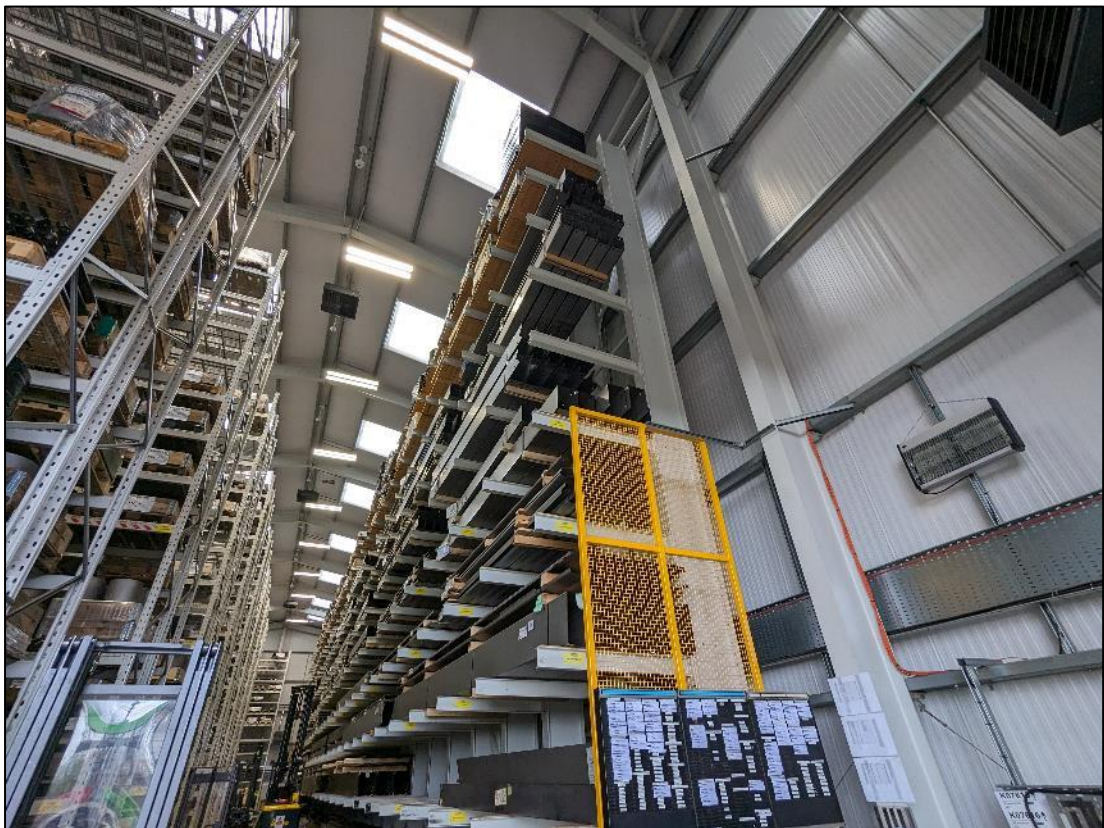
- 5.2.4 The roof was suspended on a steel frame and lacked any roof void (Plate 5). The interior of the building was in active 24 hour use. No evidence of bats was recorded from any location on the surveyed building.

Plate 5. Interior of factory adjacent to northwestern end (to be extended)
