# Better Barnsley New Library Barnsley

## Ground Investigation Report

On behalf of Barnsley Metropolitan Borough  
Council

Report 23-29-17-1-6002/GIR1  
December 2016

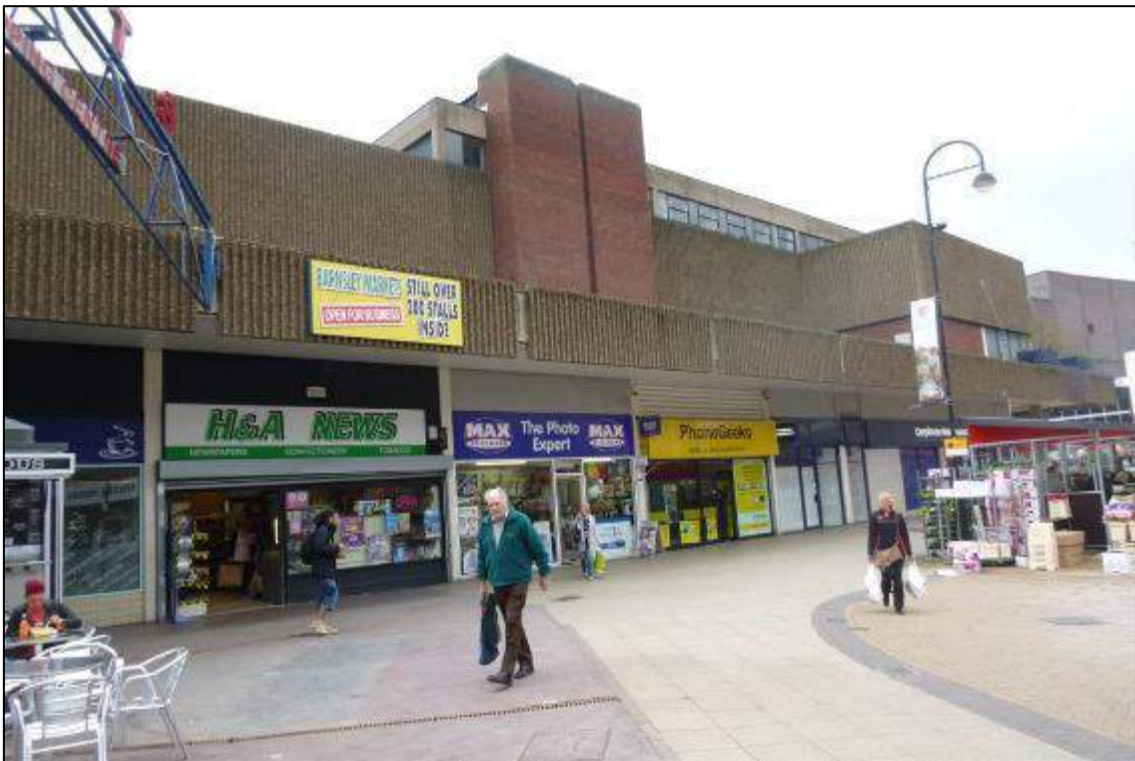
Photograph 1 The shop fronts on May Day Green, looking north west.

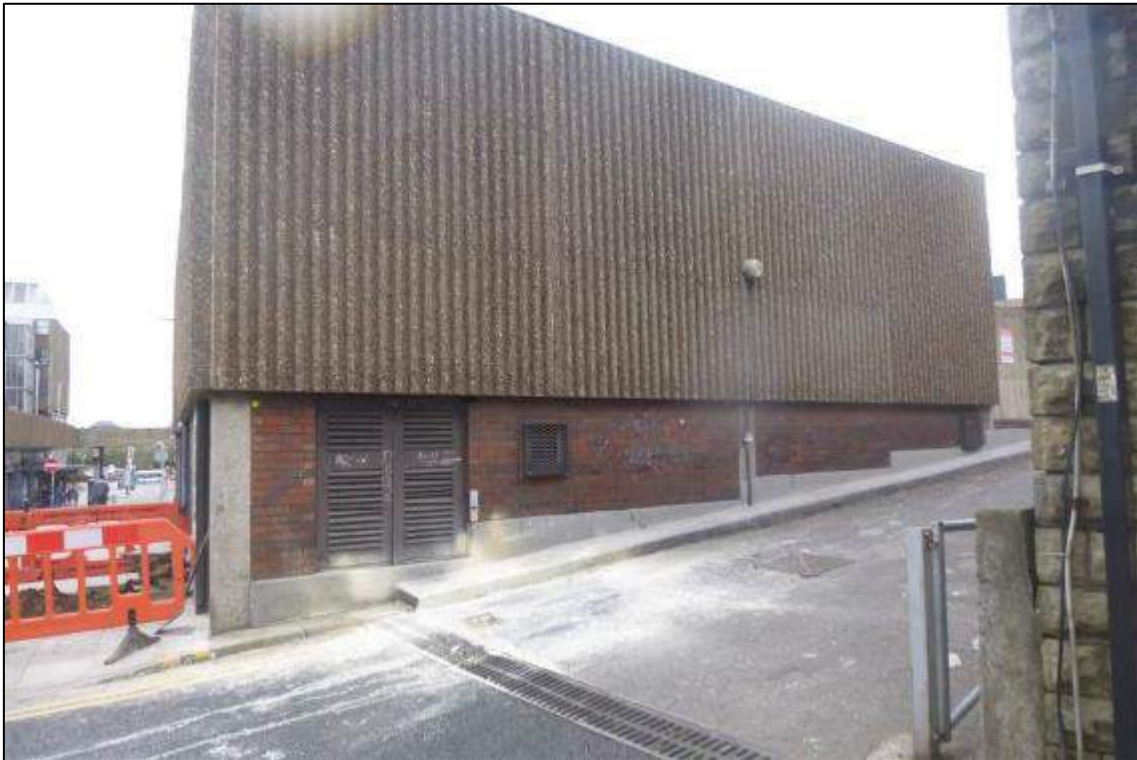
Photograph 2 The ramp to the rear of the shops leading to the roof top car park, looking south east.

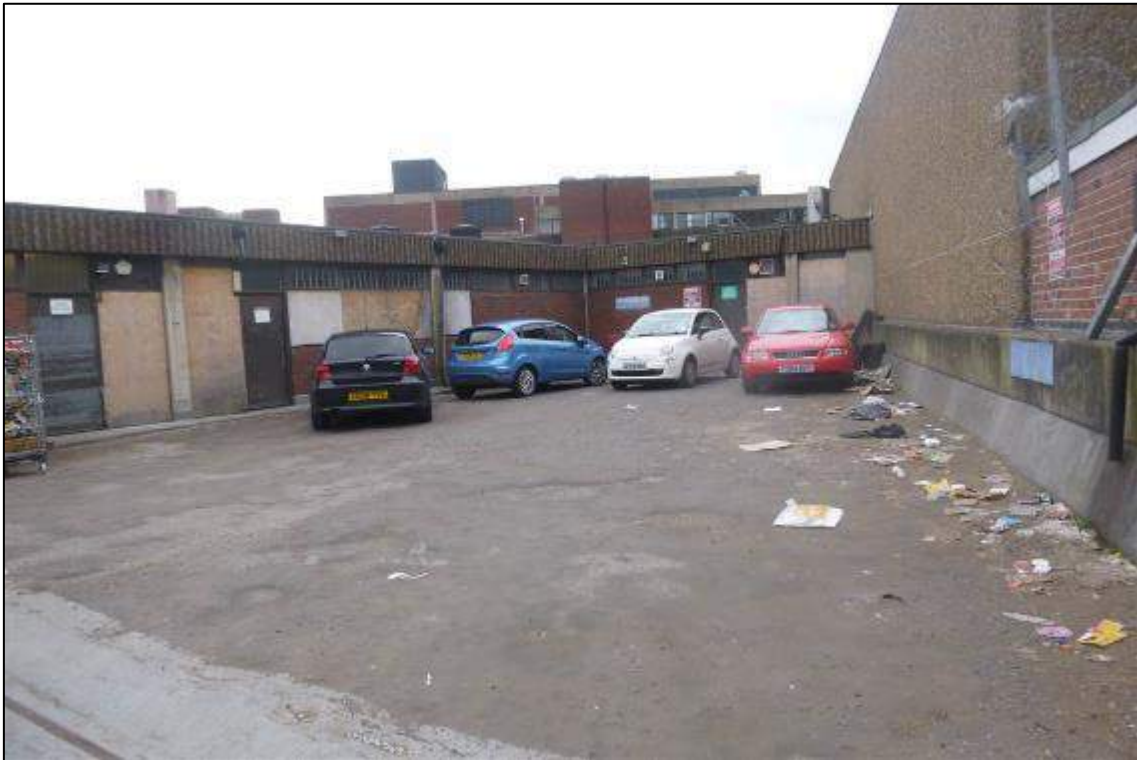
Photograph 3 The roof top car park, looking south east.

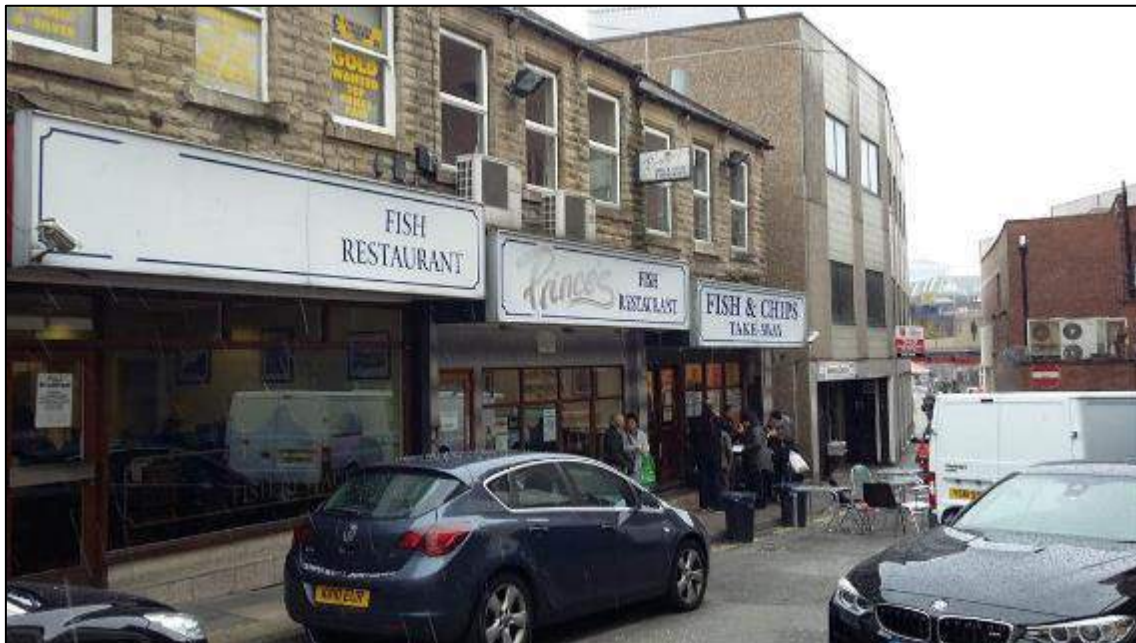
Photograph 4 Burlington Arcade – properties sharing a party wall with the May Day Green shops, looking south east.
