## Ecology Statement

### Cannon Hall Park, Barnsley

Brooks Ecological were commissioned by Plincke, on behalf of Cannon Hall Museum, to provide a brief Ecology Statement on the proposed works at Cannon Hall Park. The proposed works are:

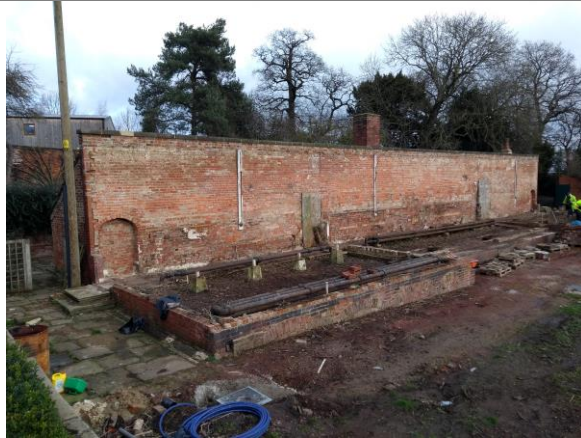
**Photo 1** North Range (southern elevation)

Dedicated Emergence Surveys were undertaken on the North Range in July & August 2017, which at the time confirmed the likely absence of roosting bats. Since this survey was completed, the glasswork and wooden frame of the greenhouse has been removed, and the masonry repointed (See Photo 1). Works to install new glasswork and re-instate the greenhouse (tying into the southern elevation) therefore present minimal risk of impacting on roosting bats and no further survey is considered necessary.

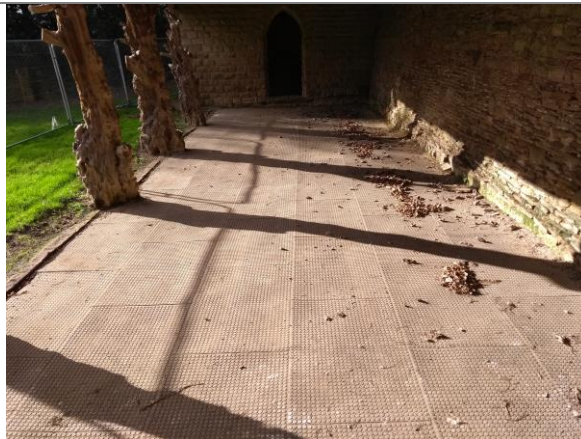
**Photo 3** Deer Shelter floor

Dedicated Emergence Surveys were undertaken on the Deer Shelter in July & August 2017, which identified the presence of several roost sites within the roof structure, including a small brown long eared maternity colony and at least six solitary common and soprano pipistrelle day roosts. A European Protected Species Mitigation License was secured in 2018 to cover all proposed works on this building, which included plans to resurface the internal floor; Natural England Ref. 2018-33921-EPS-MIT-1. A valid EPSML is therefore already in place for the proposed re-surfacing works.

The floor re-surfacing works would not be expected to impact directly on any of the identified roosts; however, if undertaken during the summer months, indirect impacts could arise from disturbance. Therefore, as stipulated in the license 'all works to building 13 (Deer Shed) will be carried out between 1<sup>st</sup> October and 31<sup>st</sup> March, inclusive.'

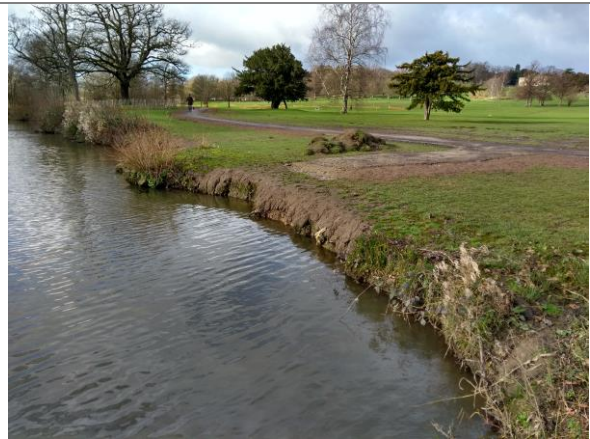
**Photo 4** Boat Shed

No rare or important bankside vegetation was identified, and no trees with roost suitability are present within influence distance of the proposed boat shed.

- Information boards / signs should be installed in prominent locations around the boating shed, informing users of the legislation surrounding nesting birds.
- Employees will be suitably trained on the legislation surrounding nesting birds and will play a key role in ensuring that users are aware of the legislation and their duty not to disturb nesting birds.
- Mooring on the central island will be prohibited. Signs to this effect will be installed at regular intervals along the shore of the island stating that 'Access to the island is Strictly Prohibited'. A system will be put in place to ensure anyone breaking the rules are removed from Site and banned from any future activities.

With regards to biohazards, the introduction of rowing boats to the lake presents a risk of (i) introducing new pathogens/ non-native invasive species to the lake and (ii) causing the spread off-site of non-native invasive species (signal crayfish) known to occur within the lake. The risk of this would be present each time boats or other submergible equipment is moved to or from the Site. A Biosecurity Protocol will need to be developed and put in place to deal with this risk; this should be in line with Environment Agency guidance CHECK-CLEAN-DRY.

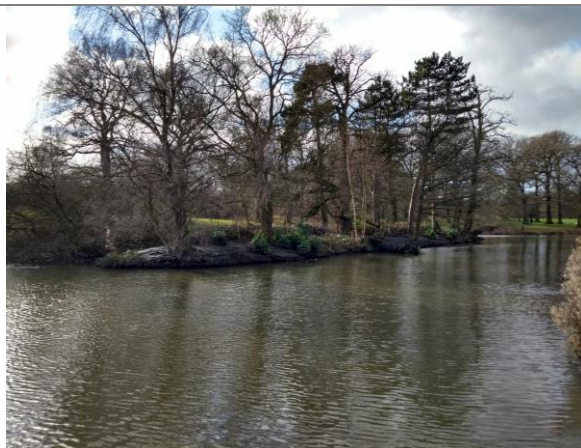
**Photo 5** Island on lake

The introduction of rowing boats on to the lake poses a risk of disturbing waterfowl nesting on the central island and along the margins of the lake. This is a common issue encountered by all sites offering recreational rowing. To minimize the risk of this activity affecting nesting birds, the following measures are recommended:
