Menagerie Wood Inlet Footbridge  
Application for Listed Building Consent: Supporting Information

February 2011  
R556-001

## Menagerie Wood Inlet Footbridge: Current Condition and Proposed Location of the Balustrade Yorkshire Sculpture Park

# Menagerie Wood Inlet Footbridge: Bridge Repair Specification Yorkshire Sculpture Park

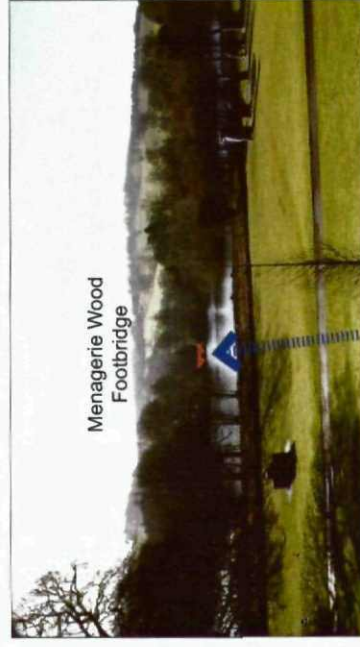
View 1: Historic view of Menagerie Wood Footbridge from Bretton Hall

Historically the footbridge was designed to be viewed and appreciated across the Lower Lake from the southern terrace of Bretton Hall, as per view 1. Viewed from this location the bridge, as highlighted in red, is a distant feature intended to provide a focus across the lake. The 440m long vista is also designed to be appreciated in return from the centre point of the bridge back to Bretton Hall as part of the original C18 pleasure ground experience.

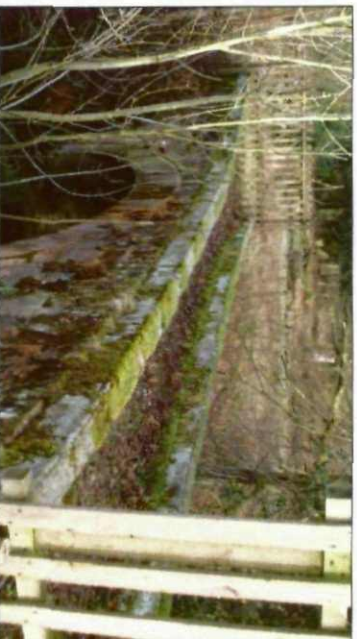
Image 5: Current condition and restricted access

Over successive years the bridge deck has been removed and the balustrade lost. Please refer to image 5 & 6. The current deck surface is a combination of organic matter and weeds over a gravel surface. Please refer to image 6.
