Harworth Estates

Gateway 36, Phase 1

Arboricultural Method Statement – Plots 5, 6, 7, 8 and 1

October 2015

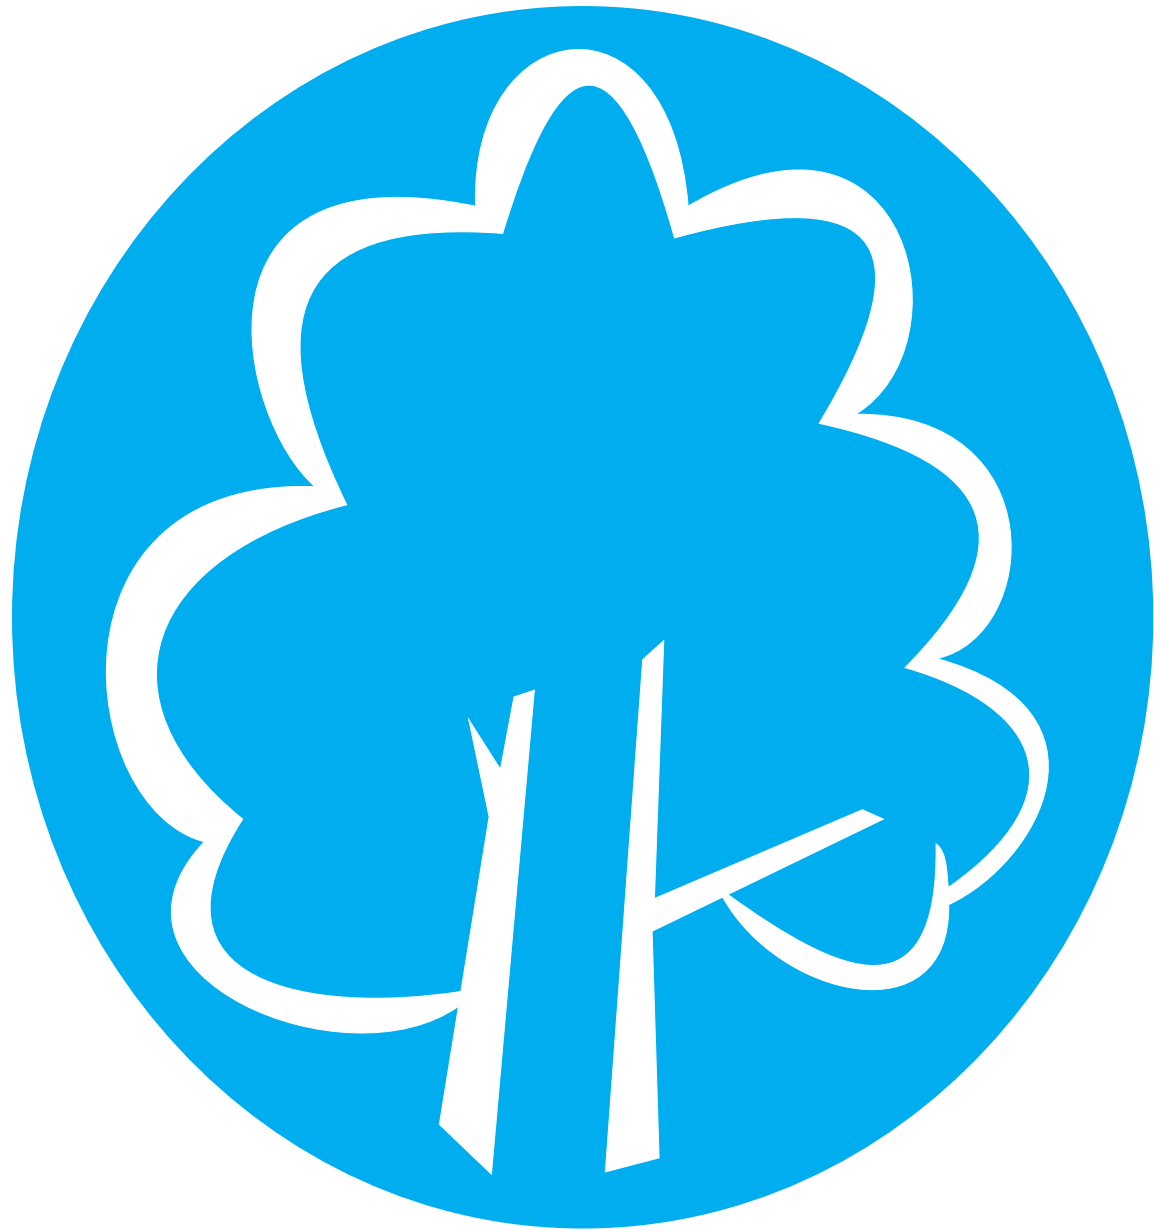
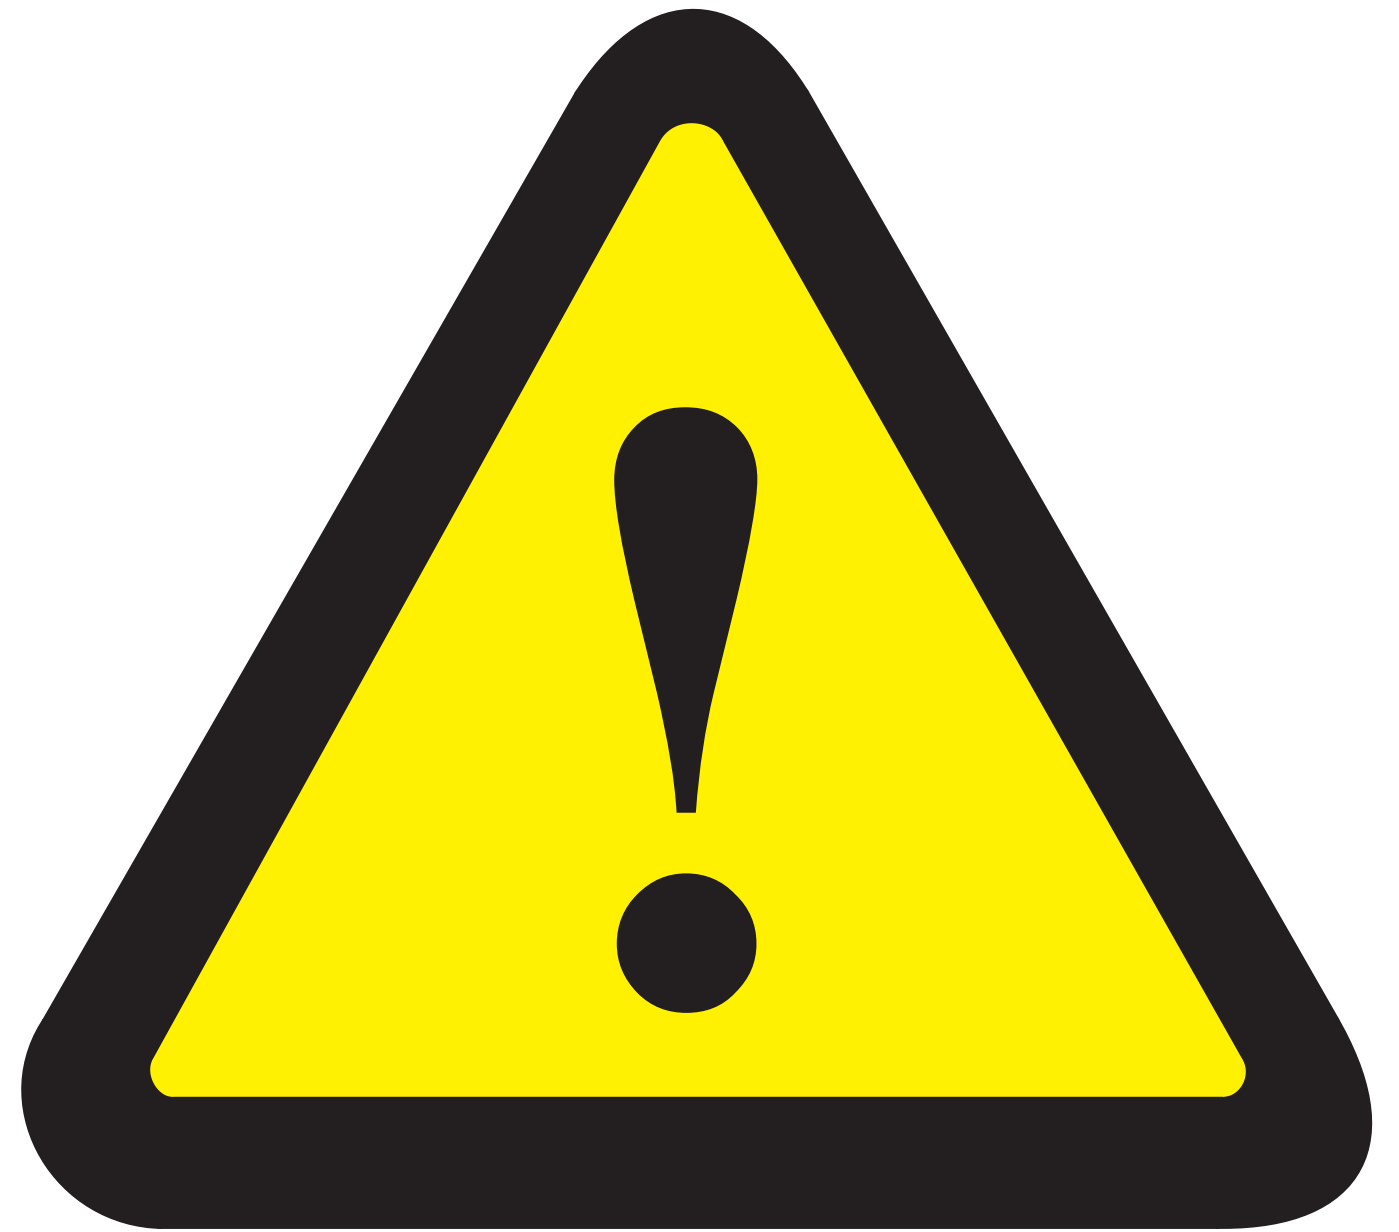
PROTECTIVE FENCING. THIS FENCING MUST BE MAINTAINED IN ACCORDANCE WITH THE APPROVED PLANS AND DRAWINGS FOR THIS DEVELOPMENT.

**TREE PROTECTION AREA
KEEP OUT !**

**(TOWN & COUNTRY PLANNING ACT 1990)
TREES ENCLOSED BY THIS FENCE ARE PROTECTED BY PLANNING CONDITIONS AND/OR ARE THE SUBJECTS OF A TREE PRESERVATION ORDER.
CONTRAVENTION OF A TREE PRESERVATION ORDER MAY LEAD TO CRIMINAL PROSECUTION**

ANY INCURSION INTO THE PROTECTED AREA MUST BE WITH THE WRITTEN PERMISSION OF THE LOCAL PLANNING AUTHORITY

- 2.6 The position and specification for tree protection fencing will be determined on site in the presence of the project arboriculturalist.
- 2.7 Tree protection fencing and work exclusion zones will be clearly marked using appropriate signage an example of which has been included as Appendix C. No materials shall be stored or placed in any area fenced off and the ground levels within those areas shall not be altered.
