# Bat Survey Report

## Dale House Barn, Cawthorne.

Middleton Ecological Consultancy, 33 Wilthorpe Road, Barnsley S75 1JA

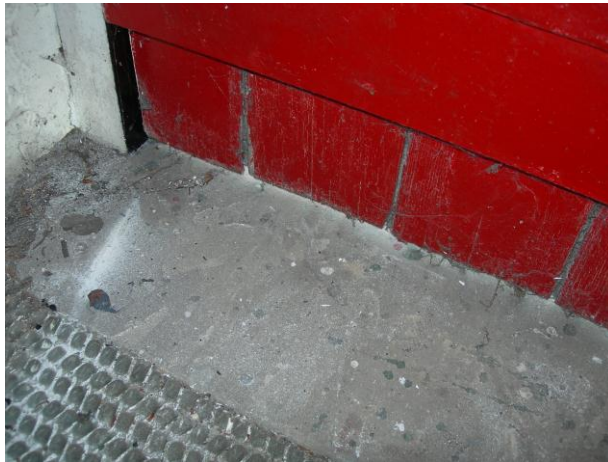
**Photograph 2 Hay Loft door (bottom)**

5.3.3 There is a hay loft door on the first floor with gaps at the top and bottom of the door (see photograph 2)

The cobwebs can be seen in the photograph at the bottom of the door.

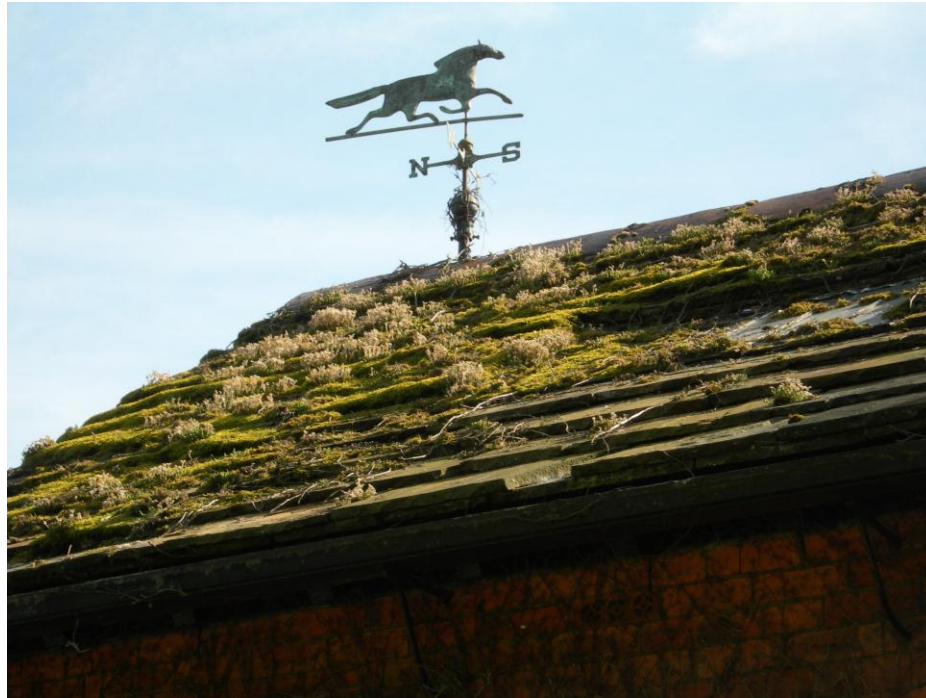
**Photograph 5**

- 5.4.1 There are little opportunities for bats to roost; the most obvious is under the end ridge tile on the south facing gable end (see photograph 4). Under the eaves there are holes behind the roof timbers but these are unlikely to be used by bats as they are wide and not deep and are also cluttered with the twigs of the *Wisteria* that formally covered the building. The brickwork is also sound and well maintained. There are perhaps a few opportunities under the York Stone slates but these are mostly covered in moss and stonecrop *Sedum* (30%) (see photograph 5).

Section of west facing roof with moss and stonecrop, the east facing roof has even more moss and stonecrop.

- 7.4 The precautionary measures are recommended.
- 7.5 The building is situated in an area where all of the locally occurring species are present, considering this it is recommended that a roost is created between the slates and boards on the west elevation where there is no security light. This can be achieved by installing a purpose made access slate at little cost.
