## Fwd: Old Corn Mill archaeology

# **ARBORICULTURAL REPORT**

## **& Impact Assessment**

**Appendix 5:**  
**Tree Constraints Plan**  
The Old Corn Mill, Manchester Road, Thurstone  
Ref: AWA2940

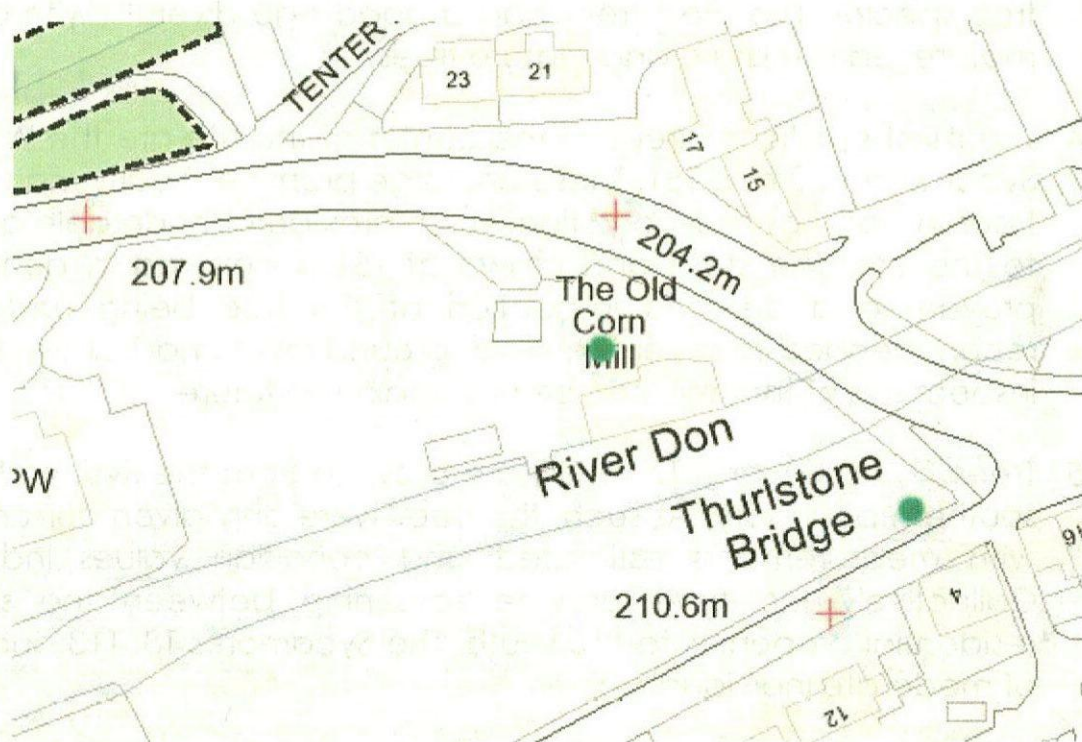
- 3.1.1 An online check was made with Barnsley Metropolitan Borough Council on the 21<sup>st</sup> of November 2019. This showed that trees at the site are protected by a Tree Preservation Order (TPO). As such, written statutory permission is required before any works can take place to the protected trees. The accessed map image from <http://barnsley.gov.uk> is detailed below:

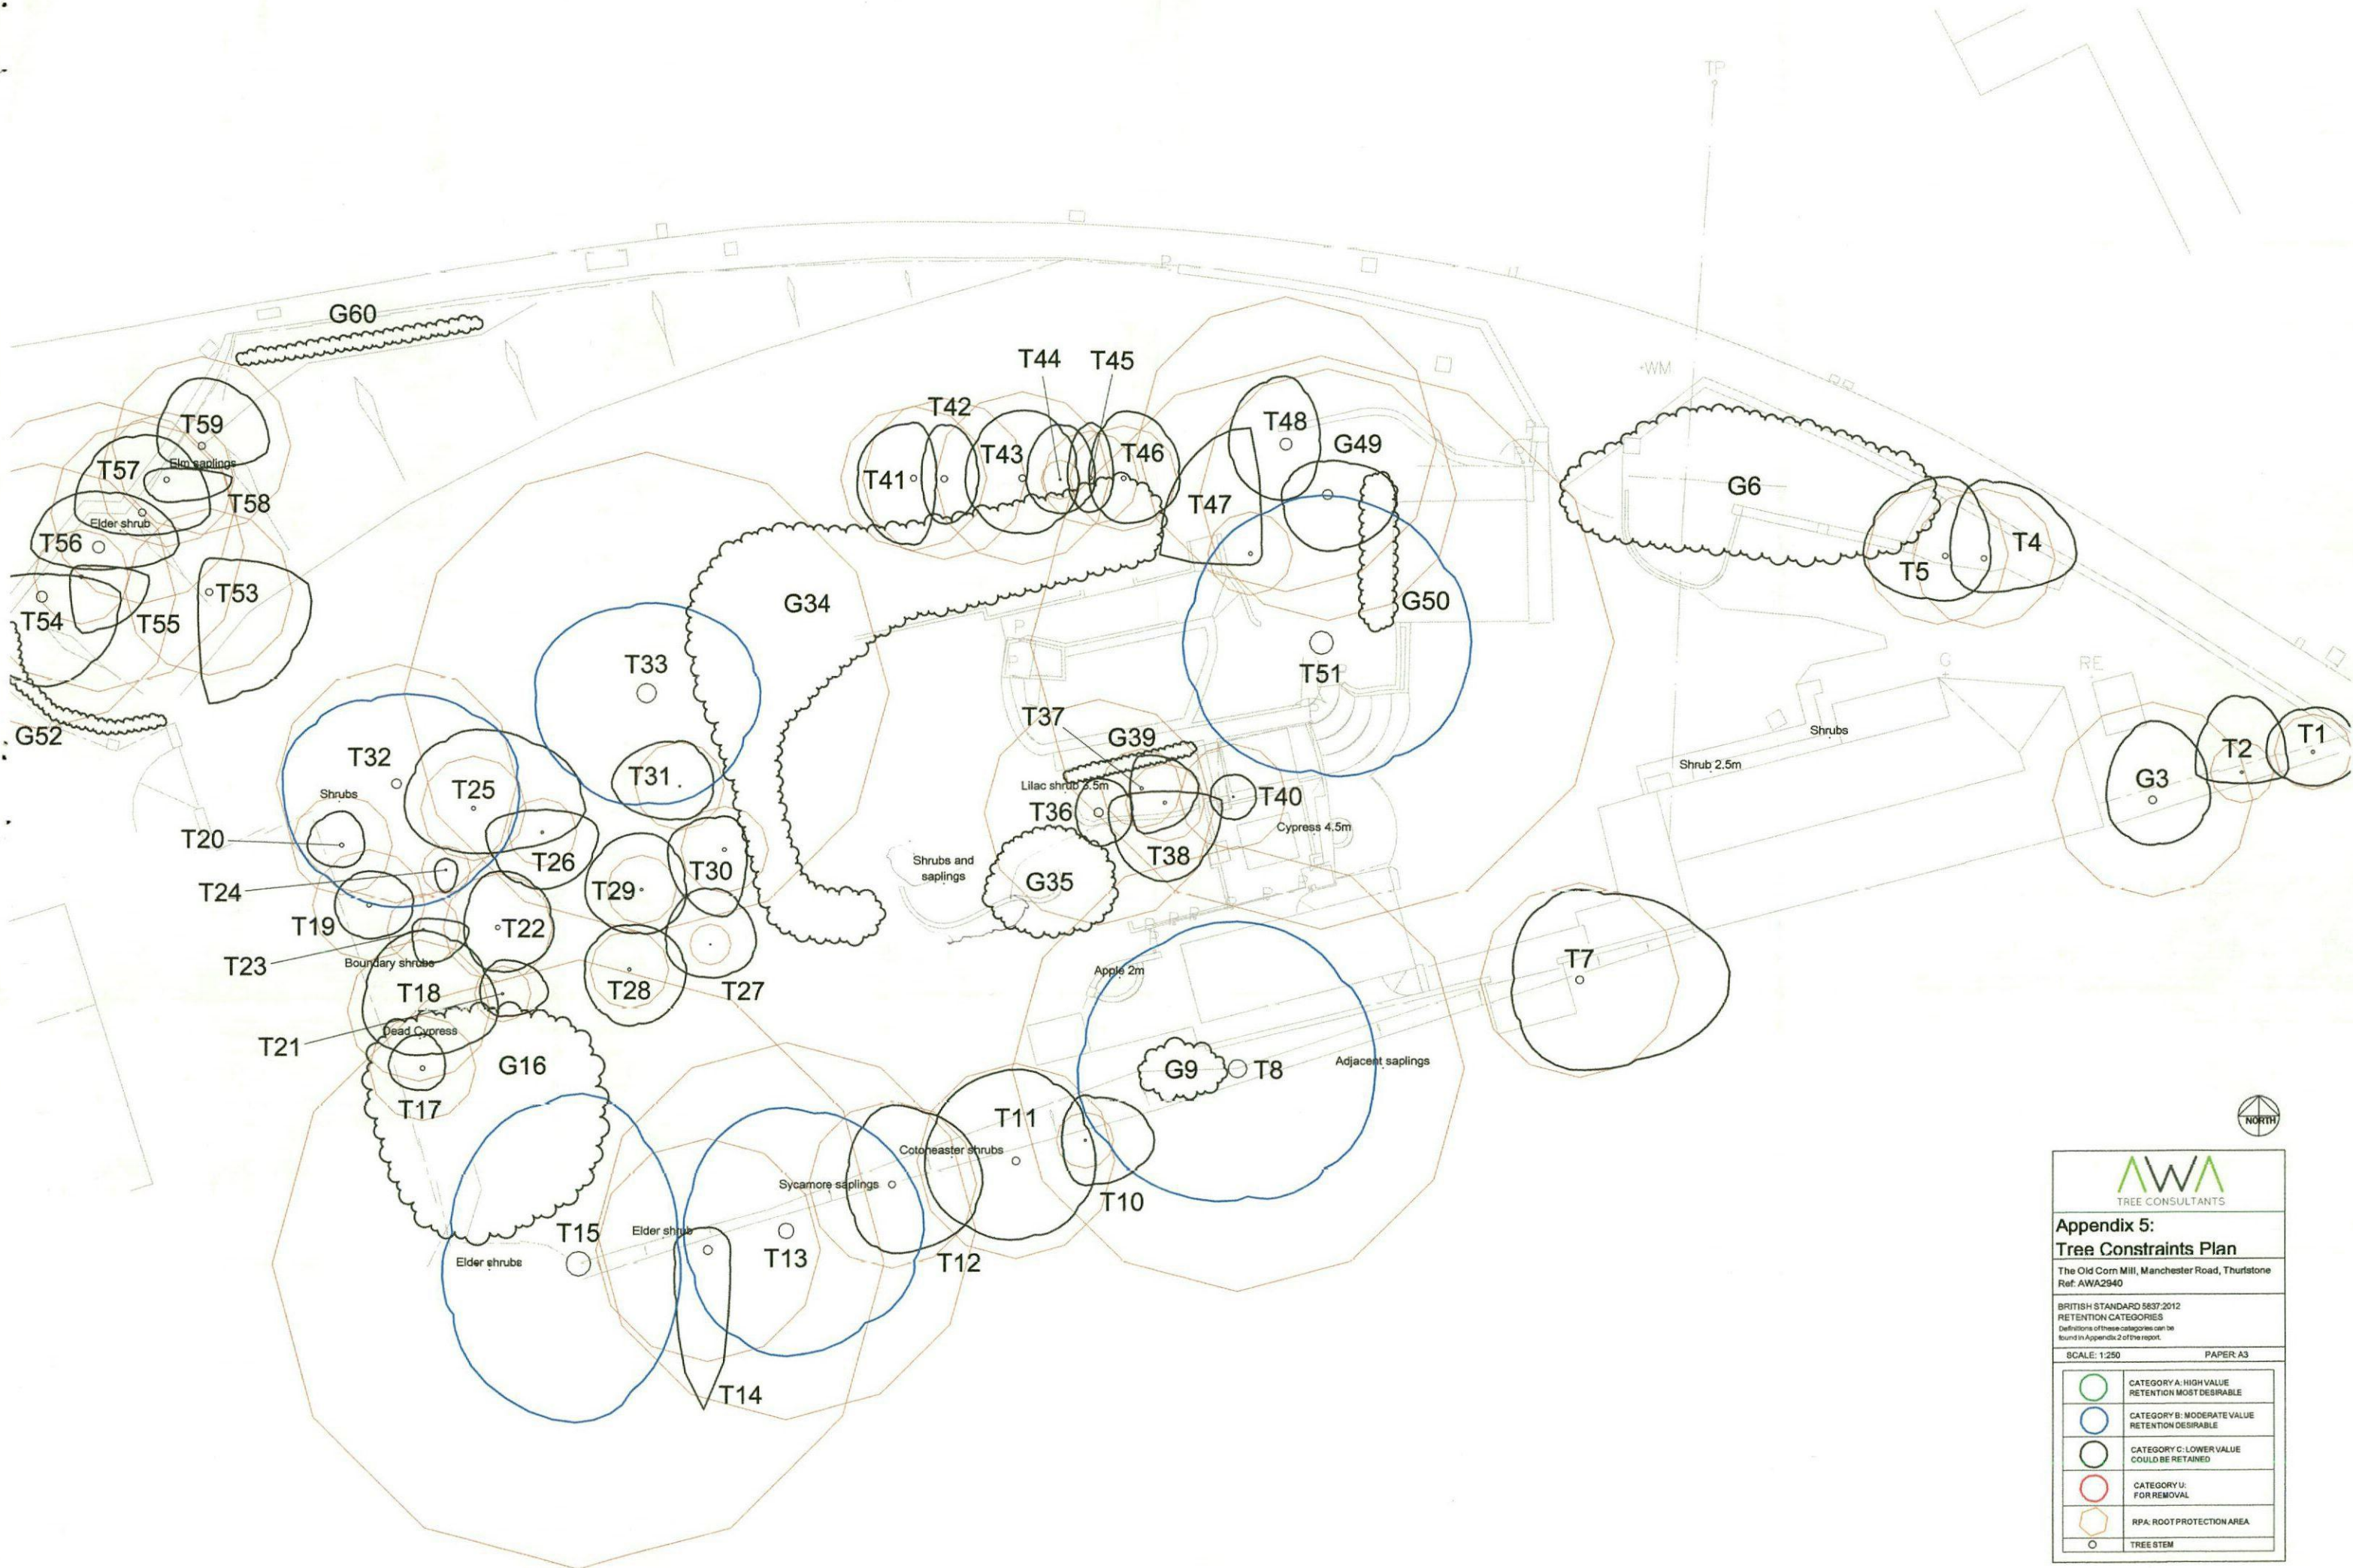
**C (marked in grey on Appendix 5) = trees which could be retained.** These trees are of low or average quality and value, and are in adequate condition to remain until new planting could be established.

**U (marked in red on Appendix 5) = trees for removal.** These trees are in such a condition that any existing value would be lost within 10 years.

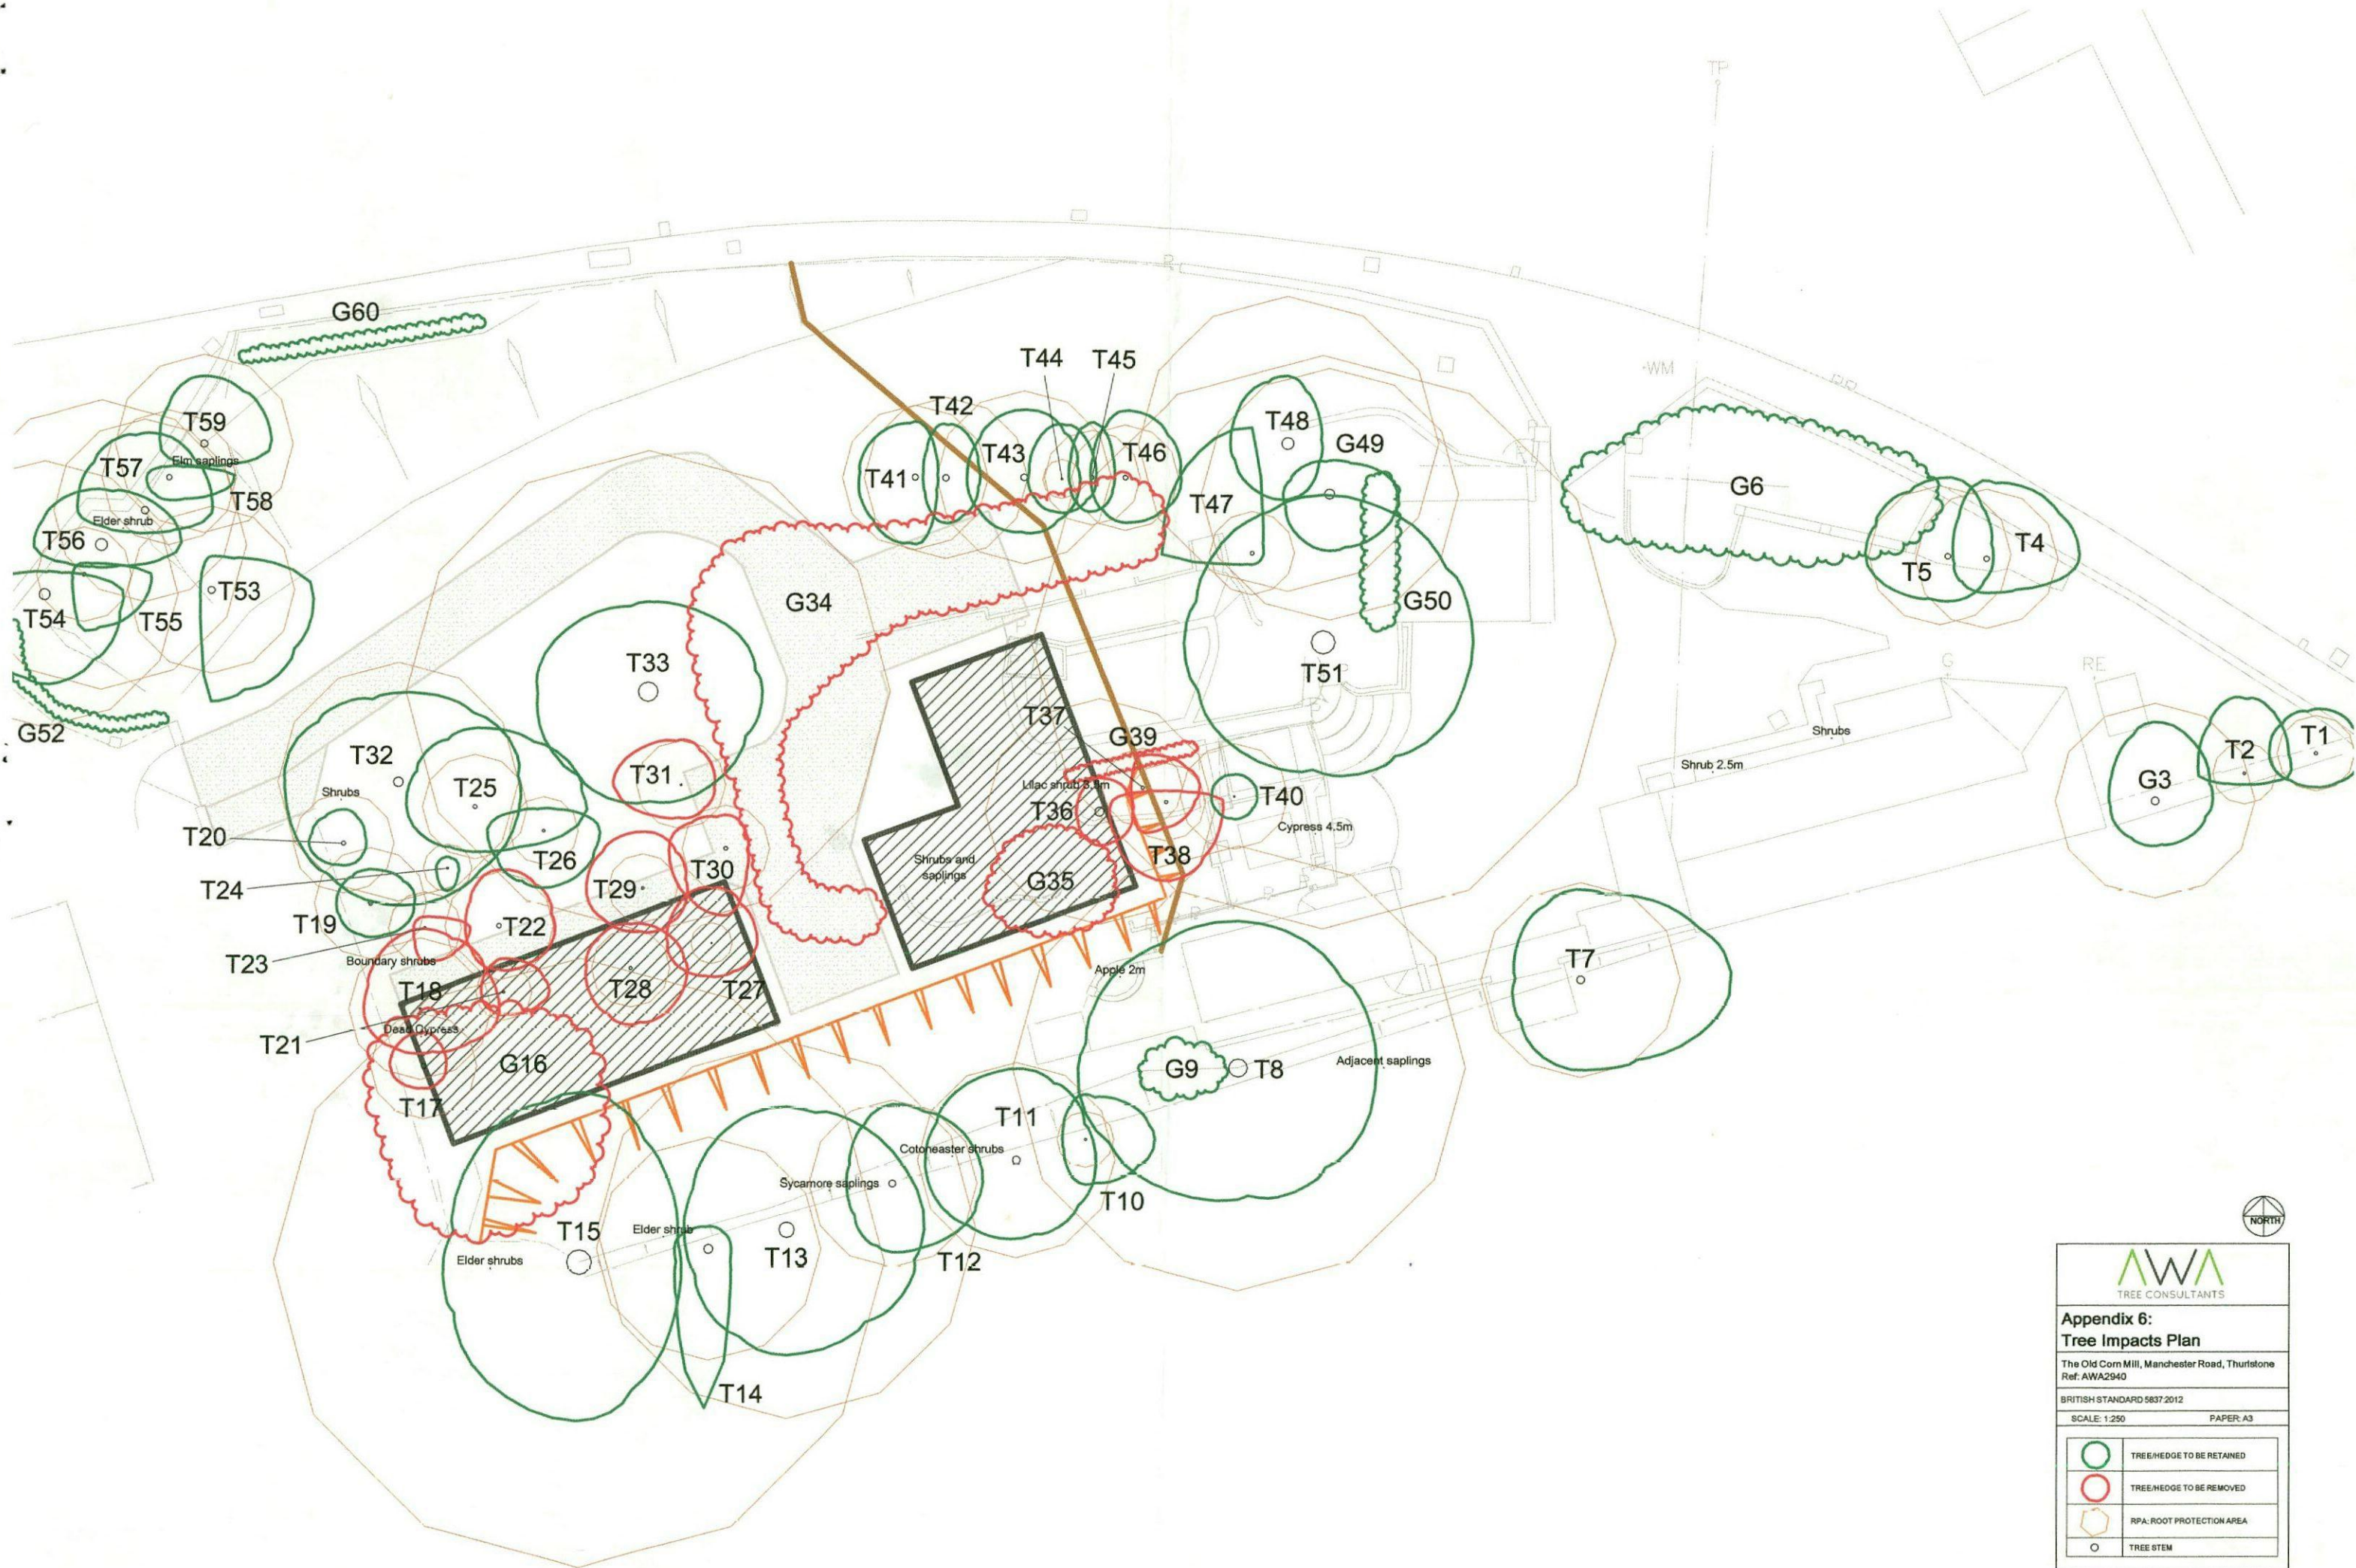
**Appendix 6:  
Tree Impacts Plan**

- 4.3.2 Potentially damaging activities are proposed in the vicinity of retained trees. The proposed new residential properties are within the RPA of retained trees T8, T12, T15 and T33. Construction within the RPA can have negative impacts on tree roots. However, it should be possible to employ special foundation design such as raft foundations, pile and suspended beam foundations or cantilevered foundations, in order to overcome or minimise any negative impact on the tree roots.

4.3.4 New boundary fencing is proposed within the RPA of retained trees T8, T41, T42 and T43. The encroachment into the tree's RPA should not significantly adversely impact on the health or future condition of the tree, provided posts and panels type footings are used as opposed to strip footings, with the holes for the posts dug by hand, and care is taken during the construction to avoid root damage.

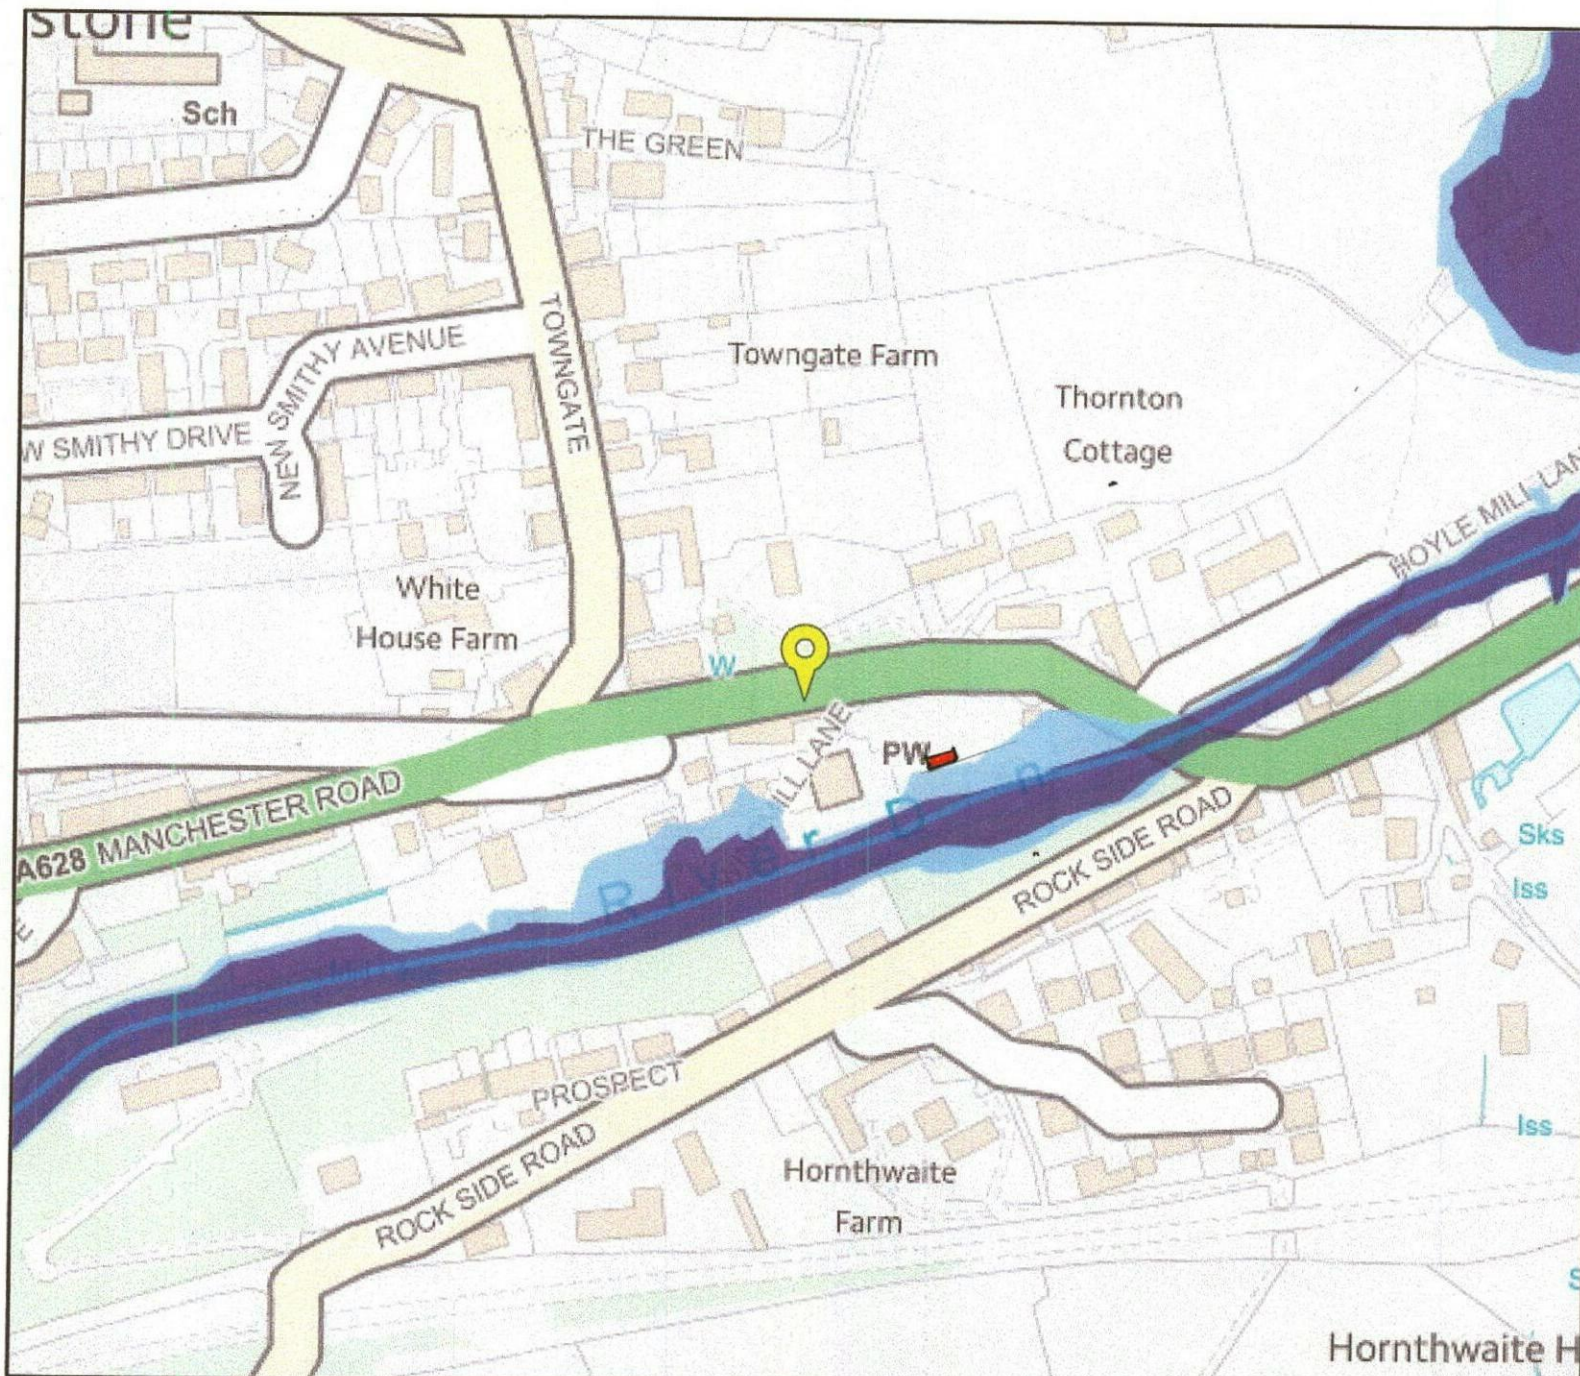
### Flood map for planning

This information relates to the selected location and is not specific to any property within it. The map is updated regularly and is correct at the time of printing.
