Weep Holes

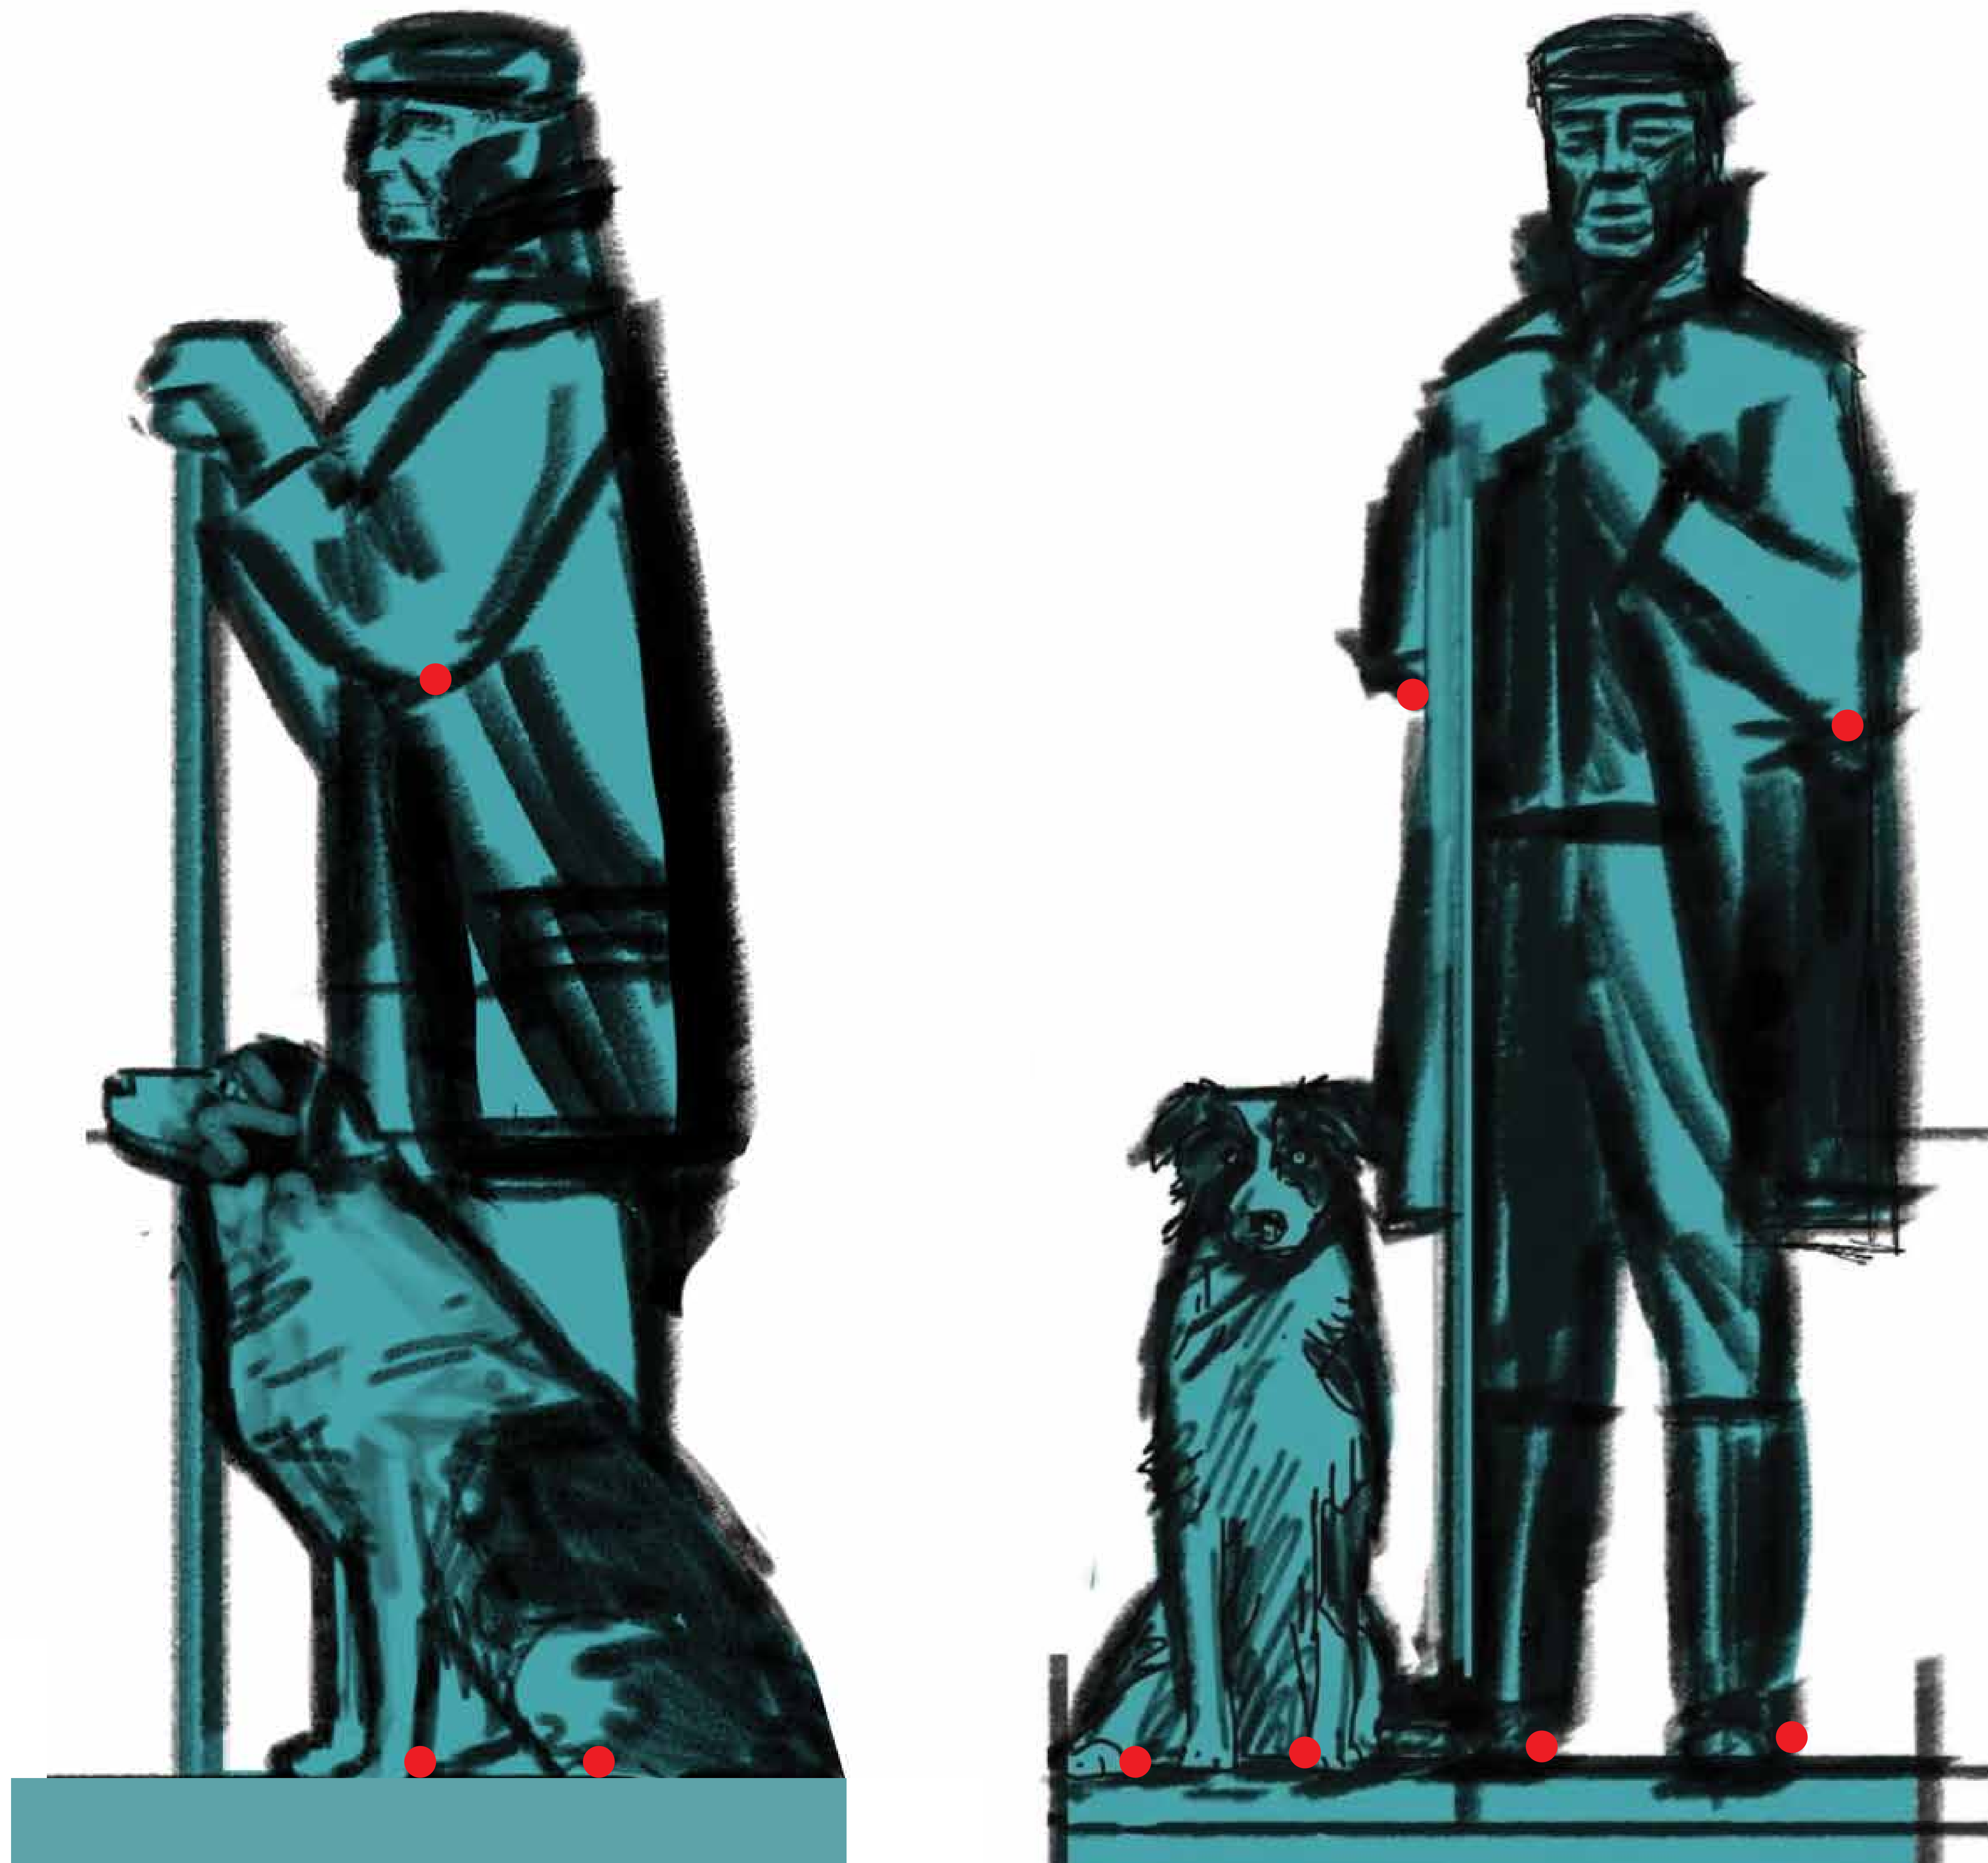
The location is shown in red on the below drawings.

The foundry have suggested that the weep holes are located on the Shepherd at the elbows and the feet. The dog will have weep holes at the base of the front legs and at the back legs.

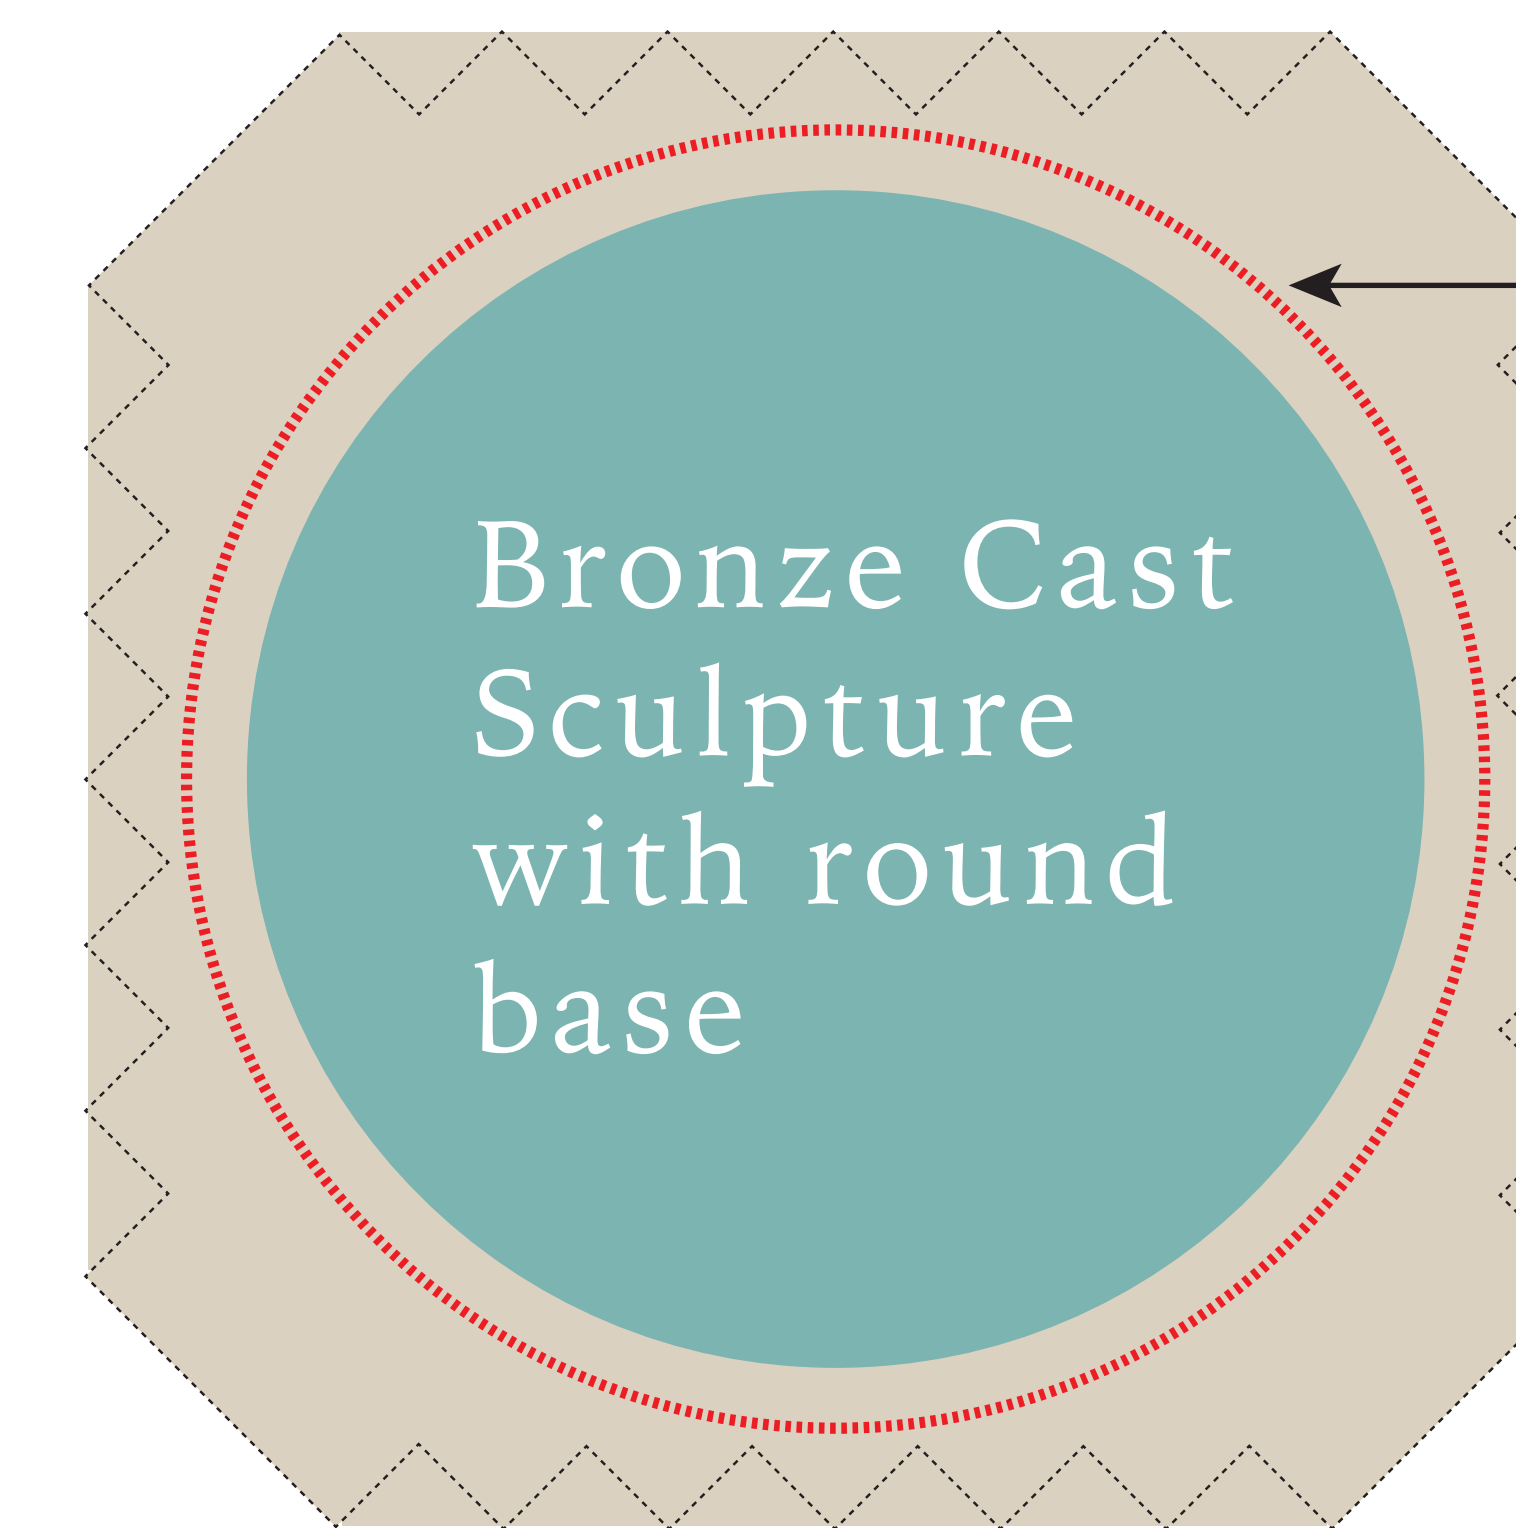
Top View

Red line indicates 15mm recessed 'basin' surrounding the base of the sculpture. This will capture run off and not be visible.

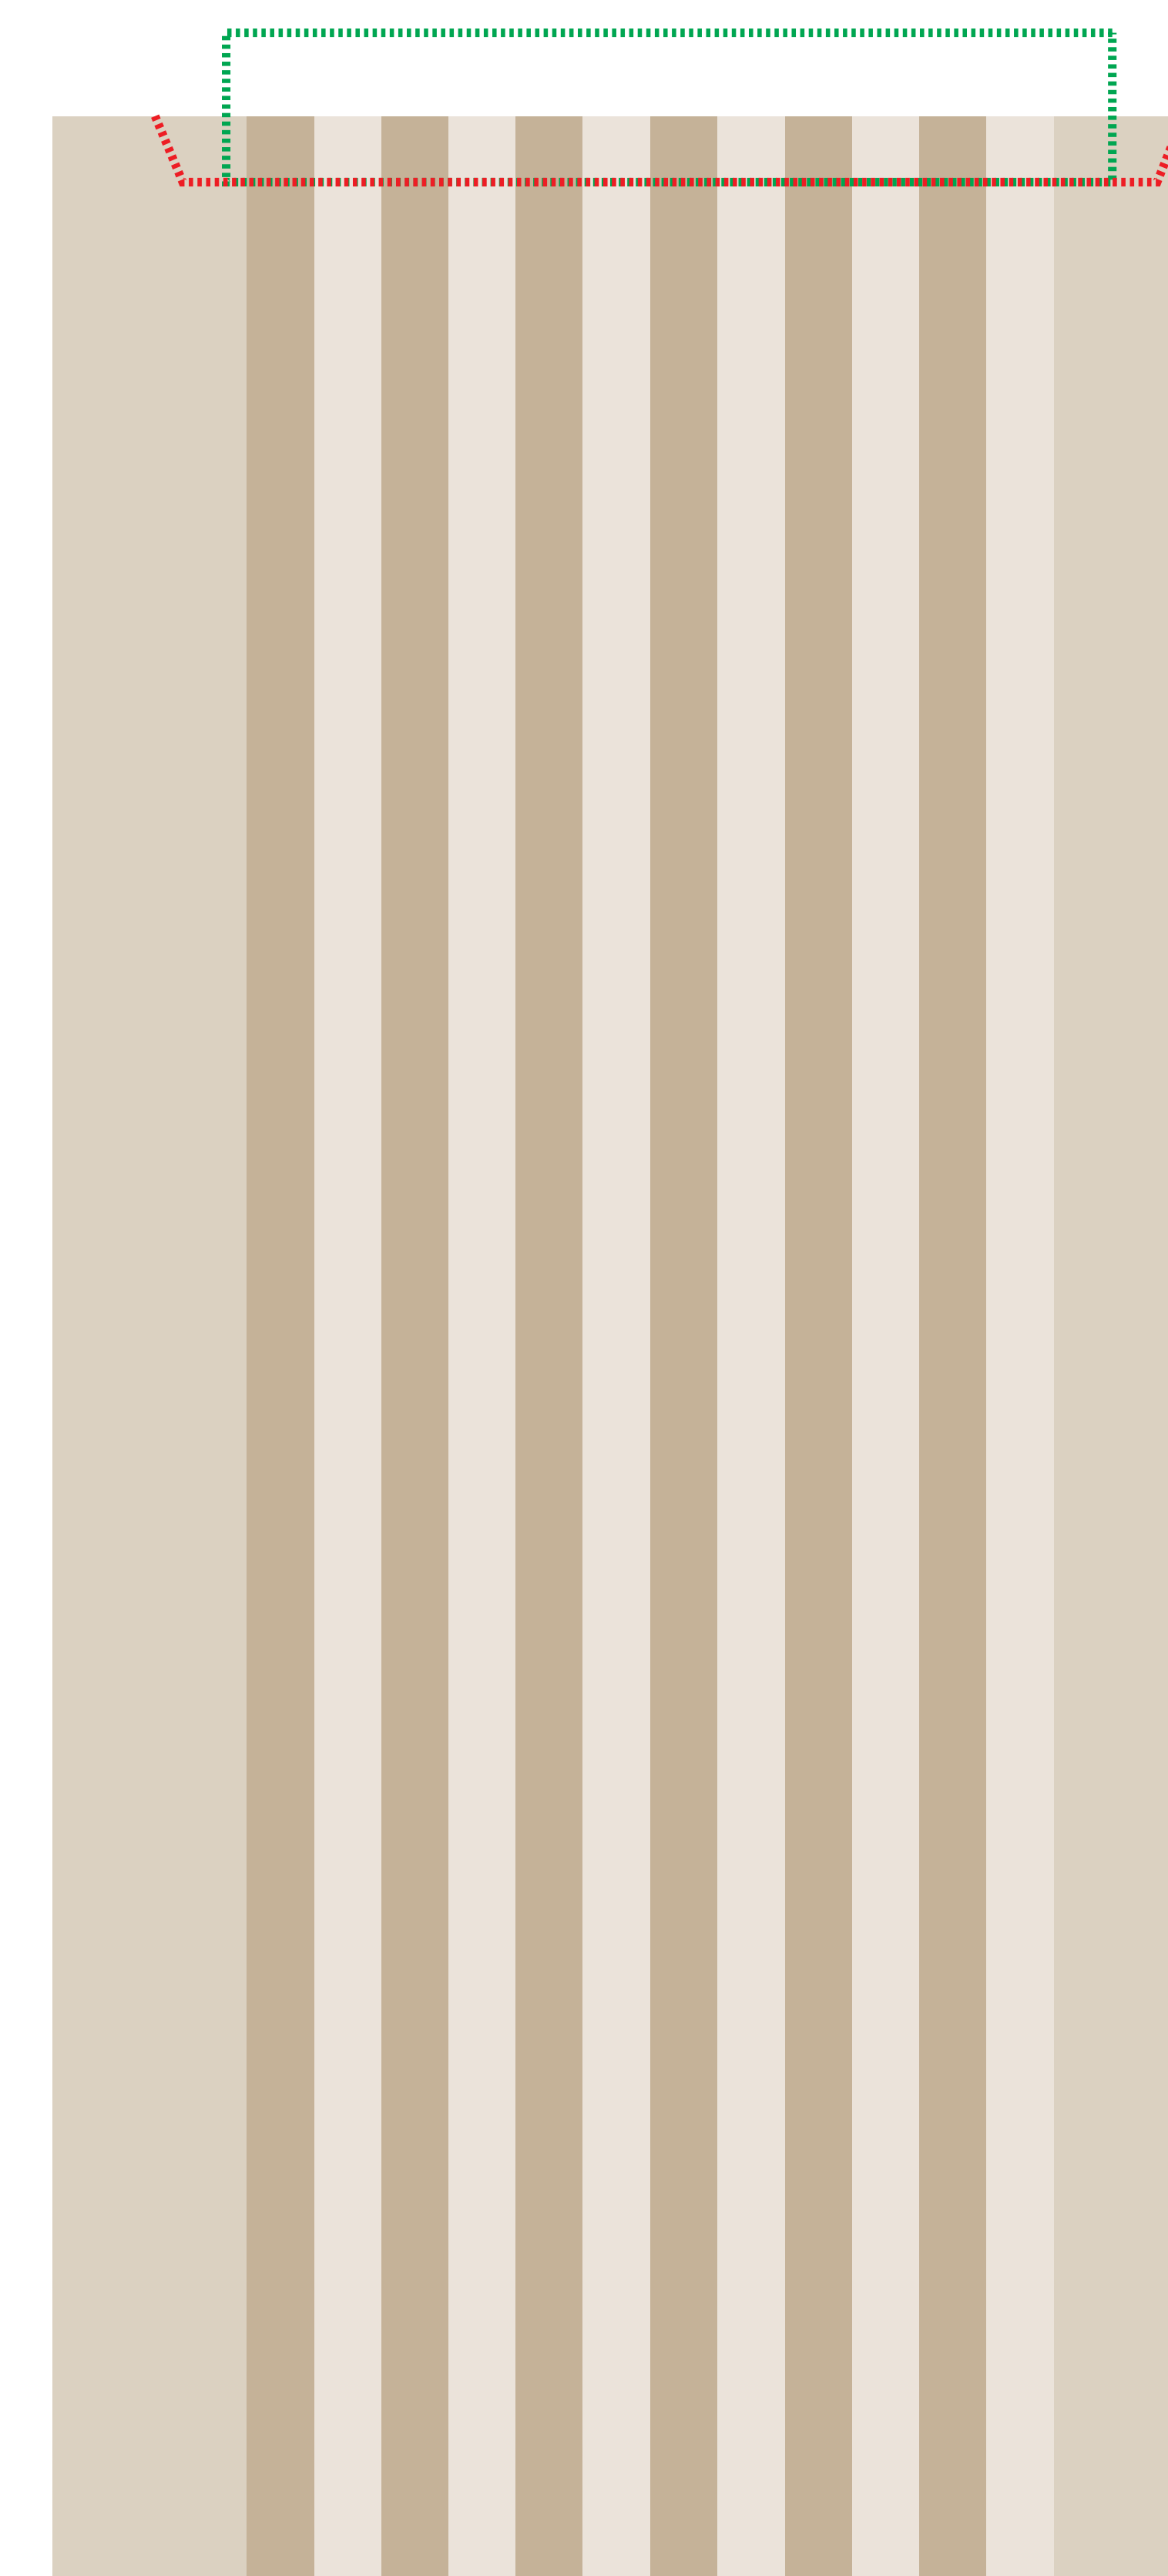
Side View

Red line cross section shows inner depth of recessed stone. This will help catch any run off, this means it discolouring due to run off will not be seen from the exterior view of column.
